CLOSURE REPORT

**BOPCO, L.P.
PLU #315H Flowline
Eddy County, New Mexico
Unit Letter "E", Section 13, Township 24 South, Range 30 East
Latitude 32.20739 North, Longitude 103.82718 West
NMOCD Reference #2RP-3207**

RE: Final Closure Report
Bopco – PLU #315H Flowline
UL-E, Section 13, Township 24 South, Range 30 East
Eddy County, New Mexico
NMOCD Reference # 2RP 3207

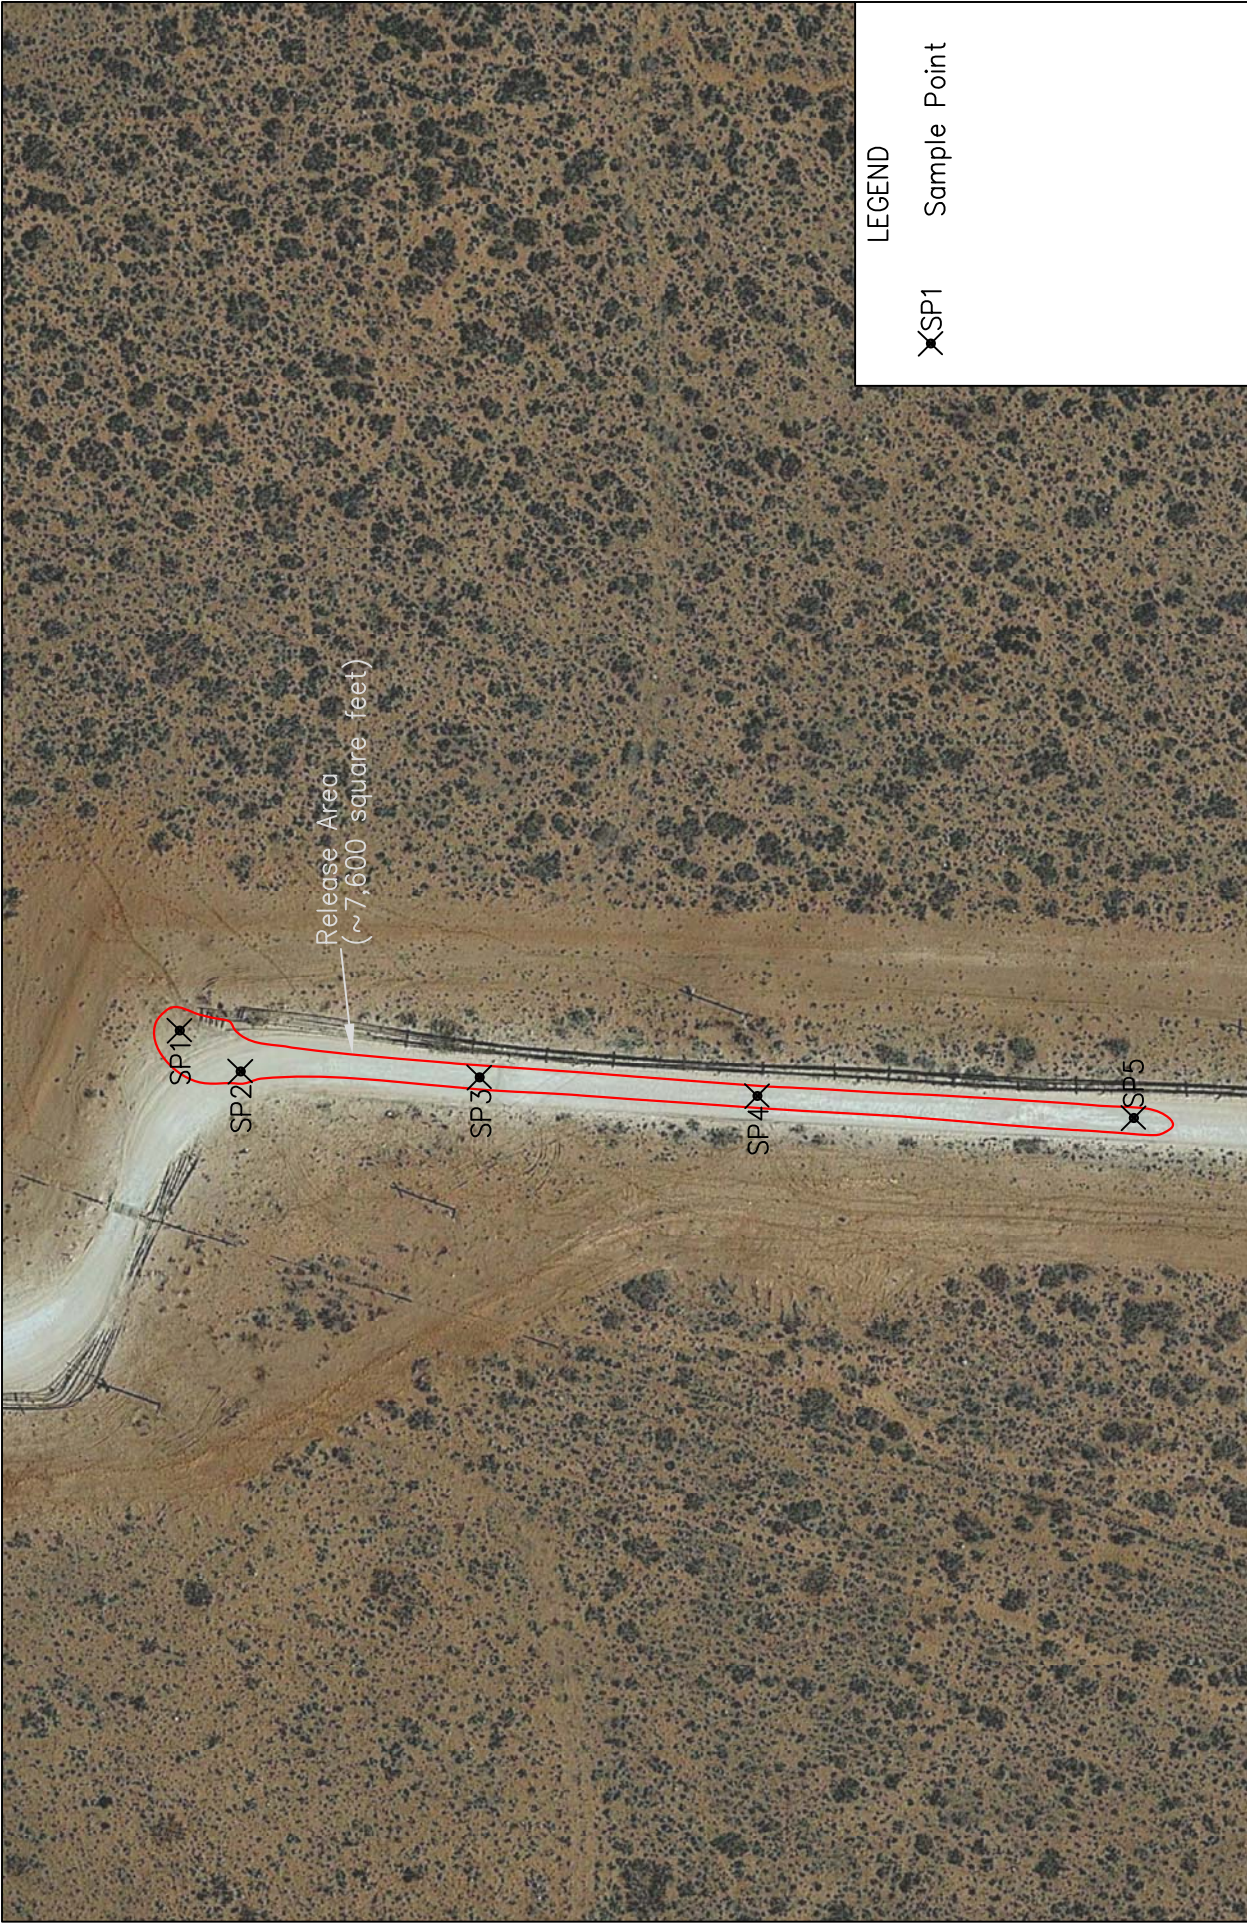
EPI personnel mobilized on the site on August 18, 2015 to collect soil samples to determine the vertical extent of contamination. A total of seventeen (17) soil samples were collected from five (5) sample locations; SP1 – SP5. Six (6) of the samples were sent to Cardinal Labs in Hobbs, New Mexico, for testing. Laboratory analytical results indicate, with the exception of SP1 at five and half (5.5) feet bgs, the release area is void of Benzene, BTEX, TPH and Chloride concentrations in excess of NMOCD Recommended Remedial Action Levels (RRALs) of 10 mg/Kg, 50 mg/Kg, 5,000 mg/Kg, and 1,000 mg/Kg, respectively (reference *Figure 3* and *Table 2*).

On August 25, 2015 two (2) additional, deeper, soil samples were collected from SP1 to determine depth of contamination in this area. One (1) of these samples, SP1 at nine (9) feet bgs, was sent to Cardinal Labs in Hobbs, New Mexico for testing. Laboratory analytical results indicate the area at nine (9) feet bgs is void of Benzene, BTEX, TPH and Chloride concentrations in excess of NMOCD RRALs of 10 mg/Kg, 50 mg/Kg, 5,000 mg/Kg, and 1,000 mg/Kg, respectively (reference *Figure 3* and *Table 2*).

The release area was excavated to a depth of two (2) feet bgs in the area of SP1; SP2 – SP5 were scraped up. Approximately 26.81 tons of contaminated soil were excavated and hauled to a state approved facility for disposal.

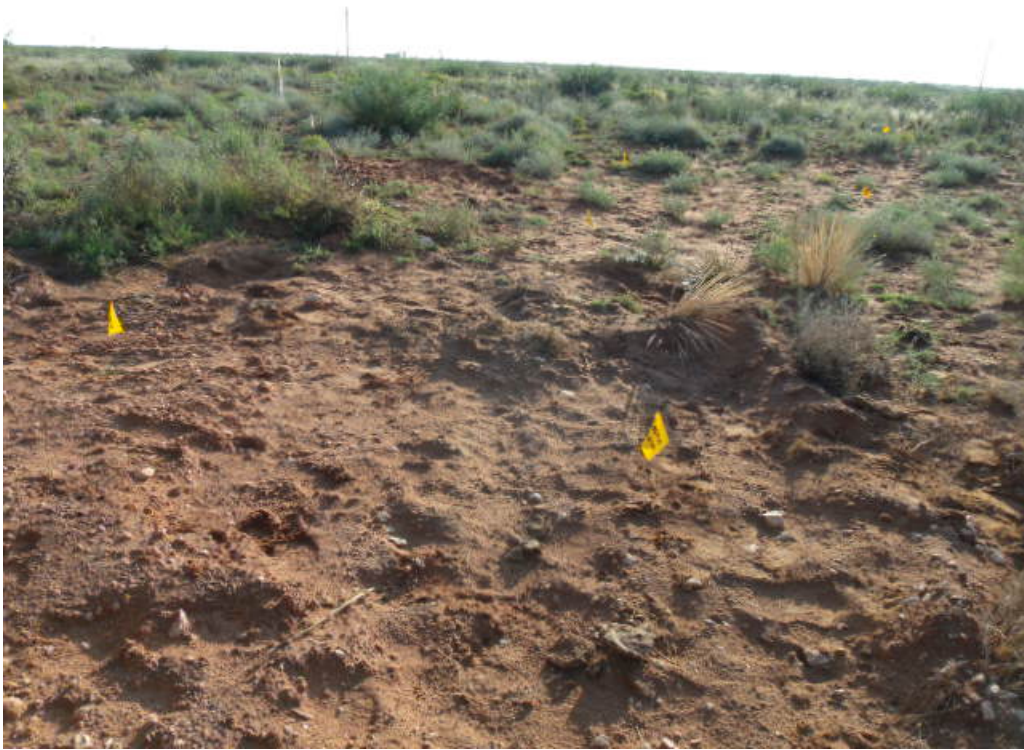
Photograph #1 – Looking across release area

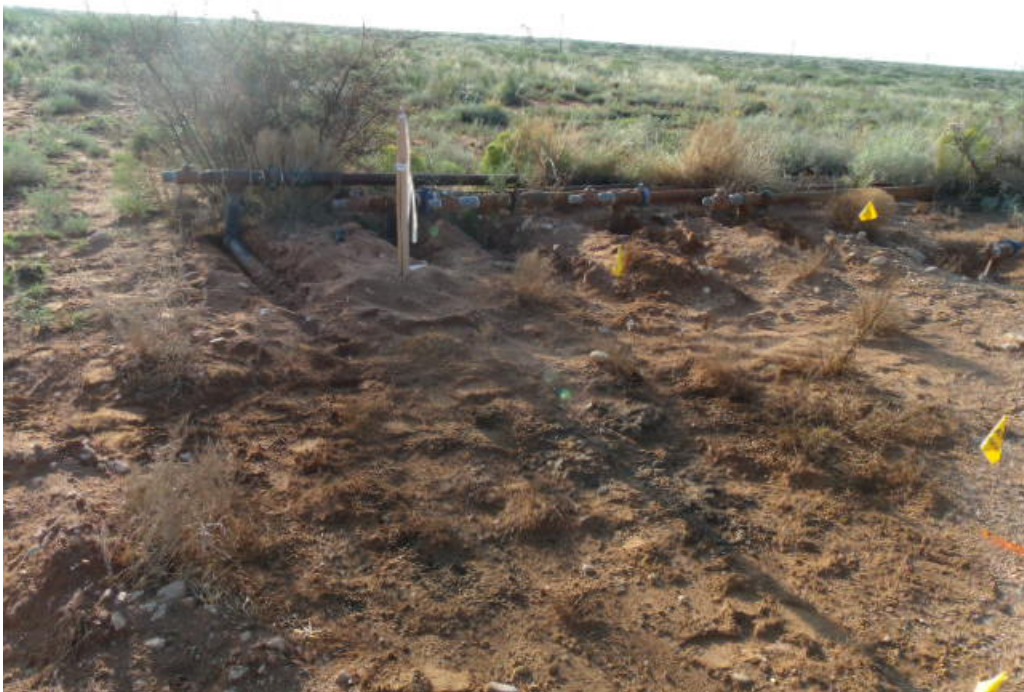
Photograph #2 – Looking across release area

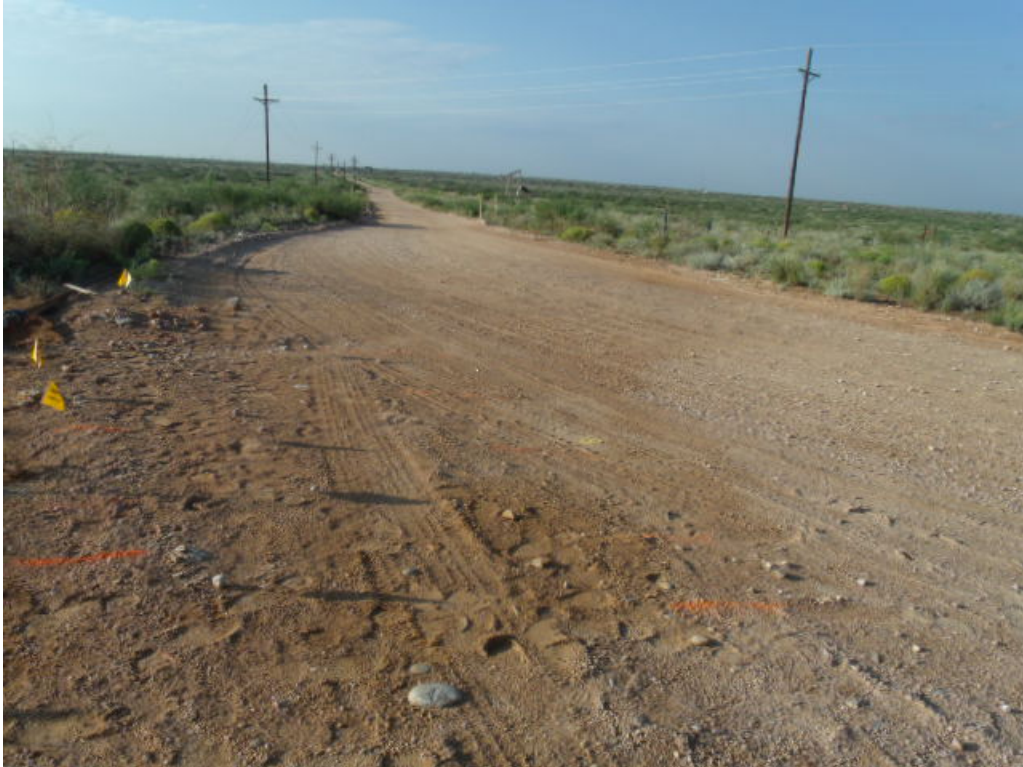
Photograph #3 – Looking across release area

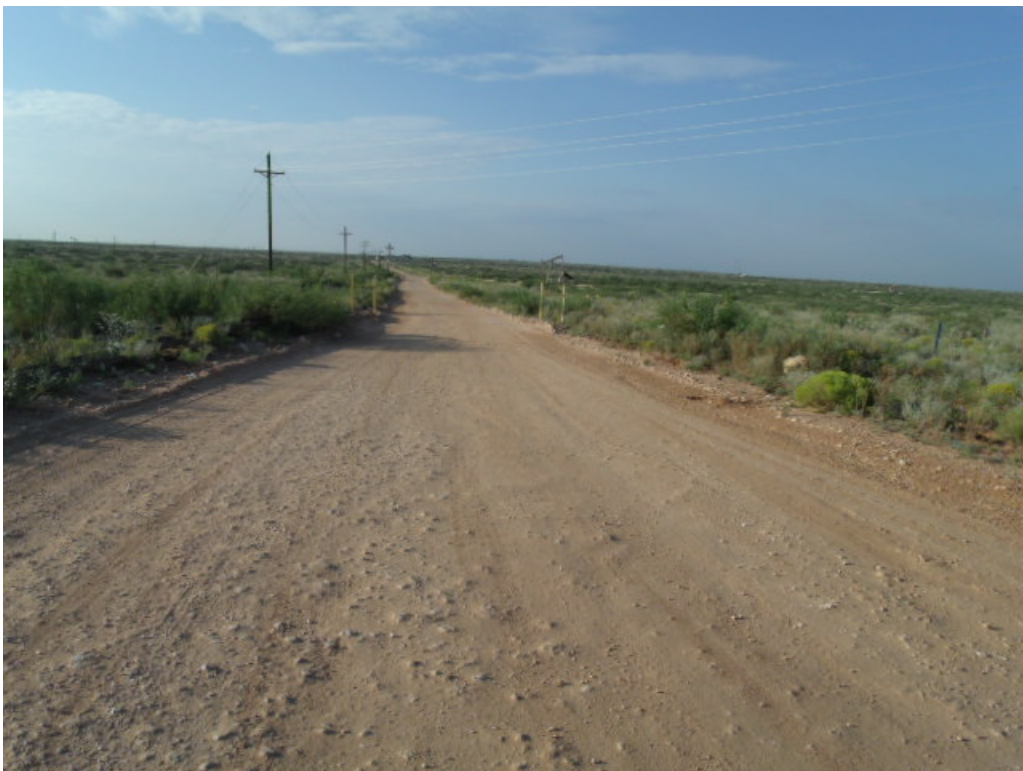
Photograph #4 – Looking across release area

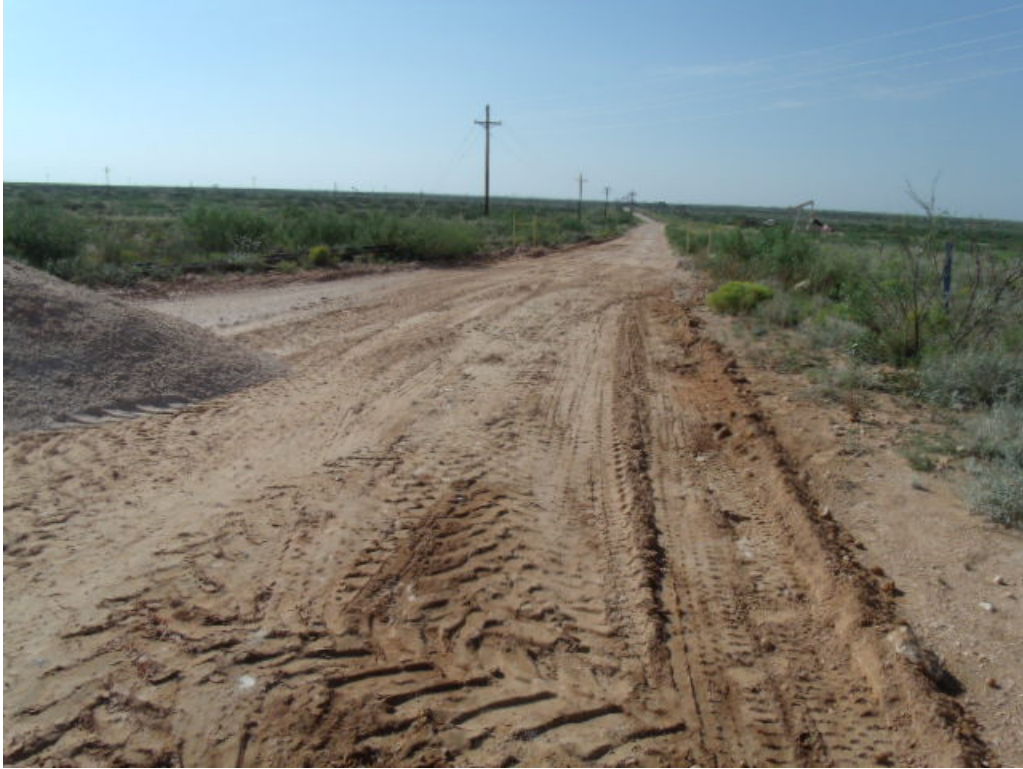
Photograph #5 – Excavated area

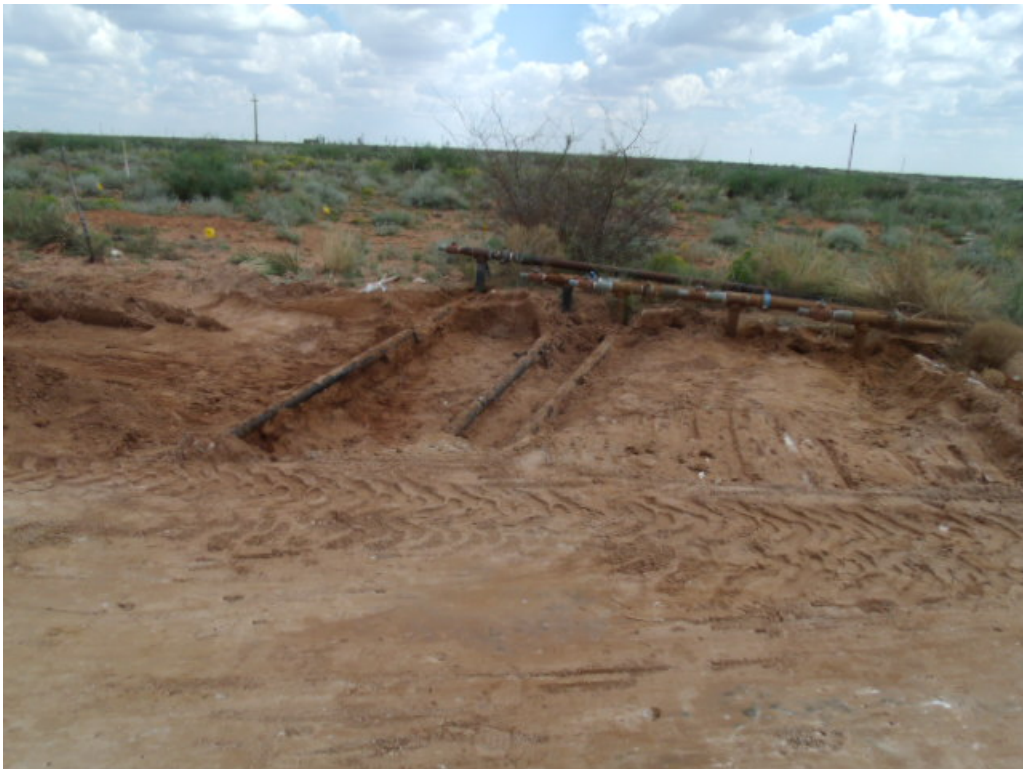
Photograph #6 – Excavated area

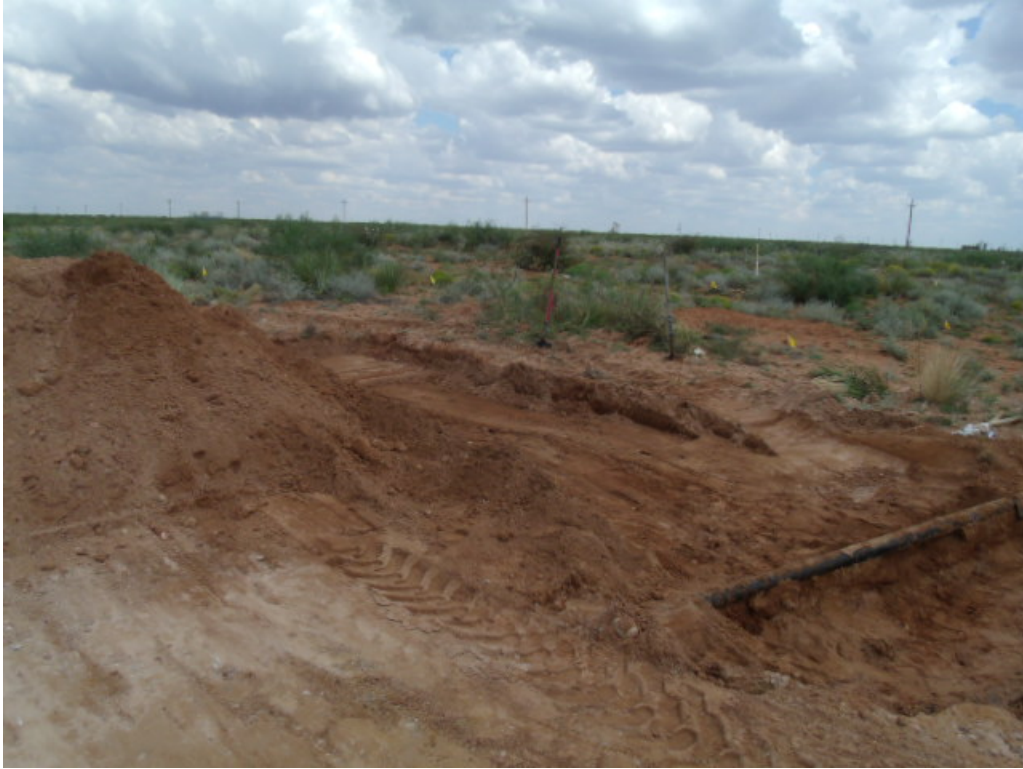
Photograph #7 – Excavated area

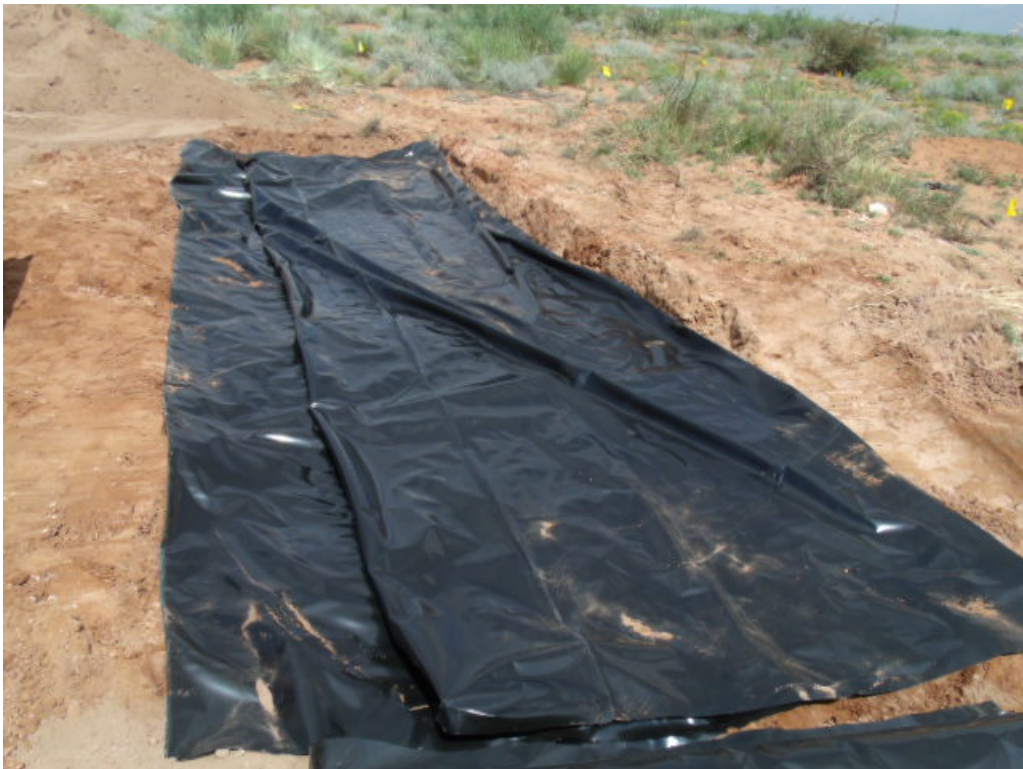
Photograph #8 – Liner installed

On September 25, 2015 a 20 mil thick poly-ethylene liner was installed in the area of SP1 (reference *Figure 4*). After installation of liner the road and excavation were backfilled with approximately 26.81 tons of clean soil. All soil was free of rocks, clumps or deleterious material. The entire disturbed area was then contoured to blend with existing lease road area and protected against wind/water erosion.

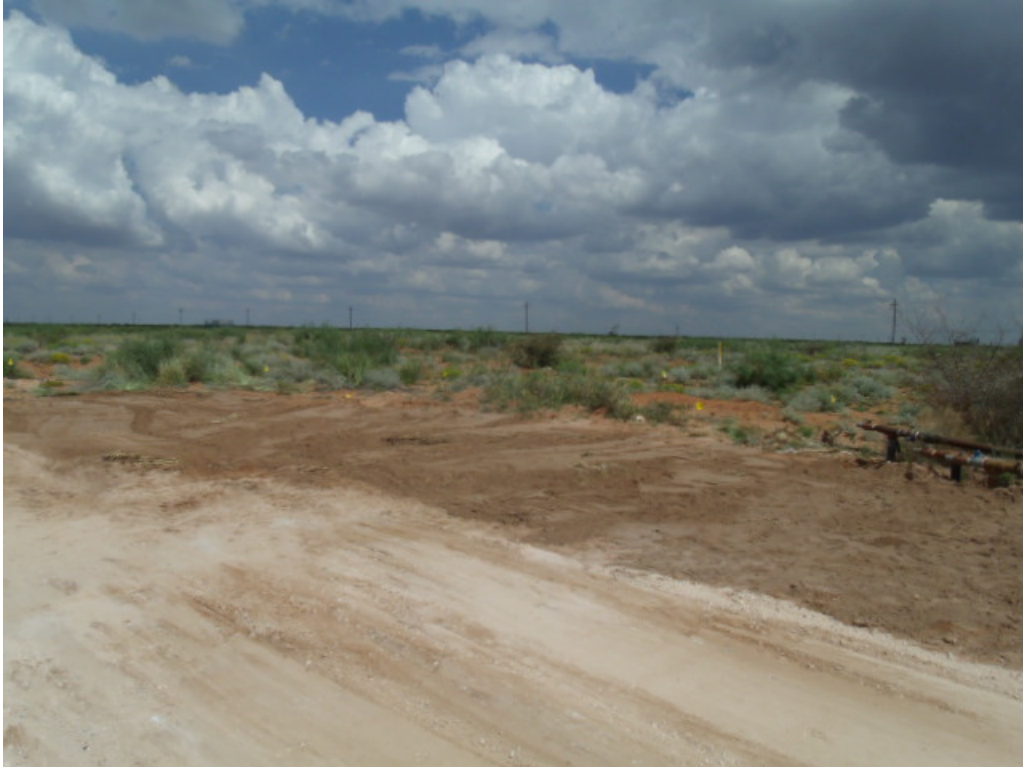
Photograph #9 – Backfilled area

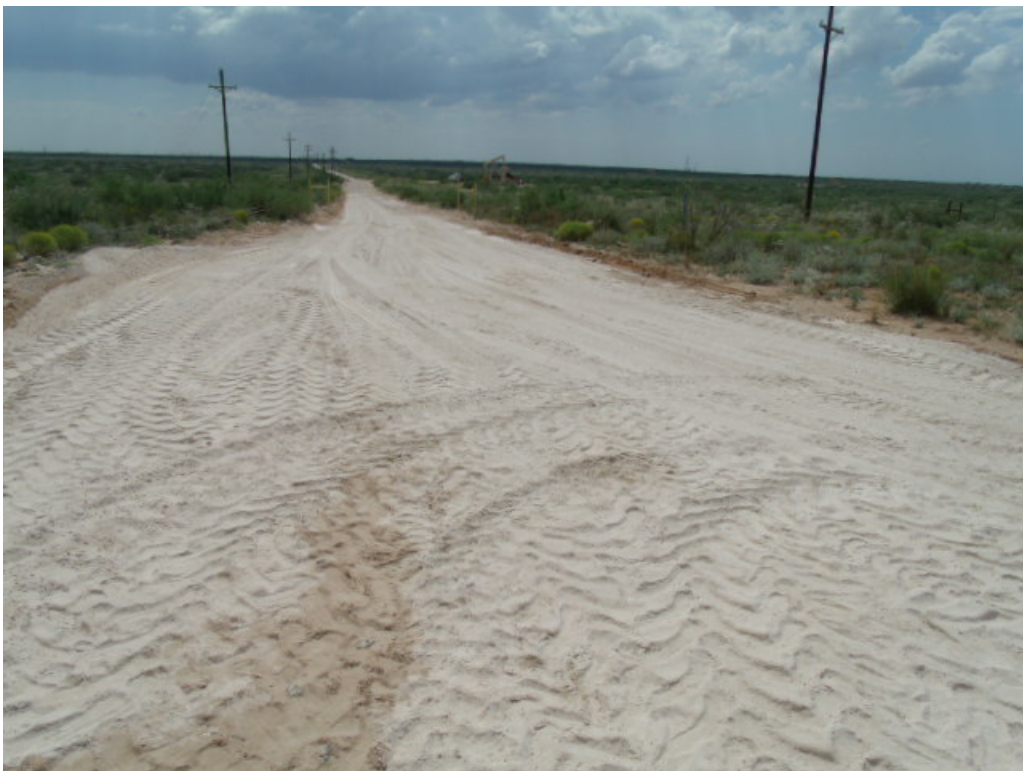
Photograph #10 – Backfilled area
