CLOSURE REPORT

BOPCO, L.P.
Big Sinks 2-24-30 State #2H
Eddy County, New Mexico
Unit Letter "E", Section 2, Township 24 South, Range 30 East
Latitude 32.24762 North, Longitude 103.85899 West
NMOCD Reference #2RP-3215

RE: Final Closure Report
Bopco – Big Sinks 2-24-30 State #2H
UL-E, Section 2, Township 24 South, Range 30 East
Eddy County, New Mexico
NMOCD Reference # 2RP 3215

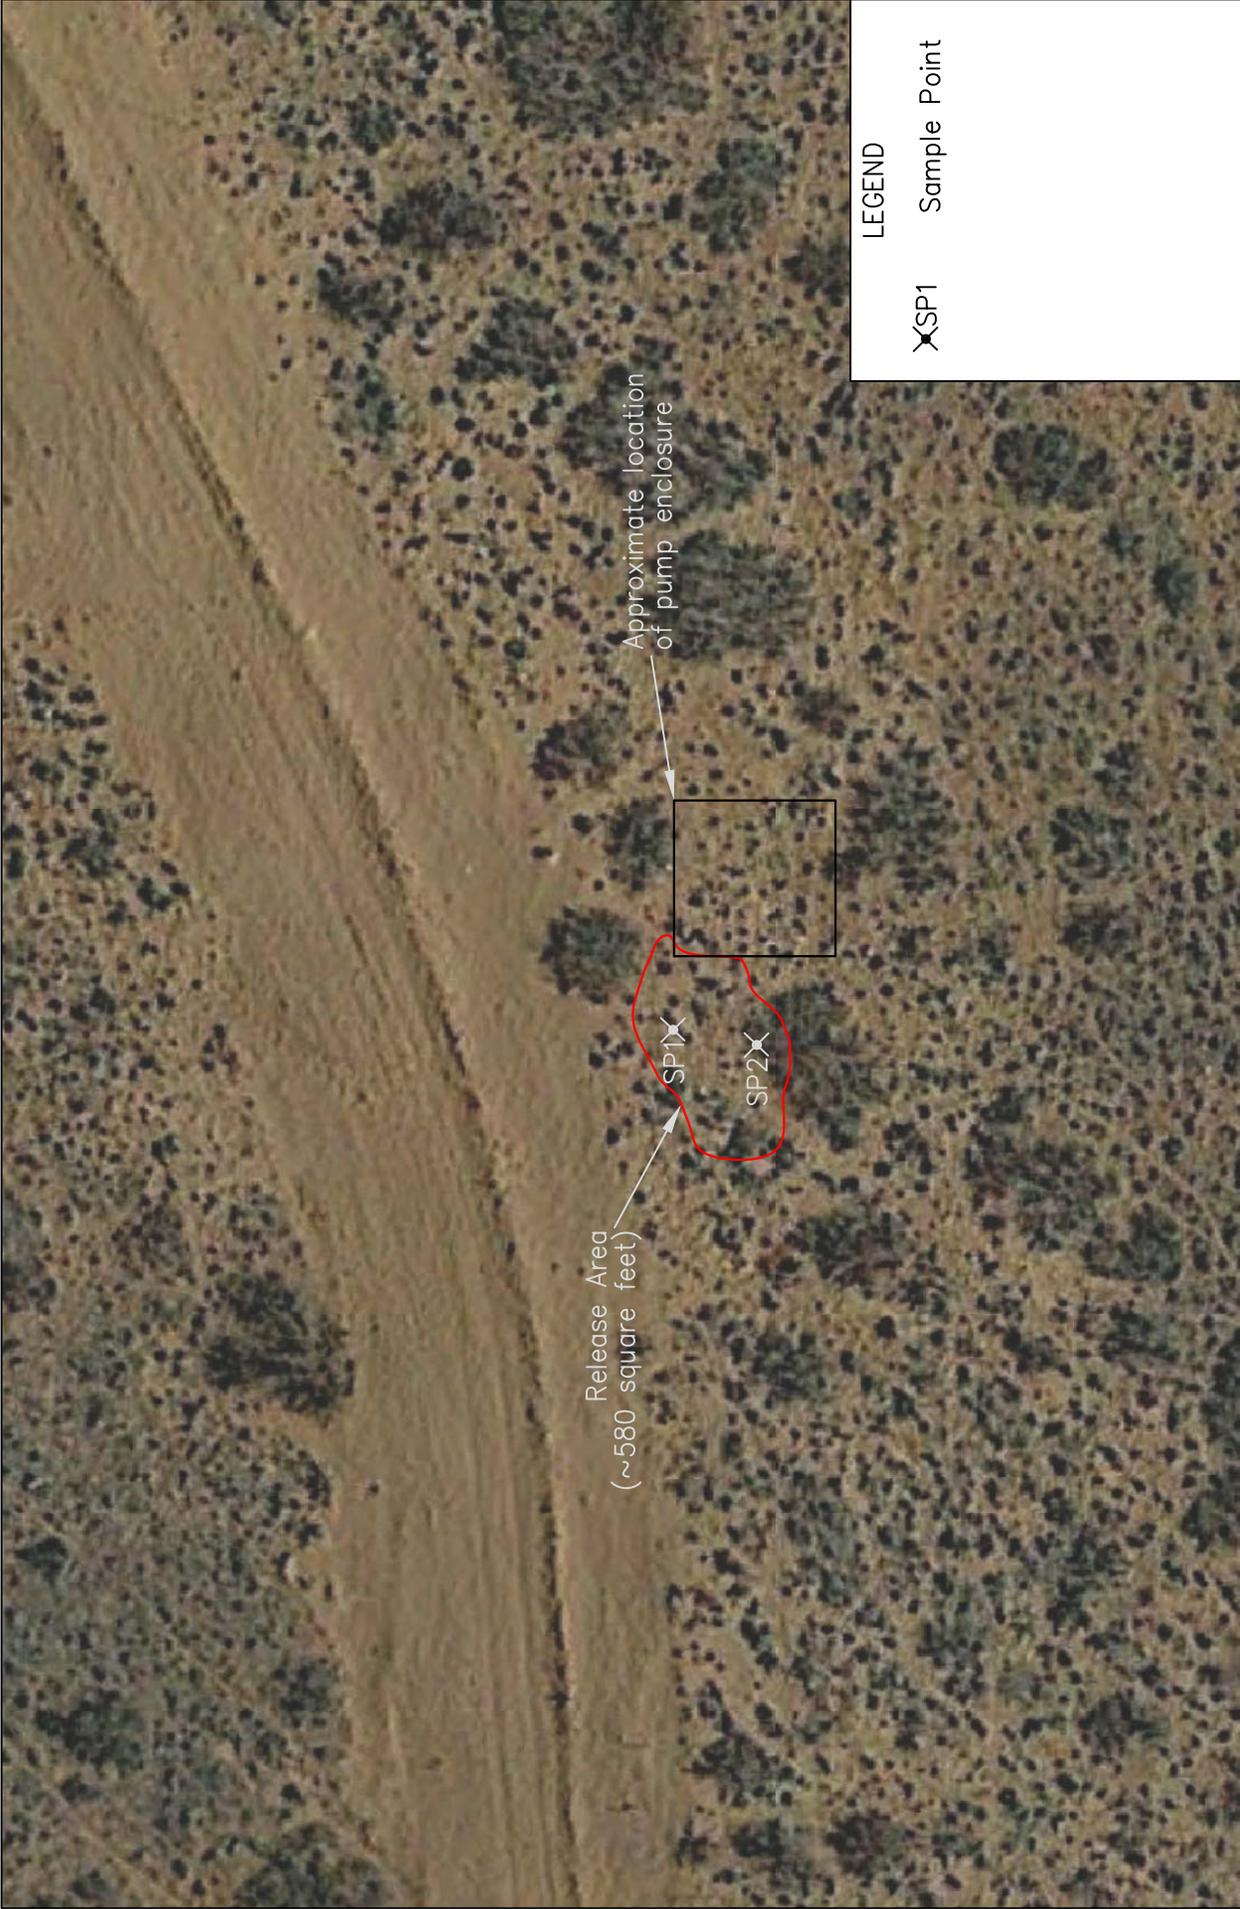
Figure 3
Site/Sample Map
Bopco, L.P.
Big Sinks 2-24-30 State #2H

Release Area
(~580 square feet)

Approximate location
of pump enclosure

SP1

SP2

EPI personnel mobilized on the site on August 28, 2015 to collect soil samples via hand auger to determine the vertical extent of contamination. A total of seven (7) soil samples were collected from two (2) sample locations; SP1 and SP2. Four (4) representative samples, two (2) from each sample location, were sent to Cardinal Labs in Hobbs, New Mexico, for testing. Laboratory analytical results indicate the release area is void of Benzene, BTEX, TPH, and Chloride concentrations in excess of NMOCD Recommended Remedial Action Levels (RRALs) of 10 mg/Kg, 50 mg/Kg and 5,000 mg/Kg, and 1,000 mg/Kg, respectively (reference *Figure 3* and *Table 2*).

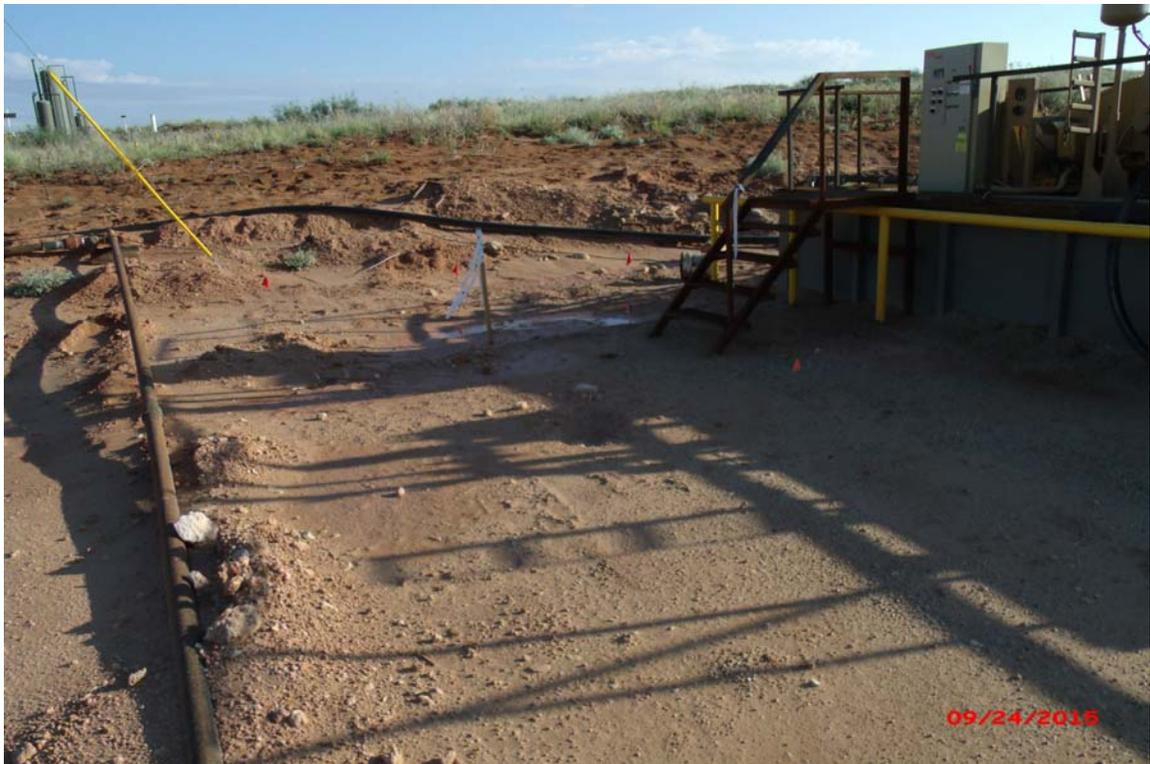
Photograph #2 – Looking across release area

A ¼ inch high pressure hose failed on murphy kill. 35 barrels of produced water were released, 30 barrels being inside the lined containment. The fluid inside the containment was recovered via vacuum truck. The high pressure hose was replaced. A vacuum truck was called to the location and was able to recover 30 barrels PW from inside the lined containment.

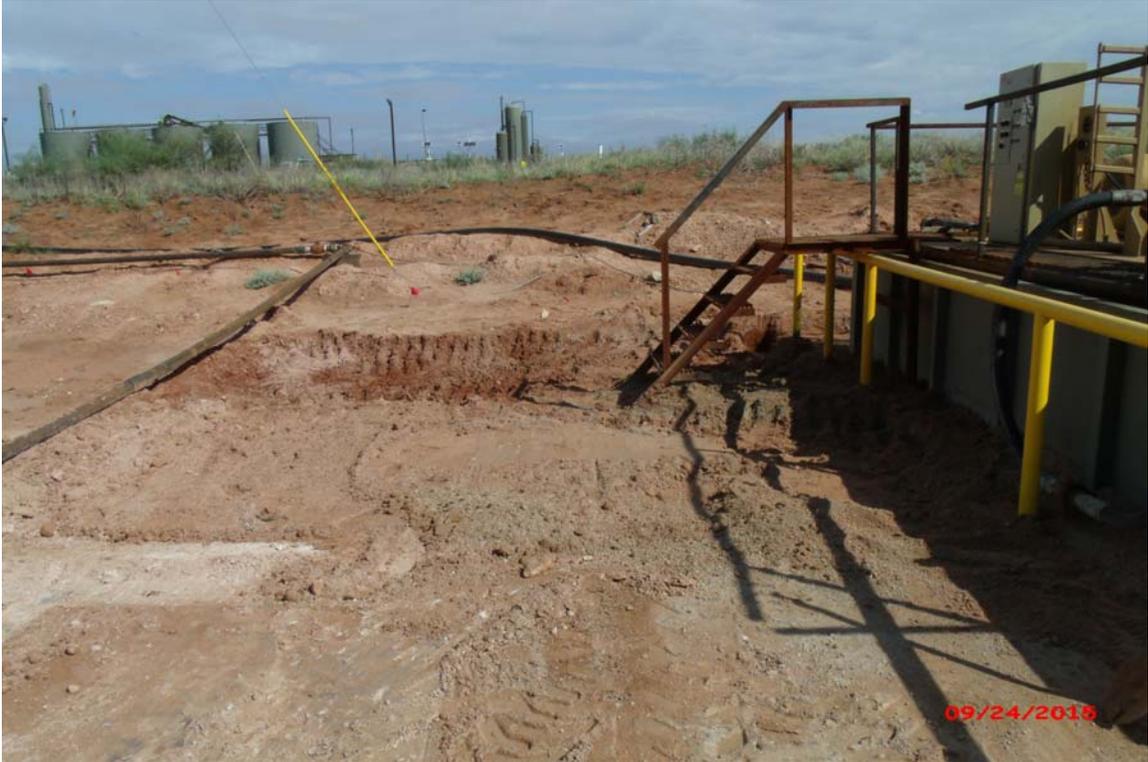
Photograph #3 – Excavated area

On September 24, 2015 the release area was excavated to a depth of one (1) foot bgs with approximately 11 tons of contaminated soil excavated and hauled to a state approved facility for disposal.

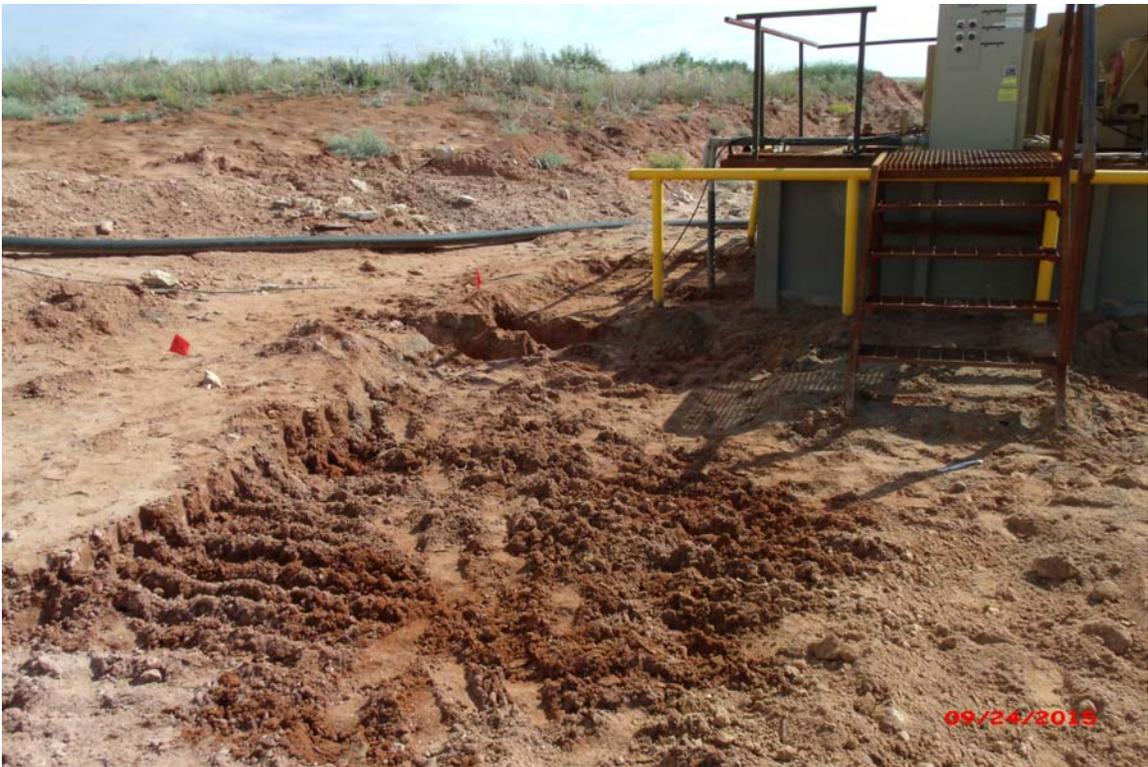
Photograph #4 – Excavated area

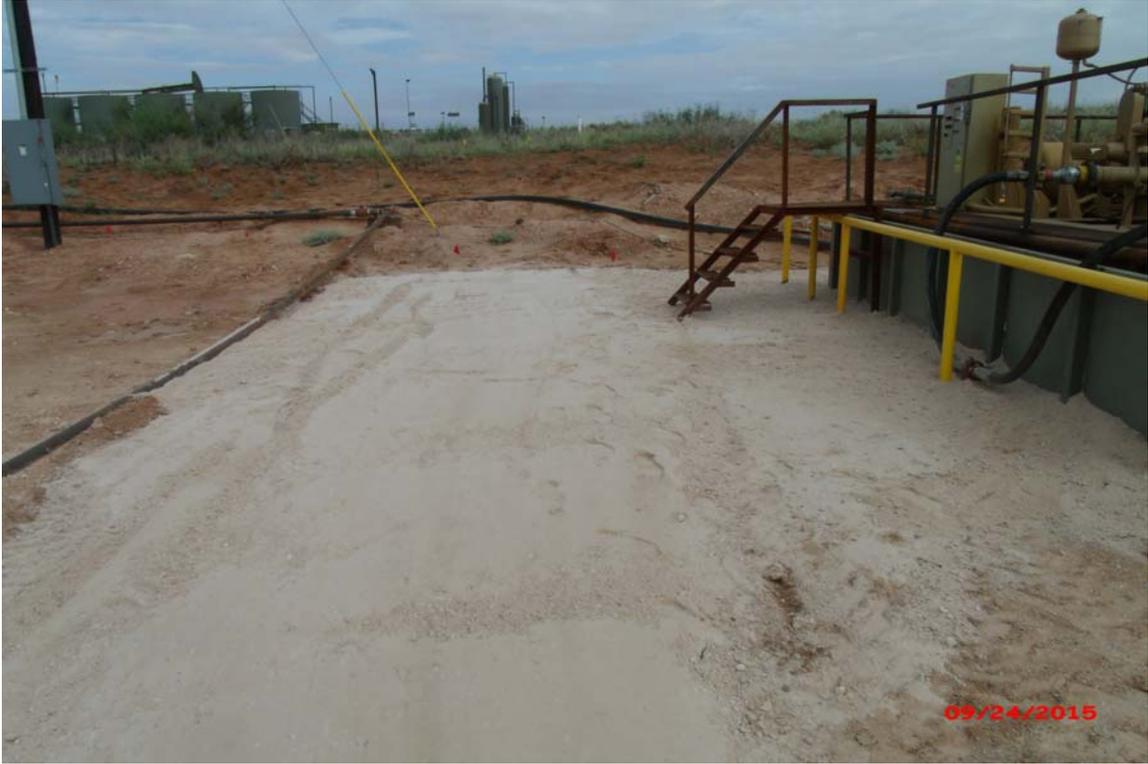
Photograph #5 – Backfilled area

After excavation activities were completed the excavation was backfilled with approximately 11 tons of clean caliche. All soil was free of rocks, clumps or deleterious material. The entire disturbed area was then contoured to blend with existing pad area and protected against wind/water erosion.

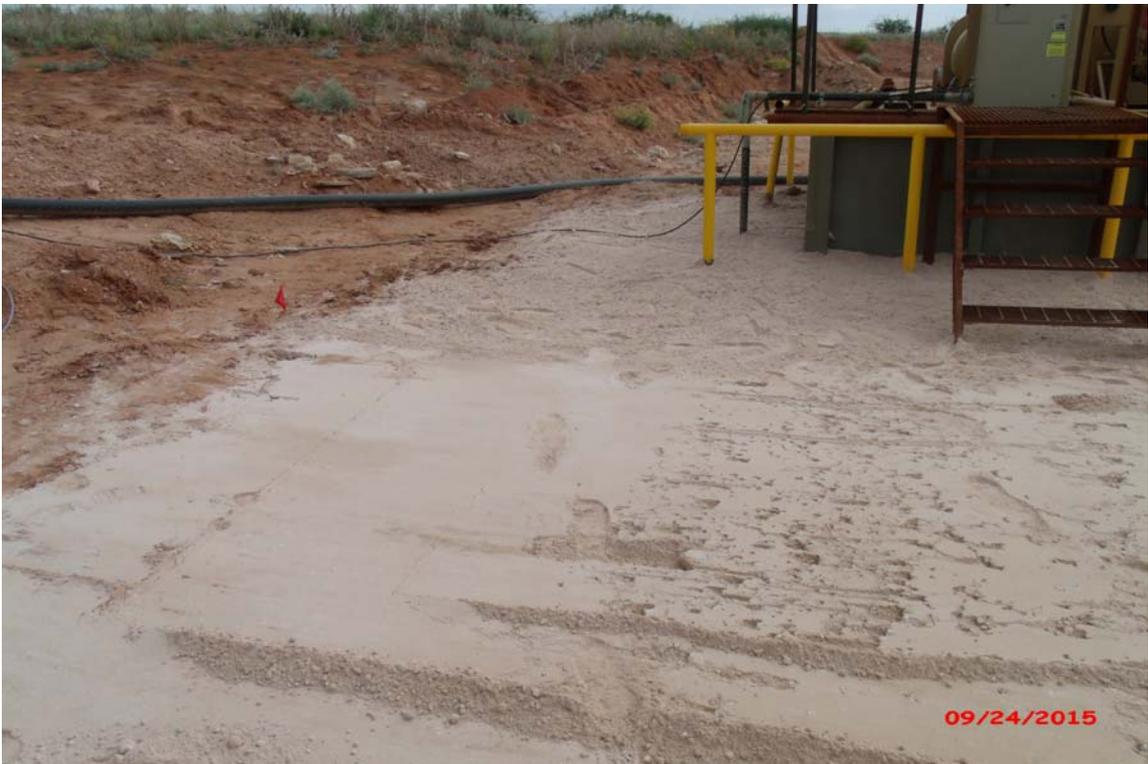
Photograph #6 – Backfilled area
