H E West B Federal #85

CLOSURE REPORT

API No. 30-015-28387

Release Date: April 7th, 2015

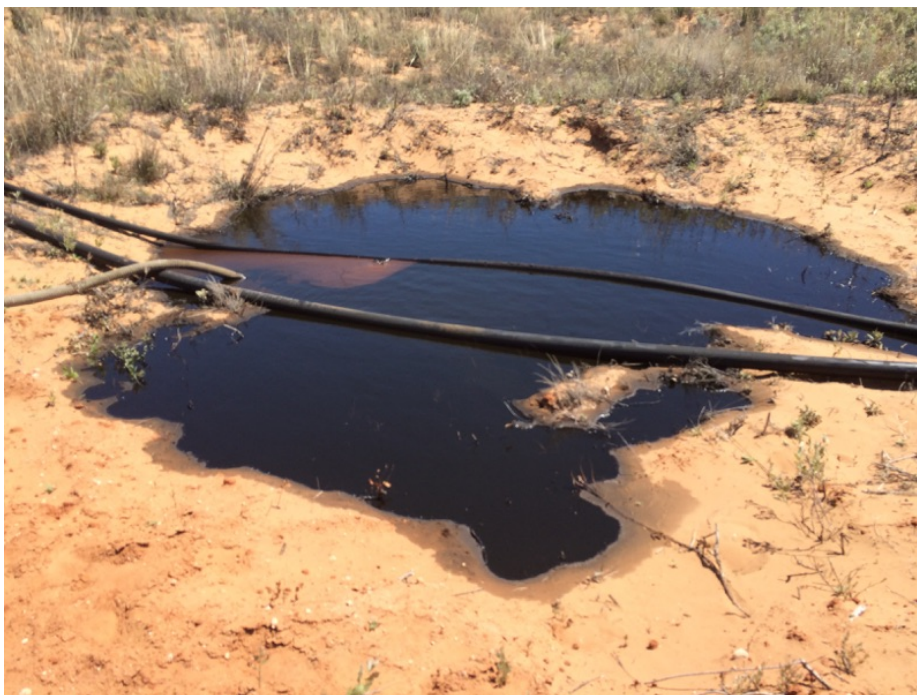
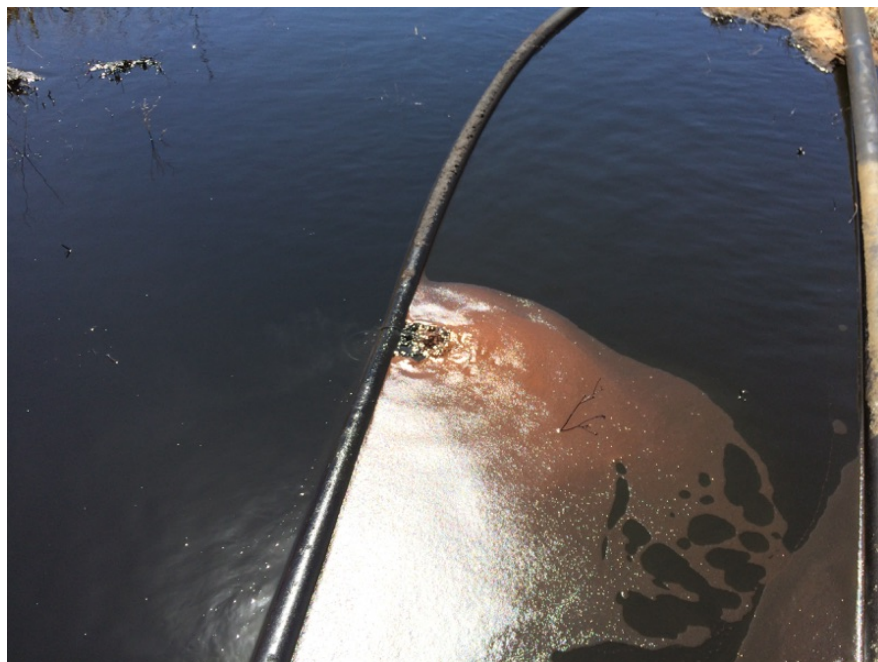
The site is located northeast of Loco Hills, NM, in Lea County. The leak site resulted from a failure in a poly joint. The impacted area is in the pasture just before the location. A site map is attached (Appendix III). A C-141 was submitted to the NMOCD on April 8, 2015 (Appendix I).

Initial spill photo

On April 7, 2015, DFSI personnel responded to the location and placed a berm around the leak to contain the fluid. After the fluid was recovered, DFSI personnel scraped up the saturated soil in the pasture to approximately 4' BGS. The contaminated soil was hauled to an approved disposal. One composite sample of the spill area was taken. This sample was tested for chloride levels as well as BTEX. The BTEX samples were performed using a Mini Rae Photoionization Detector (PID). All field samples that tested below state/BLM requirements were taken to Cardinal Labs of Hobbs to obtain confirmation sample. The results are attached. August 28, 2015, DFSI personnel responded to the location to attain measurements of the cement pit and take preliminary photos.

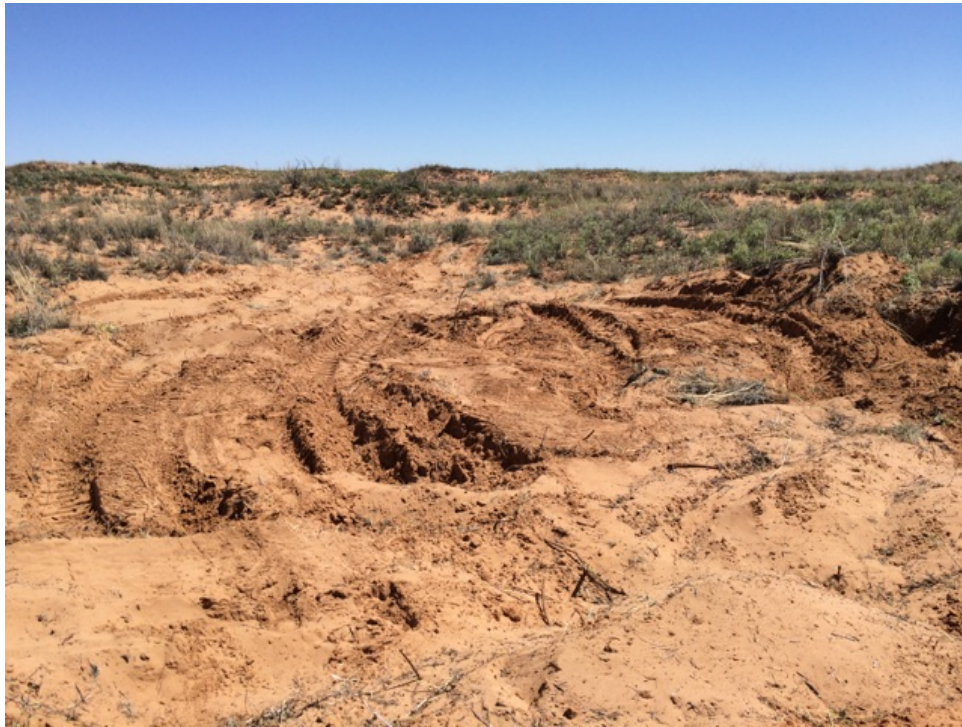
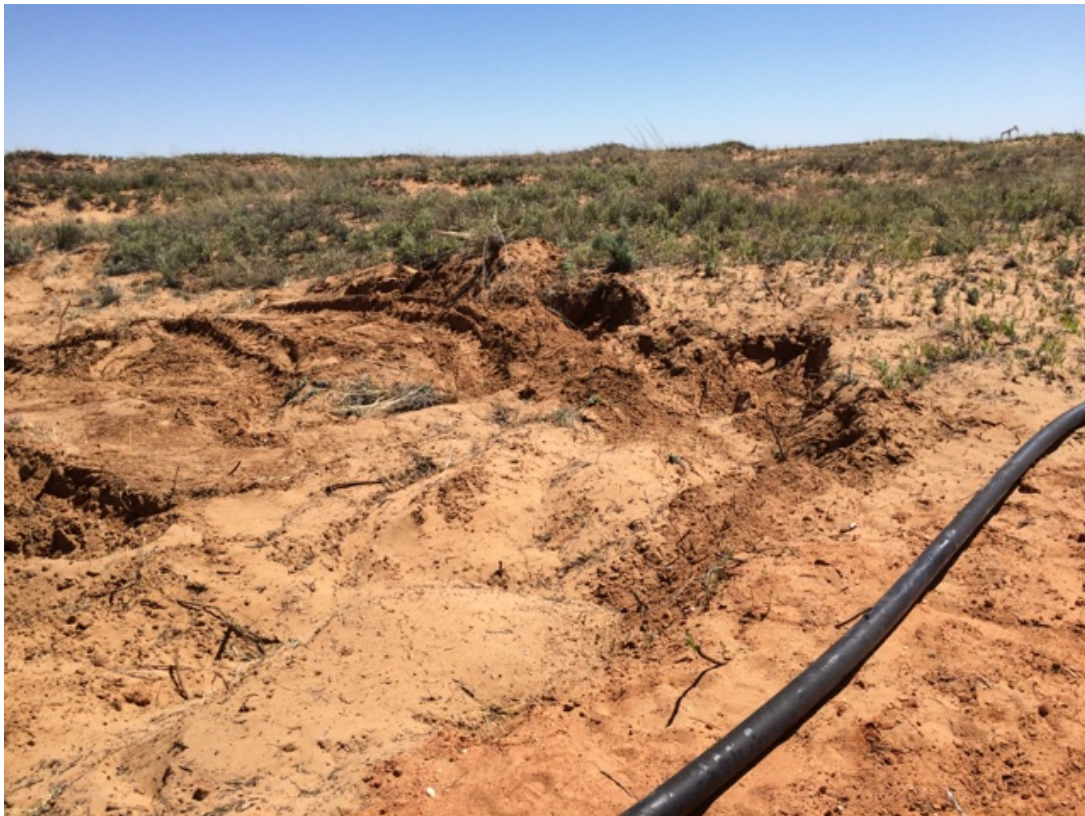
Photo after initial scrape

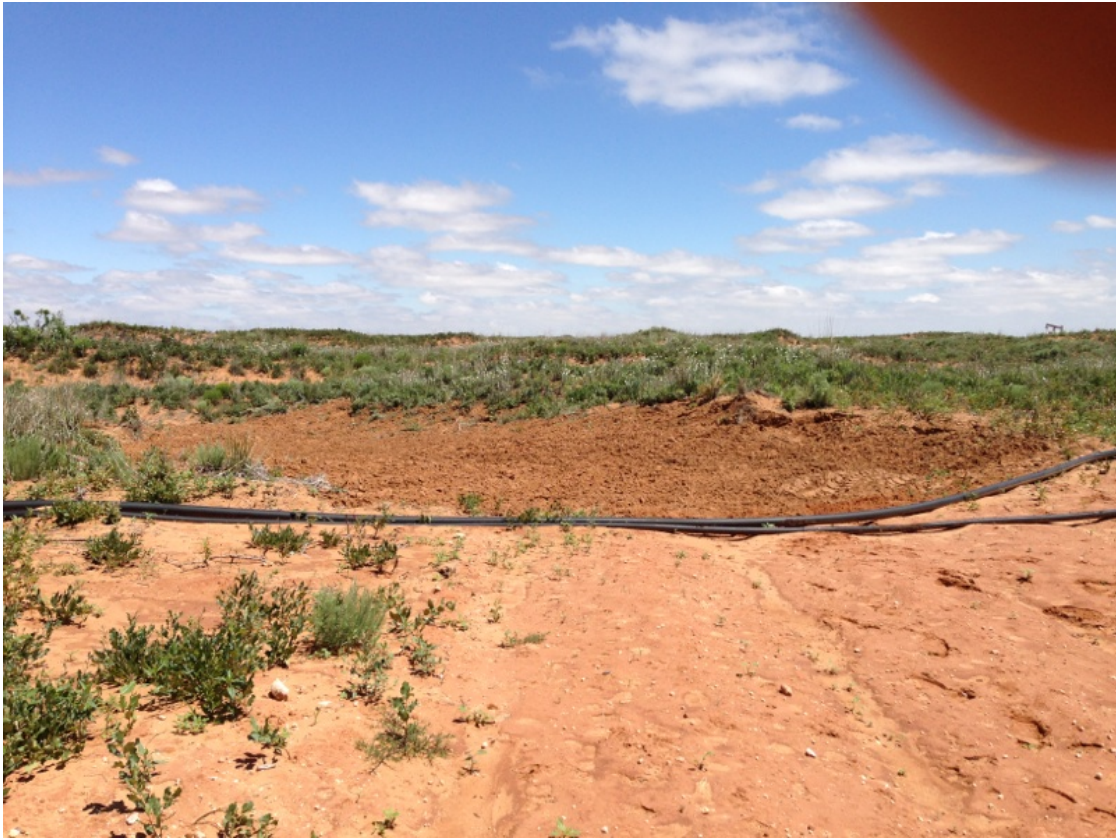
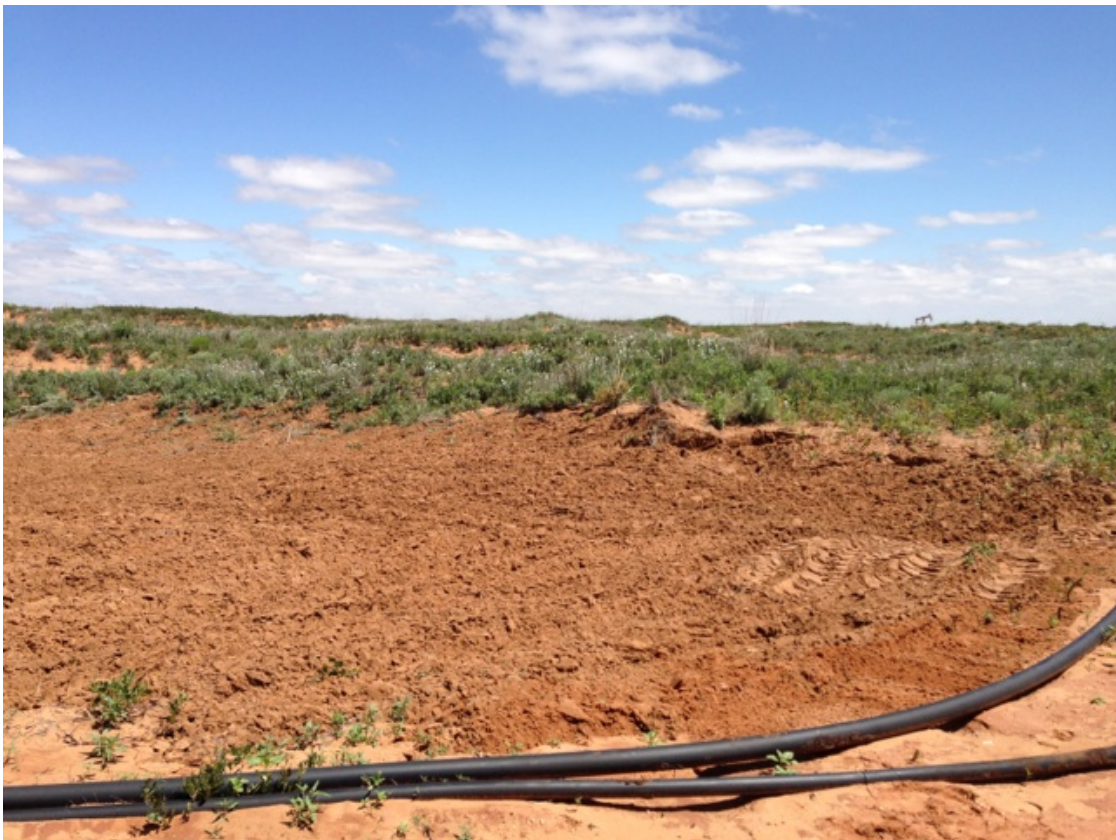
Completed location after contouring, seeding

DFSI personnel returned to the location to re-contour the affected area where the spill/scrape occurred. Twenty percent of 1-acre of LPC seed mix was planted. The site was restored to its previous state.
