De La Sierra Trucking Delineation Report

**Section 33 Township 22S, Range 27E
Eddy County, New Mexico**

October 14, 2015

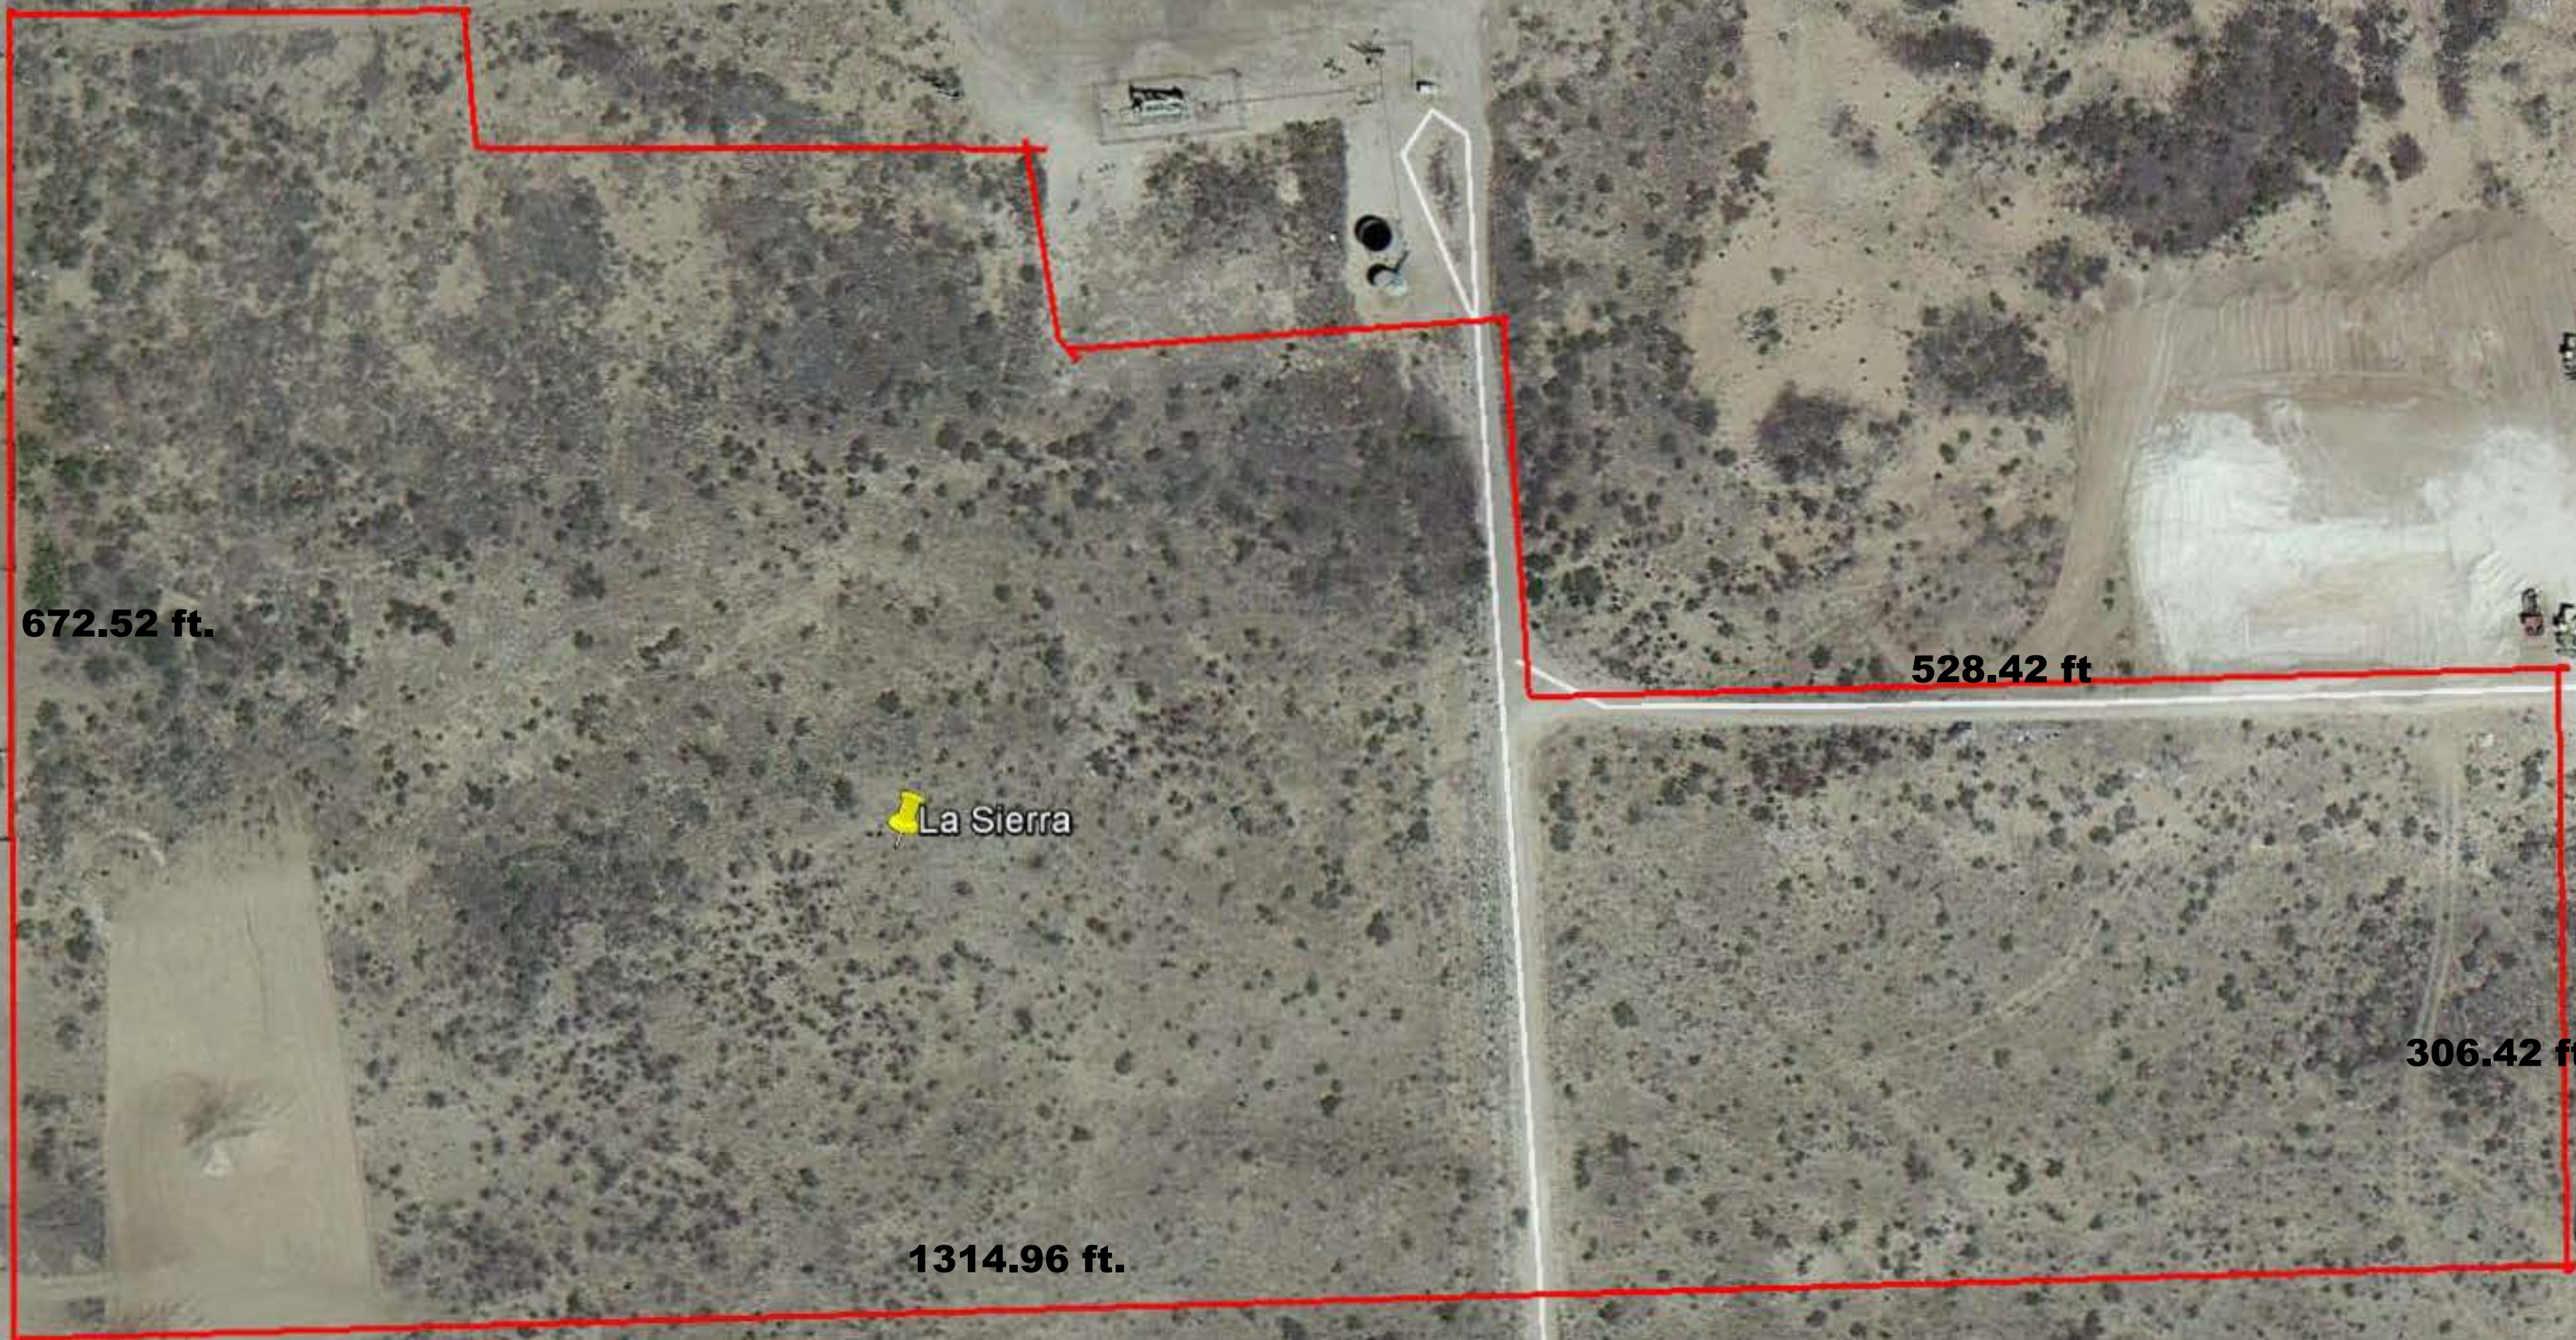
Figure 1

Vicinity Map

672.52 ft.

528.42 ft

306.42 ft

1314.96 ft.

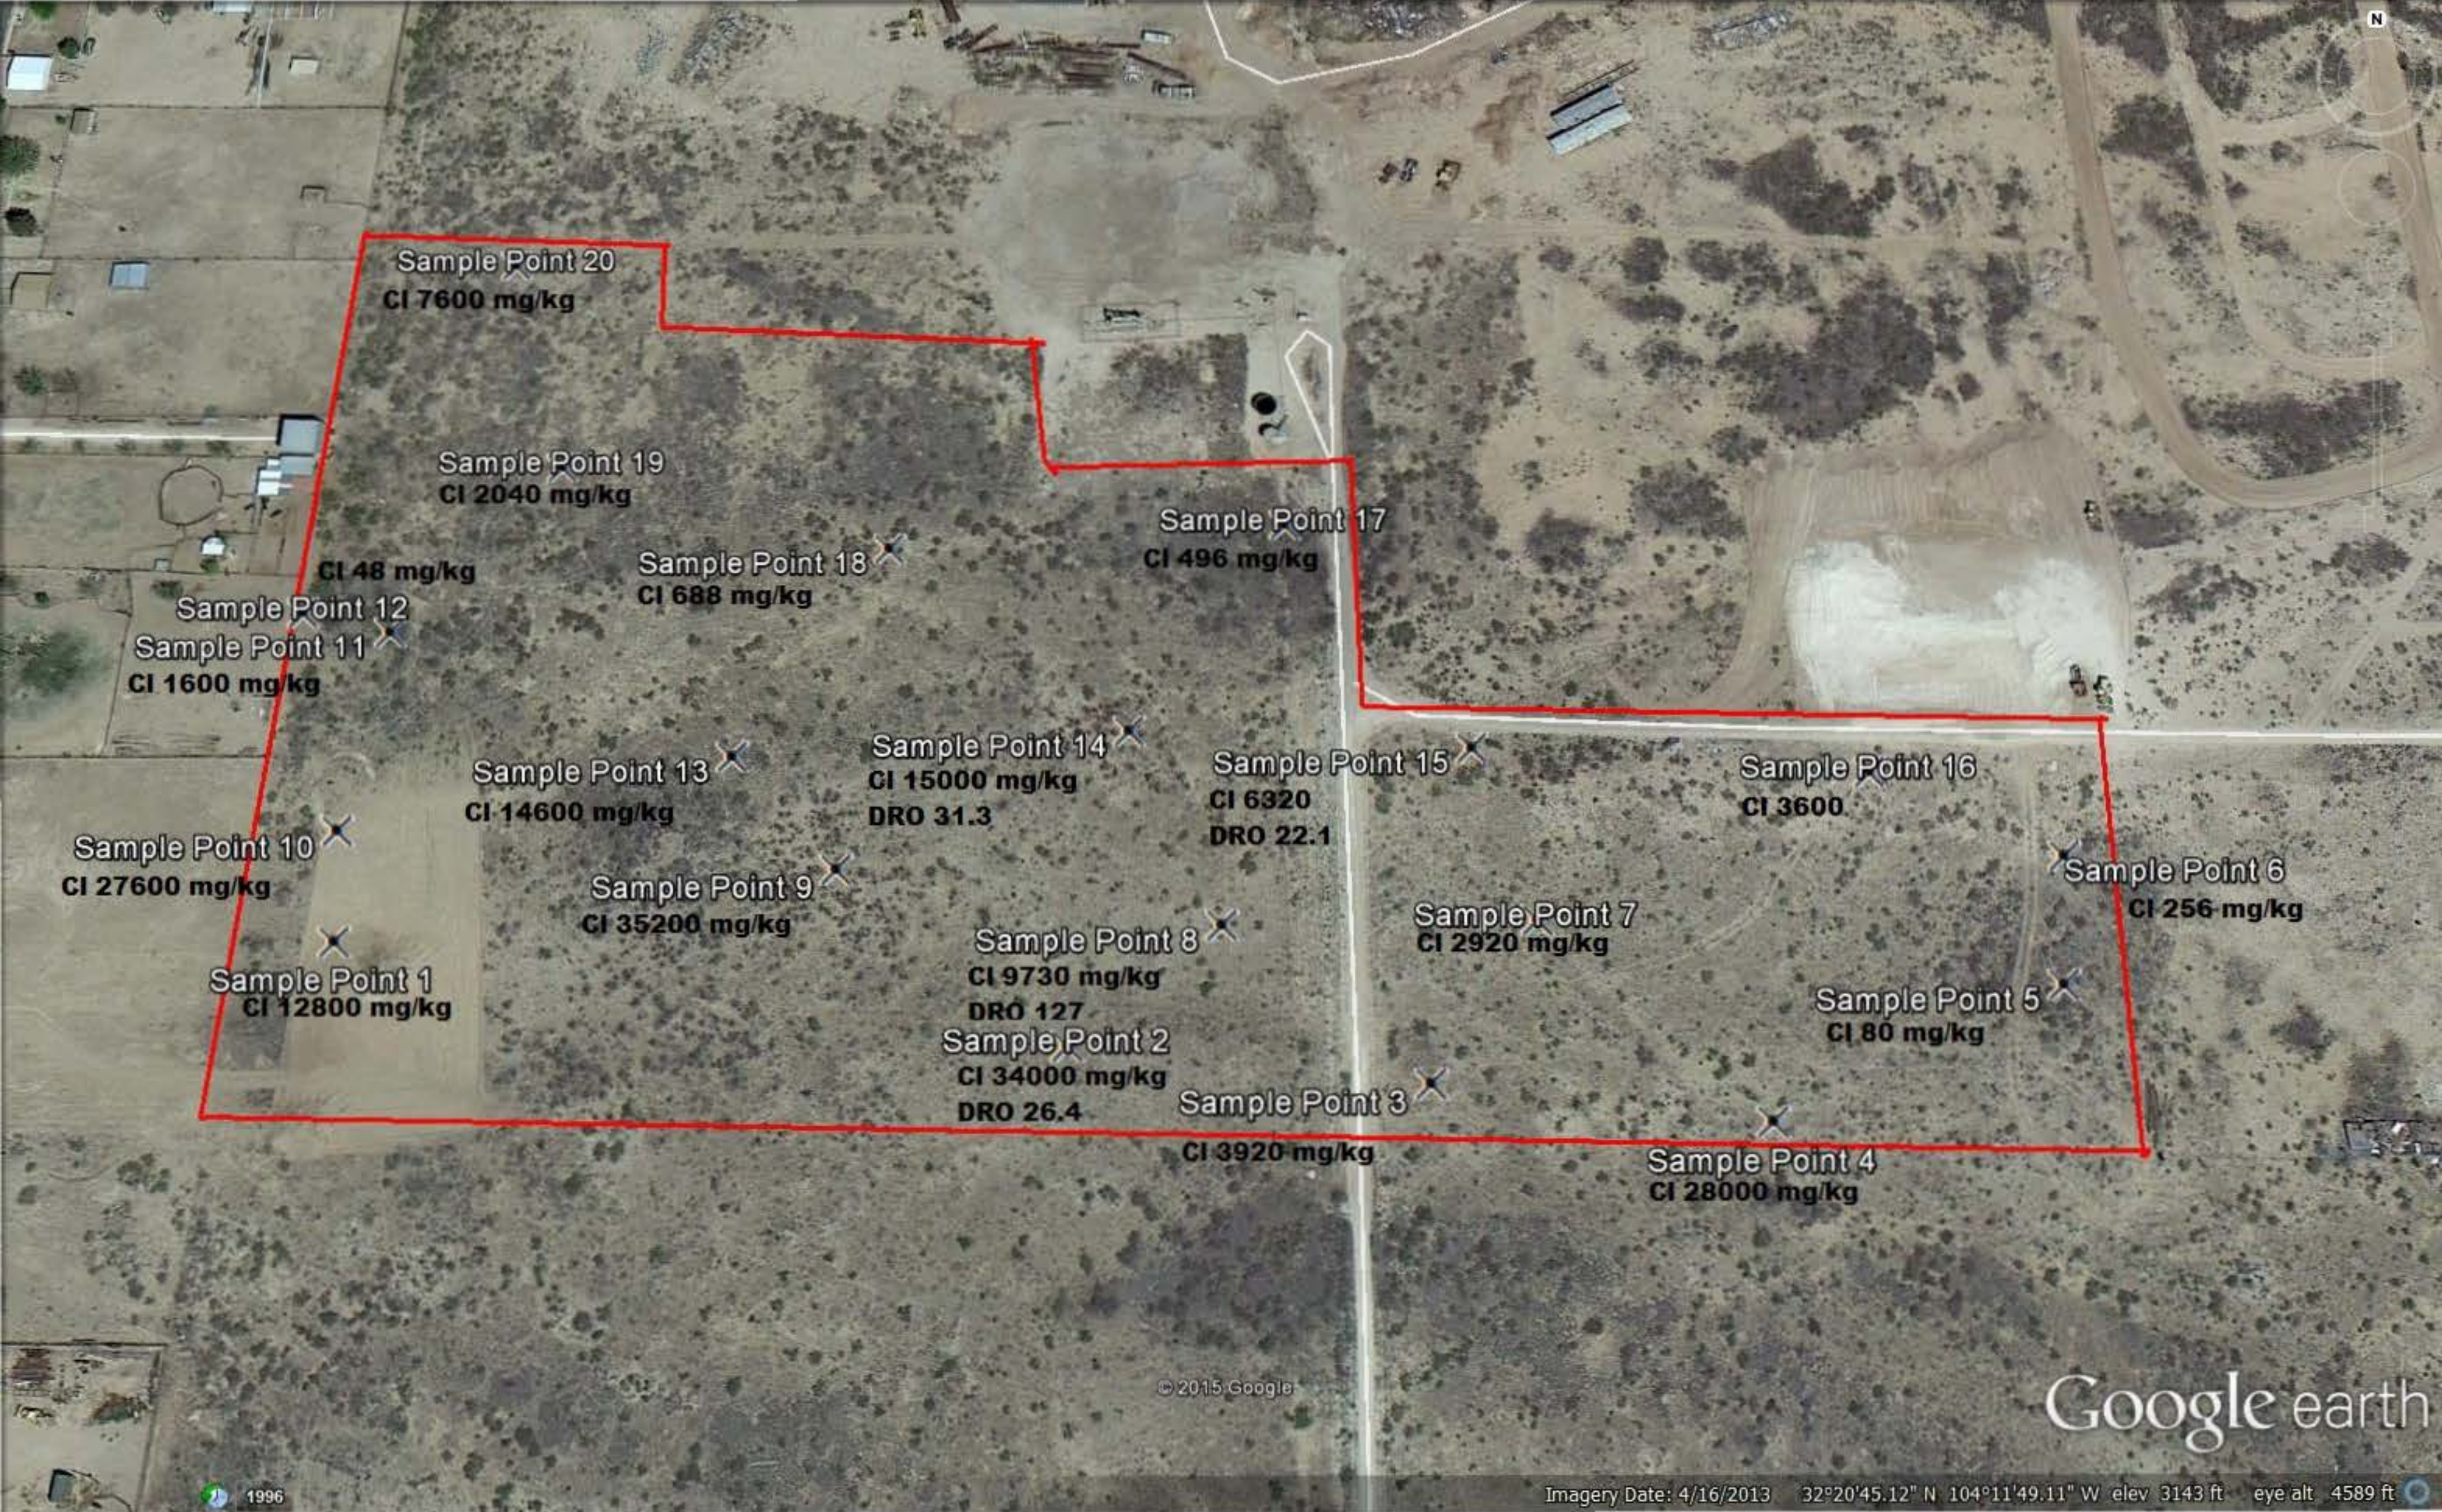
Figure 2

Juno Mapping of the spill area was conducted, siting the GPS coordinates of each sample point. Twenty (20) sample positions were established, in order to ascertain the horizontal extent of impact (Appendix C). The soil samples were properly packaged, preserved and transported to Cardinal Laboratories, Hobbs New Mexico and analyzed for Chloride (Cl⁻) (Method SM 4500Cl⁻B). The results of the analysis are presented in the following table:

Site Plan

Sample Point 20
CI 7600 mg/kg

Sample Point 19
CI 2040 mg/kg

Sample Point 17
CI 496 mg/kg

Sample Point 18
CI 688 mg/kg

CI 48 mg/kg
Sample Point 12
Sample Point 11
CI 1600 mg/kg

Sample Point 13
CI 14600 mg/kg

Sample Point 14
CI 15000 mg/kg
DRO 31.3

Sample Point 15
CI 6320
DRO 22.1

Sample Point 16
CI 3600

Sample Point 10
CI 27600 mg/kg

Sample Point 6
CI 256 mg/kg

Sample Point 9
CI 35200 mg/kg

Sample Point 7
CI 2920 mg/kg

Sample Point 5
CI 80 mg/kg

Sample Point 1
CI 12800 mg/kg

Sample Point 8
CI 9730 mg/kg
DRO 127
Sample Point 2
CI 34000 mg/kg
DRO 26.4

Sample Point 3
CI 3920 mg/kg

Sample Point 4
CI 28000 mg/kg

SESI is proposing to conduct a secondary sampling event at Five (5) different areas in order to determine the vertical extent of impact.
