# HUNGRY HORSE, LLC

To: Mike Bratcher, New Mexico Oil Conservation Division  
Shelly Tucker, Bureau of Land Management  
Reference: Remediation Work Plan (Revised)  
Operator: Devon Energy Production Company  
Location: North Pure Gold 8 Federal 11 SWD  
API: 30-015-32619  
Legals: UL. J, Sec. 8, T23S, R 31E, Eddy County NM  
GPS: 32.31545, -103.79585

## Release Notification and Corrective Action

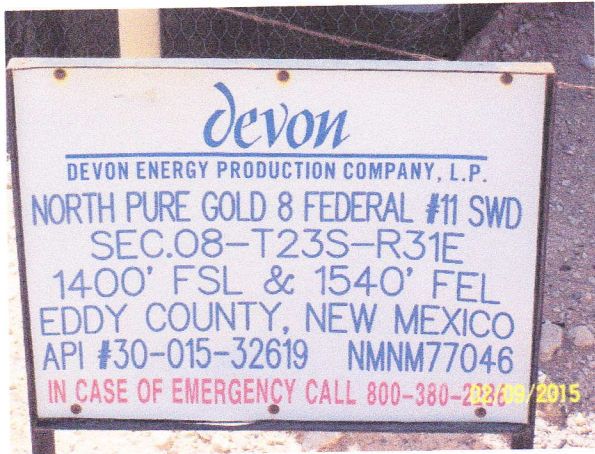
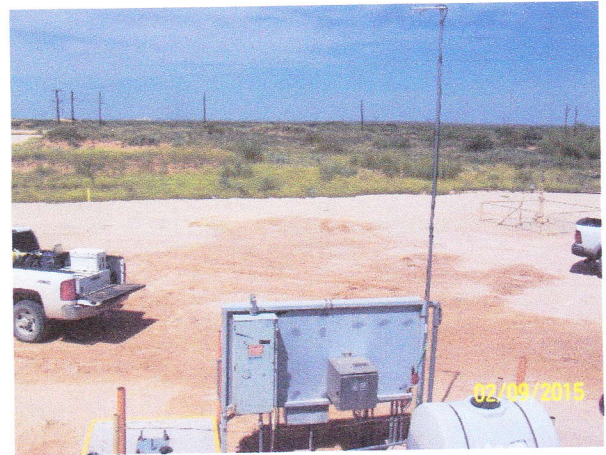
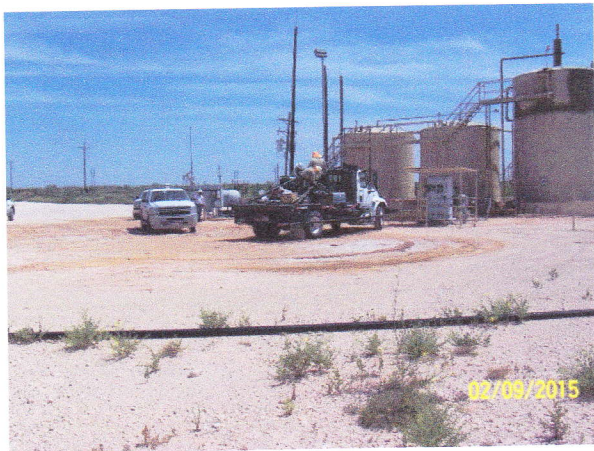
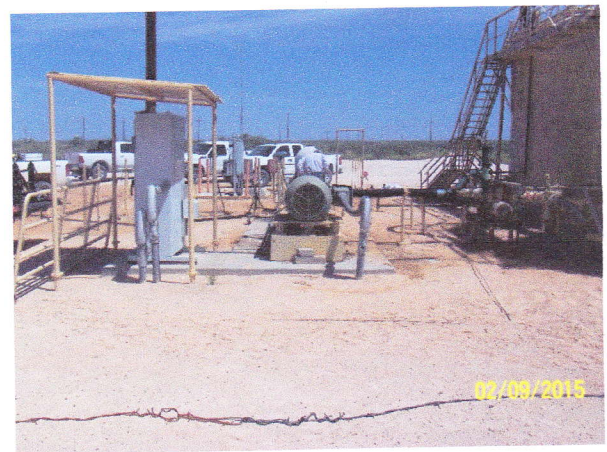
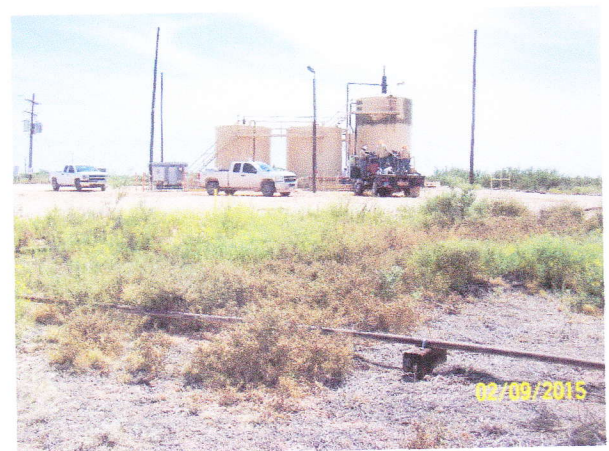
Devon Energy Production Company-North Pure Gold 8 Fed 11 SWD

The release is due to a failure of a high pressure line that resulted in a release of produced water. The impacted area is the well pad and small area off the north edge of pad. The major impact seems to be at the point of release which is inside the fenced area of the Salt Water Disposal (SWD). Run-off from the point of release spread to the north side of the pad. Upon discovery the well was shut in and the line has been repaired/replaced.

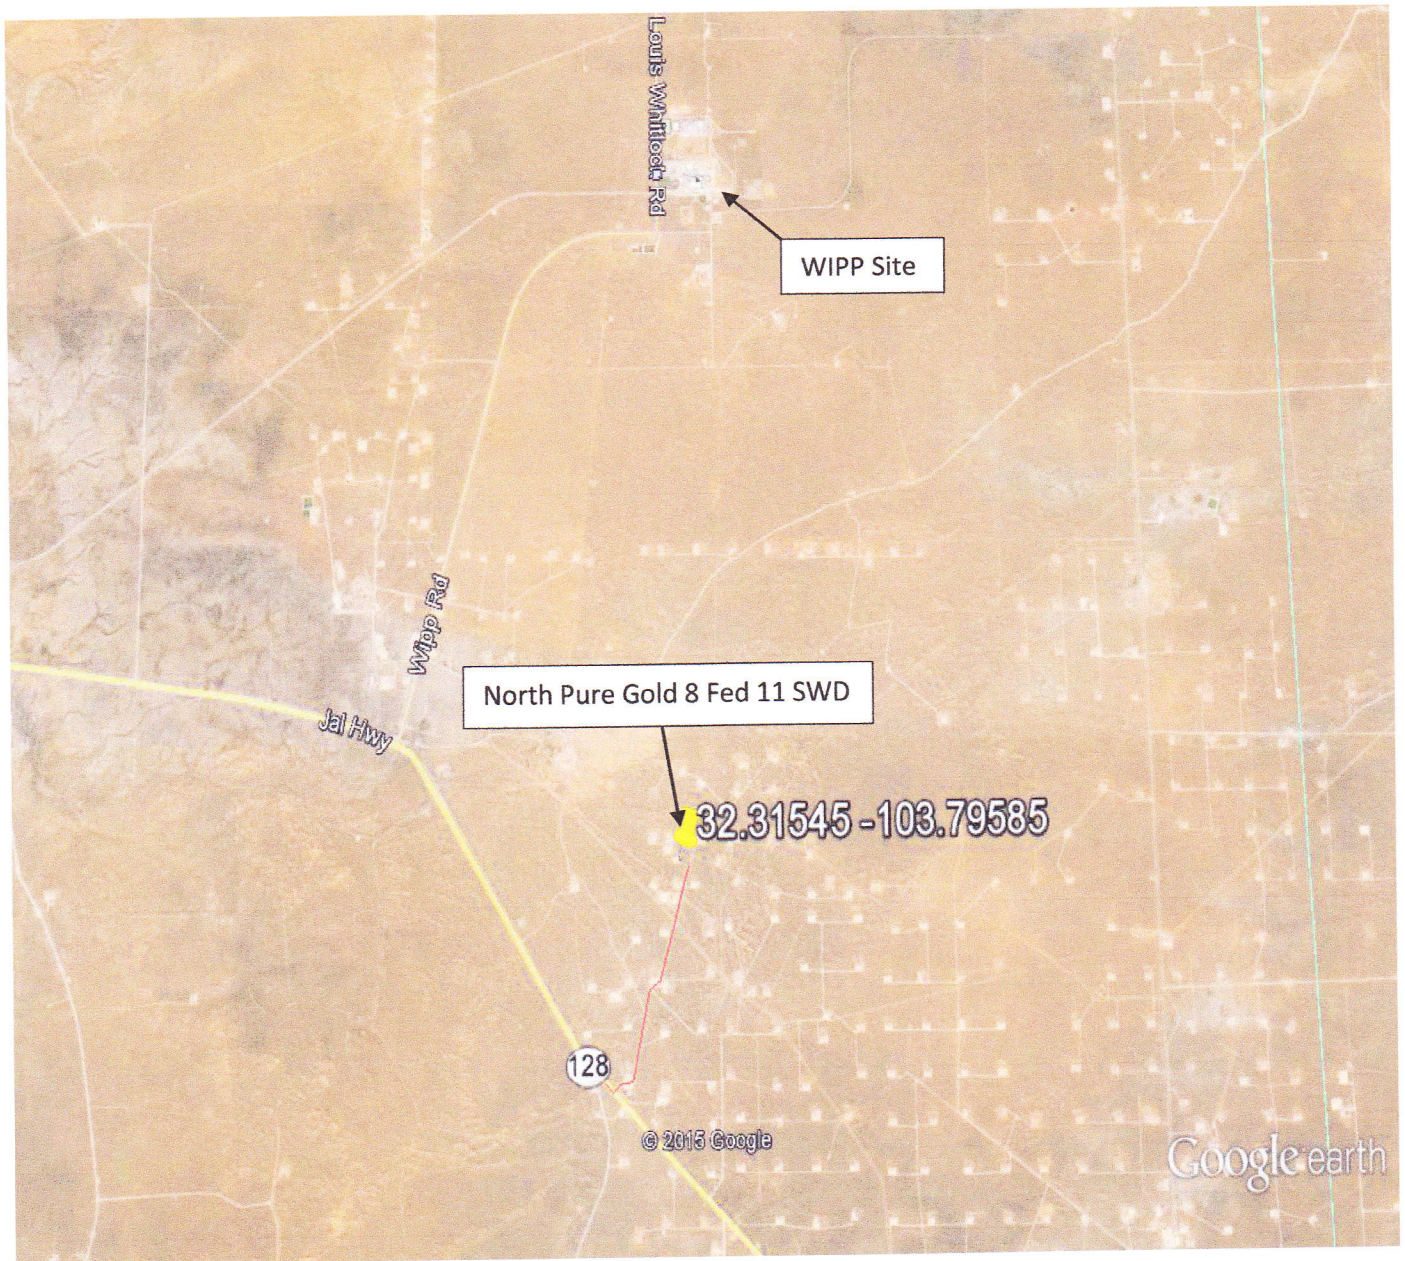
As requested, a site delineation was conducted on 22Sept15, using a backhoe. Soil samples were collected to a depth of 10' BGS on the pad (Sample Points 1-2). At 10' BGS bucket refusal occurred due to hard rock. At Sample Point 3 off the north side of the pad, soil samples were taken down to a depth of 7' BGS at which point bucket refusal occurred. Samples were taken at 1' intervals beginning at 1' BGS.

The impacted area at the point of release (inside the fence) will be hand excavated to 2' BGS. The impacted area outside the fence will be and excavated to a depth of 1' BGS. The excavated area will then be backfilled with fresh caliche, brought back to grade and compacted. This is an active and working SWD, a full delineation and remediation will be conducted when the facility is removed from service.

The impacted area off the north side of the pad will be excavated to a depth of 5' BGS and backfilled with fresh soil and seeded.
