## **REMEDIATION SUMMARY AND RISK-BASED SITE CLOSURE REQUEST**

**BOPCO, LP  
Hudson Federal Battery #1  
Eddy County, New Mexico  
Unit Letter "F" (SE/NW), Section 1, Township 23 South, Range 30 East  
Latitude 32.336050° North, Longitude 103.836788° West  
NMOCD Reference # 2RP-1732**

**December 2014**

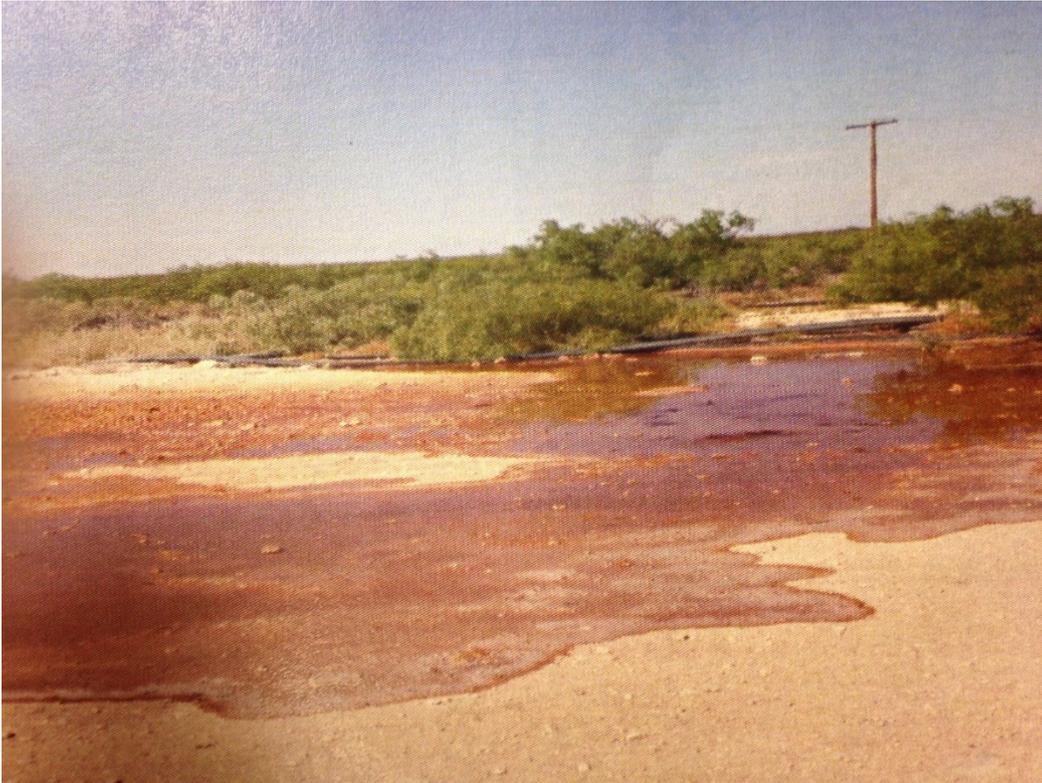
Photograph of the initial release at the Hudson Federal Battery #1 Remediation Site.

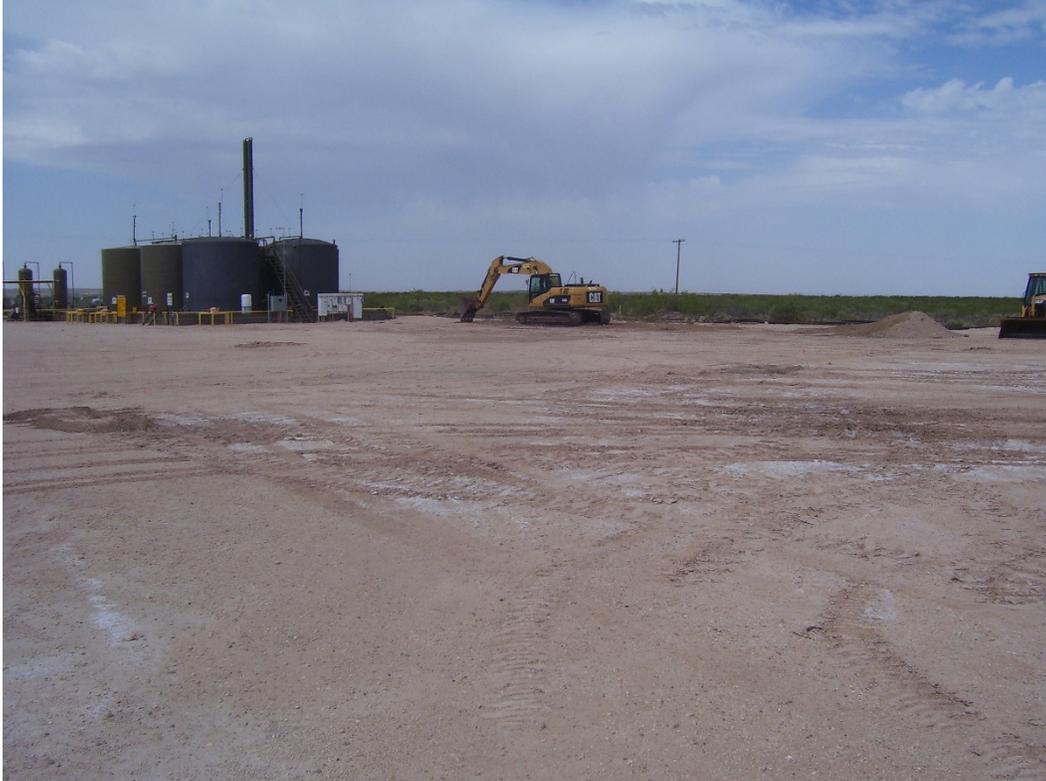
Photograph of the affected well pad and chloride leaching from the 1974 drilling reserve pit at the Hudson Federal Battery #1 Remediation Site.

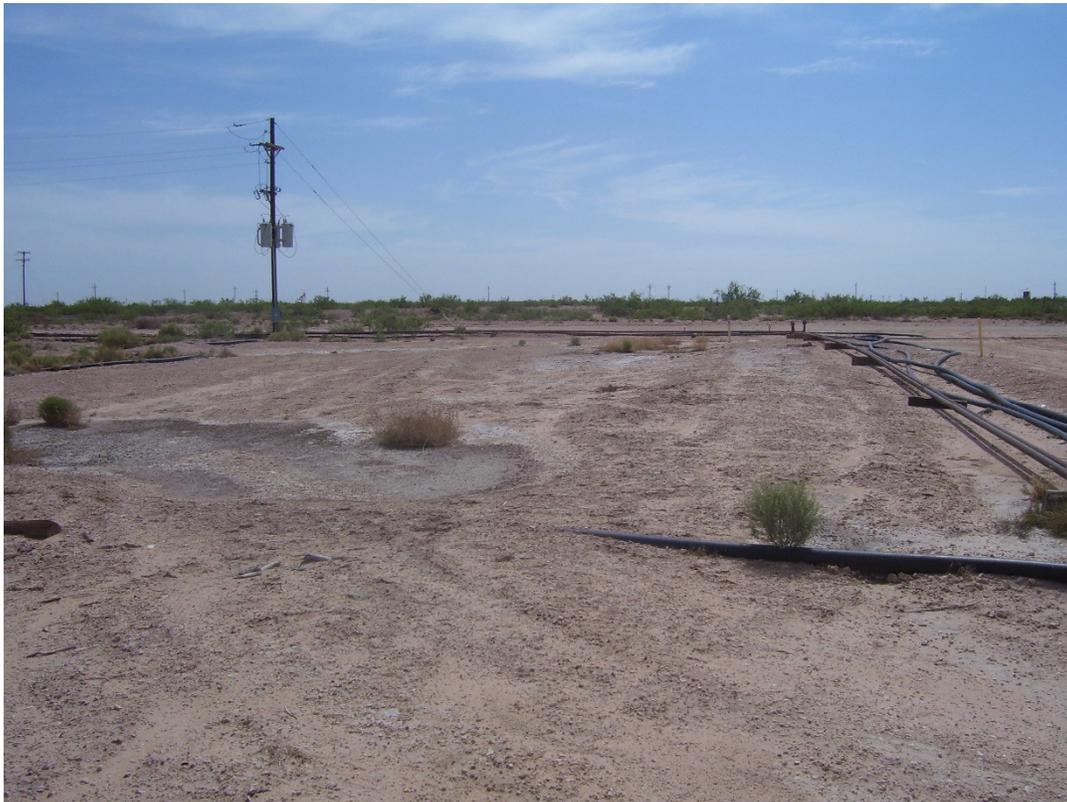
Photograph of the barren area above the 2000 drilling reserve pit north of the well pad at the Hudson Federal Battery #1 Remediation Site.

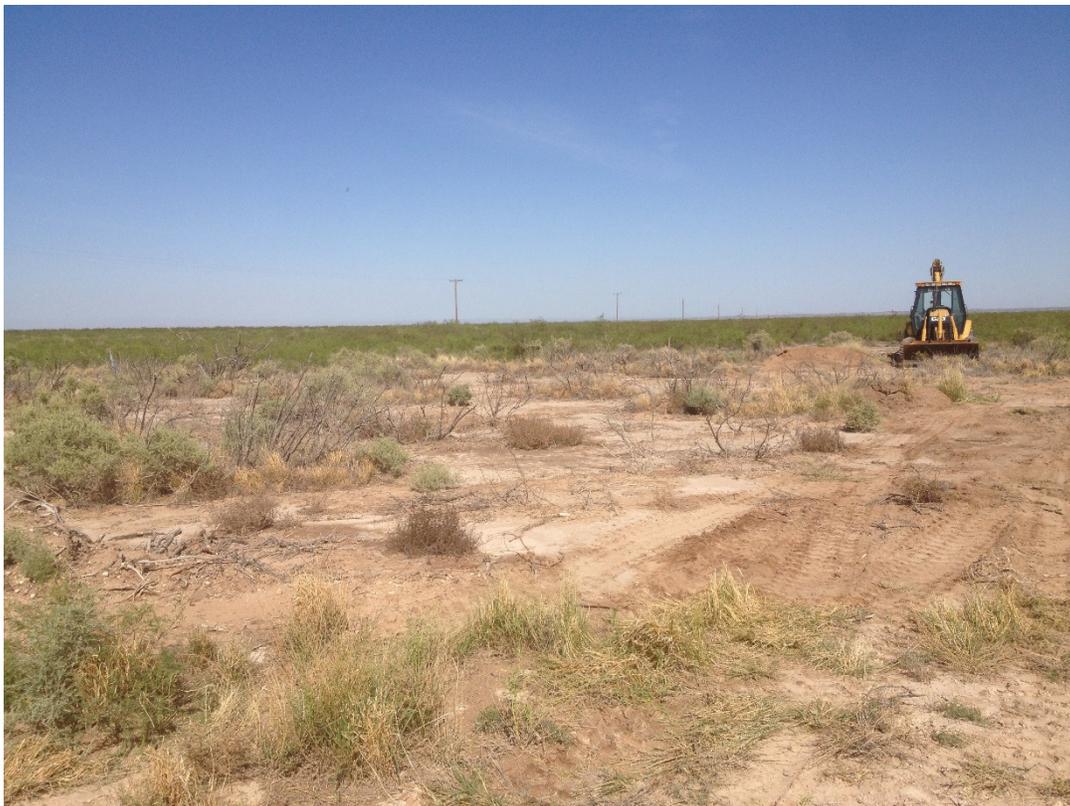
Photograph of the affected pasture at the Hudson Federal Battery #1 Remediation Site.

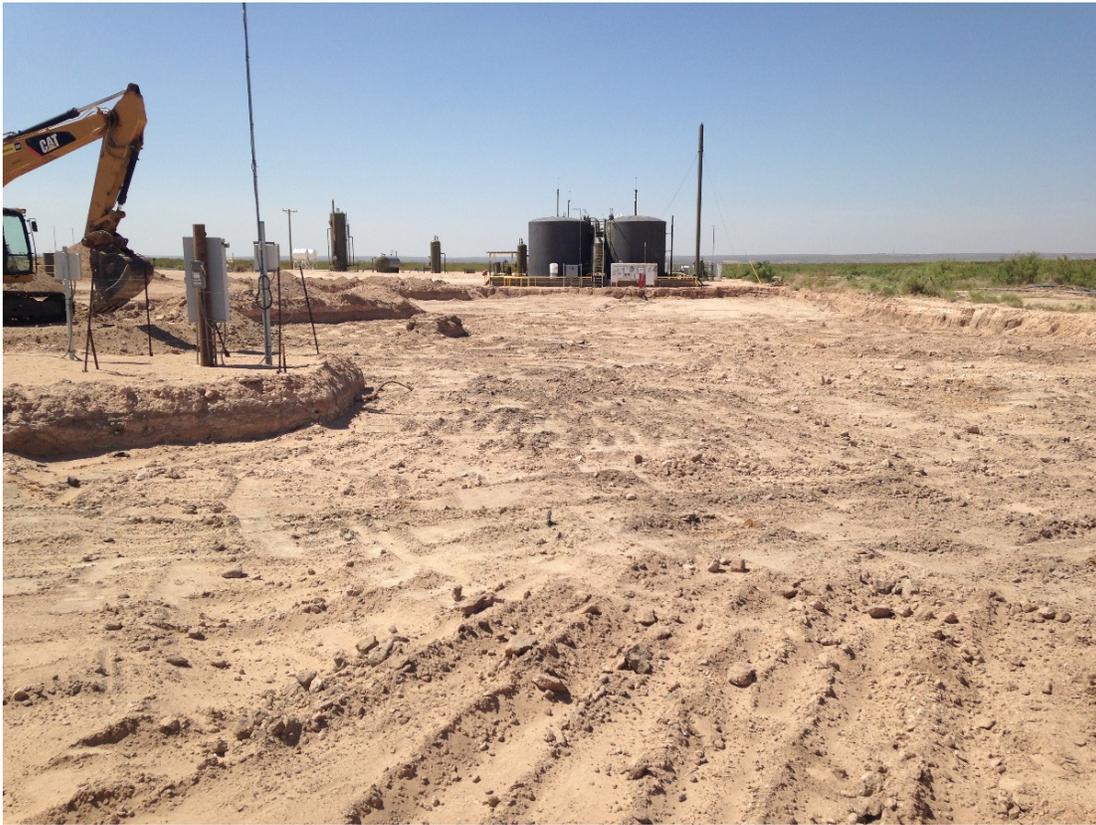
Photograph excavation activities on the caliche well pad at the Hudson Federal Battery #1 Remediation Site.

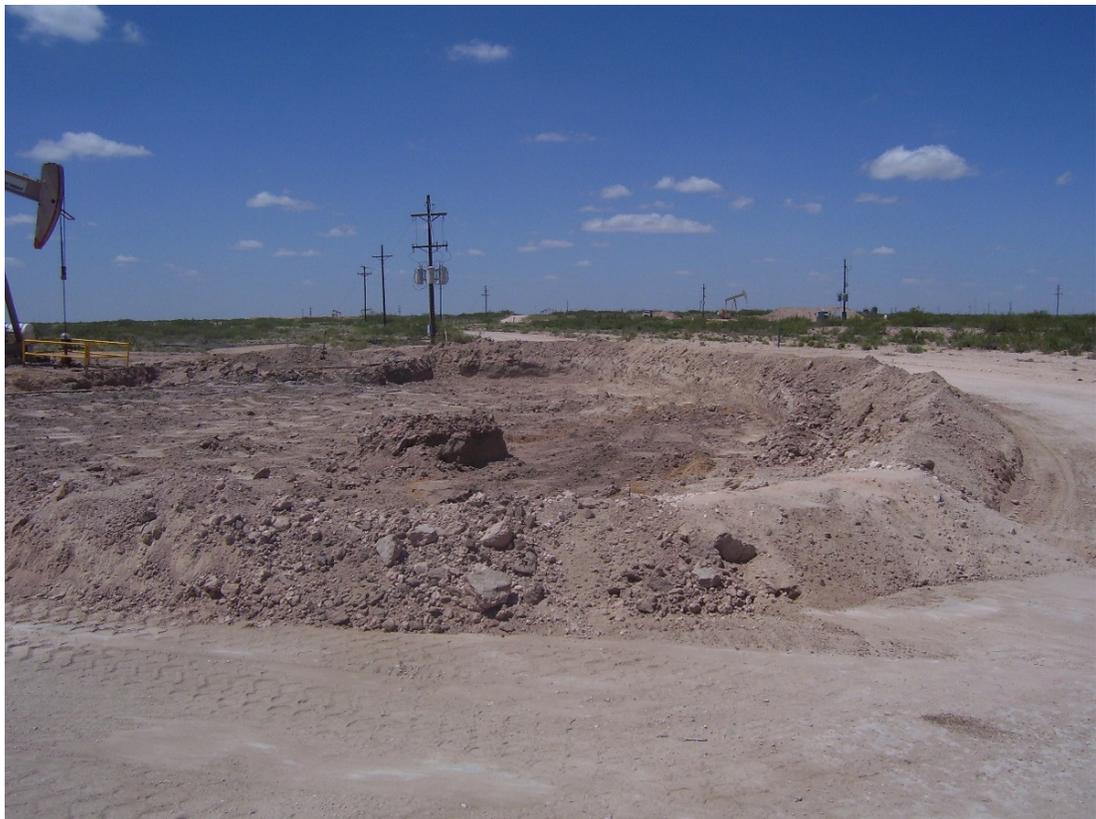
Photograph excavation activities on the caliche well pad at the Hudson Federal Battery #1 Remediation Site.

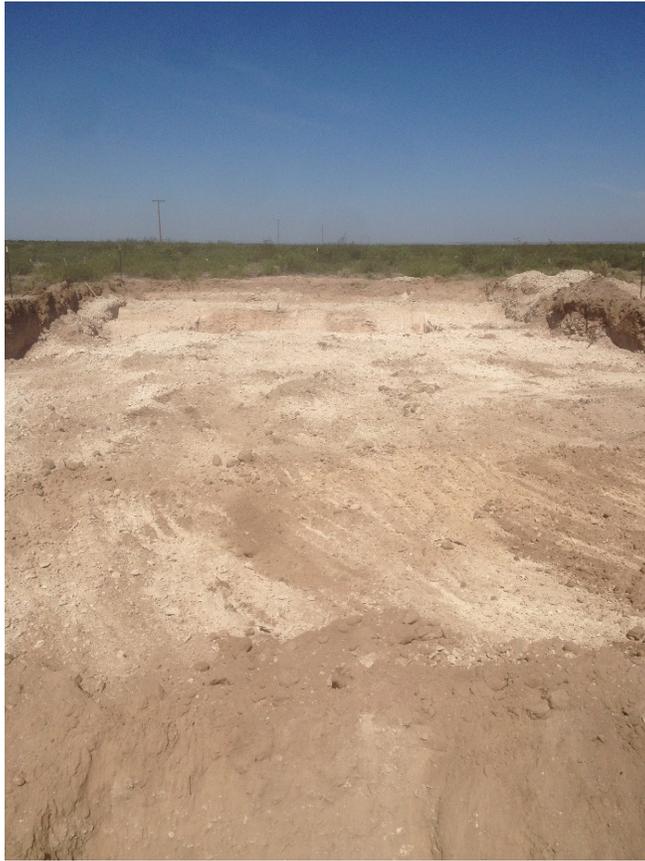
Photograph of the excavated area within the affected pasture at the Hudson Federal Battery #1 Remediation Site.

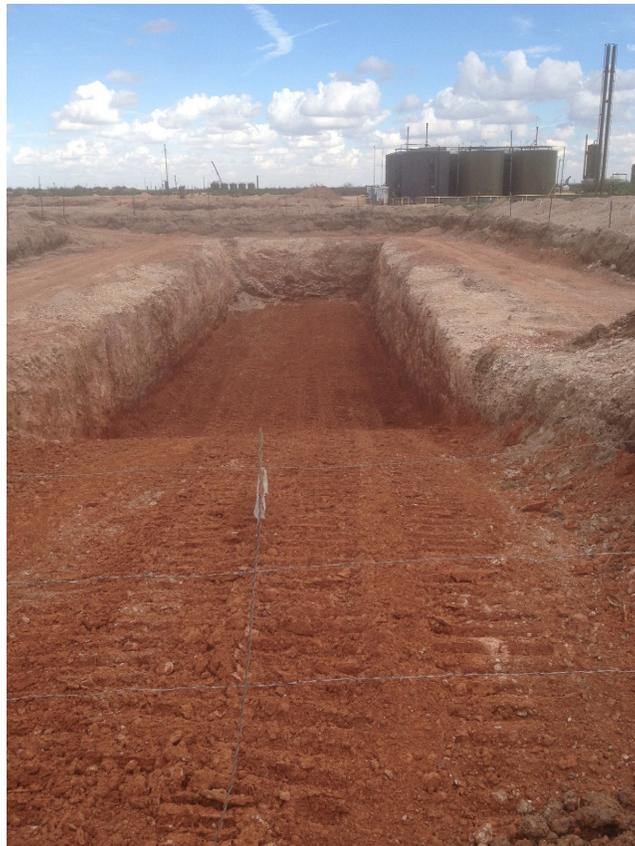
Photograph of the deep burial trench at the Hudson Federal Battery #1 Remediation Site.

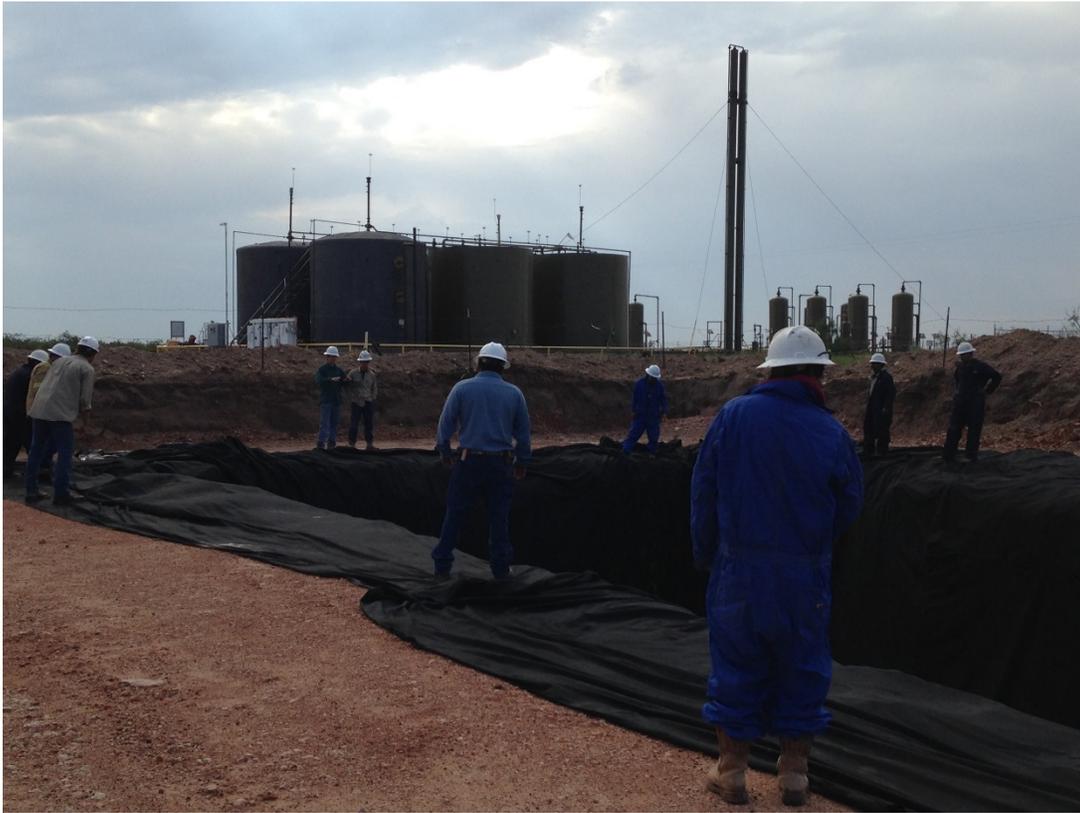
Photograph of the installation of the felt liner within the deep burial trench at the Hudson Federal Battery #1 Remediation Site.

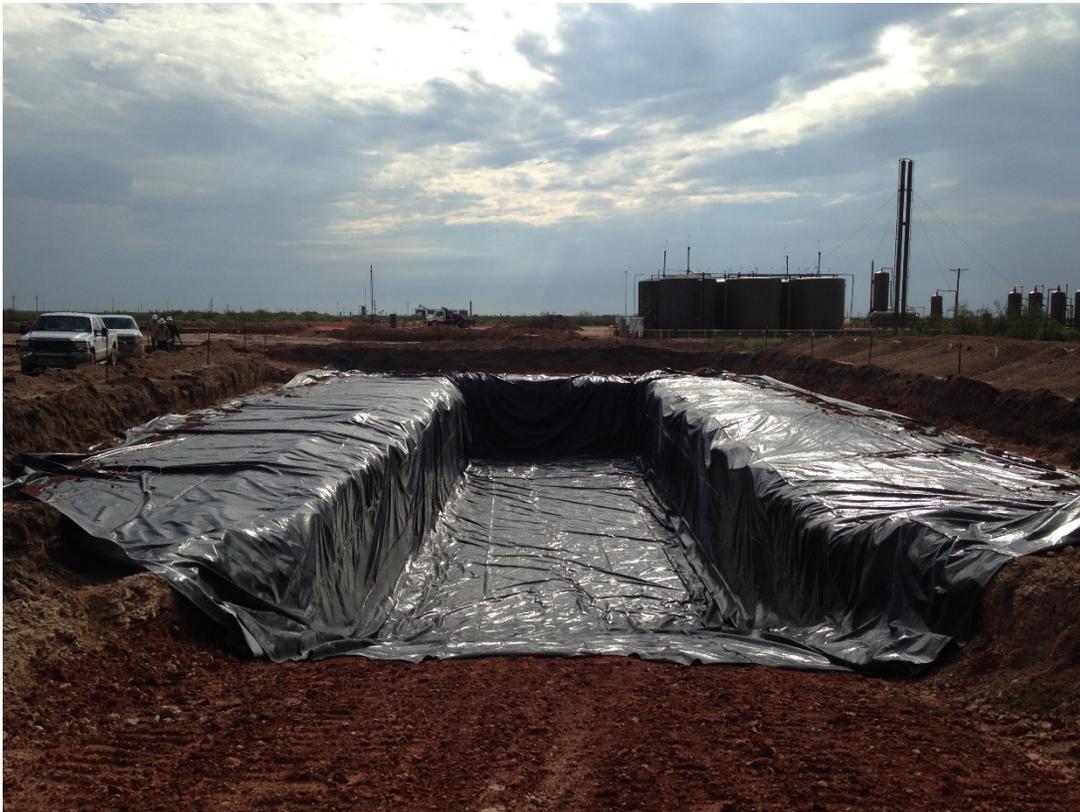
Photograph of the installation of the polyethylene liner within the deep burial trench at the Hudson Federal Battery #1 Remediation Site.

On October 22, 2014, Basin installed a twenty millimeter (20 mm) polyethylene liner over the overlapped trench liner at approximately four feet (4') bgs, as per Section 5.C of the approved Work Plan. The polyethylene liner was extended to the north, at the same grade, atop soils exhibiting chloride concentrations above NMOCD regulatory guidelines characterized by soil samples TT-1a @ 8' and TT-1a @ 10'. This engineering control was designed to prevent the infiltration of water into the burial trench and mitigate the vertical migration of contaminants left in-situ. Upon installing the NMOCD-approved liner, the excavation was backfilled with non-impacted material and contoured to match the surrounding topography.

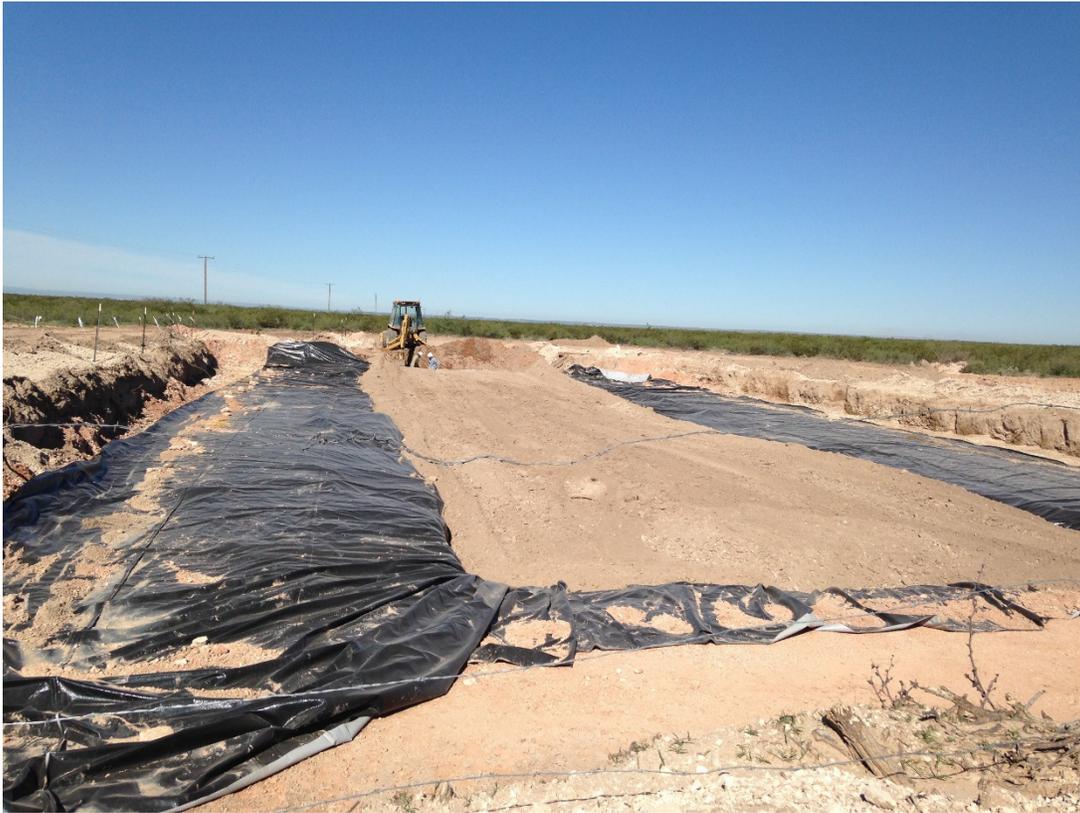
Photograph of the disposition of material generated from the 2000 drilling reserve pit into the deep burial trench at the Hudson Federal Battery #1 Remediation Site.

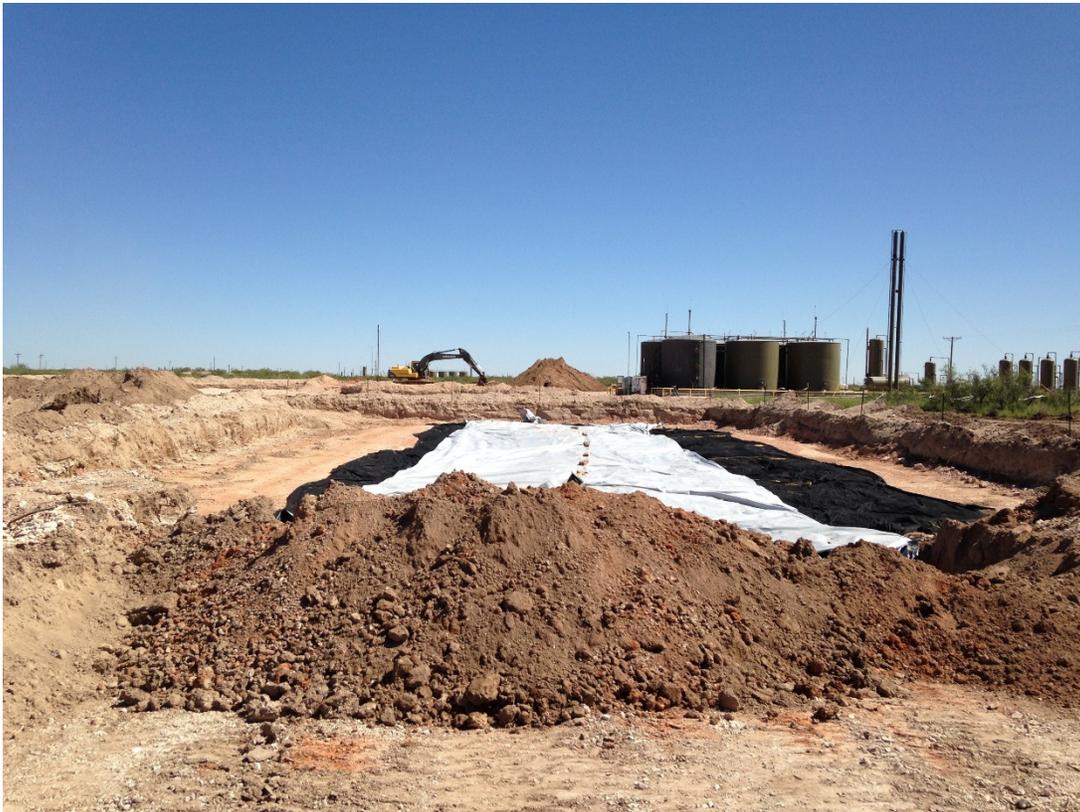
Photograph of the encapsulated material from the 2000 drilling reserve pit at the Hudson Federal Battery #1 Remediation Site.

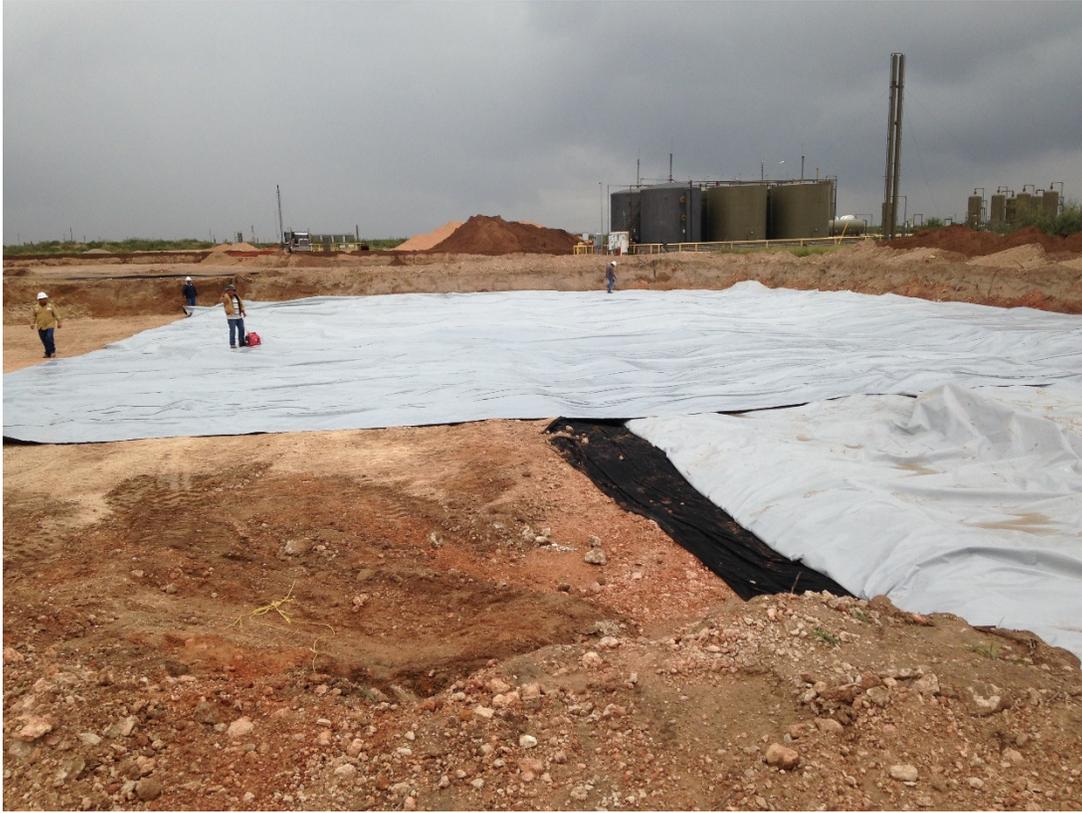
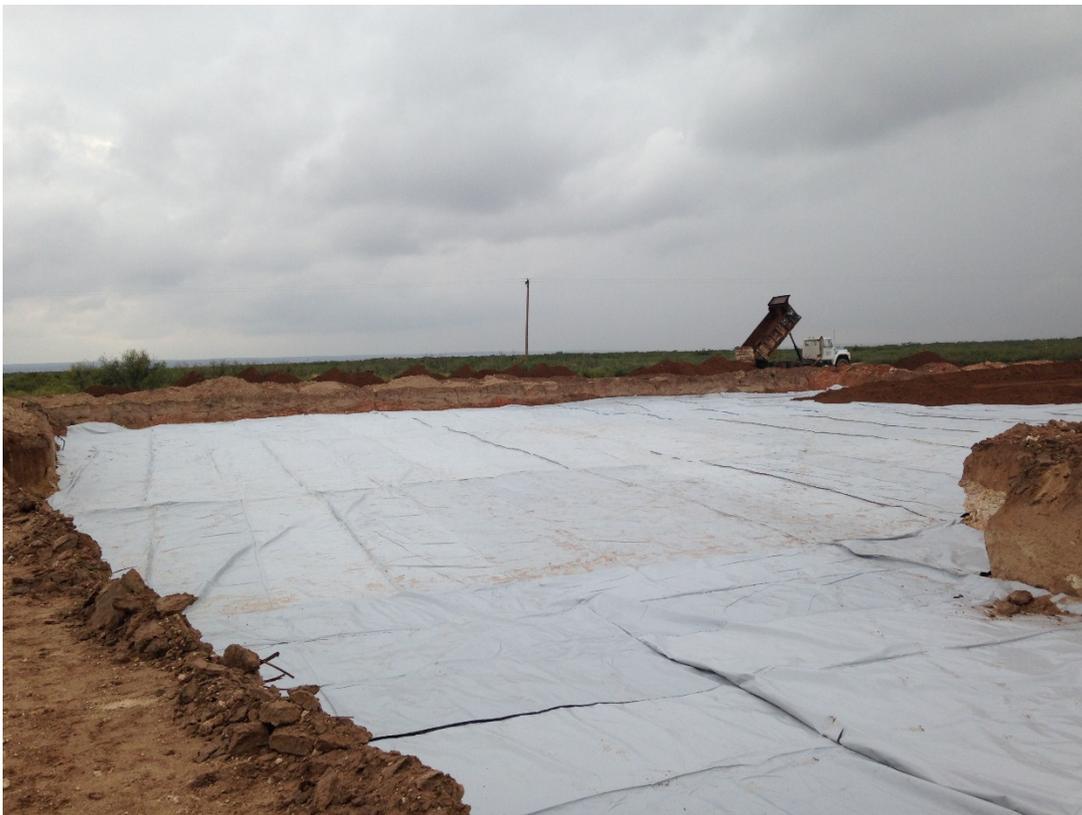
Photograph of the installation of polyethylene liner over the deep burial trench and risked-out portion of the affected pasture.

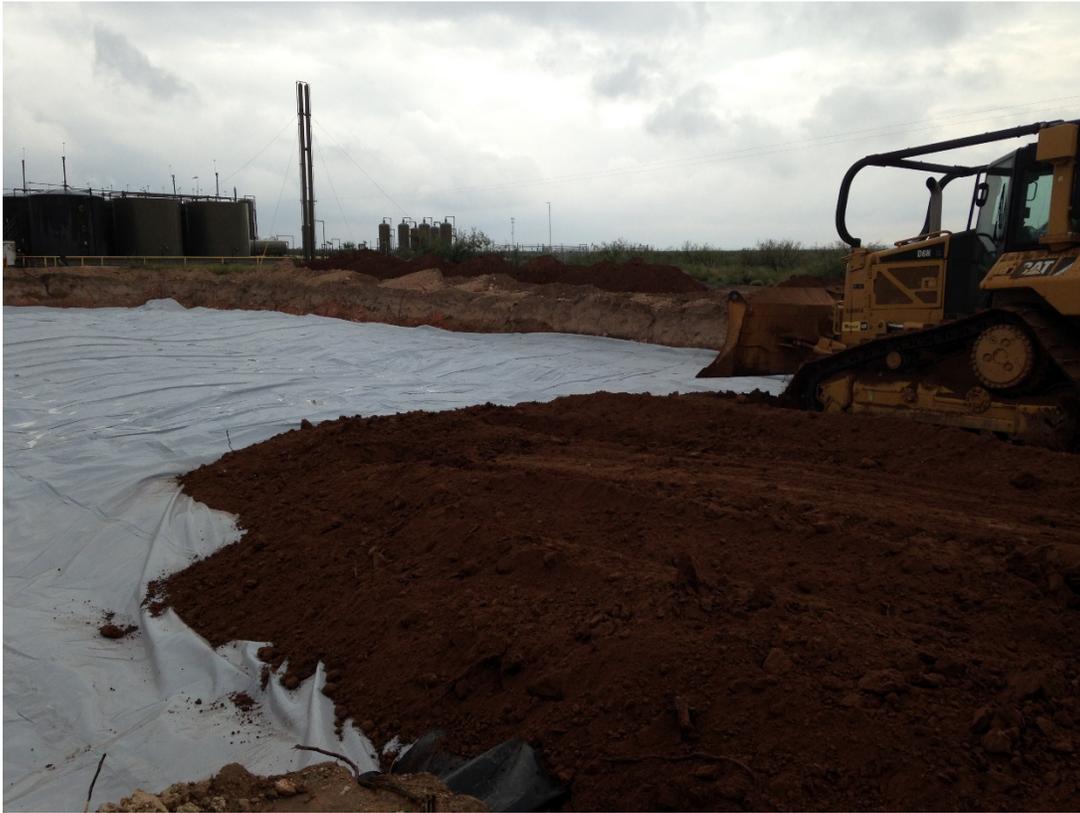
Photograph of the installation of the soil cover over the deep burial trench at the Hudson Federal Battery #1 Remediation Site.

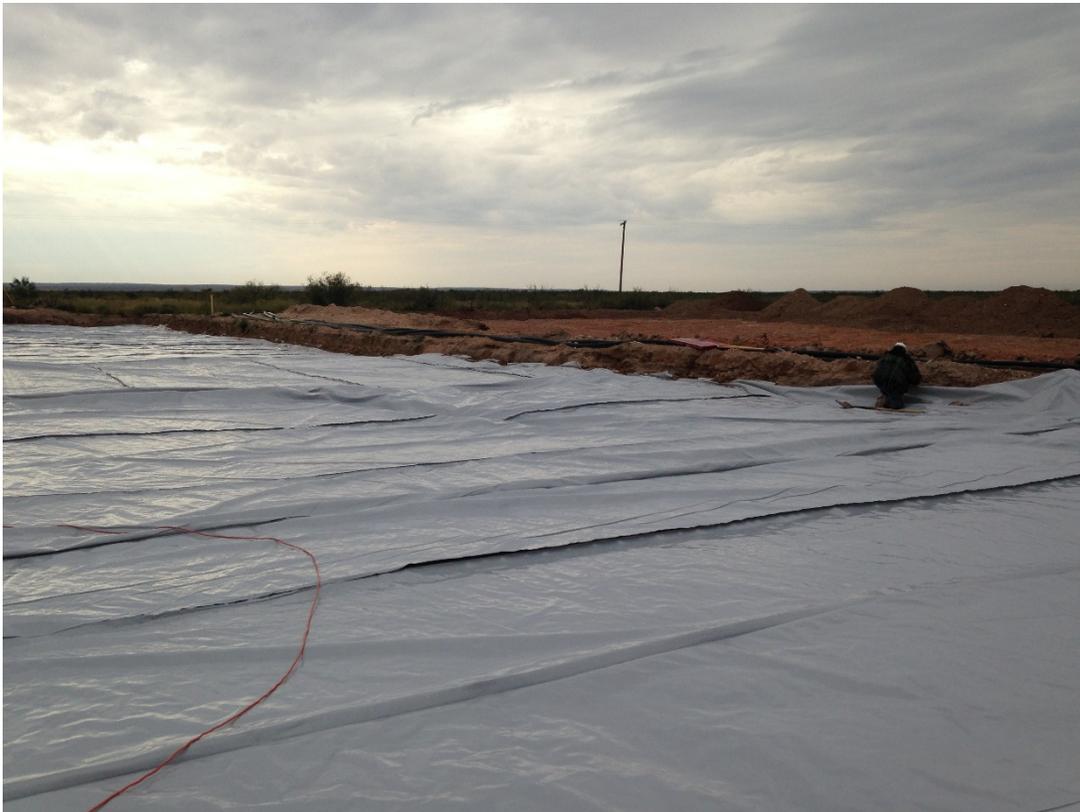
Photograph of the installation of polyethylene liner over the 1974 drilling reserve pit on the caliche well pad at the Hudson Federal Battery #1 Remediation Site.

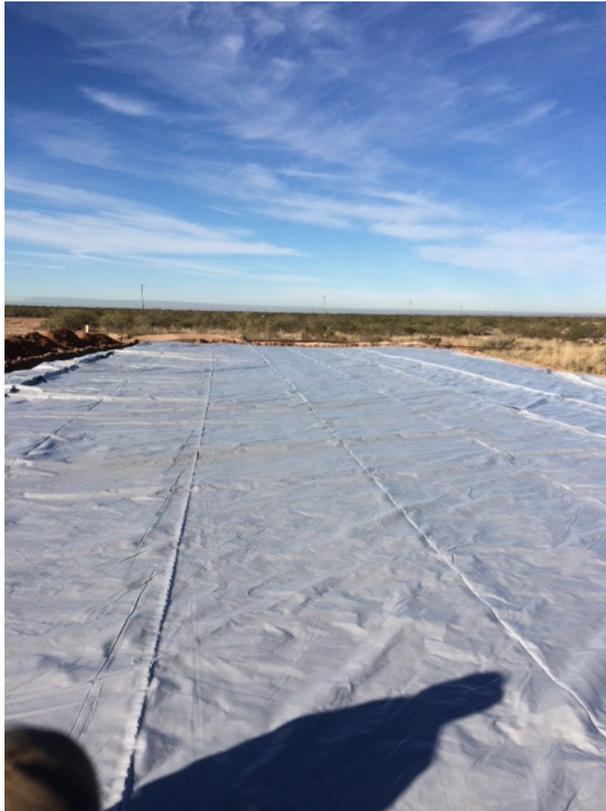
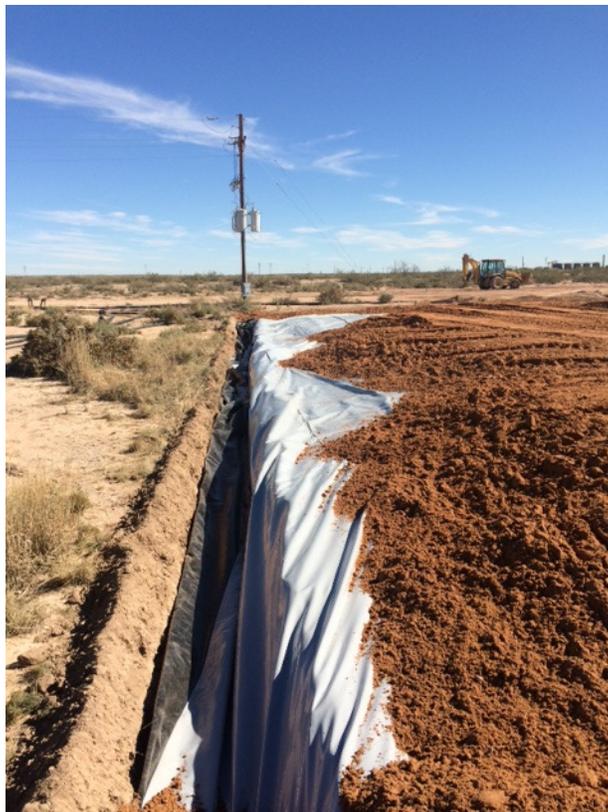
Photograph of the installation of the polyethylene liner over the barren area above the 2000 drilling reserve pit at the Hudson Federal Battery #1 Remediation Site.

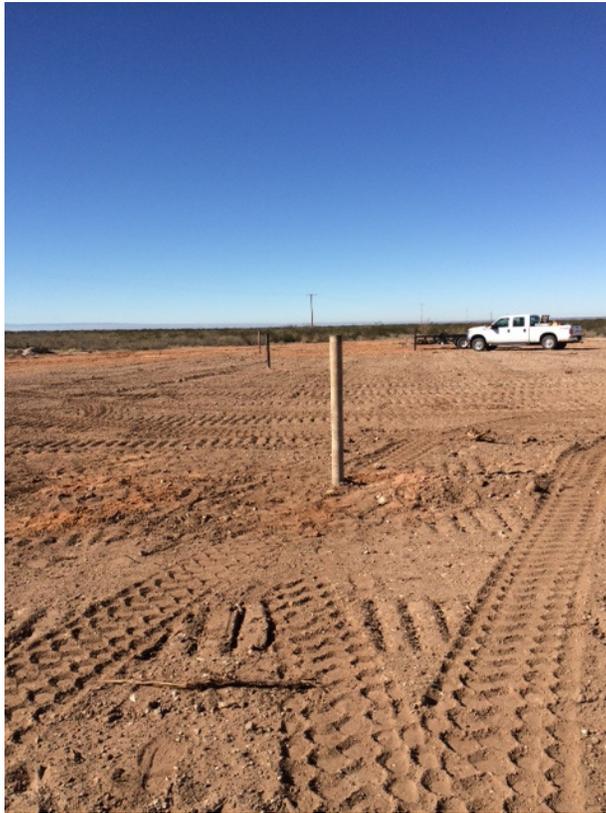
Photograph of the deep burial trench and affected pasture area after remediation activities at the Hudson Federal Battery #1 Remediation Site.

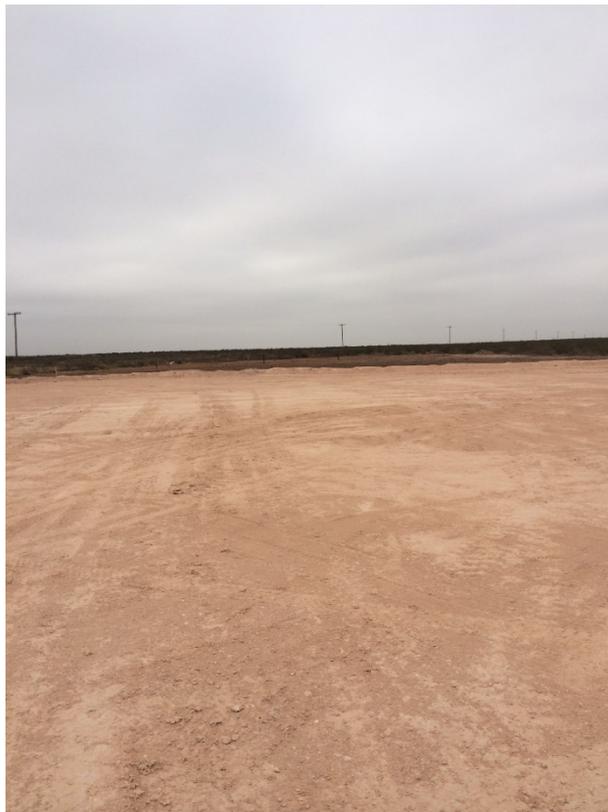
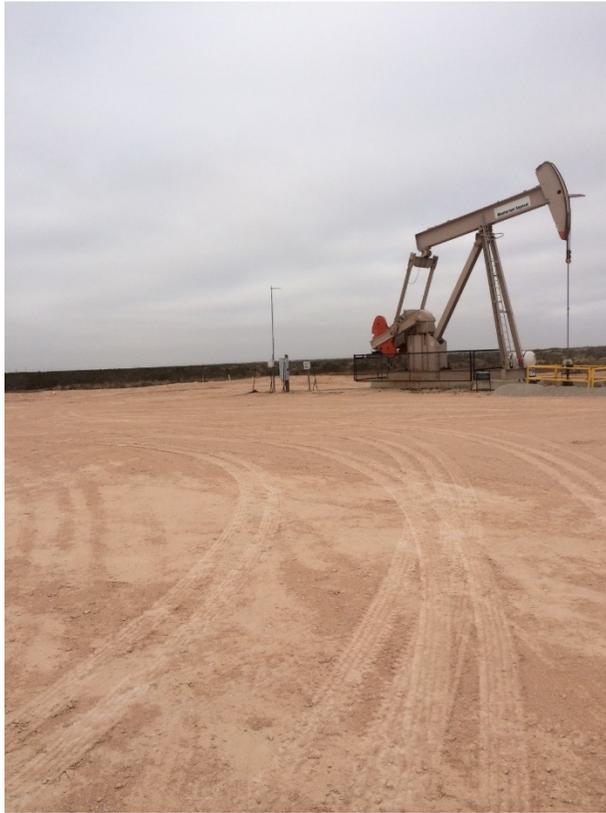
Photograph of the affected well pad area at the Hudson Federal Battery #1 after remediation activities.

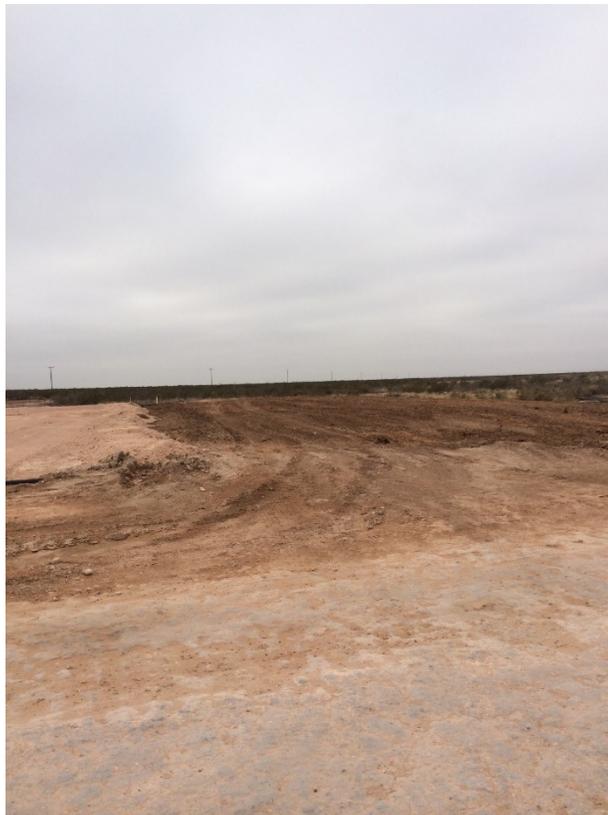
Photograph of the reclaimed area north of the caliche well pad at the Hudson Federal Battery #1 Remediation Site.
