To: Heather Patterson, New Mexico Oil Conservation Division
Reference: Remediation Work Plan
Operator: Devon Energy Production
Location: Diamond PWU 22 #5H
API: 30-015-0822
Legals: UL. D, Sec. 22, T19S, R29E Eddy County, New Mexico
GPS: 32.6518 -104.0699
2RP-3352

Release Notification and Corrective Action

Devon Diamond PWU 22 #5H

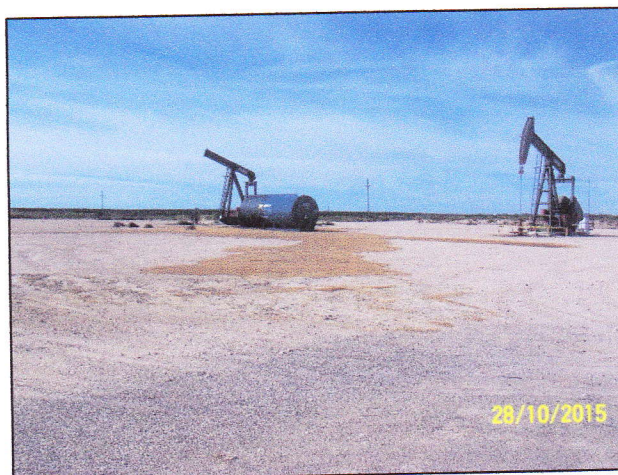
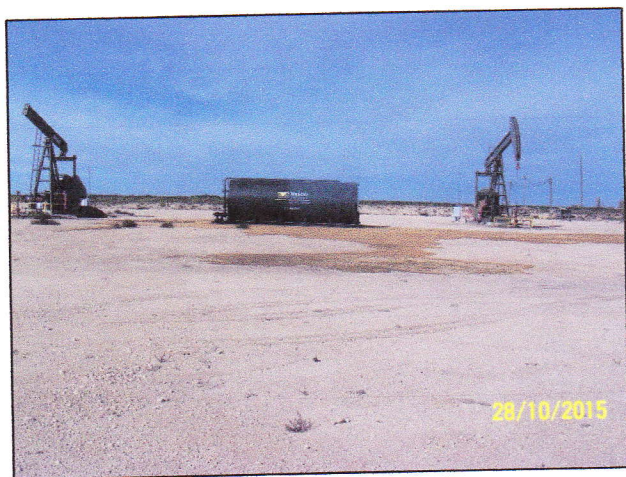
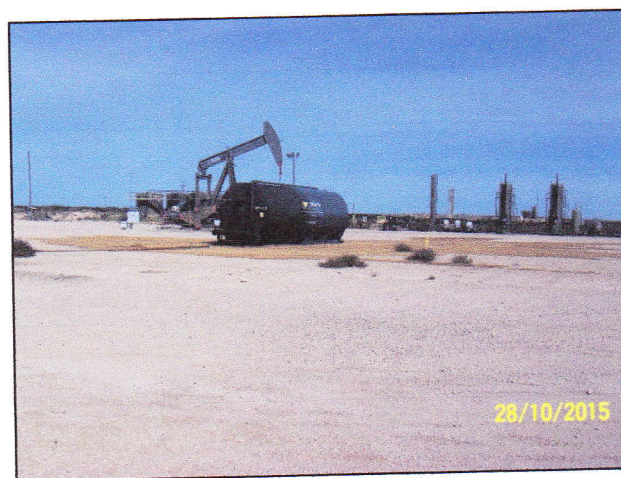
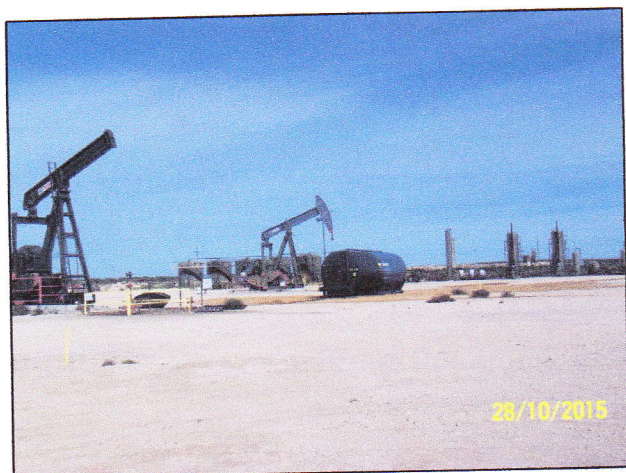
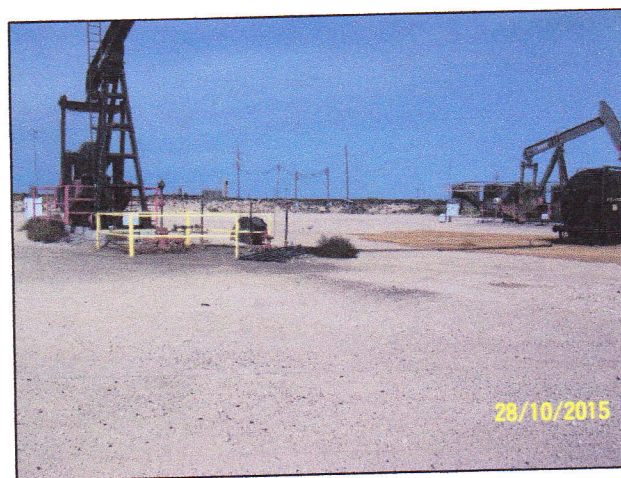
This site is located in rural Eddy County, NM on Curry Comb Road approximately 7.7 miles west of the intersection of Highway 360 and Curry Comb Road. This is an active well/battery site. The New Mexico Office of the State Engineer's website, list no ground water data for Section 22 or for Section 21 in Township 19S, Range 29E. The Eddy County Depth to Groundwater Map indicates depth to groundwater to be 100'. This release of produced water/oil that occurred on 22Oct15, remained on the caliche well pad and had no impact off site.

Upon discovery of the release, the well was shut in and a vacuum truck was used to recover all free standing liquids. On 28Oct15, soil sampling was conducted at two separate sample points using hand tools. Samples were obtained at Surface, .5' BGS, and 1.5' BGS. Lab analysis was conducted. See attached lab report and map with sample points. The impacted area of the pad is an irregular configuration that is approximately 250' x 170'.

The lab analysis indicates that the downward migration of the released fluids was limited to the top 6" of the compacted caliche pad. I propose to mechanically remove this impacted layer. All impacted soil will be transported to a division approved facility and fresh material will be used to backfill the excavated area. The area will then be compacted and brought back to its original grade.
