# Cottonwood Draw 22 Fed 2H

## WORK PLAN

API # 30-015-36757

**RE: Cimarex, Cottonwood Draw 22 Fed 2H – Remediation Work Plan**  
UL/I, Section 22, T25S, R26E  
API No. 30-015-36757

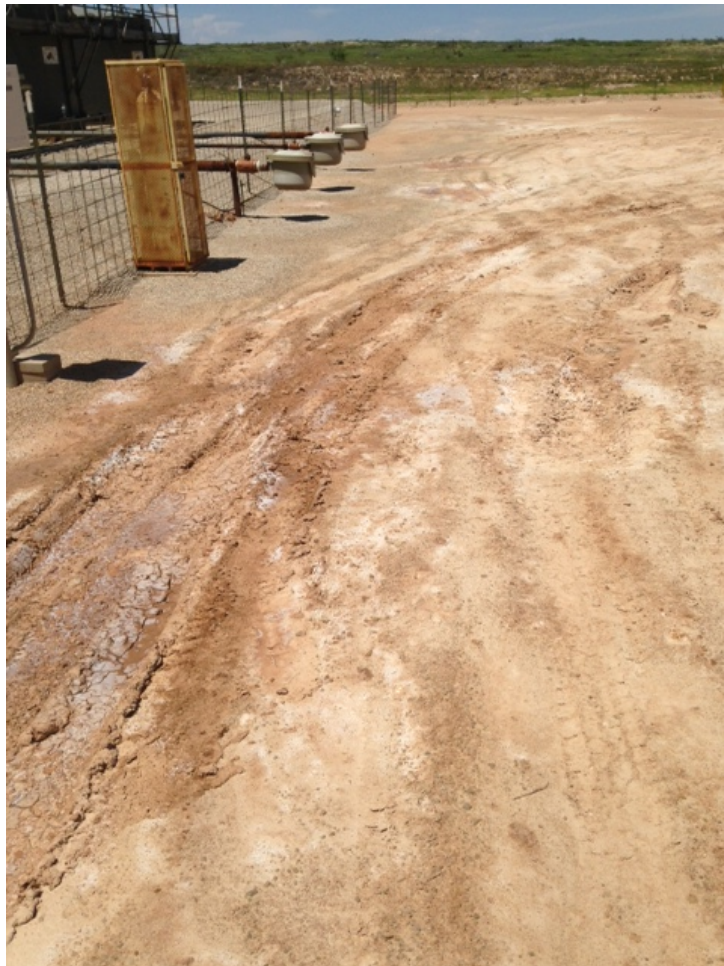
The site is located east of White's City, in Eddy County. The leak occurred on 07/09/2015. The leak site resulted from a failed regulator. The regulator was installed incorrectly, getting fluids instead of getting gas. Approximately 12 bbls of oil and 8 bbls of produced water were released. Four bbls of oil and 6 bbls of produced water were recovered using a vacuum truck. The spill affected the location pad and ran down a cow path into the pasture area. A C-141 was drafted.

Spill area on pad

Remove 6" BGS of contaminated soil on the pad, then backfill with fresh caliche. In the pasture area, remove 4' BGS and install either impervious river rock or a 20 mil liner and backfill with native topsoil. The pasture area will also be seeded with a BLM approved seed mixture. All contaminated material will be hauled to an approved NM state disposal.

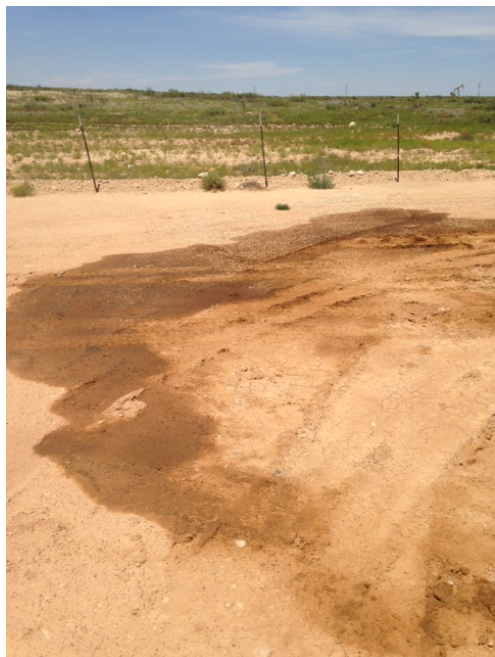
Spill area on pad

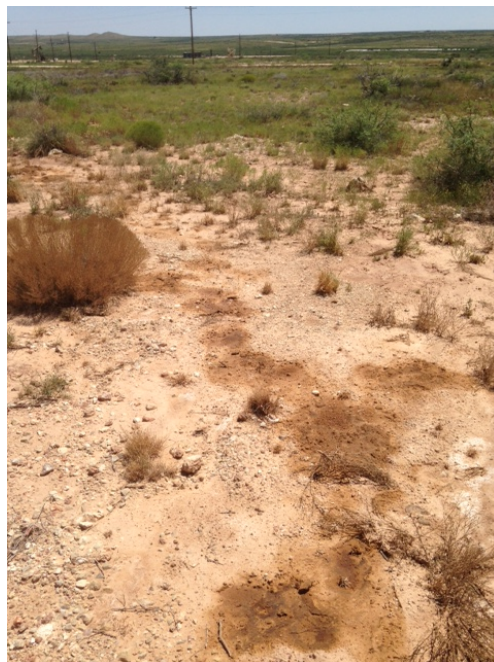
Spill area in pasture

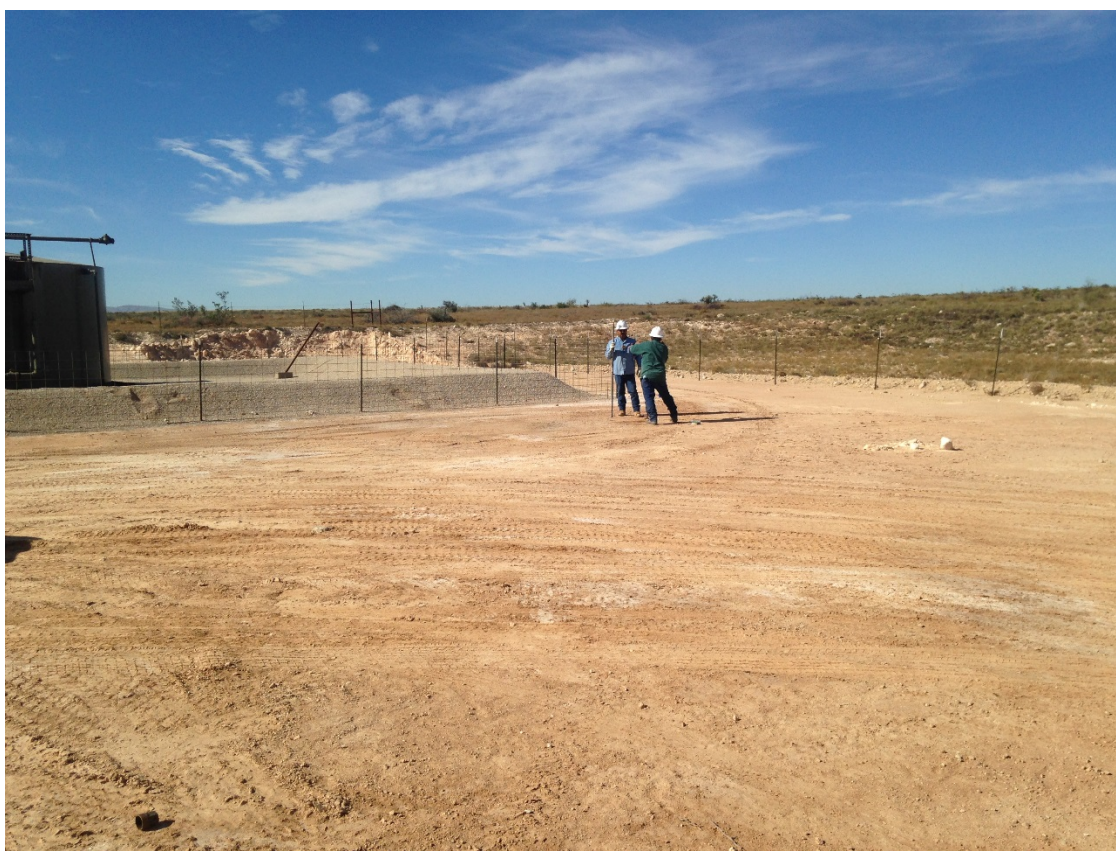
On November 24, 2015 DFSI personnel delineated 6 sample points of the leak area. Each sample was tested for chlorides levels as well as BTEX. The BTEX samples were performed using a Mini Rae Photoionization Detector (PID). The results are attached. Clean samples were taken to a commercial laboratory for confirmation.

Collecting soil samples on pad

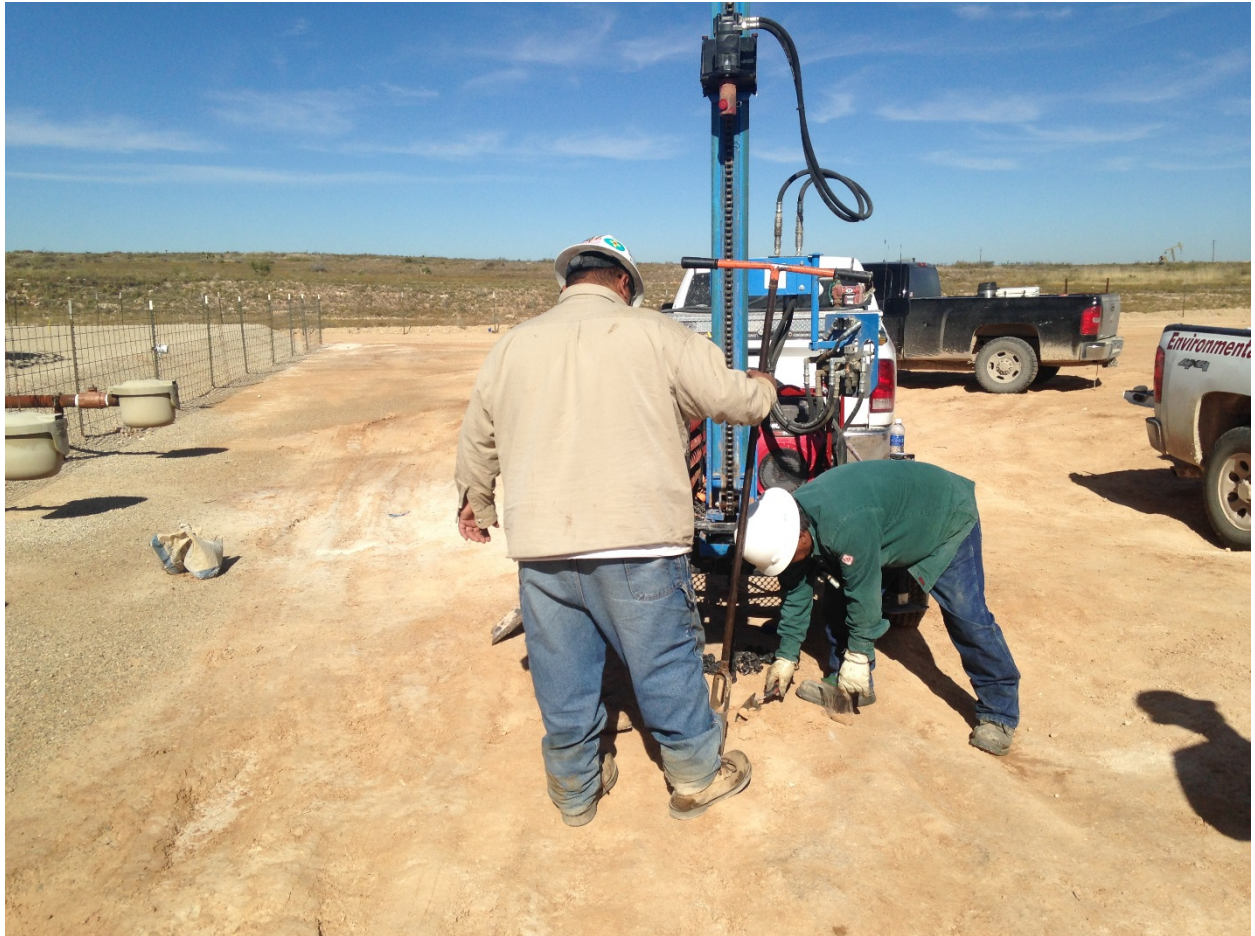
DFSI personnel also drilled two bore holes at the location, due to auger refusal on sample points. One bore hole was drilled on the pad, and the other was drilled in the pasture. Clean samples from the drilling were also taken to a commercial lab for confirmation. Those results are attached as well.

Drilling for samples on pad
