SUBJECT: SOIL REMEDIATION WORK PLAN FOR INCIDENT 2RP-3356 BRUTUS 12 FEDERAL COM #002H, EDDY COUNTY, NEW MEXICO

# SOIL REMEDIATION WORK PLAN FOR INCIDENT 2RP-3356

BRUTUS 12 FEDERAL COM 2H

November 18, 2015  
SMA Reference  
5B23978 BG8

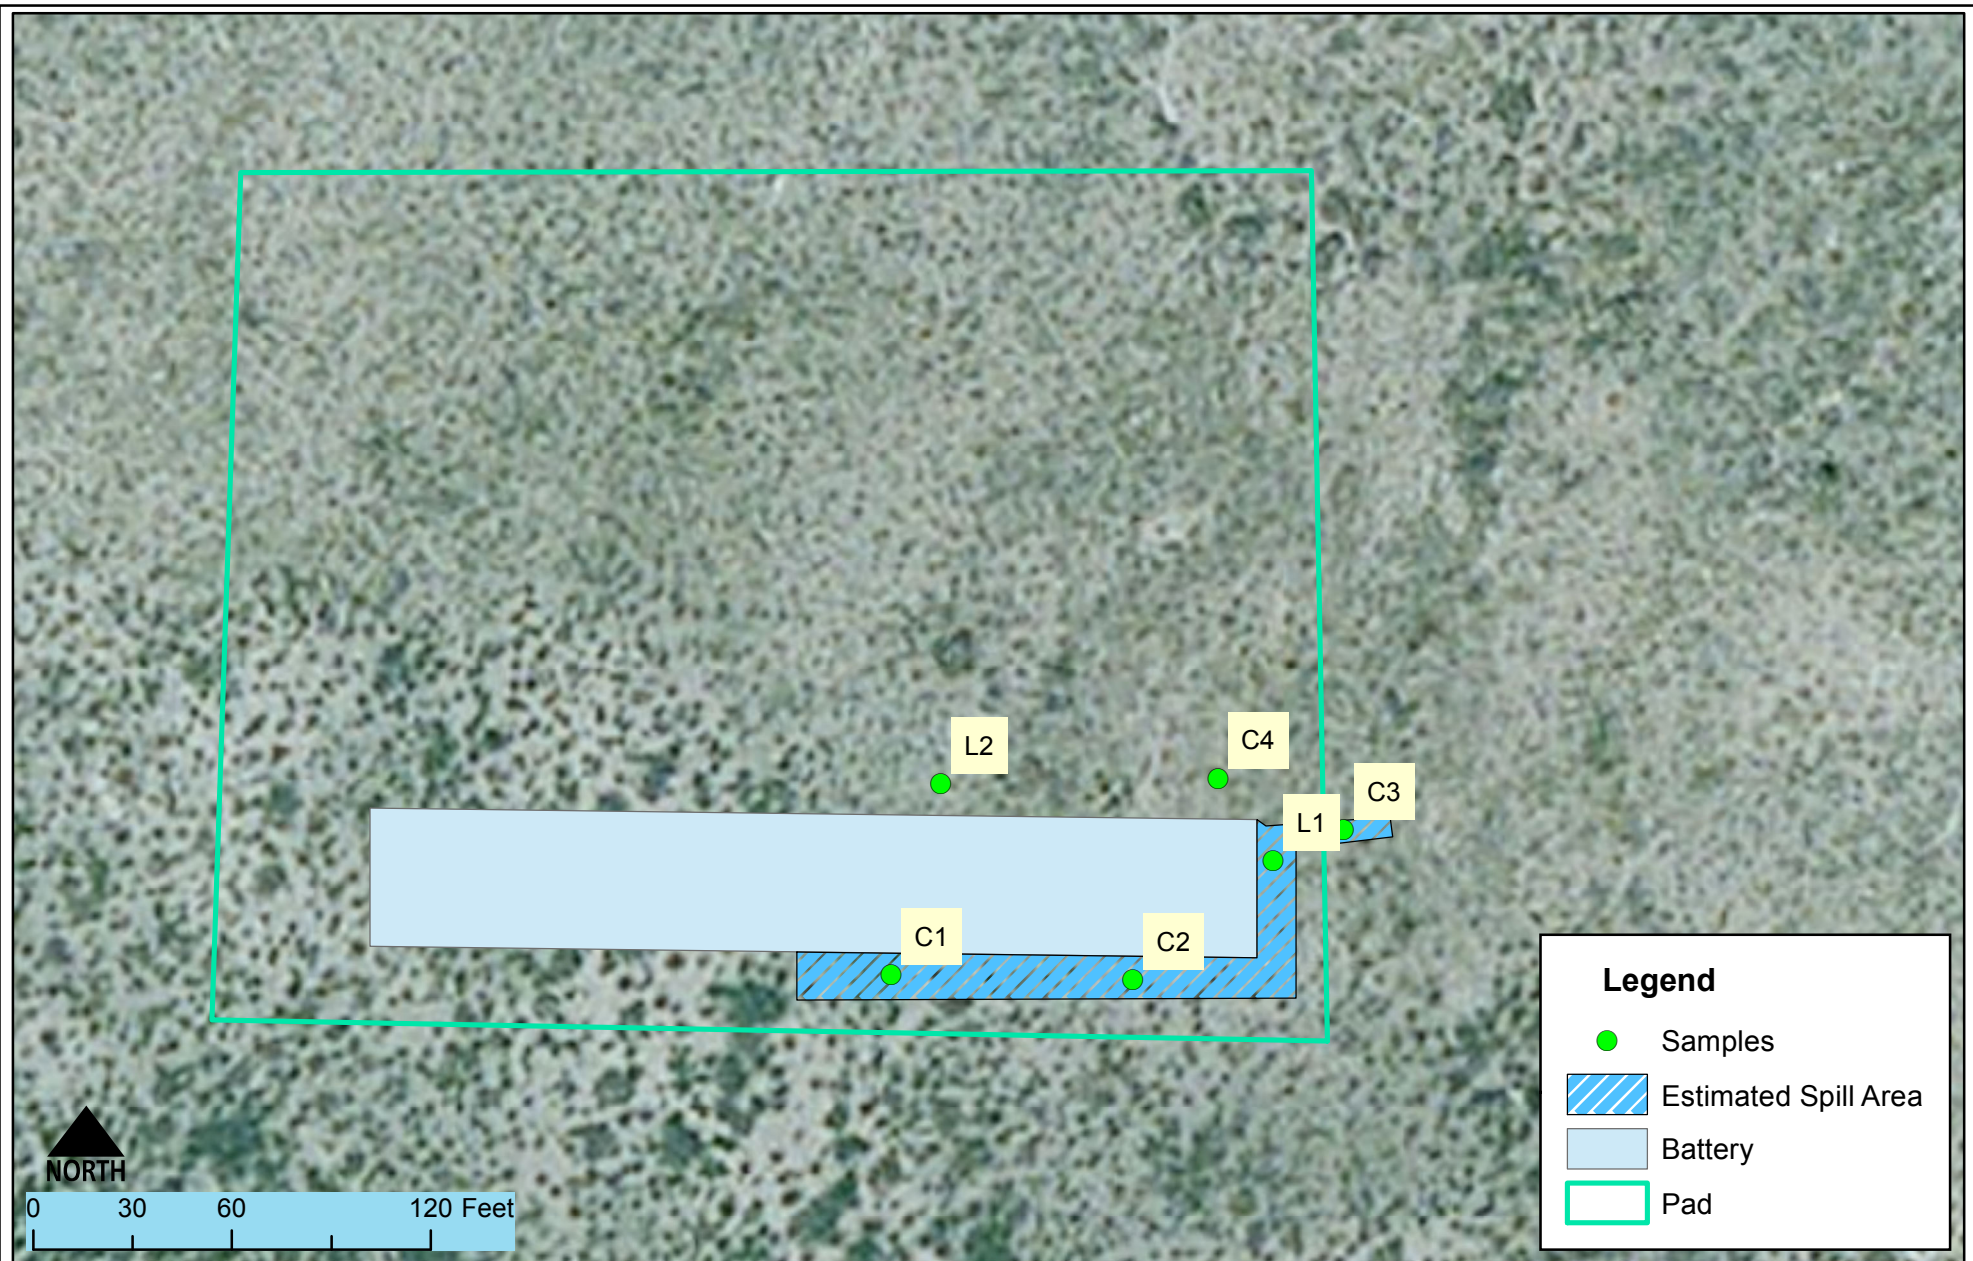
The release site is located approximately 1.4 miles (> 1,000 feet) west of Pecos River, in an area managed by BLM with an elevation of approximately 2,950 feet above sea level. After evaluation of the site using aerial photography and topographic maps, depth to groundwater is estimated to be less than 100 feet but greater than 50 feet below ground surface (bgs). Figure 1 depicts the site vicinity and Figure 2 depicts the site details and sample locations.

Soil contaminant concentrations found during the initial delineation are illustrated in Figure 2. A summary of the laboratory analyses is included in Table 2. Laboratory reports are included in Appendix A.

## SITE DETAILS AND SAMPLE LOCATIONS MAP

Site Detail and Sample Locations  
COG Brutus 12 Federal Com 2H  
Malaga, New Mexico

SMA will begin the excavation of affected soils, with approval from area utilities owners via 811 and NMOCD. The composite sample locations C3 and C4 are within a crude oil pipeline right of way (ROW). SMA will continuously guide the excavation activities by collecting composite soil samples for field screening with a mobile titration unit (EPA 4500) and a calibrated PID. Delineation will occur to depths to sufficient to delineate the plume by NMOCD Division 1 standards. Excavation will be done to affectively remove hydrocarbon contaminated soil. Closure samples will be collected at final depth of excavation and on sidewalls to show that contaminated soil was removed on a vertical and horizontal extent. Approximately 330 cubic yards of contaminated soil will be removed and replaced with clean backfill material to bring the

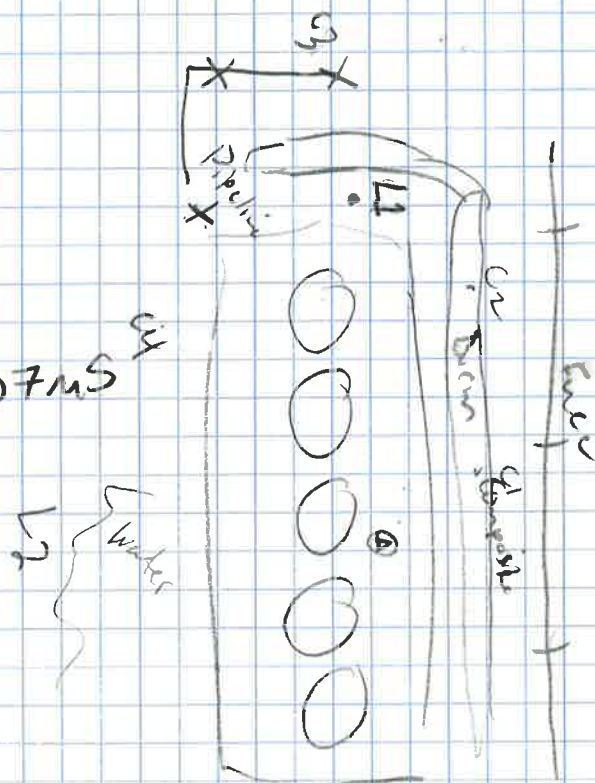
Brutus 12 FED Com  
Produced Oil  
10/2/2015

Location is burned  
Burn intact - no holes  
Battery is lined

EC RAN AT. CASE  
FOUND NO SALT 0.07mS
