EL Federal #13

CLOSURE REPORT

Remediation

API No. 30-015-36662

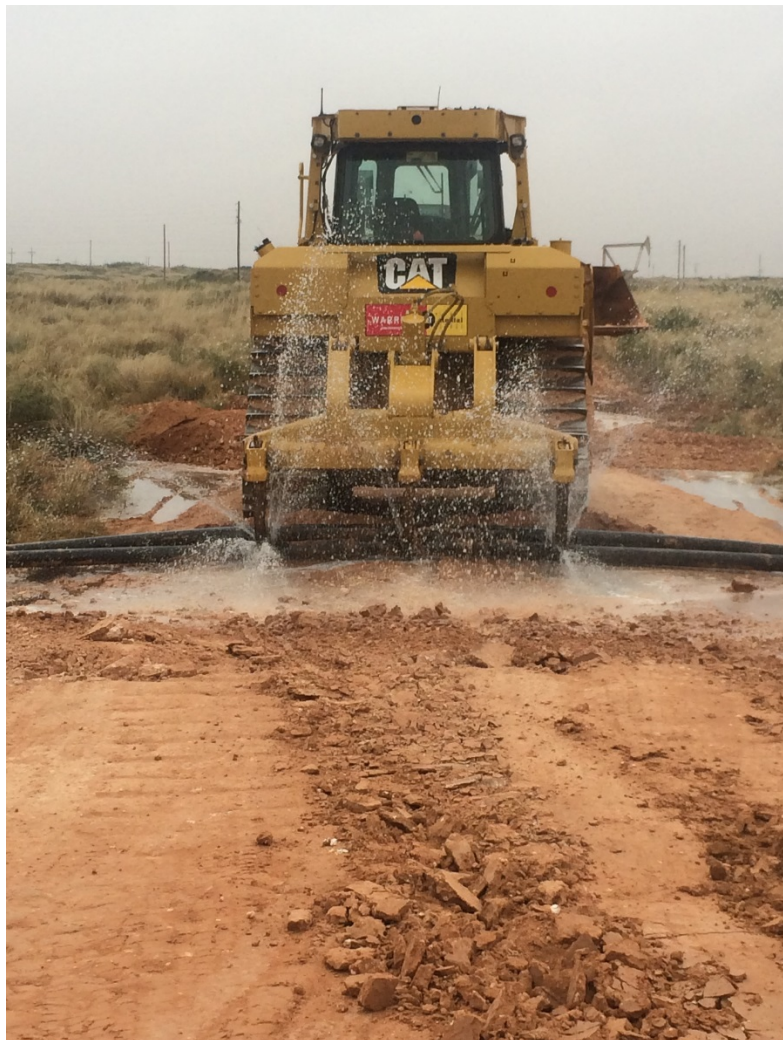
Line strike with dozer rippers in line, fluid gushing out

The flow line was buried under the lease road and a dozier operator engaged the rippers while driving down the lease road causing the line to rupture. The line was shut in and repaired.

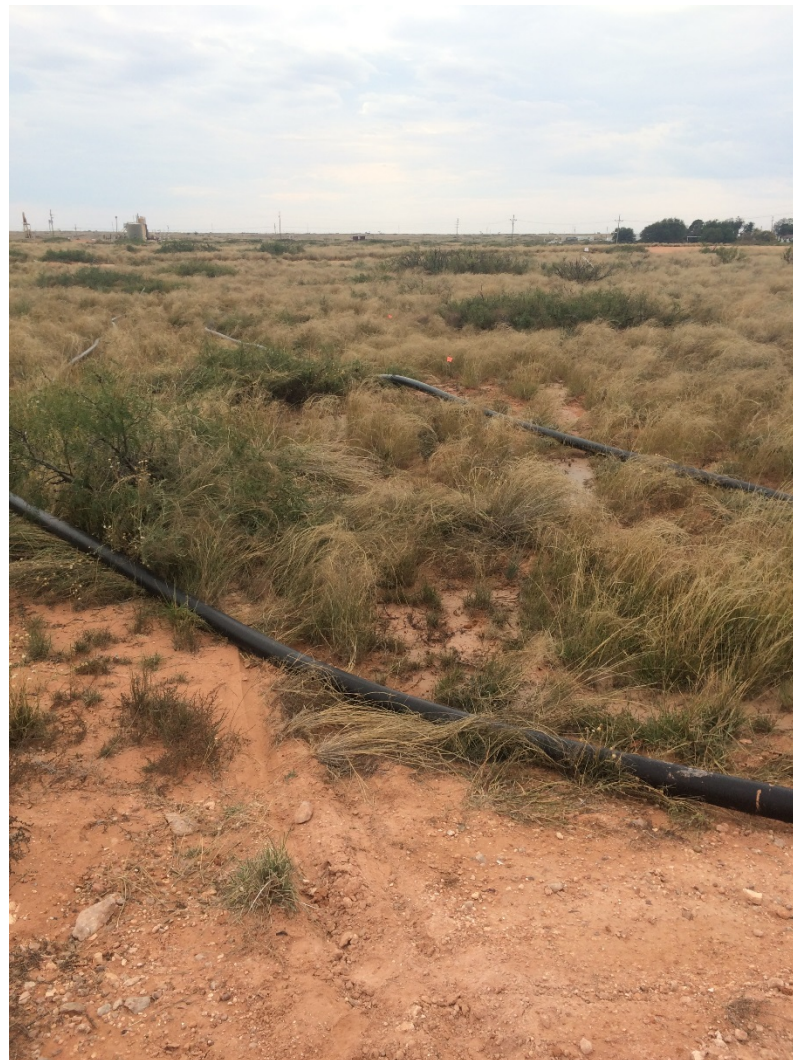
Spill area in pasture

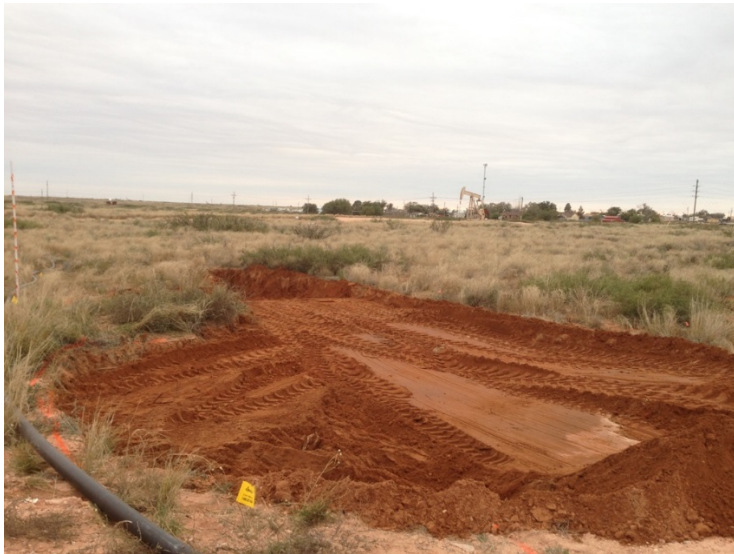
Scraped area where spill lied in pasture

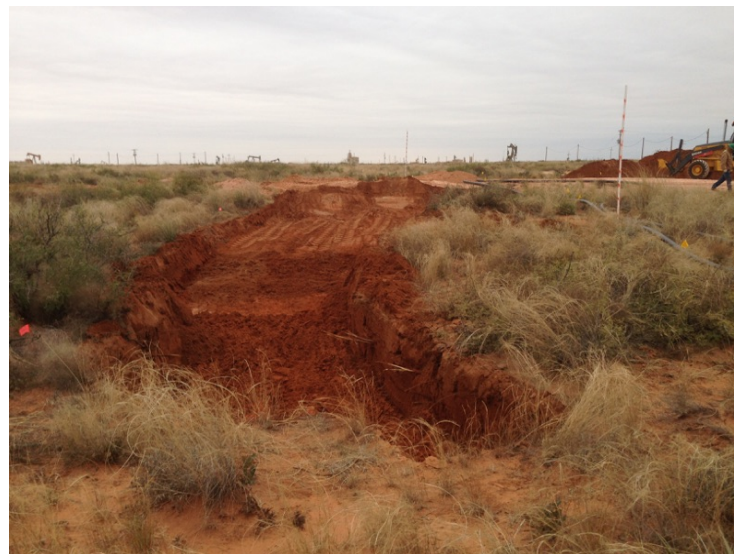
Scraped area where line lied in pasture

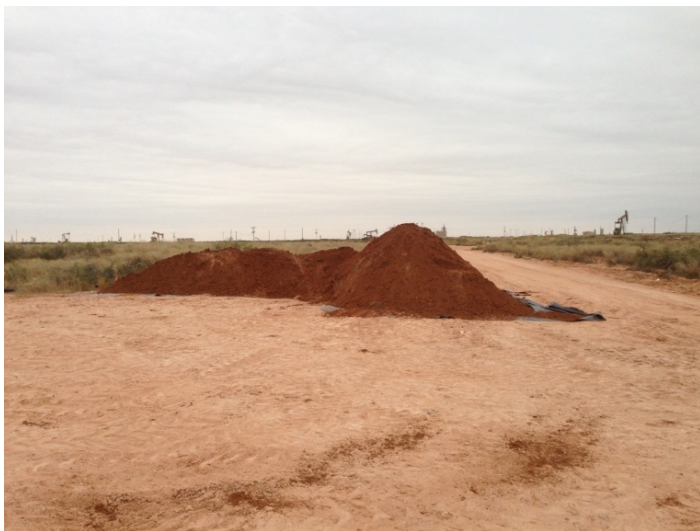
Stockpiled soil from initial scrape

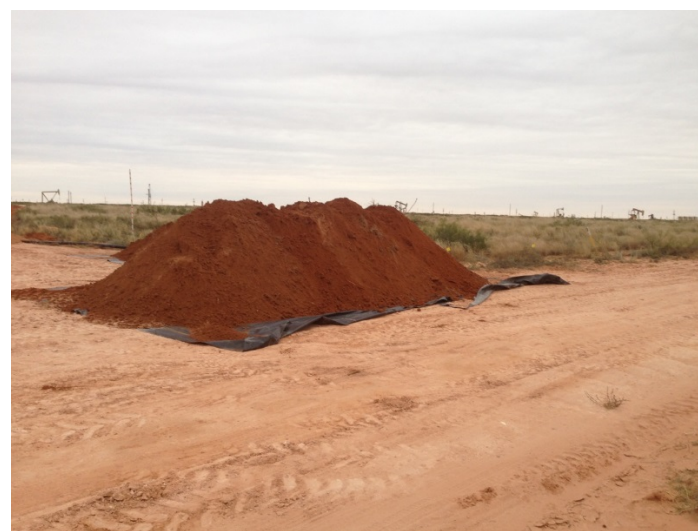
Stockpiled soil after excavation

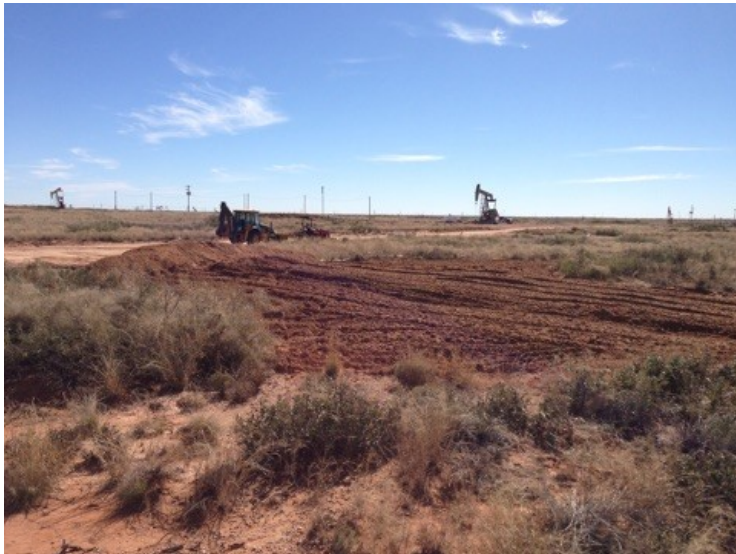
Completion of excavation area, backfilled and reseeded

On November 12, 2014, DFSI personnel returned to the site to begin excavation. The areas of sample points one and five were dug out to 3' bgs; sample points two and four were dug out to 1' bgs and sample point three was dug out to 2' bgs. Fresh topsoil was brought in for backfill. All contaminated soil was hauled to an approved NM state disposal. The area was contoured and reseeded with 25 pounds of LPC seed. The location was restored to its previous state.

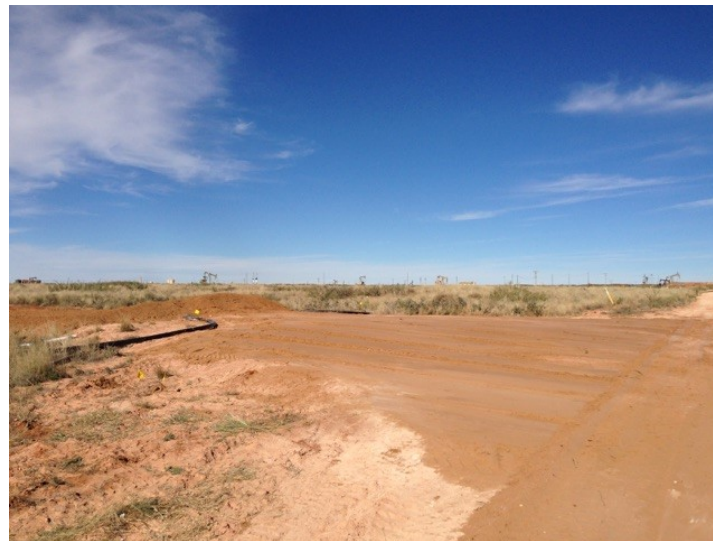
Completion of excavated area, backfilled and reseeded

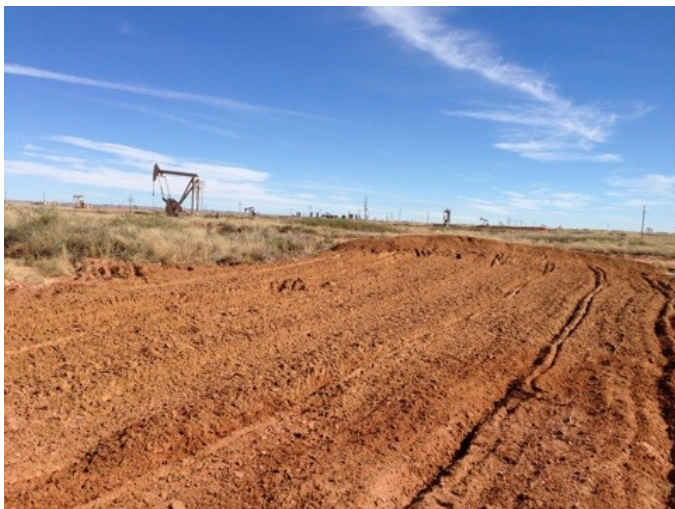
Contoured and reseeded area

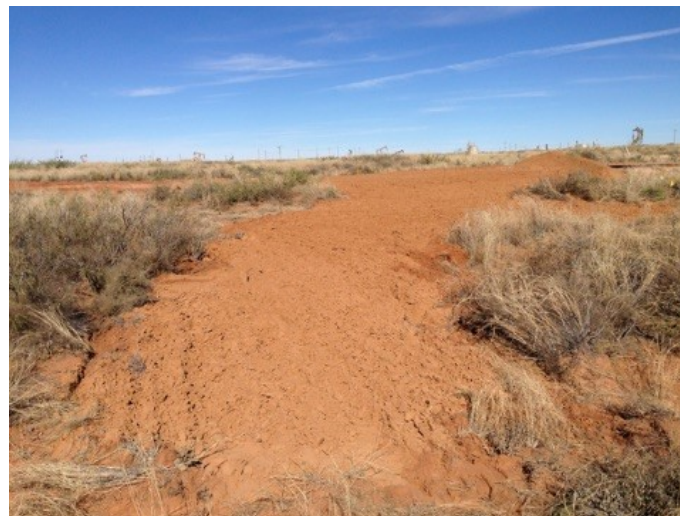
Contoured and reseeded area
