## **CLOSURE REPORT**

**BOPCO, L.P.  
PLU CVX JV PC #019H  
Eddy County, New Mexico  
Unit Letter "B", Section 21, Township 24 South, Range 30 East  
Latitude 32.210641 North, Longitude 103.885696 West  
NMOCD Reference #2RP-3270**

RE: Final Closure Report  
Bopco – PLU CVX JV PC #019H  
UL-B, Section 21, Township 24 South, Range 30 East  
Eddy County, New Mexico  
NMOCD Reference # 2RP 3270

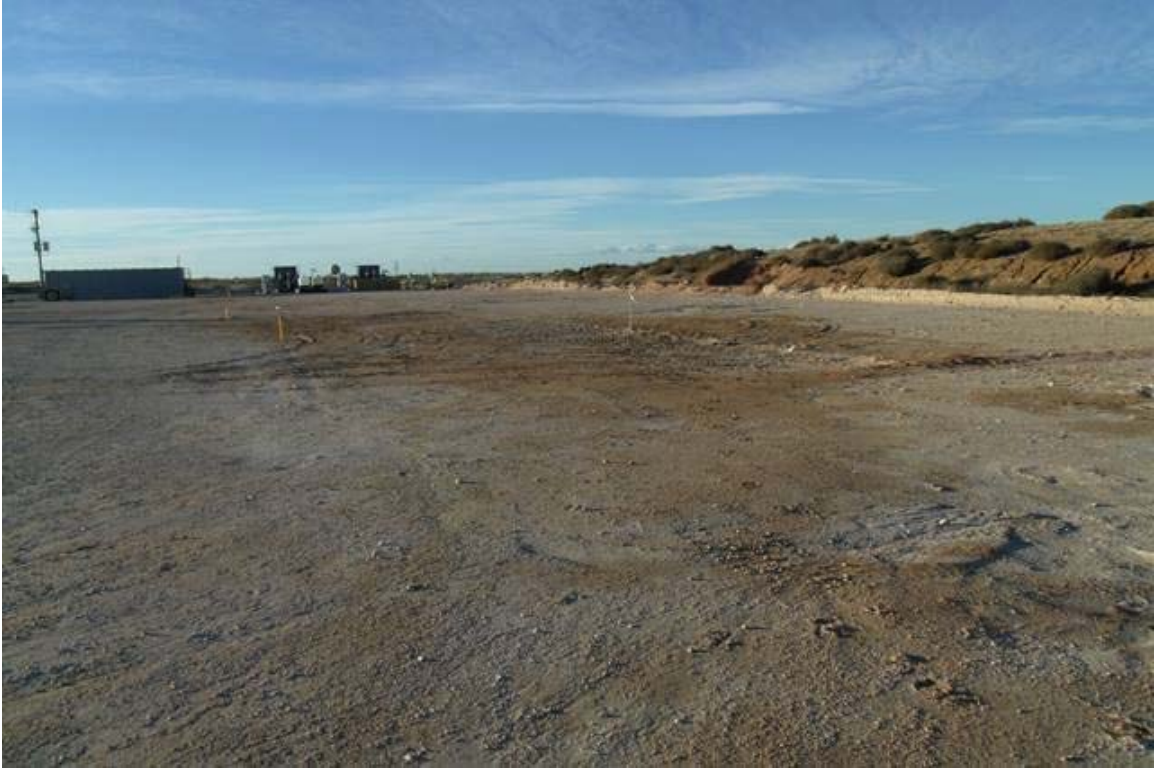
Photograph #1 – Looking across release area

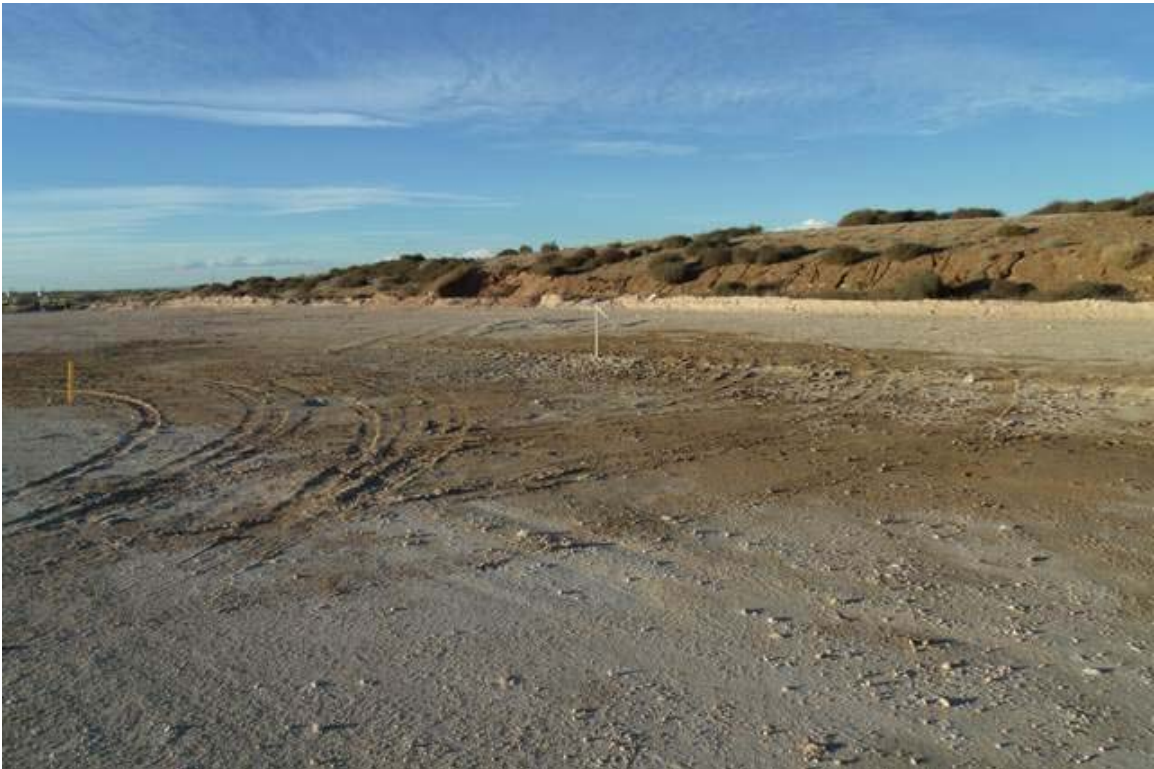
Photograph #2 – Looking across release area

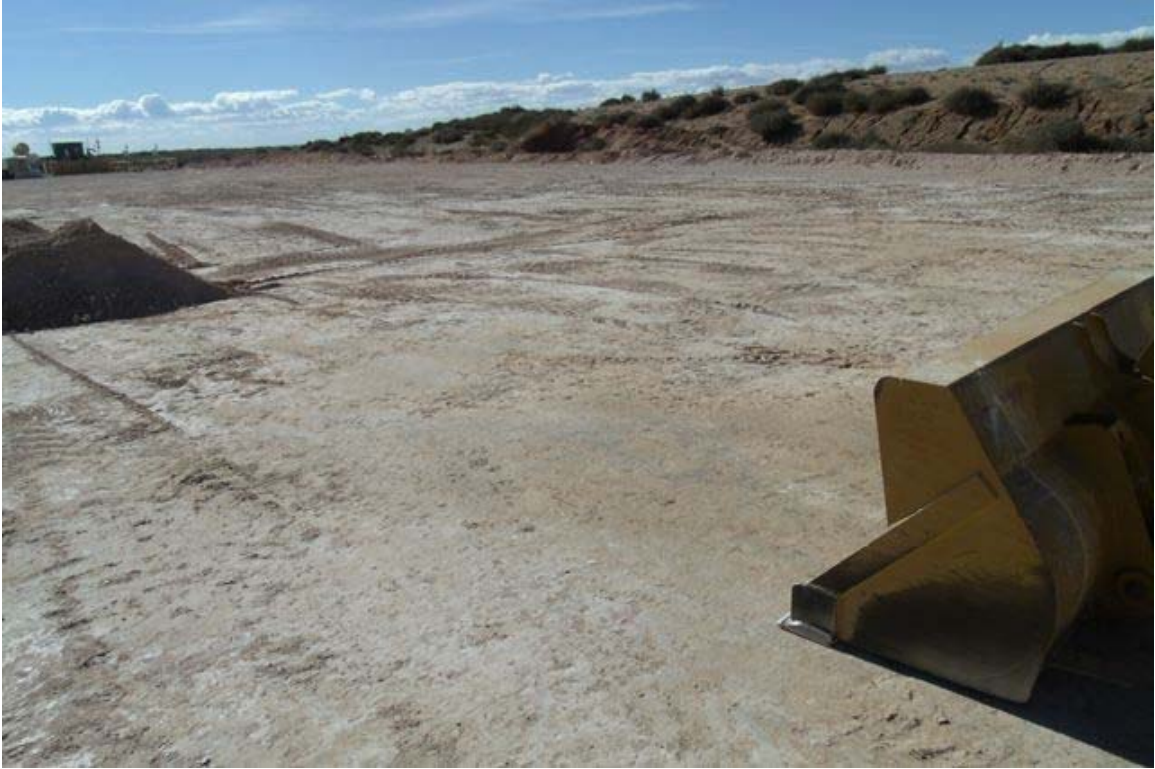
Photograph #3 – Excavated

The release area was excavated to a depth of approximately six (6) inches bgs. Approximately 36 tons of contaminated soil were excavated and hauled to a state approved facility for disposal.

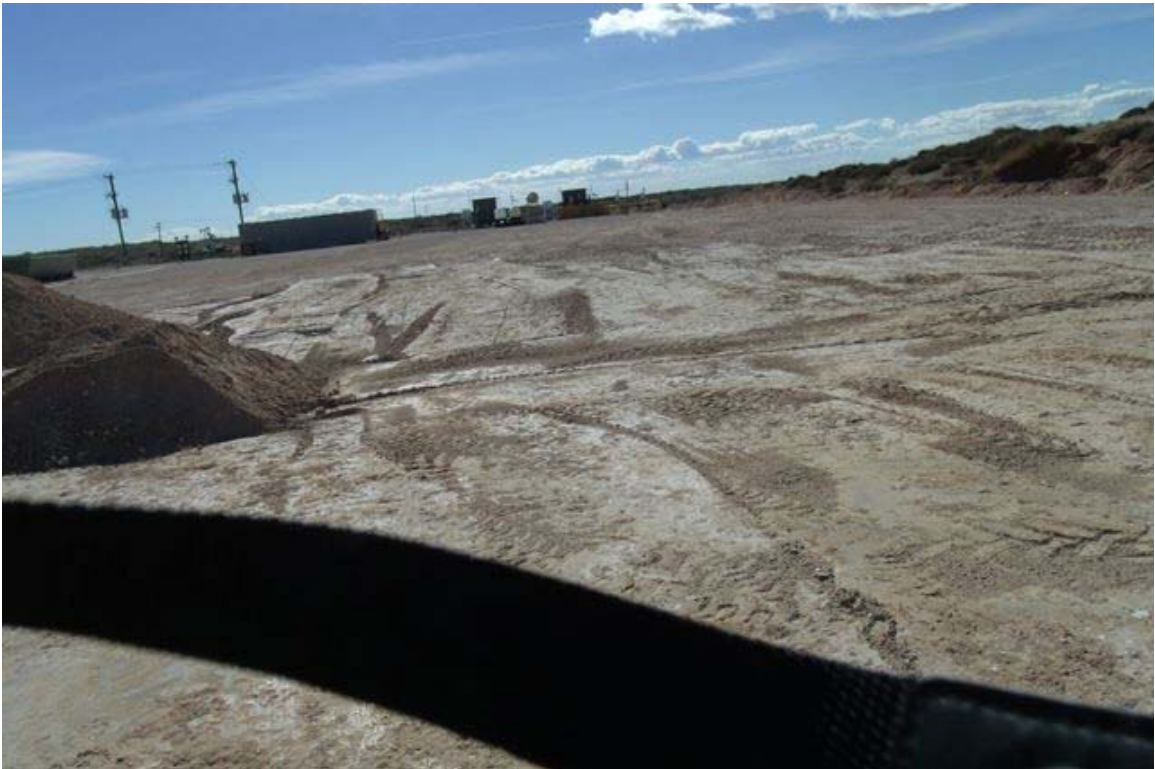
Photograph #4 – Excavated

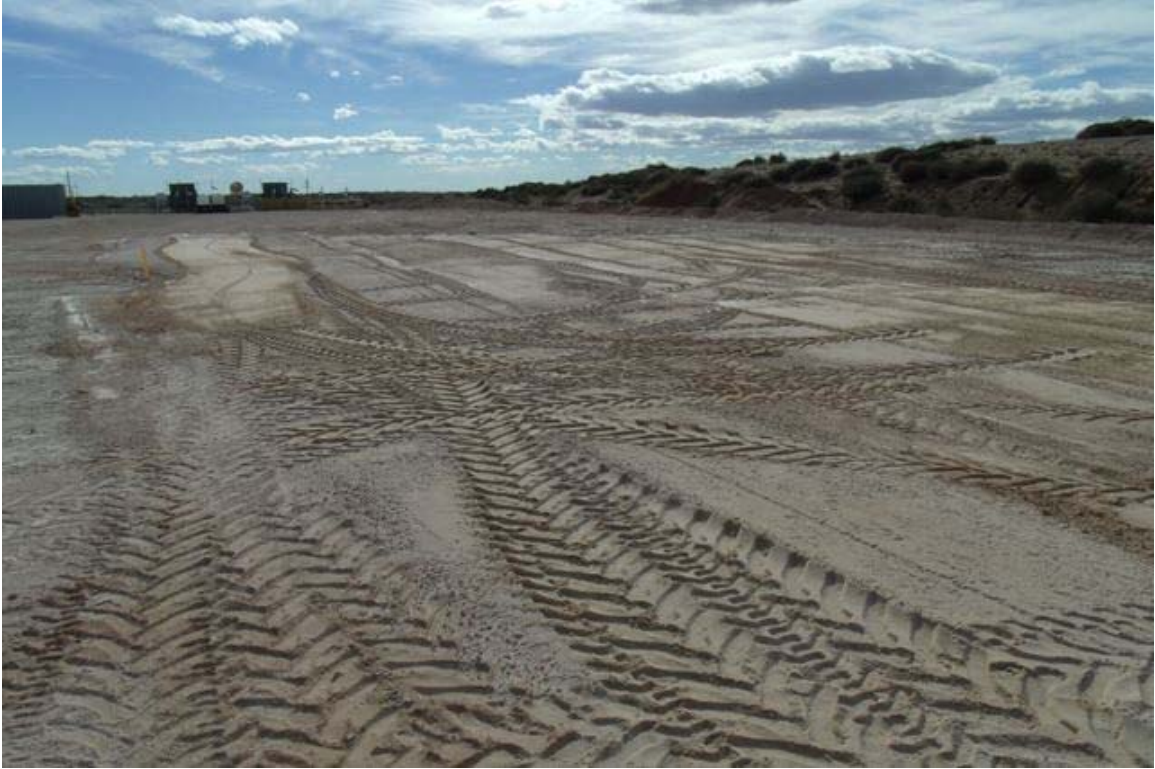
Photograph #5 – Backfilled

Based on laboratory analytical results and with NMOCD approval the excavation was backfilled with approximately 36 tons of clean soil. All soil was free of rocks, clumps or deleterious material. The entire disturbed area was then contoured to blend with existing well pad area and protected against wind/water erosion.

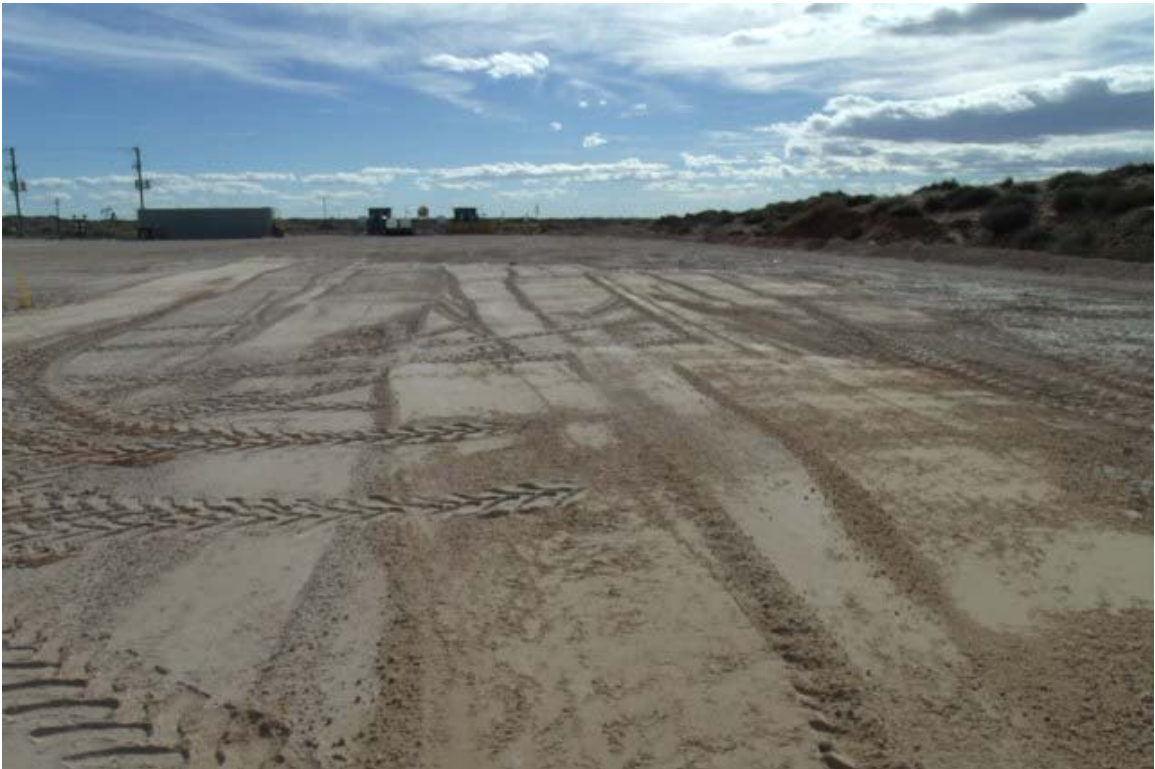
Photograph #6 – Backfilled
