James E Federal Upper Battery
(2RP-1509 & 2RP-2197)

Termination Request

ConocoPhillips James E Federal Upper Battery (2RP-1509&2RP-2197)

Excavation Data

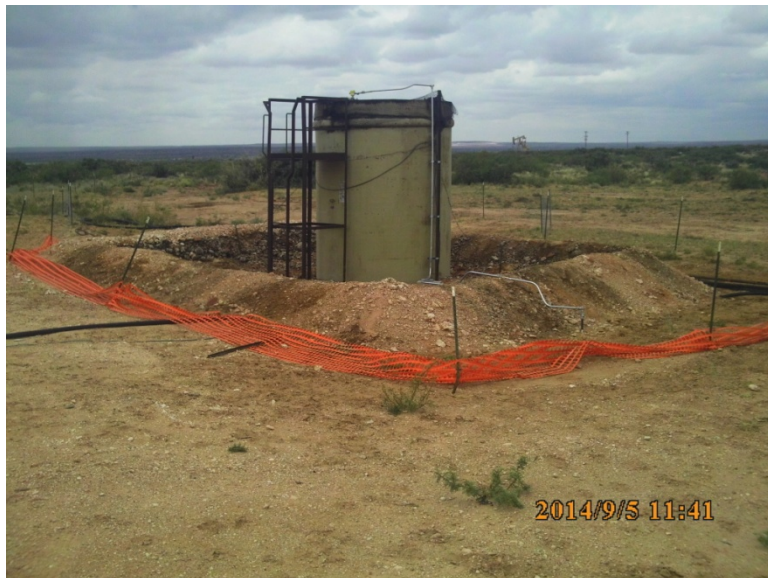
9/5/14

Initial release area, facing northeast

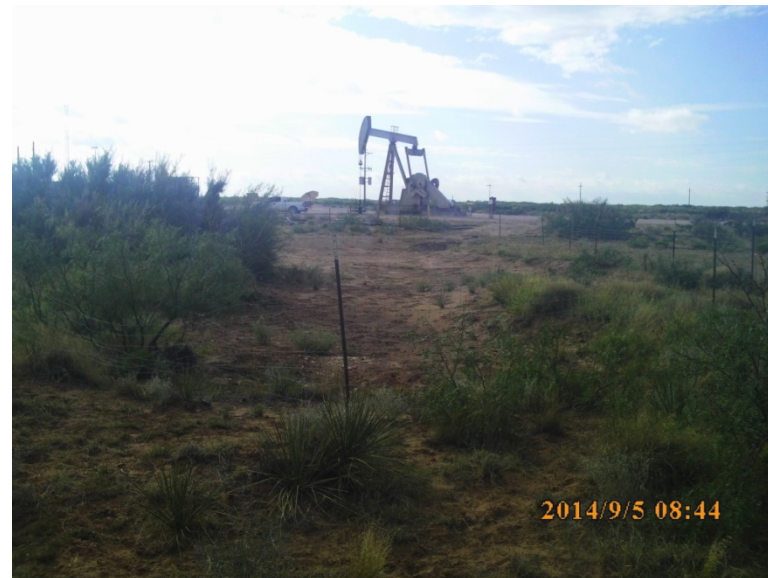
9/5/14

Initial release area, facing southeast

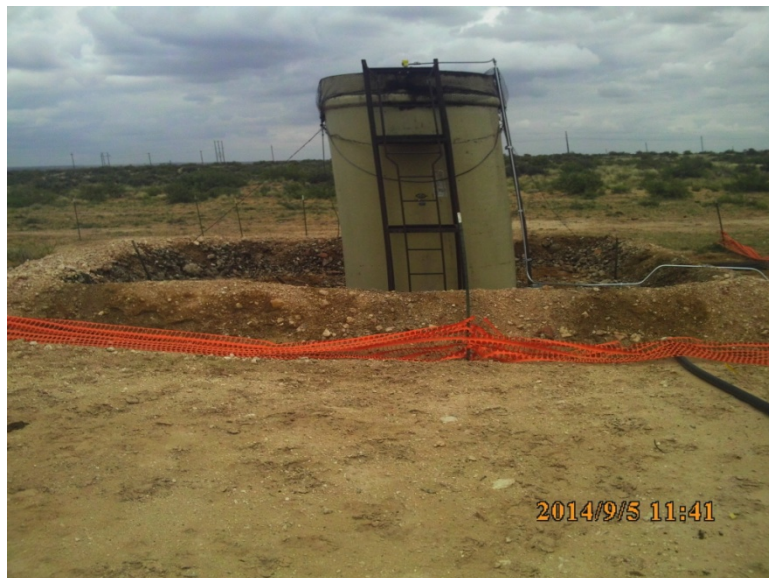
9/5/14

Initial release area, facing north

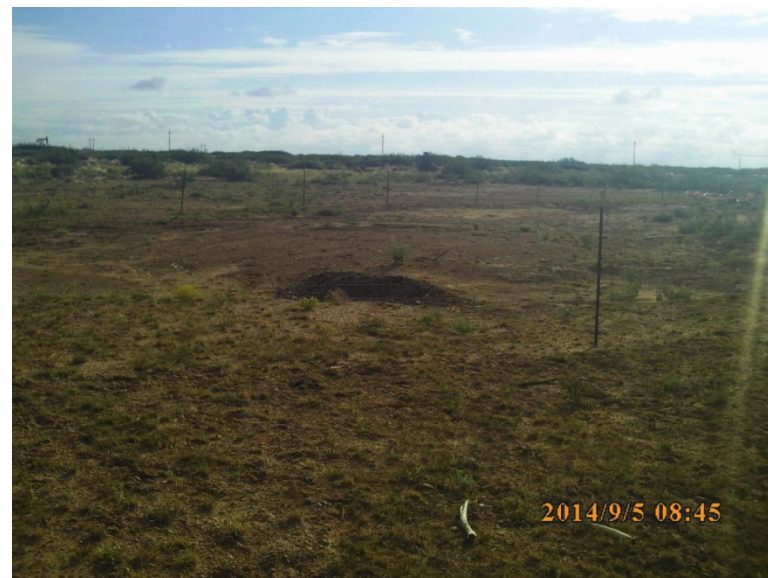
9/5/14

Initial release area, facing northeast

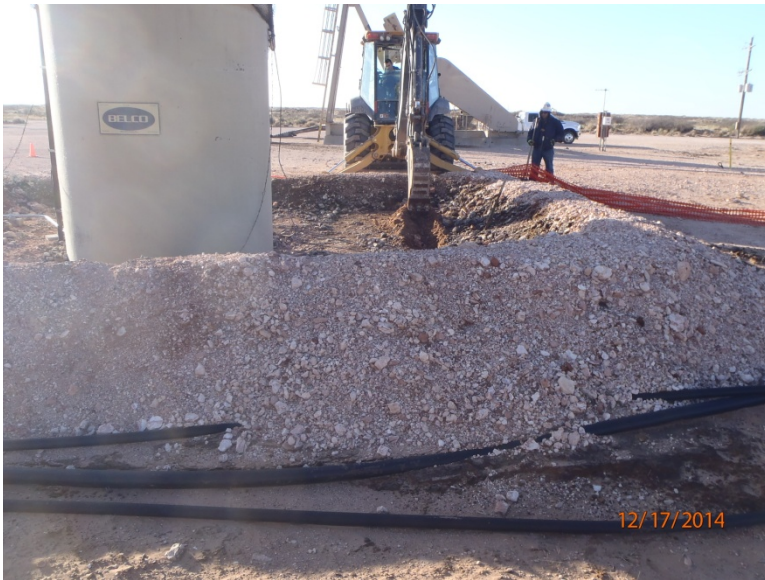
12/17/14

Installing vertical, facing south

Corrective actions began at the site on December 17th, 2014. A vertical was installed in the overflow tank area to 2 ft bgs, per NMOCD's request to delineate the bermed area before any excavation depths in the area were approved. Samples were taken every 6 inches and representative samples were sent to a commercial laboratory for analysis (Appendix B). Laboratory analysis revealed that chloride, Gasoline Range Organics (GRO), Diesel Range Organics (DRO) and BTEX were all below regulatory standards. On January 1st, 2015, Basin met with NMOCD to discuss the site. It was decided that the bermed area would be scraped down to 1.5 ft bgs and a 40-mil liner installed at the base

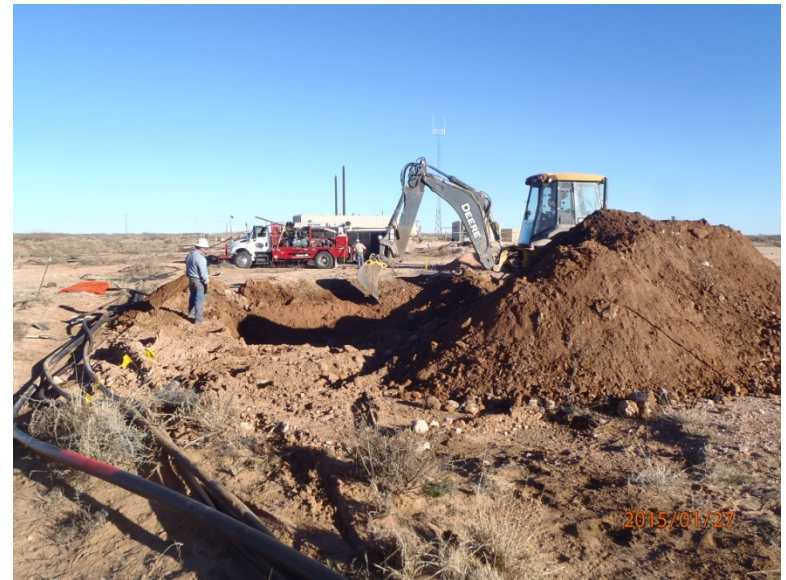
1/27/15

Excavating to 1.5', facing east

In accordance with NMOCD's stipulations, the bermed area was scraped down to 1.5 ft bgs and a 40- mil, reinforced poly liner was installed and properly seated, the liner extended up over the surrounding berms. All excavated soil, a total of 120 cubic yards, was taken to a NMOCD approved facility for disposal. A total of 180 cubic yards of top soil and 35 yards of base course were imported to the site to serve as backfill. A 5 pt. composite was taken from the imported soil and sent to a commercial laboratory for analysis, revealing a chloride level of 80 mg/kg. The site was backfilled with the imported soil and contoured to the surrounding location. On January 29th, 2015, the disturbed area was seeded with BLM #2.

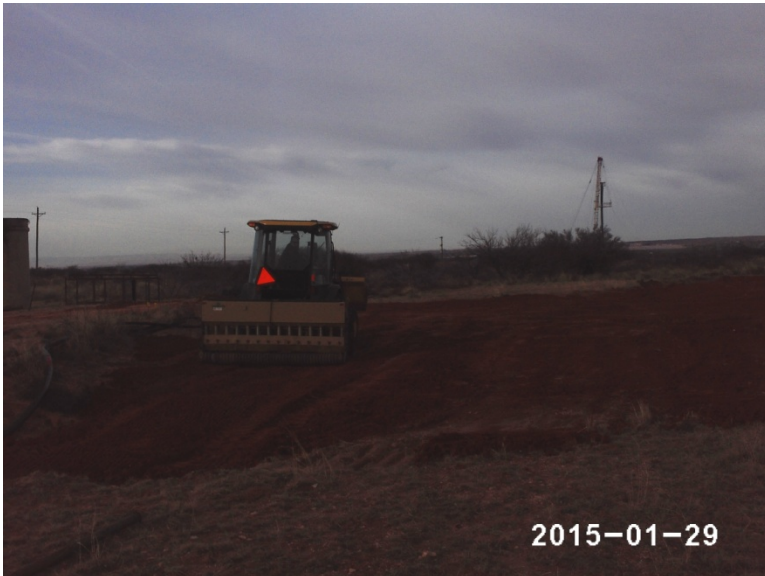
1/29/15

Seeding disturbed area, facing west

The scrape in the pasture would be backfilled with the imported top soil and contoured to the surrounding area. The disturbed area in the pasture would then be seeded with a blend of native vegetation.

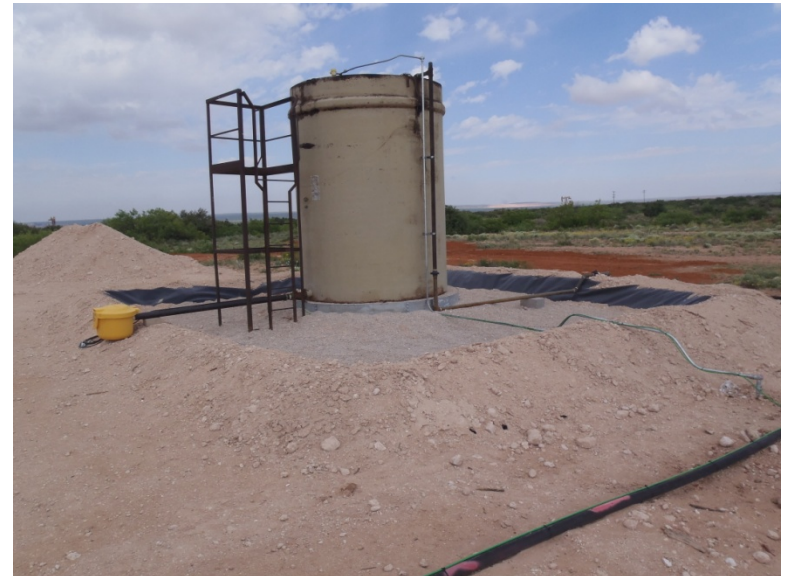
5/4/15

Completed site, facing southwest

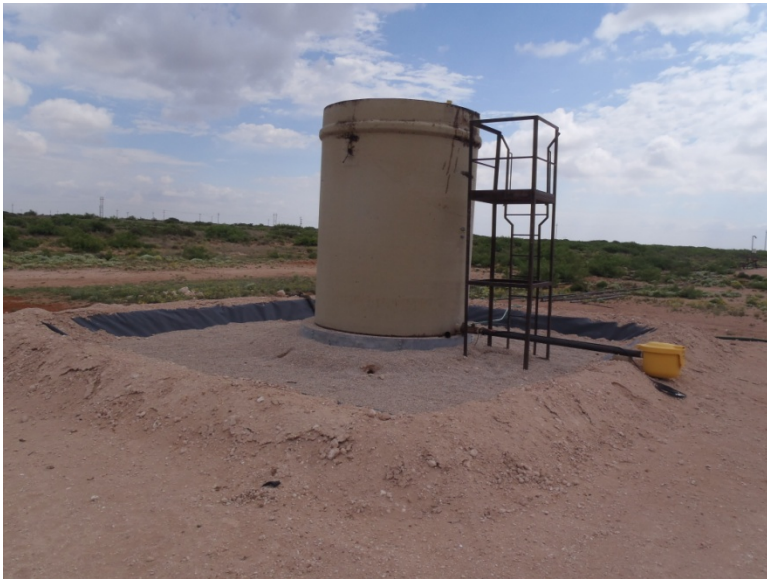
5/4/15

Completed site, facing northeast

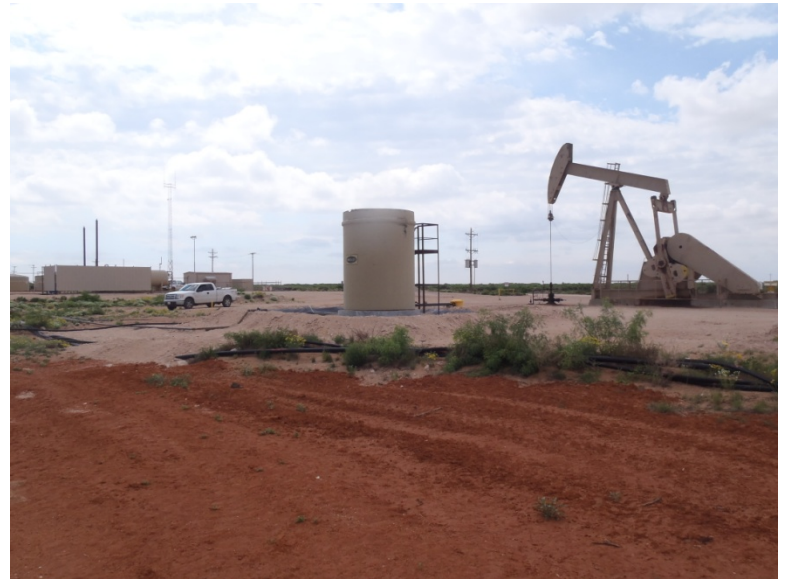
5/4/15

Completed site, facing east
