J L Keel A #11

REMEDIATION WORK PLAN

API No. 30-015-05099

December 21, 2015

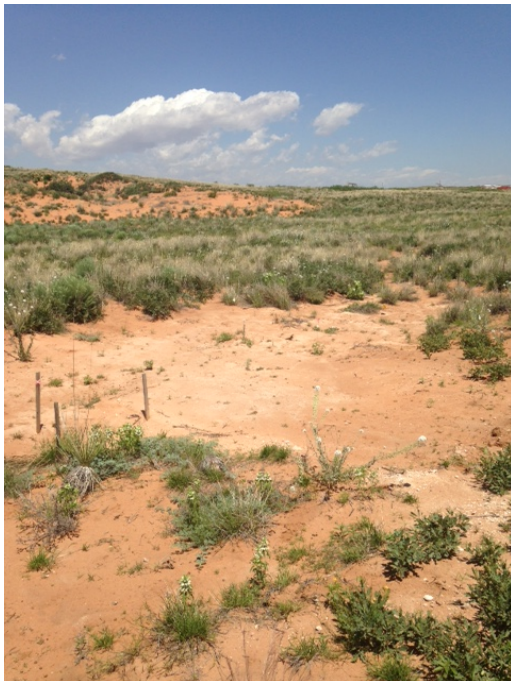
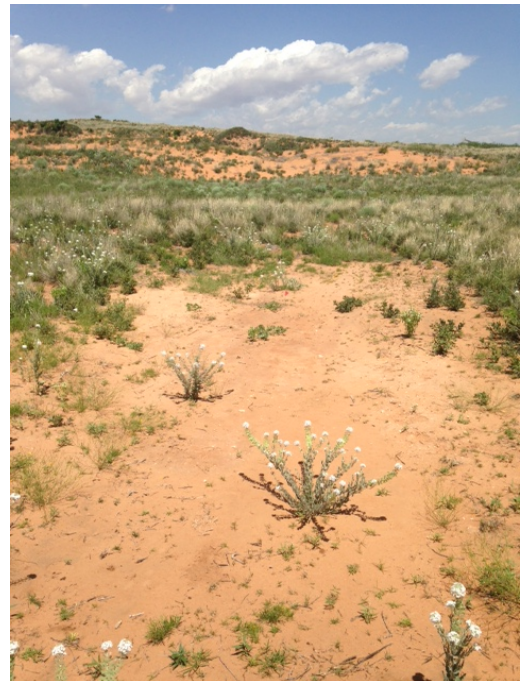
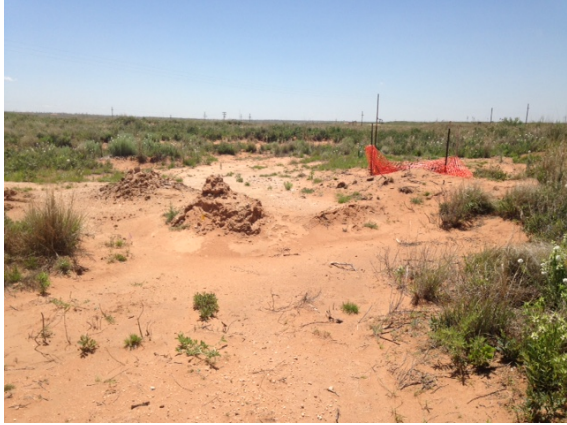
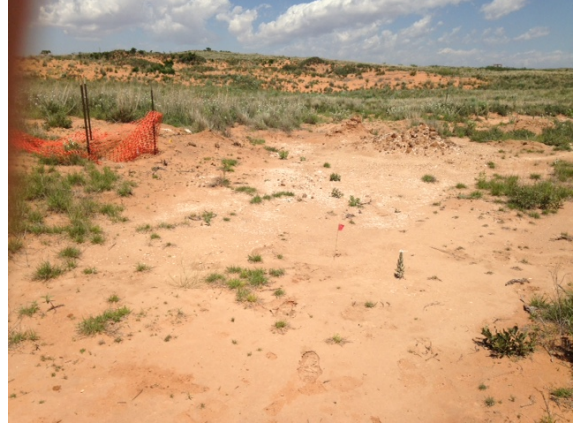
PHOTO PAGE

The site is located northeast of Loco Hills NM, in Eddy County. The leak site resulted from an injection line failure. The impacted area is south of the location approximately 300 yards, in the pasture. Approximately 4 bbl of produced water was released. Nothing was recovered. A site map is attached. A C-141 was submitted to the NMOCD on April 16, 2014.

On May 15, 2015 DFSI personnel sampled the spill area. We took four samples of the spill area. The samples were tested for chloride levels as well as BTEX. The BTEX samples were performed using a Mini Rae Photoionization Detector (PID). The field samples that field tested below state/BLM requirements were taken to Cardinal Lab of Hobbs to obtain confirmation samples. The results are attached.

DFSI personnel returned to the site to re-sample and fully delineate the spill area. Four samples were taken once again, and all cleaned up except for SP2. DFSI encountered drill refusal at SP2 at 10' BGS. The results are attached.

In the area of SP2, we will excavate to 4' BGS and install a 20 mil liner or impervious river rock. The area will then be backfilled with native topsoil, and seeded with a BLM, OCD approved mix. The rest of the spill area will be reseeded with a BLM, OCD approved seed mix, since the samples came back.

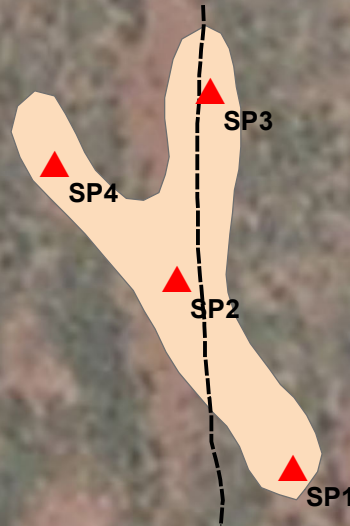
Site Diagram

Spill Area:
2643 sq. ft.
