Wigeon 23 Fed Com #2

CLOSURE REPORT

UL/H Sec 23, T25 south, R26 east, Eddy County, NM

API # 30-015-33684

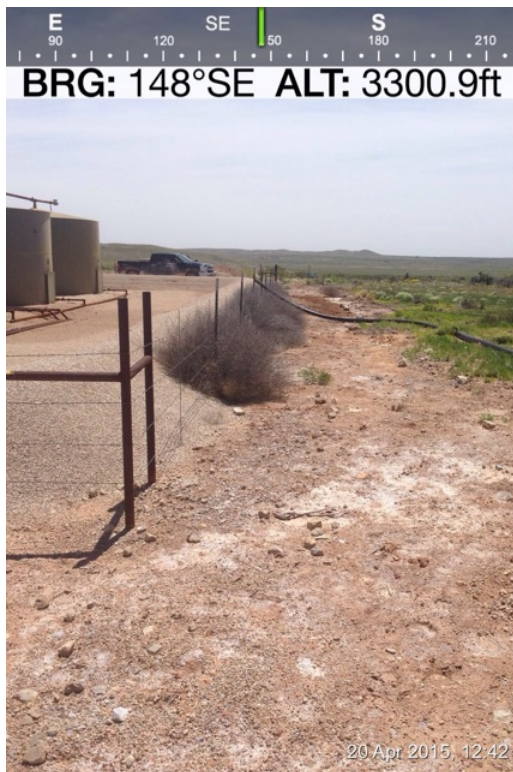
Spill area behind battery

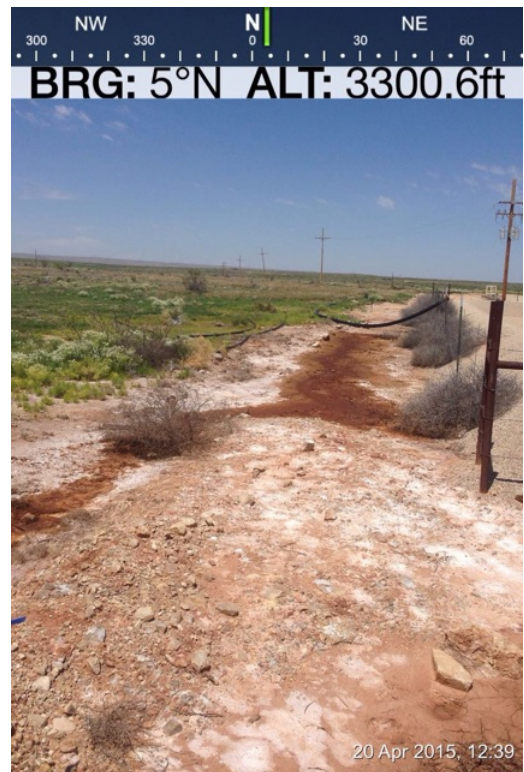
Spill area leading to pasture

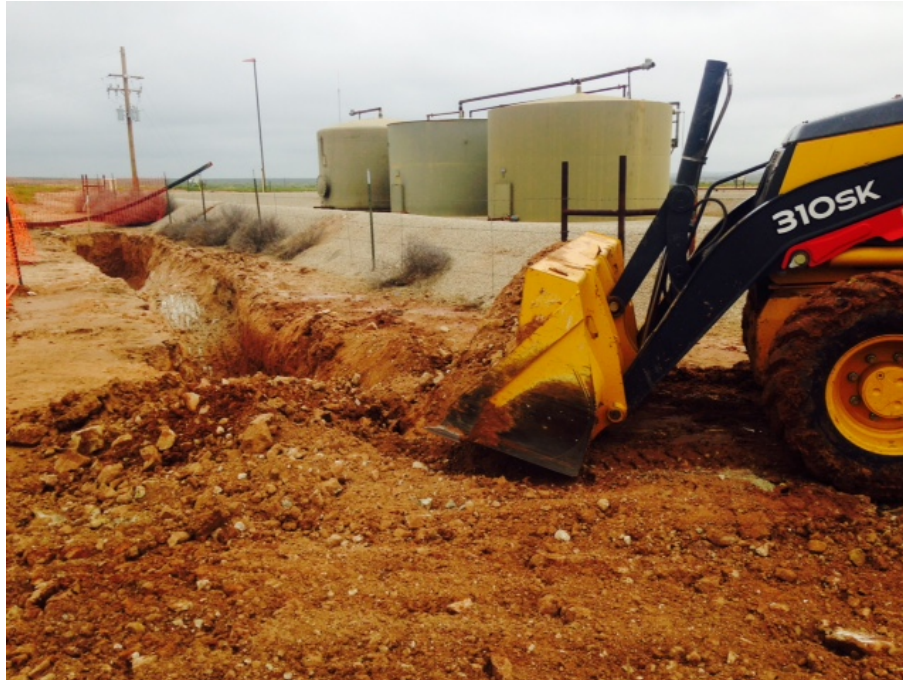
Excavating spill area behind battery in pasture

On July 6, 2015, DFSI personnel returned to the site, per the BLM to obtain three soil samples at 4'bgs with a backhoe. The lab data for those samples are also attached. After obtaining the samples, DFSI personnel excavated the entire spill area to 4'bgs. An email from the BLM is also attached which stated for DFSI to proceed with backfill of the excavated area.

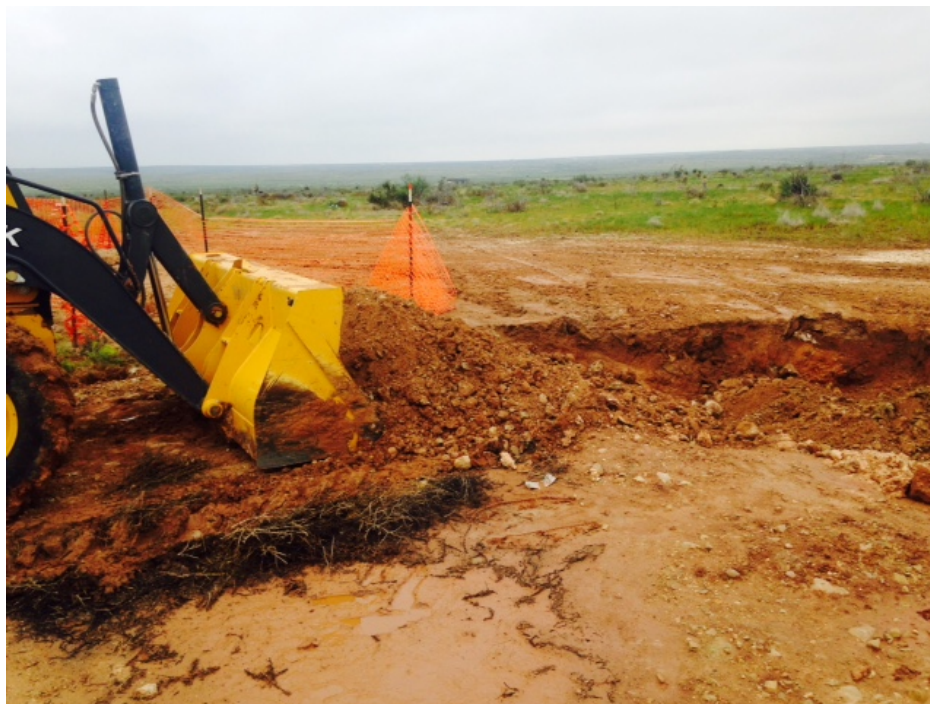
Excavating spill area behind battery in pasture

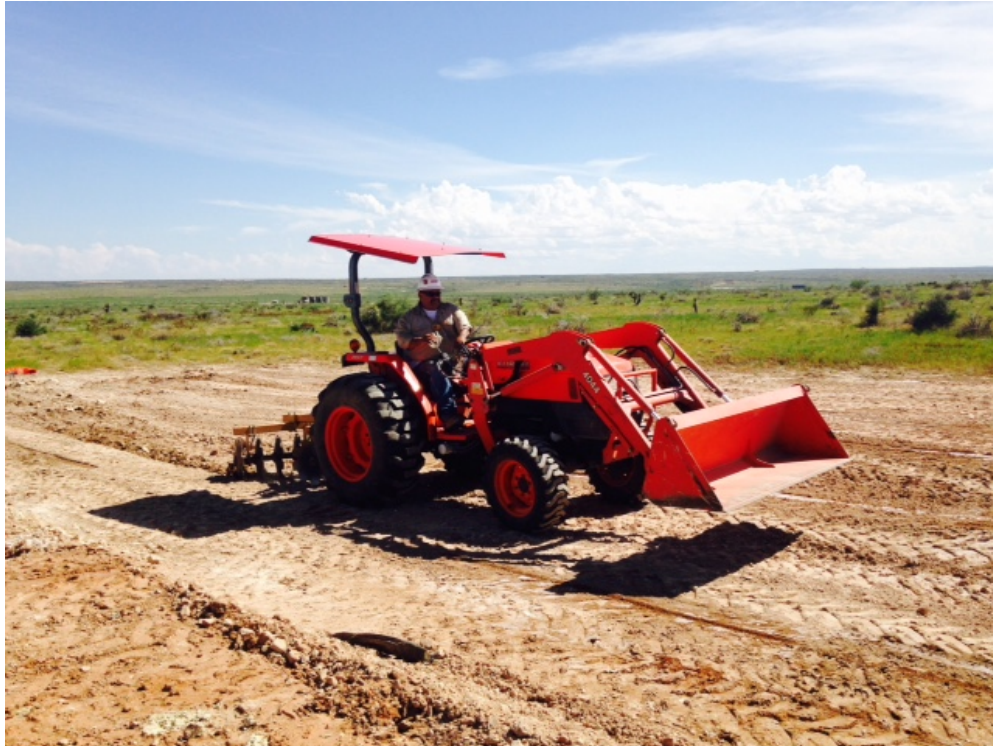
Reseeding backfilled area in pasture

On July 7, 2015, DFSI personnel backfilled the location with surrounding terrain. The area was also blended, contoured, and seeded with 5.48 pounds of BLM #4 seed.

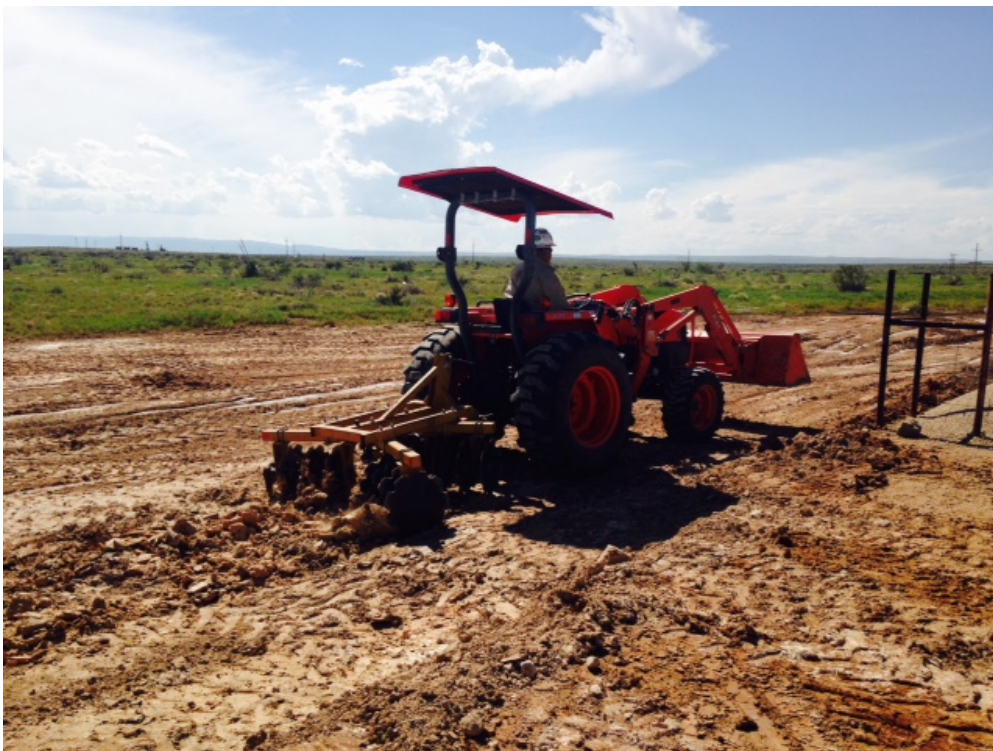
Reseeding backfilled area in pasture

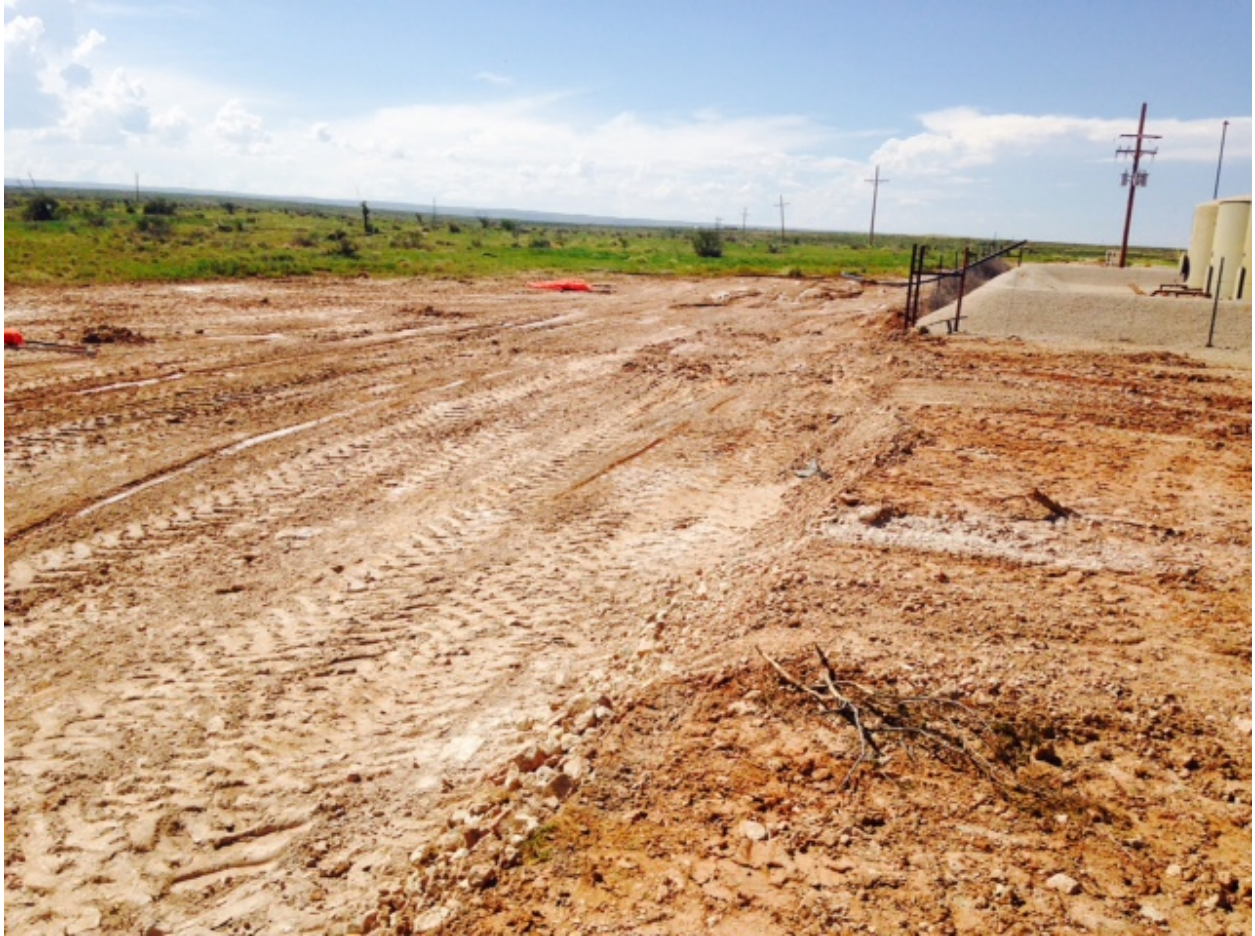
Backfilled and reseeded area in pasture behind battery

All contaminated soil was hauled to an approved NM state disposal. The location was restored to its previous state.

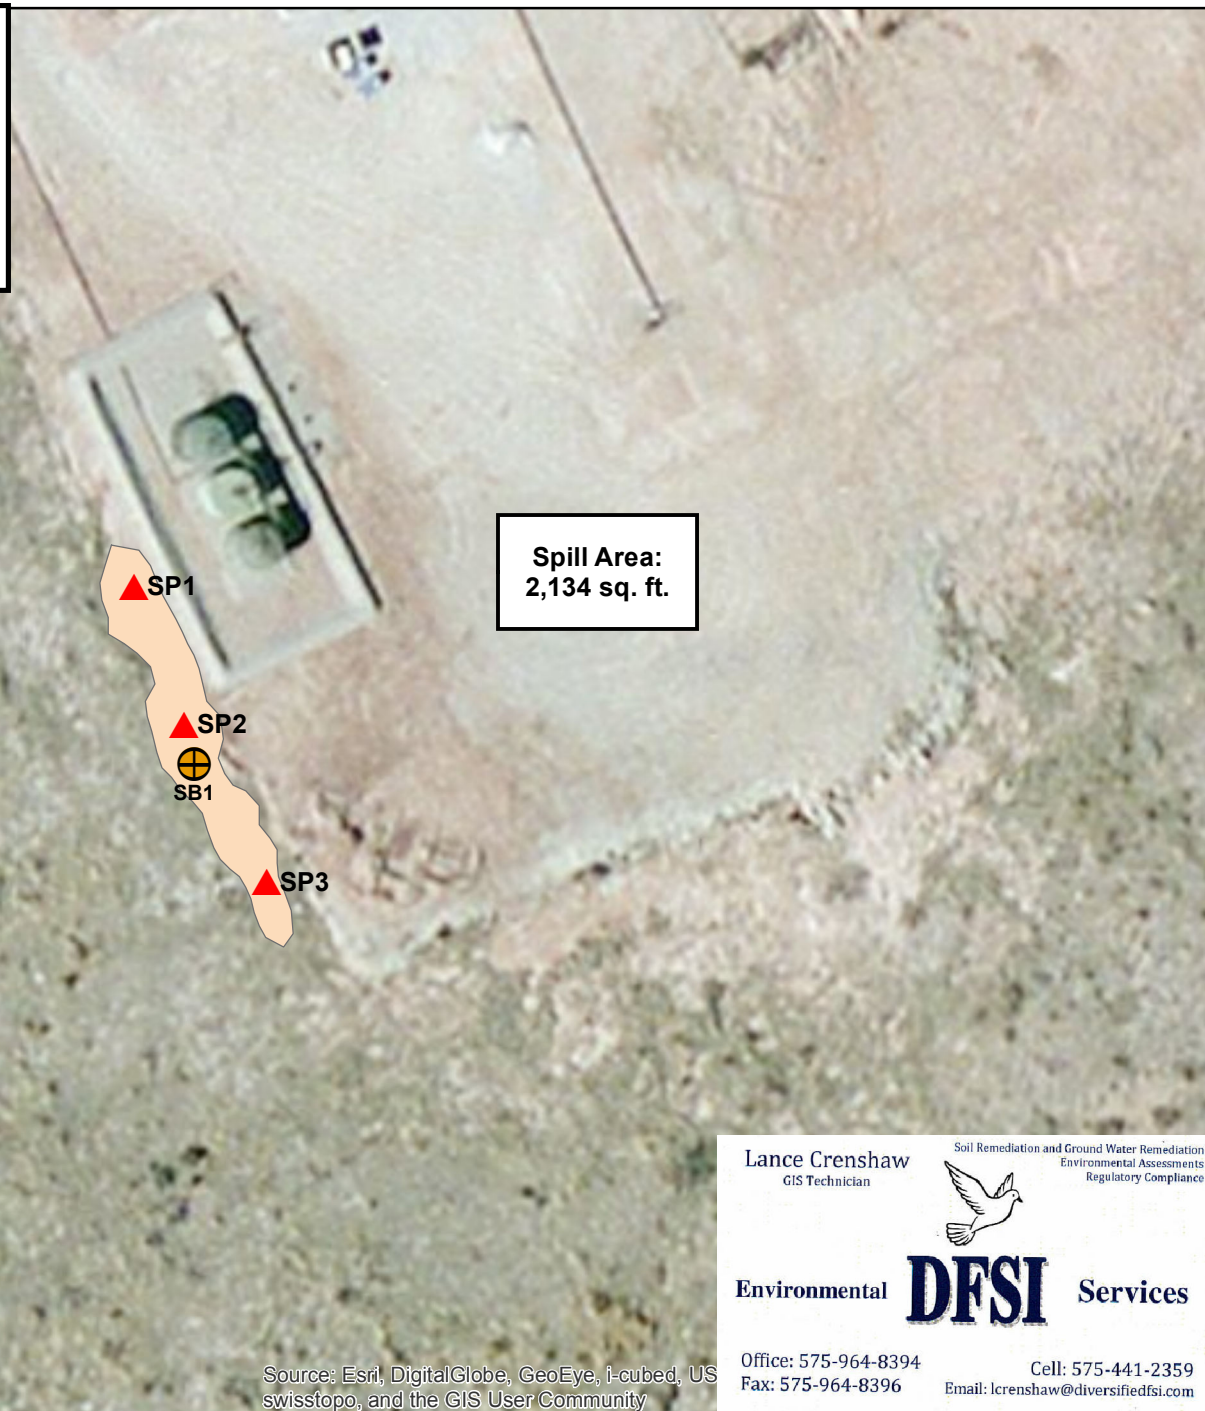
Site Diagram

Cimarex, Wigeon 23 Fed Com 2
UL/H, Sec. 23 T25S R26E
Eddy County, NM
Drafted By: Lance Crenshaw, 4-21-15
