To: Heather Patterson, New Mexico Oil Conservation Division, District II
Reference: Remediation Work Plan
Operator: Devon Energy Production Company
Location: Peridot 13 St 3H
API: 30-015-40778
Legals: UL. H, Sec. 12, T 19S, R29E, Eddy County
GPS: 32.6782 -104.0237
NM OCD: 2RP 3456

Devon Energy Production Company-Peridot 13 St #3H

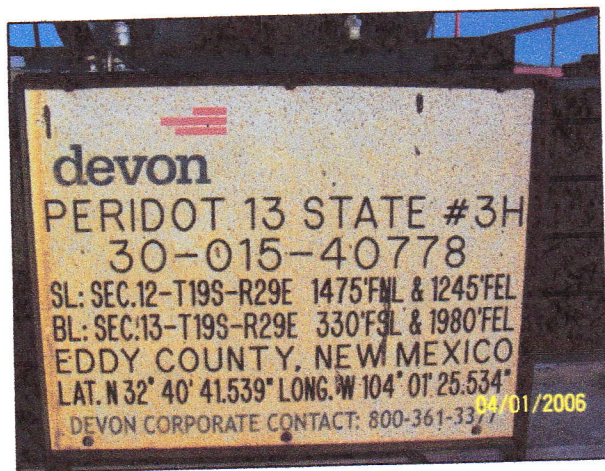
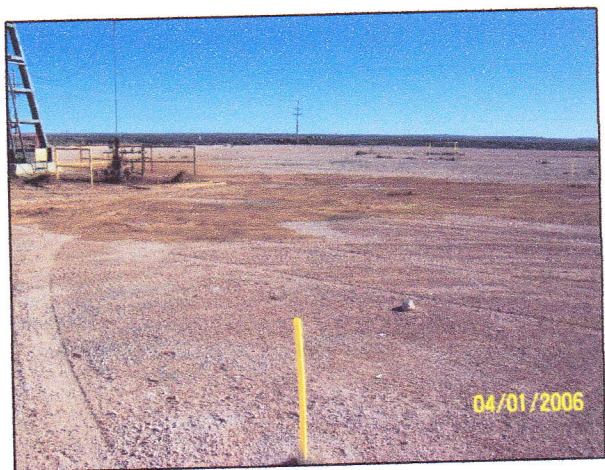
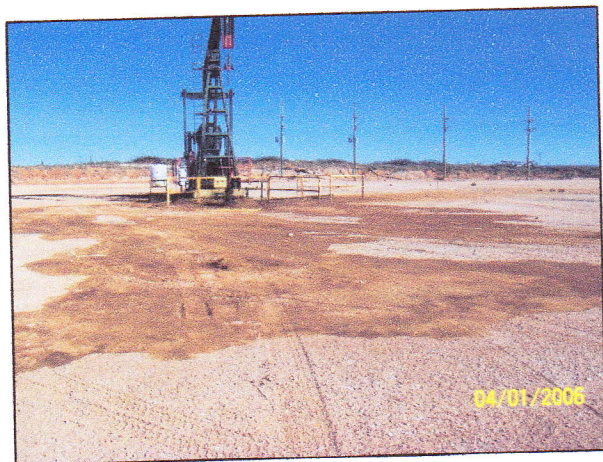
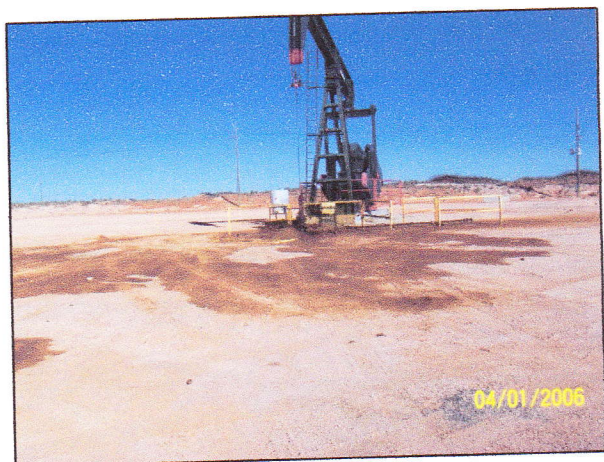
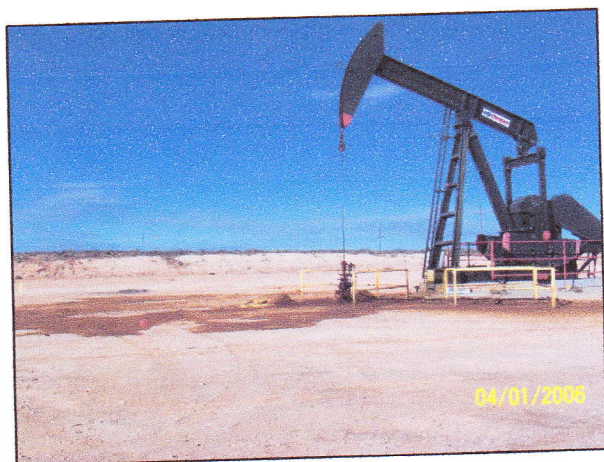
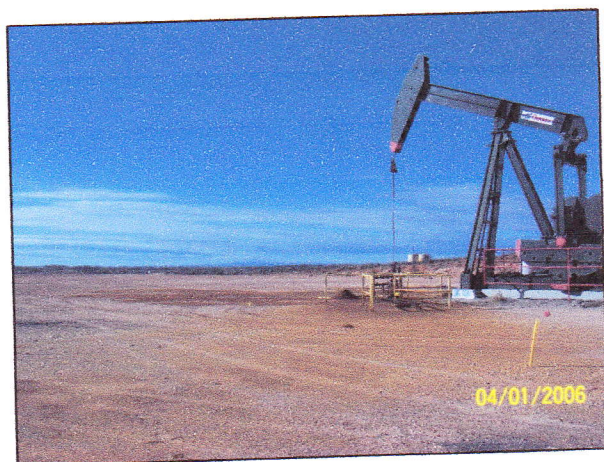
The release is the result of a failed gauge. All released fluid remained on the caliche pad. The impacted area is 65' x 140'.

Due to the hydrocarbon contamination being contained to the top few inches of soil. I propose to remediate the impacted using the in-situ method using MicroBlaze. A liberal application of 1.5 gallons of MicroBlaze to 10 cubic yards of soil, mixed to a 10% solution, will be applied to the impacted area.
