Subject: **Remedial Activities and Closure Report**
Bridger Logistics, LLC
Centurion-Pecos River Station: Oxy Unload
2RP-3323

Centurion Pipeline, LP has contracted Talon/LPE (Talon) to perform soil assessment and remediation services at the Centurion Pecos River Station: Oxy Truck Unload Battery. The incident description, soil sampling results, remediation activities and closure request are submitted herein.

Pecos River Station Oxy Truck Unload
Centurion Pipeline L.P.
Eddy County, New Mexico
Figure 1 - Site Plan

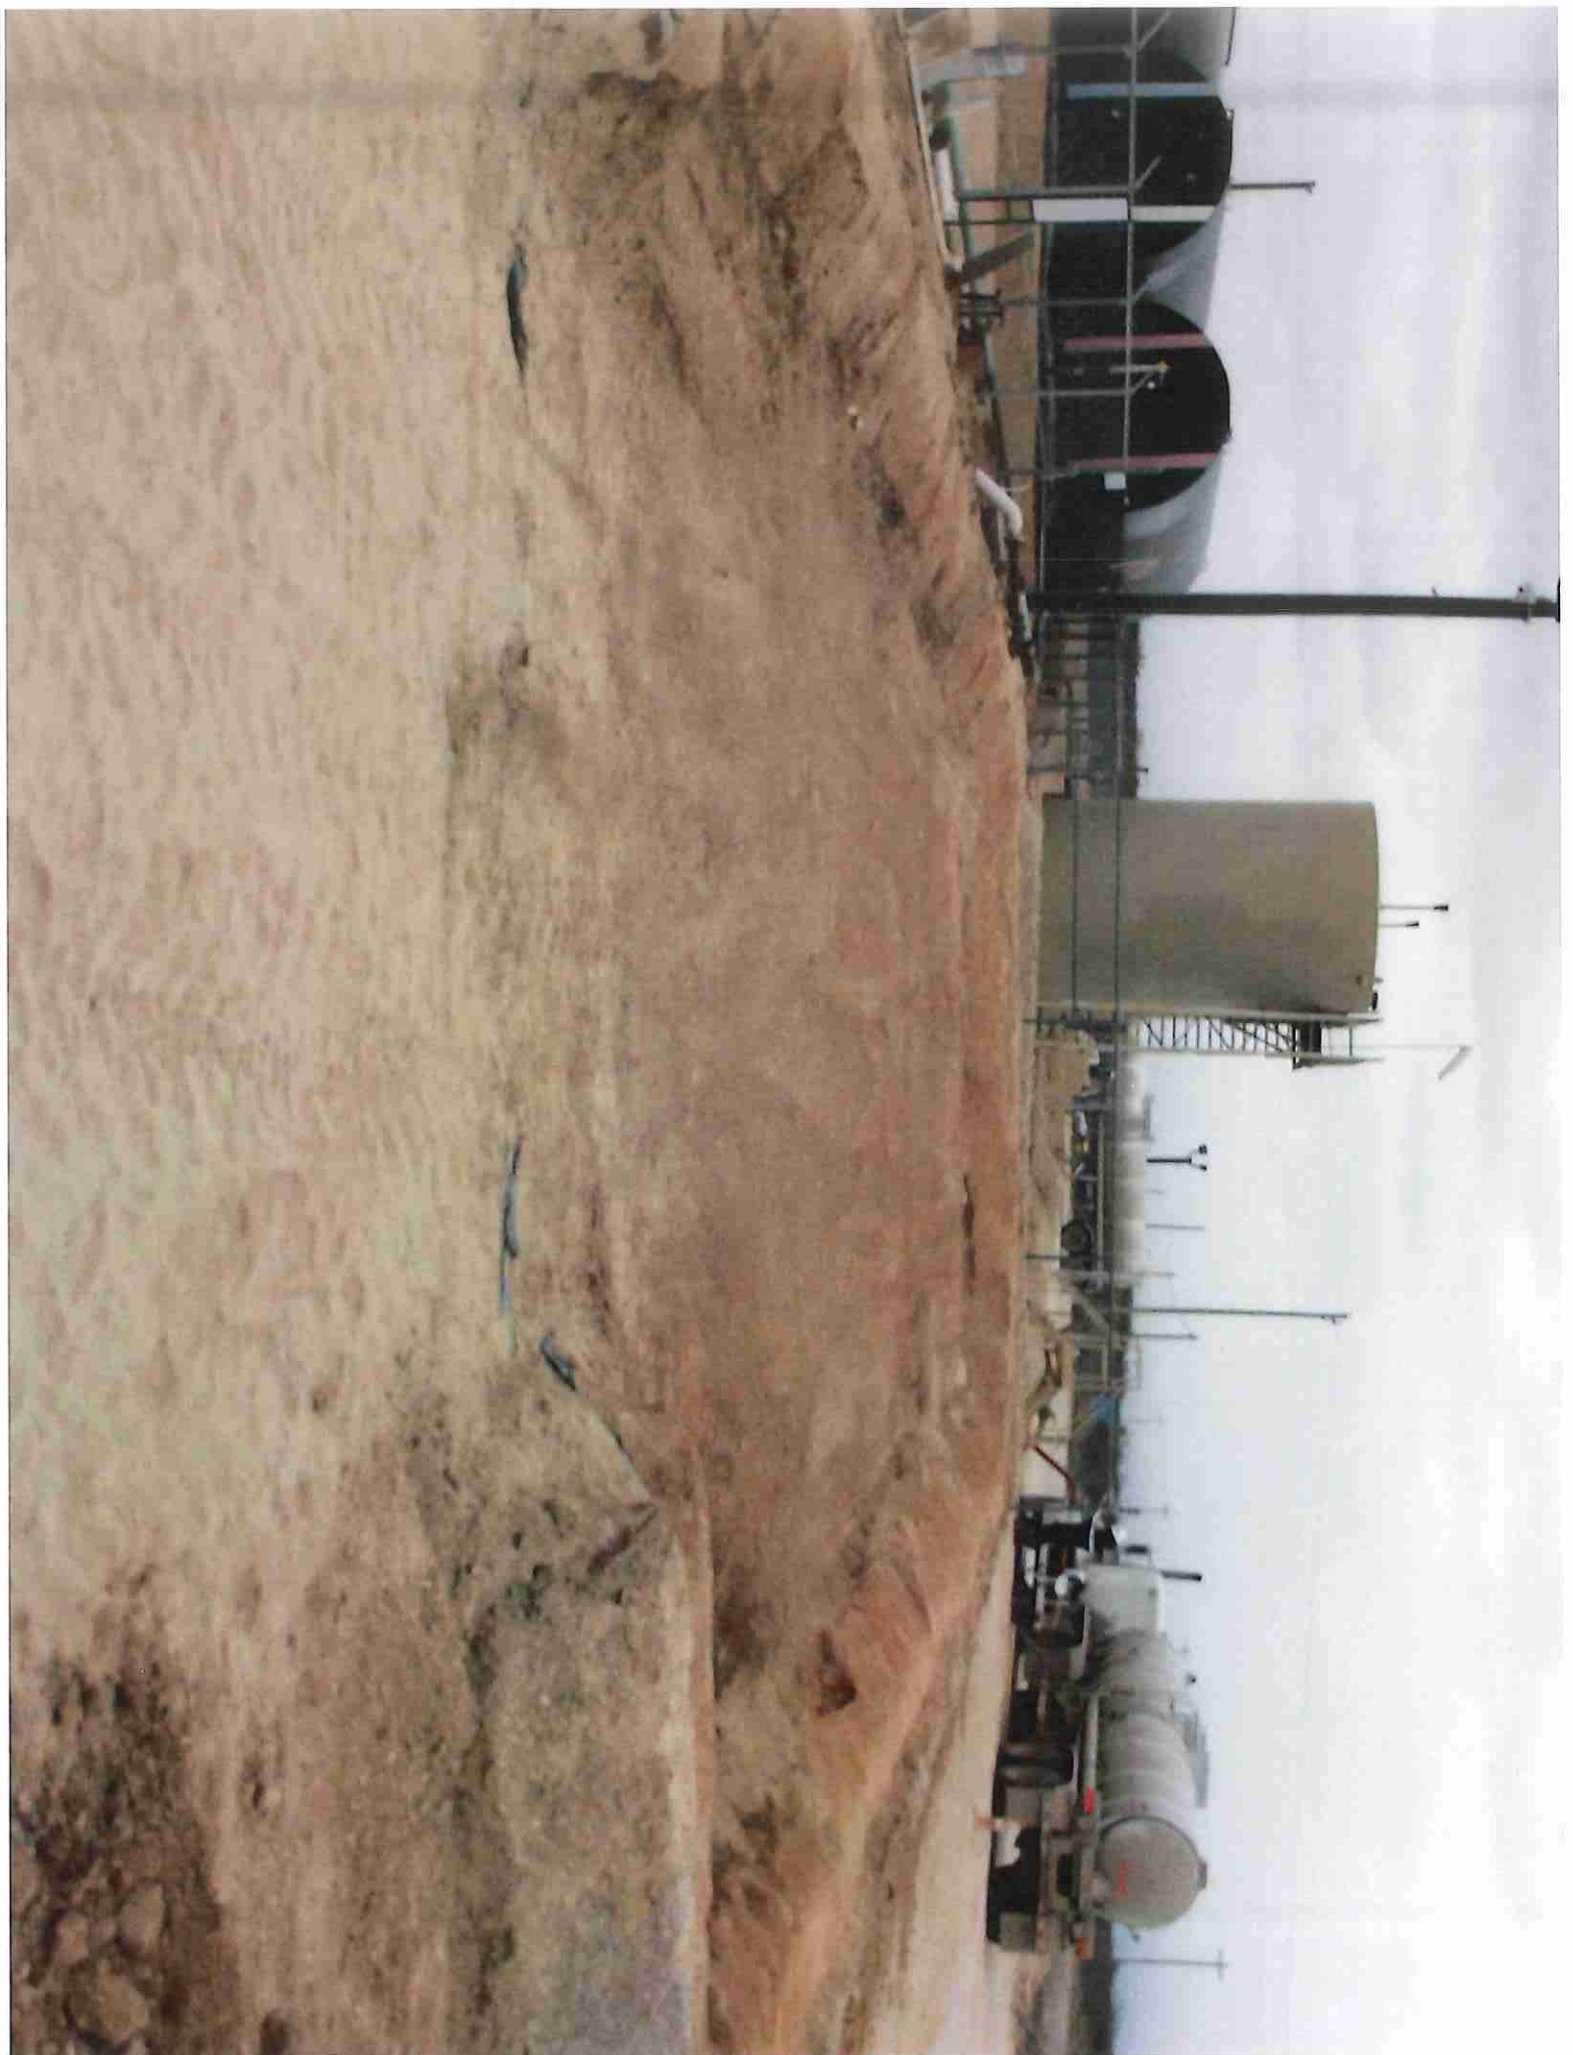
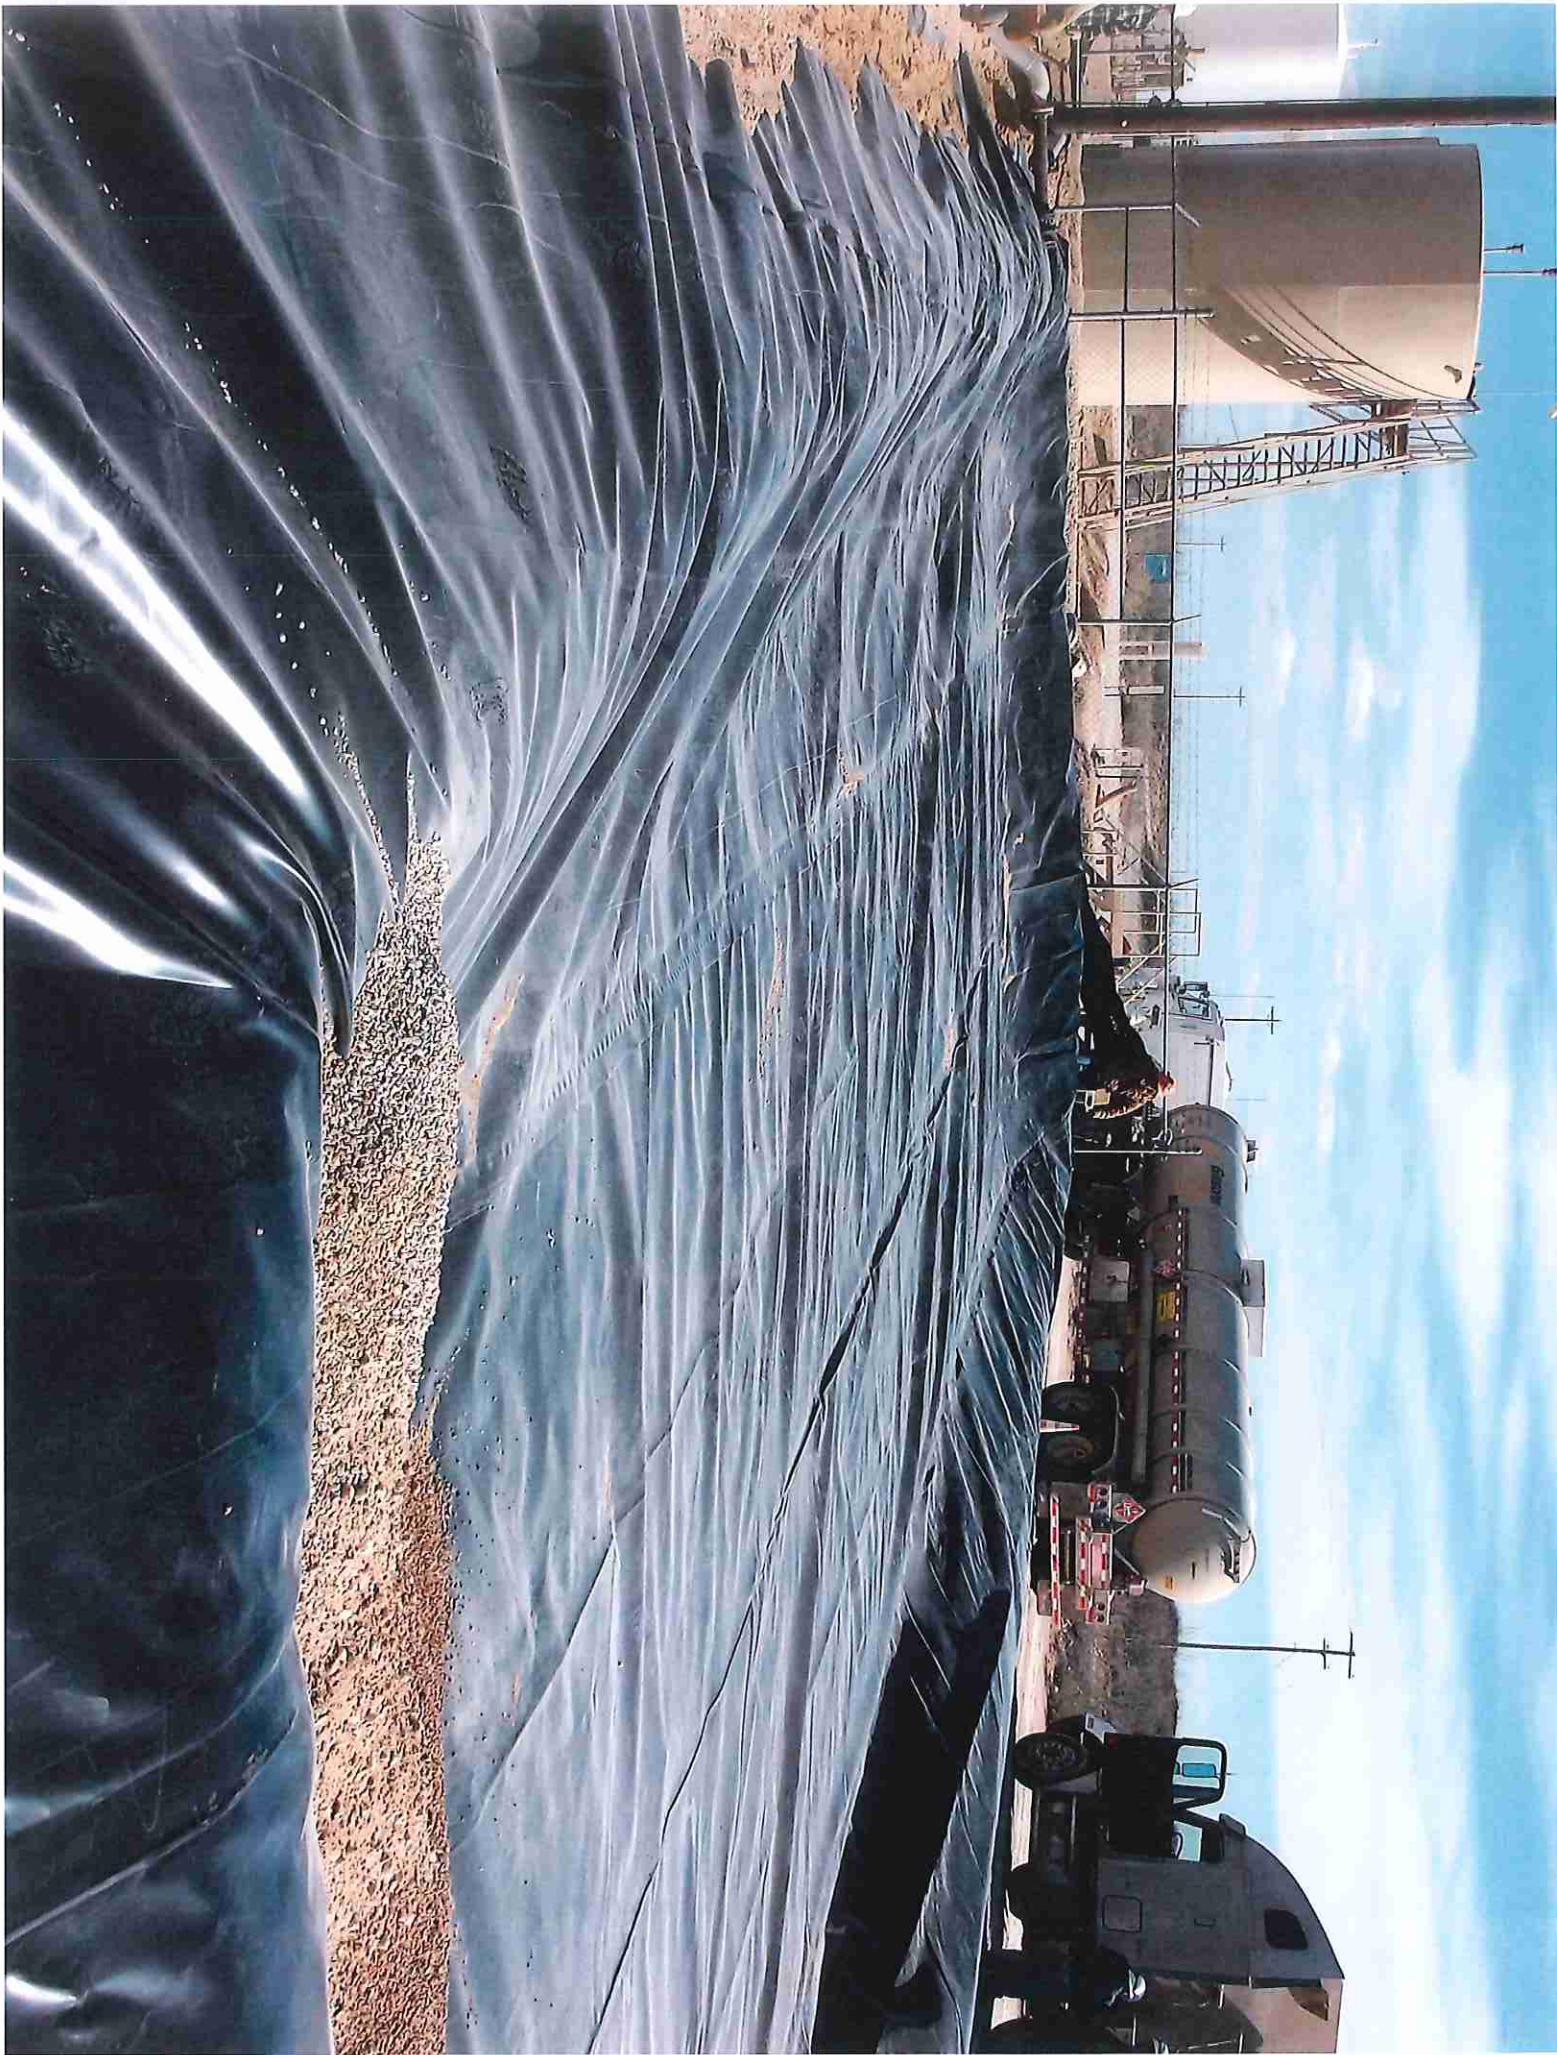
PHOTOGRAPHIC DOCUMENTATION

Human error caused a tank battery to overflow while a truck was unloading into the tanks. Vacuum trucks were immediately dispatched to the location to recover the released fluid. All of the fluid was contained within a lined and bermed facility.

The affected area was inside of a lined and bermed tank battery. Vacuum trucks were utilized to recover 63.5bbls of crude from the battery. Soil sampling will not be possible within the facility due to the liner. The gravel in the battery will be removed, hauled to an NMOCD approved solid waste disposal facility and replaced. Once the remediation activities are complete, a final C-141 will be submitted to NMOCD for review.
