# SOIL REMEDIATION WORK PLAN FOR INCIDENT 2RP-1099

## ALAMO PERMIAN RESOURCES

COWTOWN UNIT 101

API# 30-015-01843

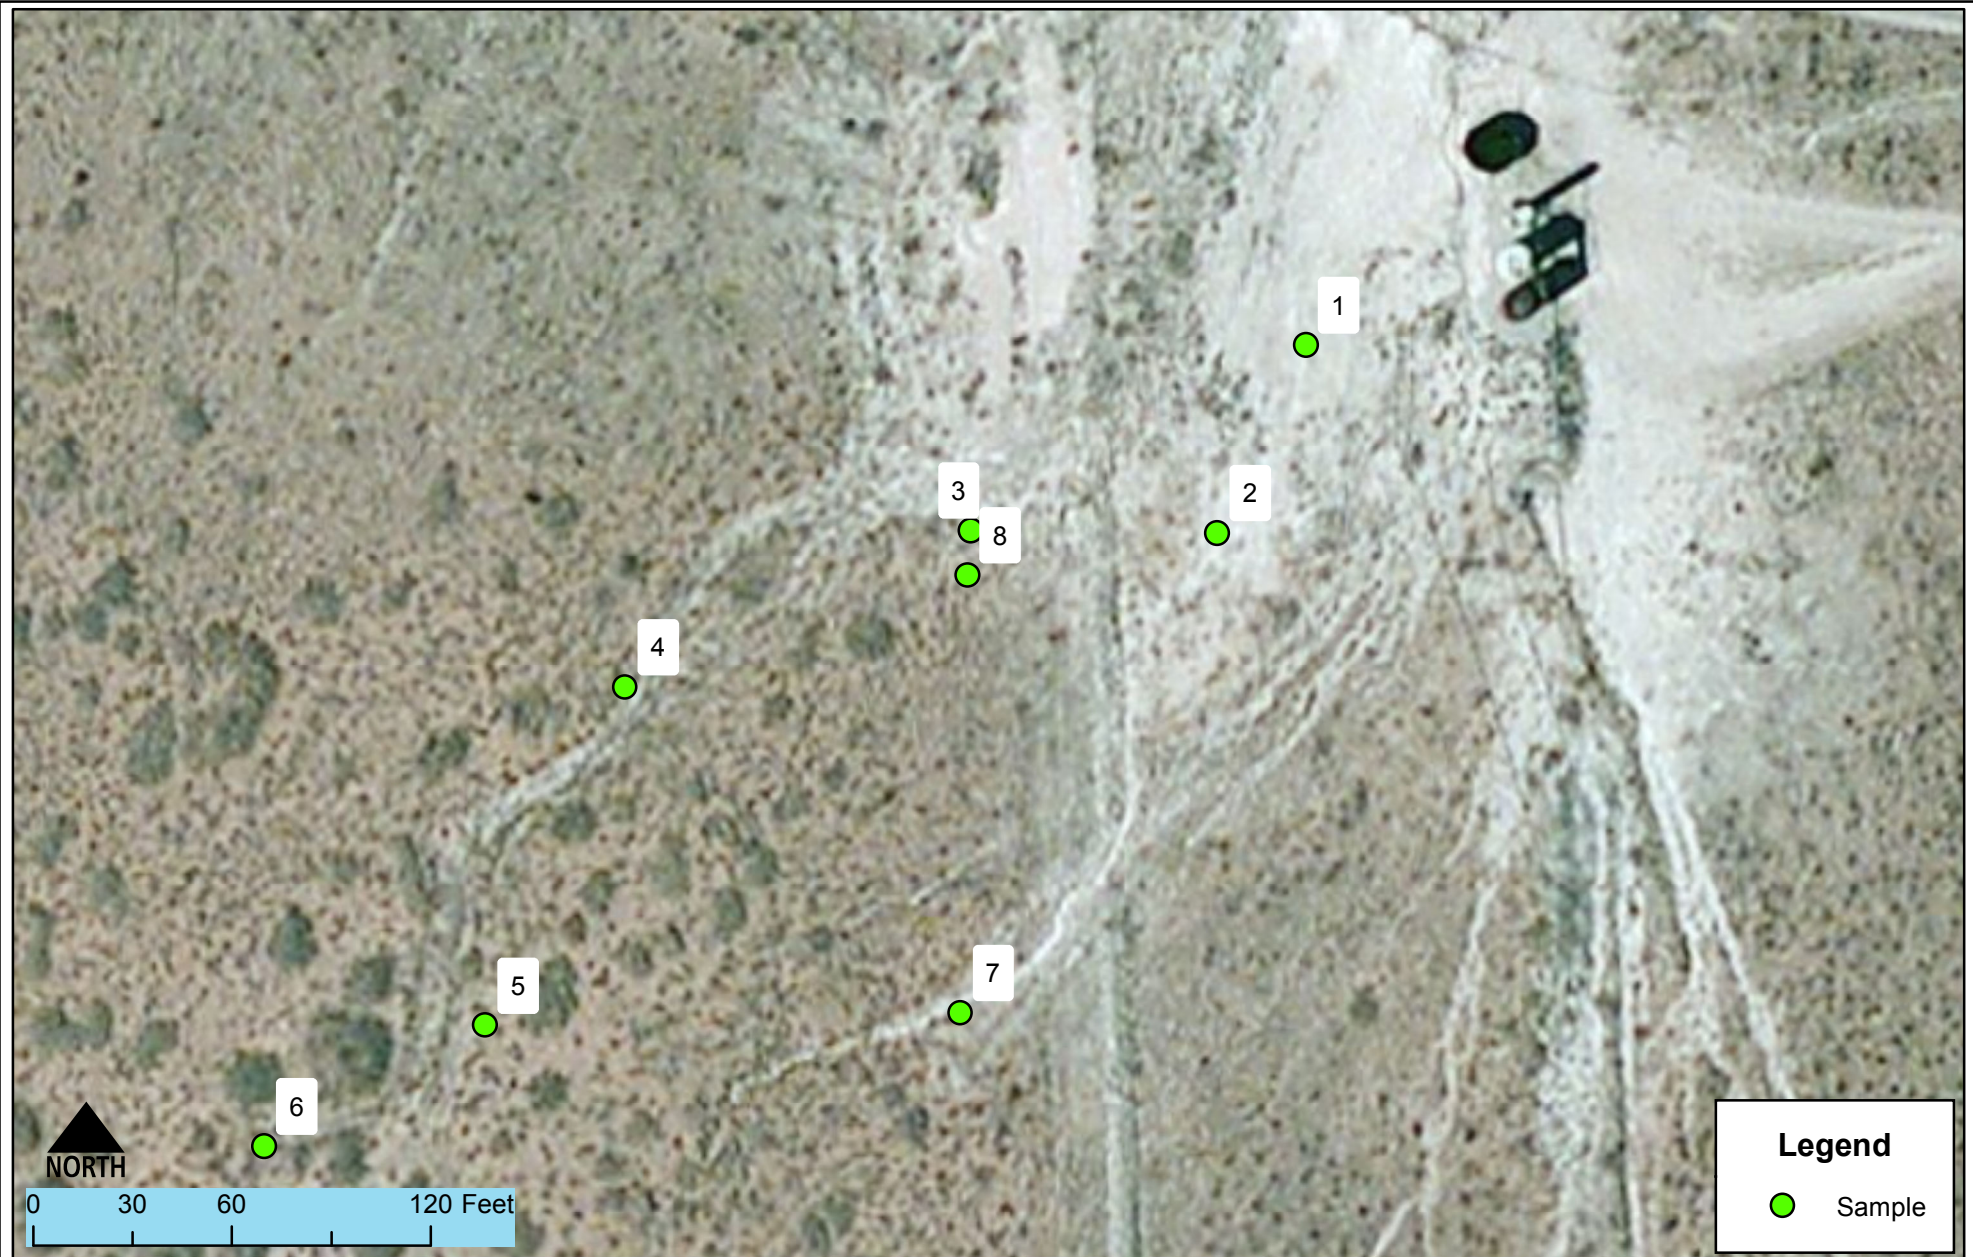
Figure 2

Site Detail and Sample Locations  
Alamo Permain Resources- Cowtown Unit #101  
Artesia, New Mexico

Soil sample locations are illustrated in Figure 2. A summary of the laboratory analyses is included in Table 2. Laboratory reports are included in Appendix A.
