J L Keel A #11

CLOSURE REPORT

API No. 30-015-05099

March 10, 2016

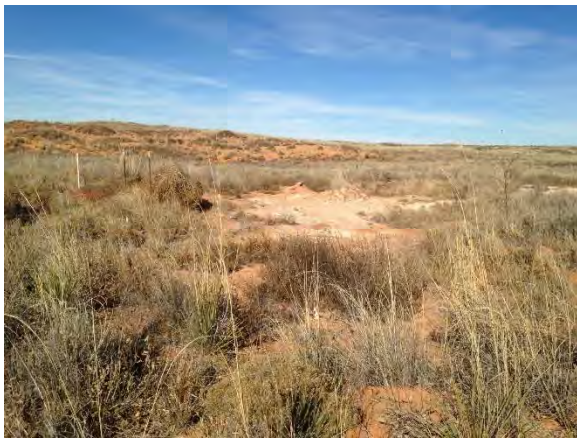
Site prior, facing northwest

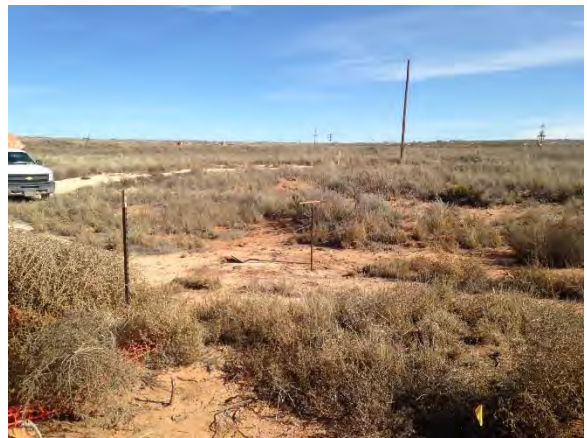
Collecting samples, facing east

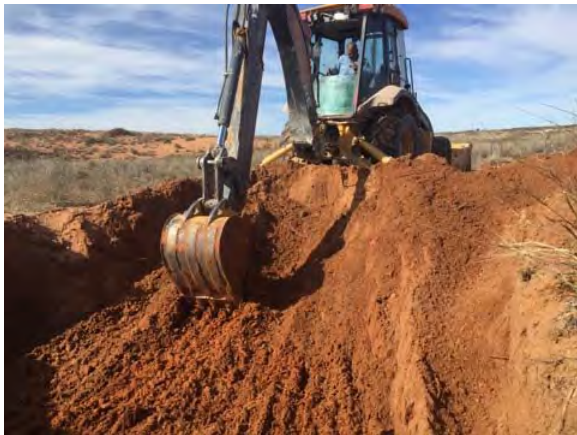
Excavating site, facing northwest

A work plan was submitted to NMOCD and BLM on December 21, 2015, and approved by BLM on January 21, 2016 and NMOCD on February 17, 2016. Beginning February 12, 2016, DFSI personnel were on site to excavate the area to 4' bgs around SP-2 (Appendix IV). At 4 ft bgs, a 20-mil, reinforced poly liner was installed. The excavation was backfilled with clean, imported topsoil to ground surface and contoured to the surrounding area. Contaminated soil was properly disposed of at an NMOCD approved facility. An approximate area of ¼ acre was seeded with LPC mix (Appendix V).

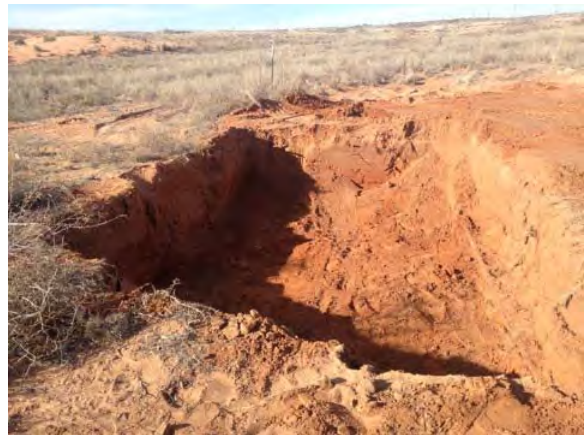
Excavation at 4 ft bgs, facing northwest

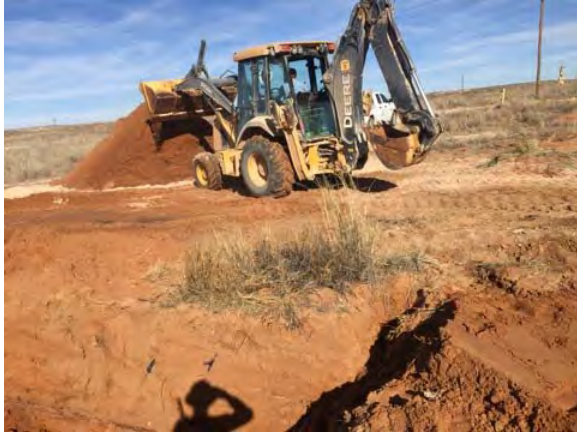
Excavating site, facing east

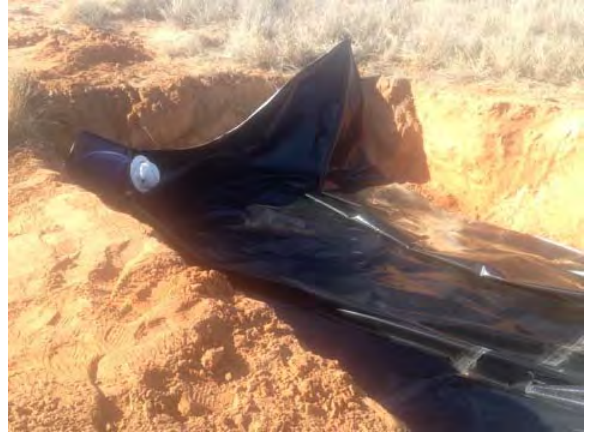
Installing 20-mil, reinforced poly liner at 4 ft bgs

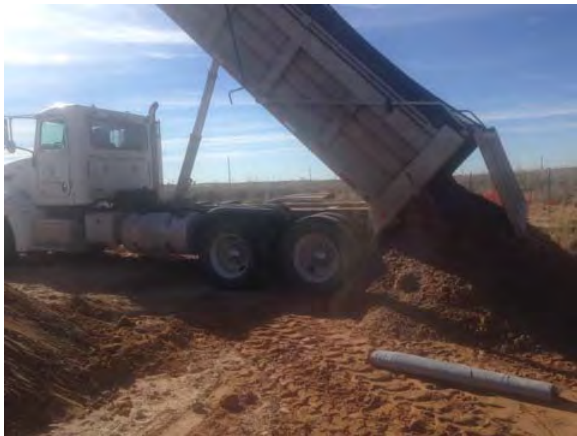
Importing clean topsoil, facing southeast

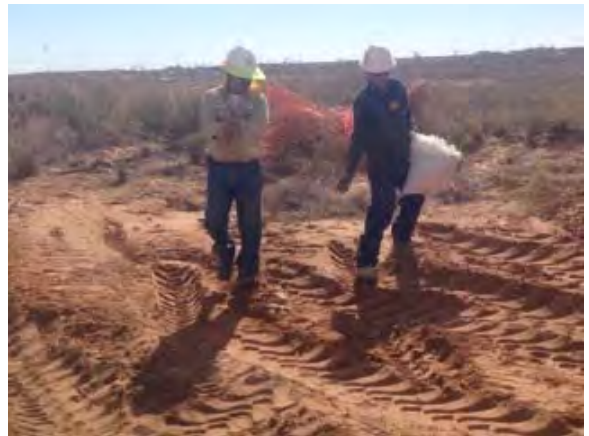
Seeding location, facing southeast

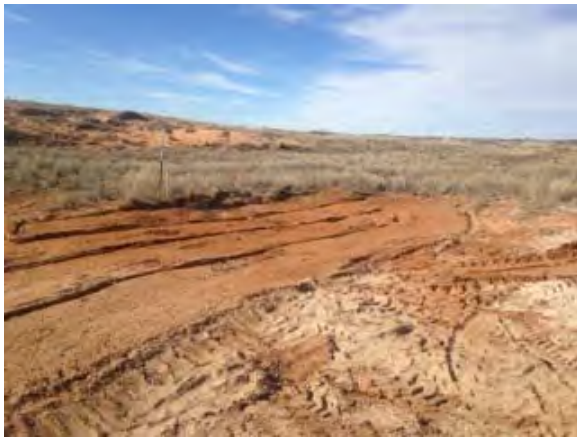
Site completed, facing northwest

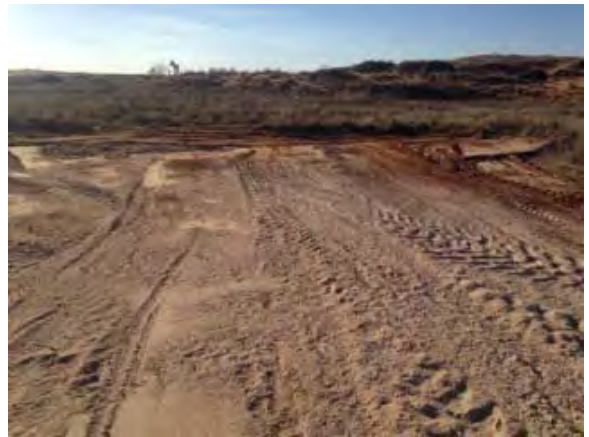
Site completed, facing west
