## **CLOSURE REPORT**

**BOPCO, L.P.**  
**PLU CVX JV BS #008H East Riser**  
**Eddy County, New Mexico**  
**Unit Letter "N", Section 14, Township 25 South, Range 30 East**  
**Latitude 32.13089 North, Longitude 103.84192 West**  
**NMOCD Reference #2RP-3495**

RE: Final Closure Report  
Bopco, L.P. – PLU-CVX-JV-BS #008H East Riser  
UL-N, Section 14, Township 25 South, Range 30 East  
Eddy County, New Mexico  
NMOCD Reference #'s 2RP 3495

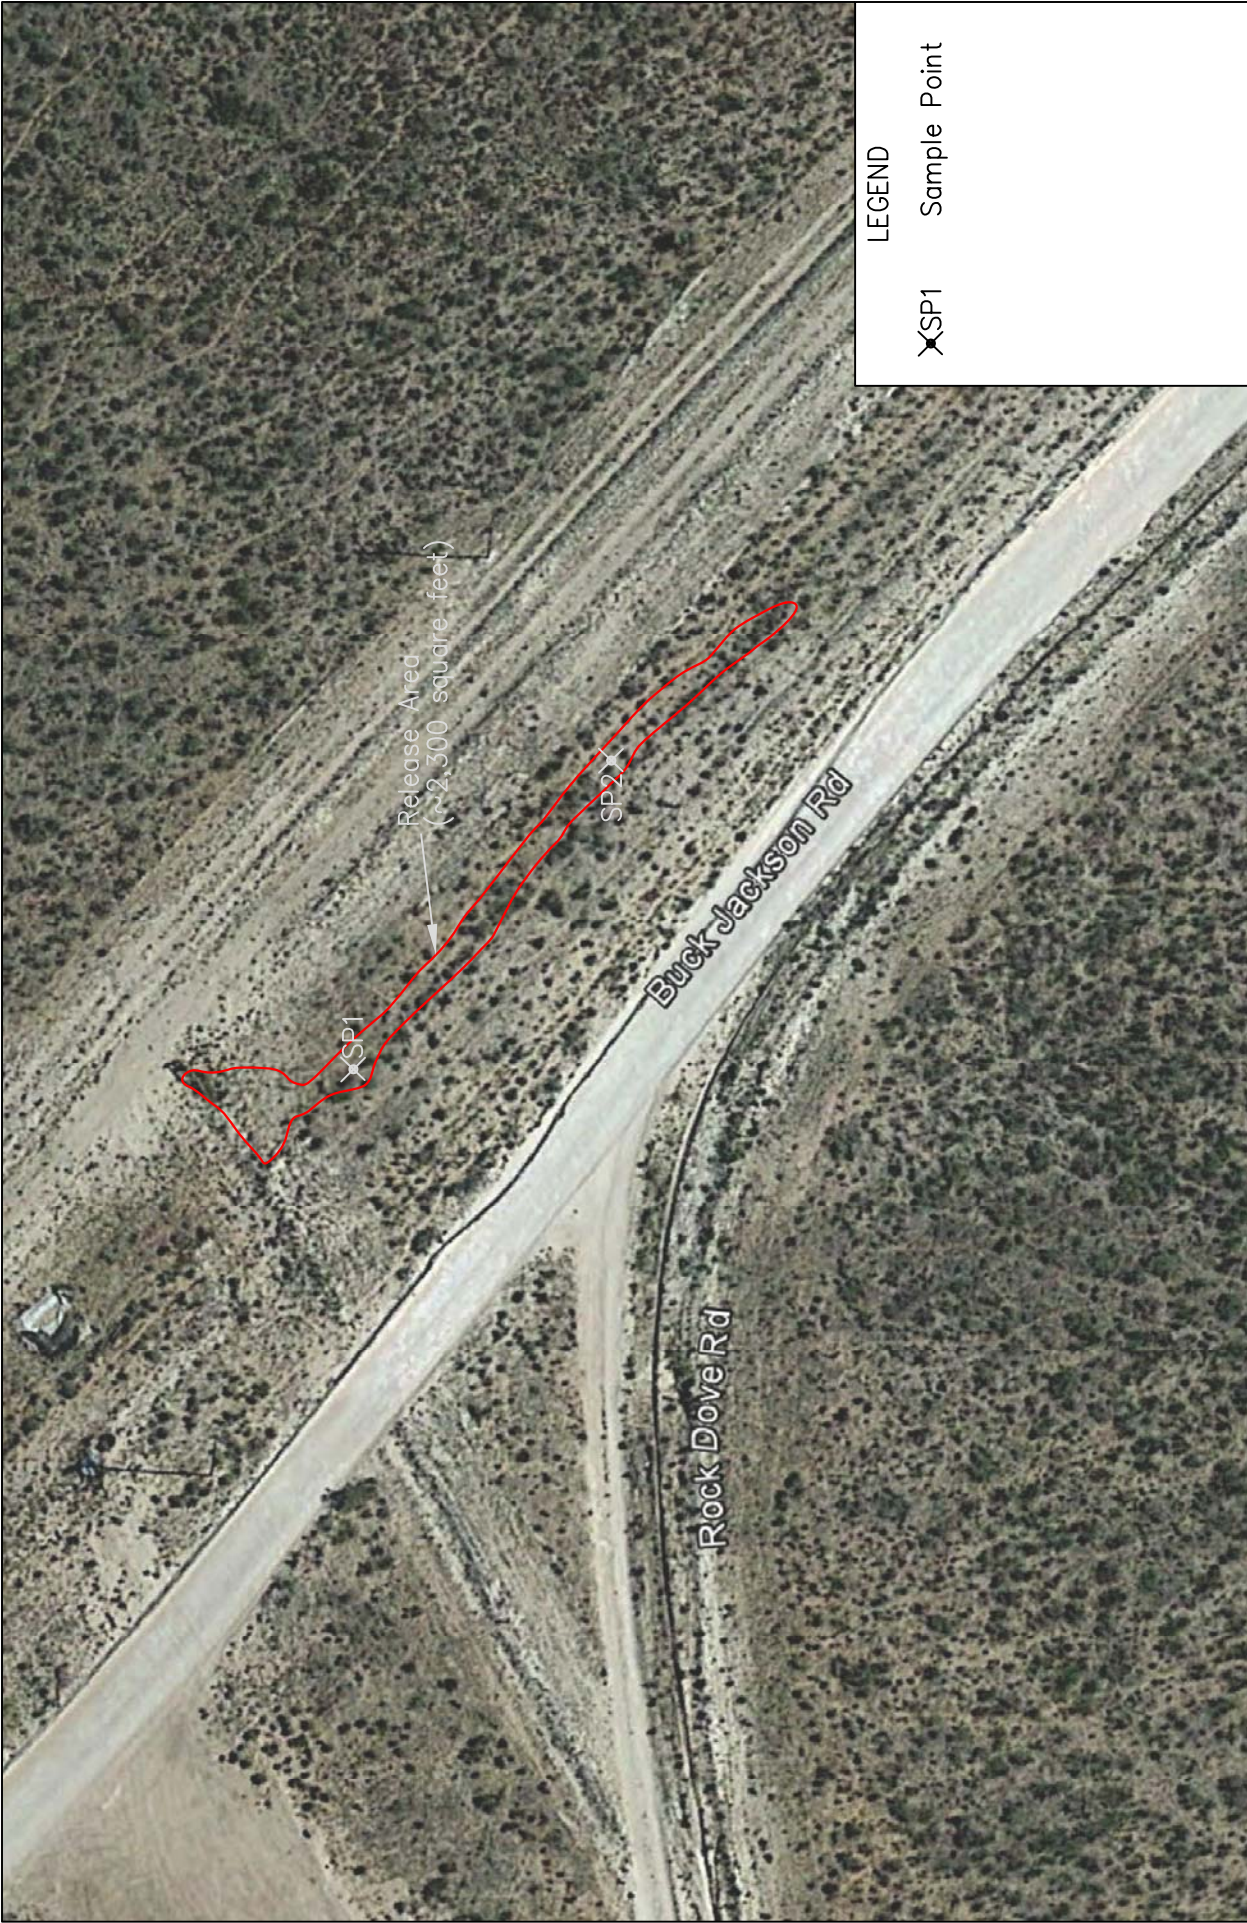
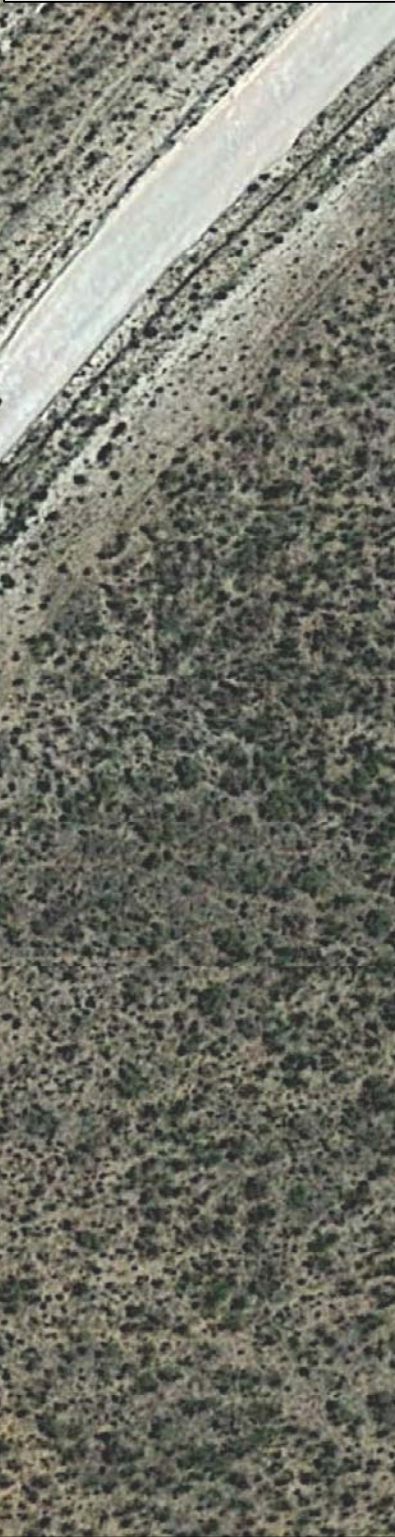
<p>Figure 3 Site/Sample Map Bopco, L.P. PLU CVX JV BS #008H East Riser</p>		<p>Eddy County, New Mexico SE 1/4 of SW 1/4, Sec. 14, T25S, R30E N 32° 07' 51.00" W 103° 50' 30.82" Elevation: 3,372 feet amsl</p>		<p>DWG By: D Dominguez March 2016</p>	<p>REVISED:</p>	<p>LEGEND</p> <p>XSP1 Sample Point</p>

EPI personnel mobilized on the site on January 25, 2016 to collect soil samples to determine the vertical extent of contamination. A total of eight (8) soil samples were collected from two (2) sample locations; SP1 and SP2. Two (2) representative samples were sent to Cardinal Labs in Hobbs, New Mexico, for testing. Laboratory analytical results indicate the release area to be void of Chloride concentrations in excess of NMOCD Recommended Remedial Action Levels (RRALs) of 1,000 mg/Kg (reference *Figure 3* and *Table 2*).

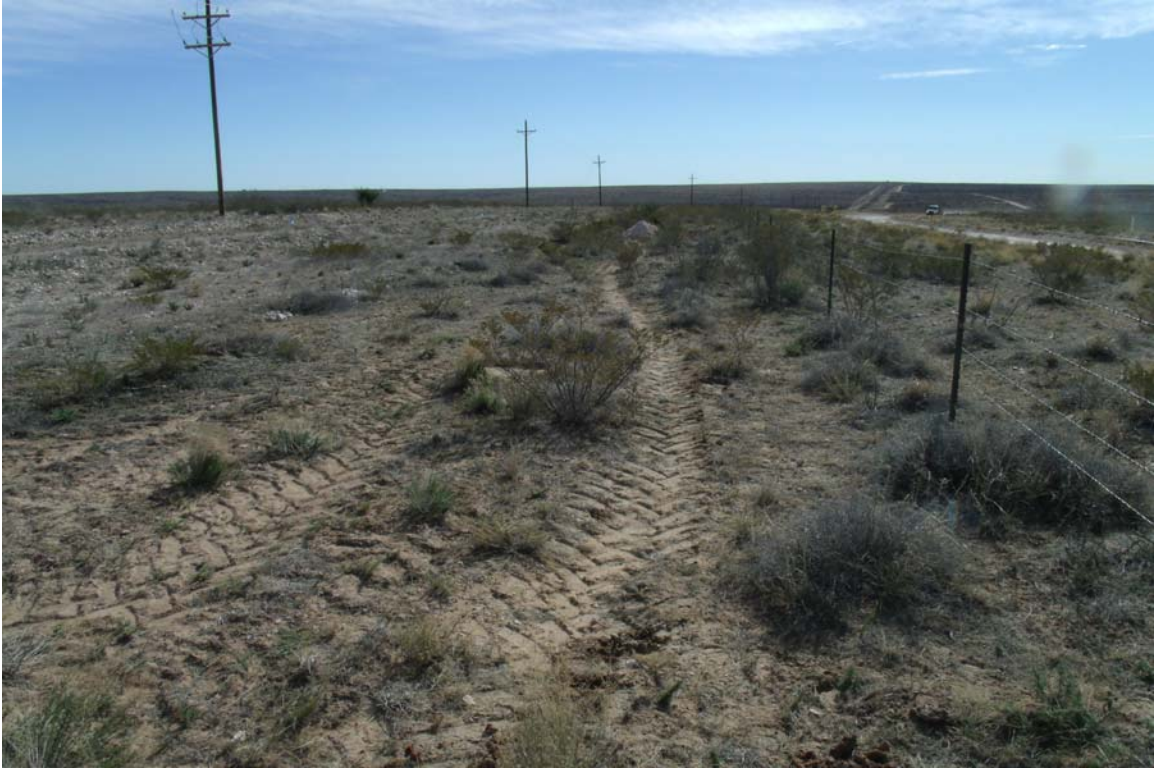
Photograph #1 – Southern view across release area

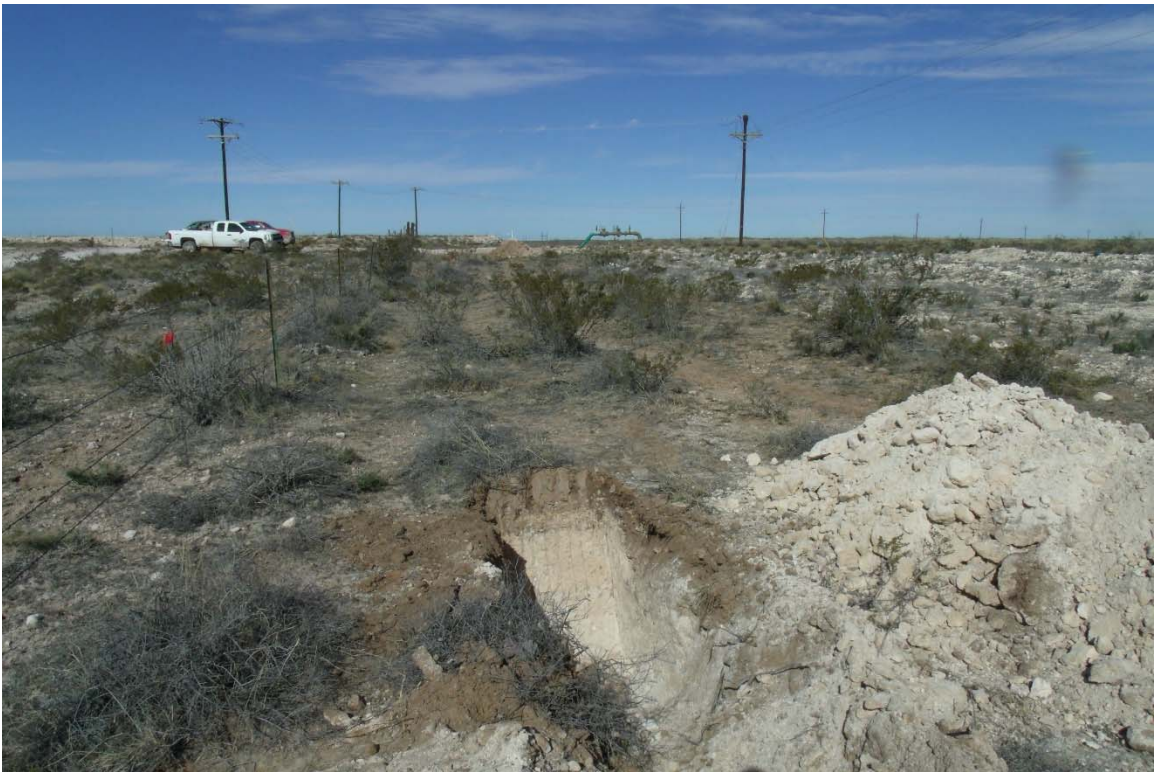
Photograph #2 – Northern view across release area

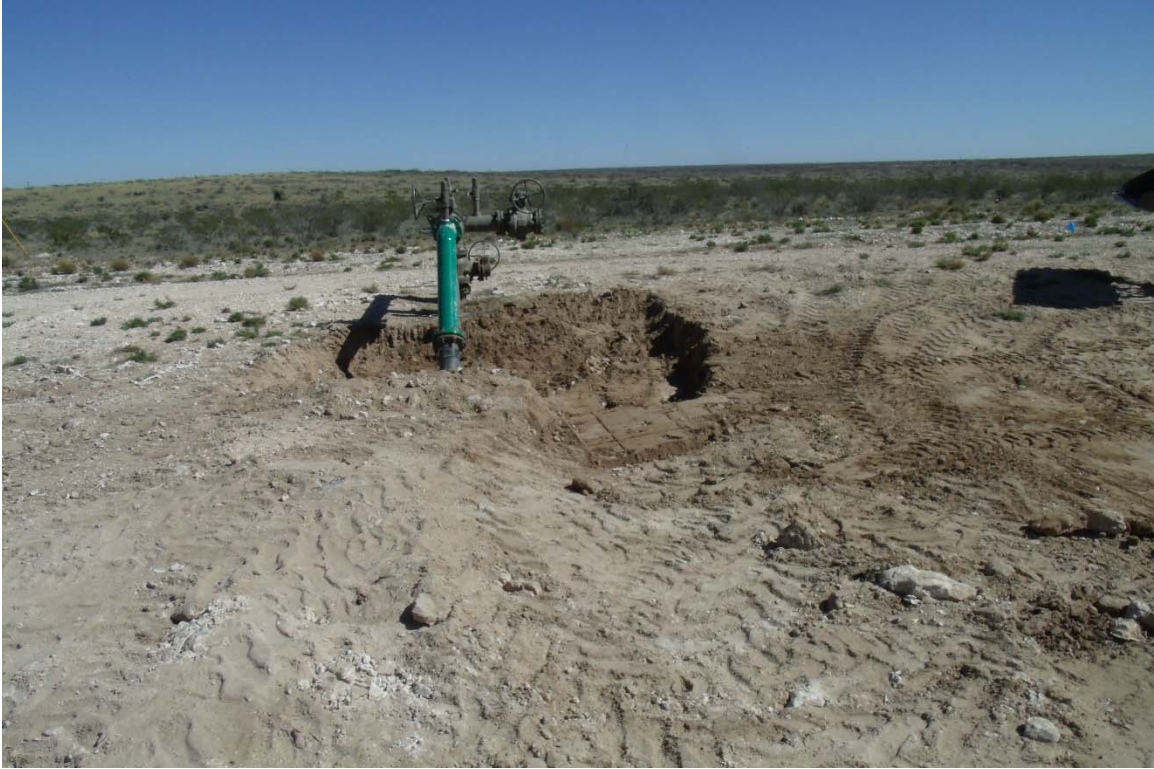
Photograph #3 – Excavated area around riser

The release area around the riser was excavated to a depth of approximately one (1) foot bgs; the remainder of the release area was surface scraped. Approximately 28 yards of contaminated soil was excavated and hauled to a state approved facility for disposal.

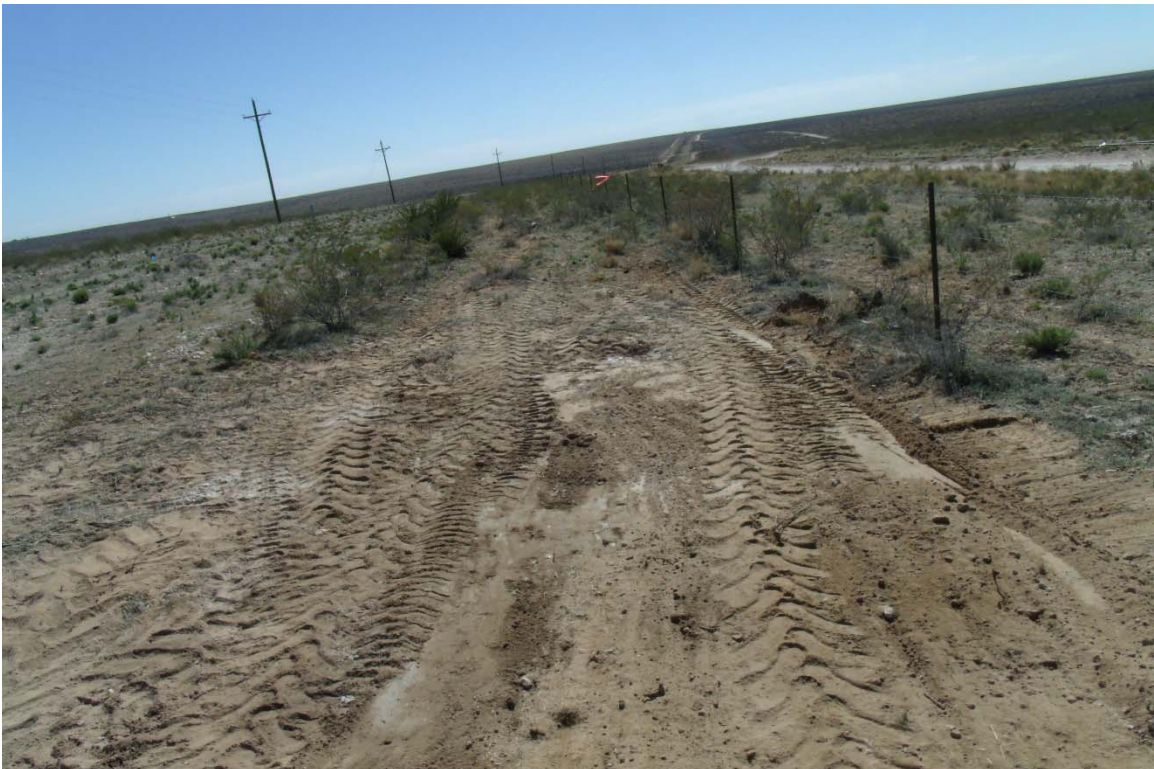
Photograph #4 – Surface scraped at south end of release area

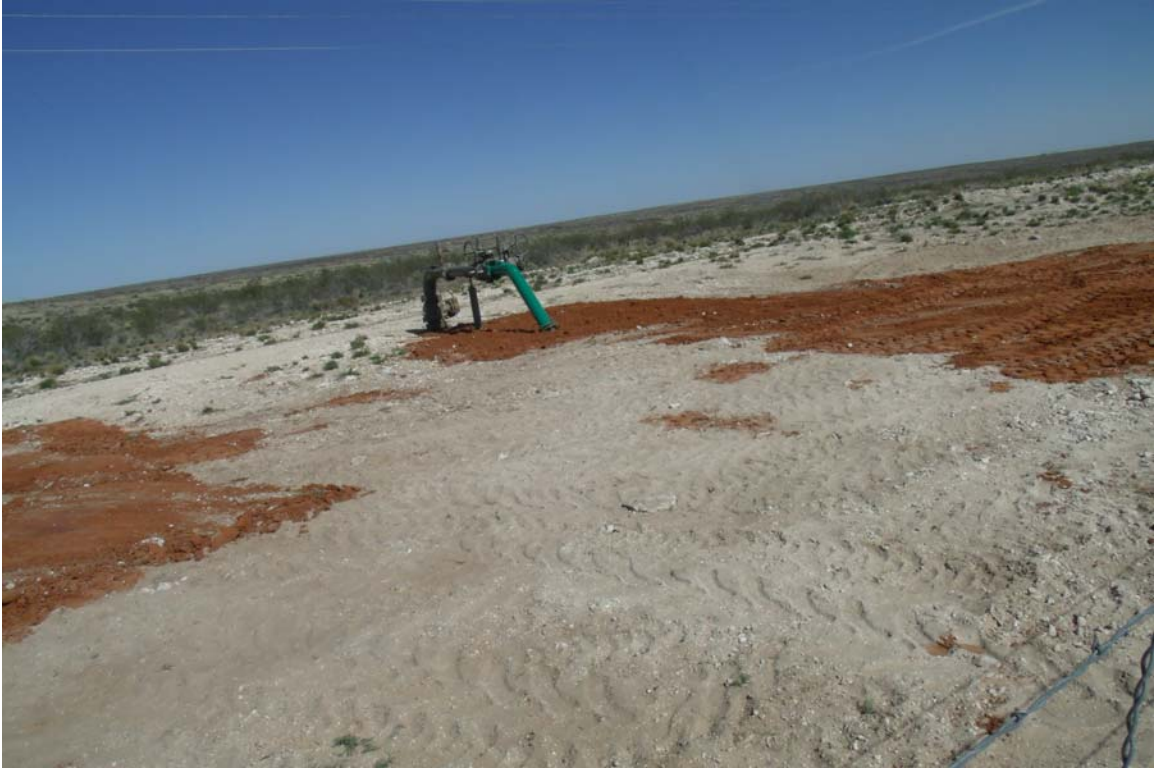
Photograph #5 – Backfilled

Based on laboratory analytical data and NMOCD approval, the excavation was backfilled with approximately 28 yards of clean soil. The entire disturbed area was then contoured to blend with existing ROW and protected against wind/water erosion.

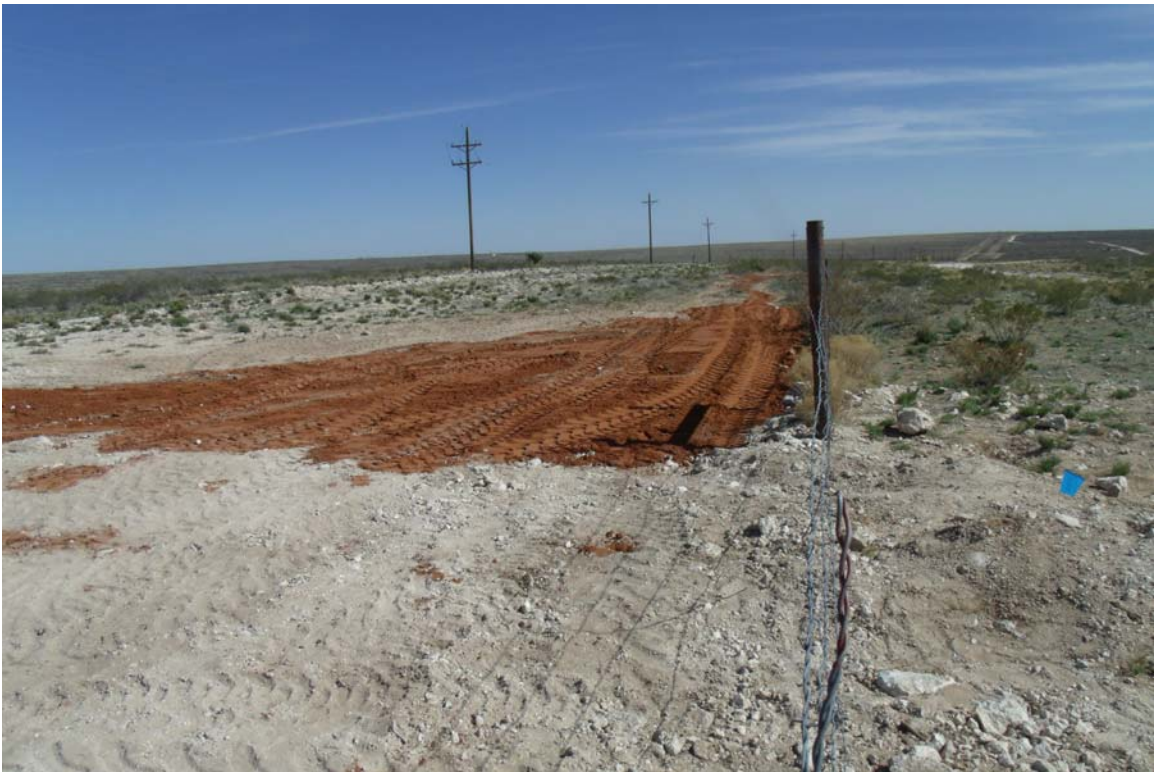
Photograph #6 – Backfilled
