**Devon Energy
Cotton Draw 163 (11 Federal #2H)
Closure Report**

**Unit Letter C, Section 11, T25S, 31E
Eddy County, New Mexico**

**2RP-3021
November 06, 2015**

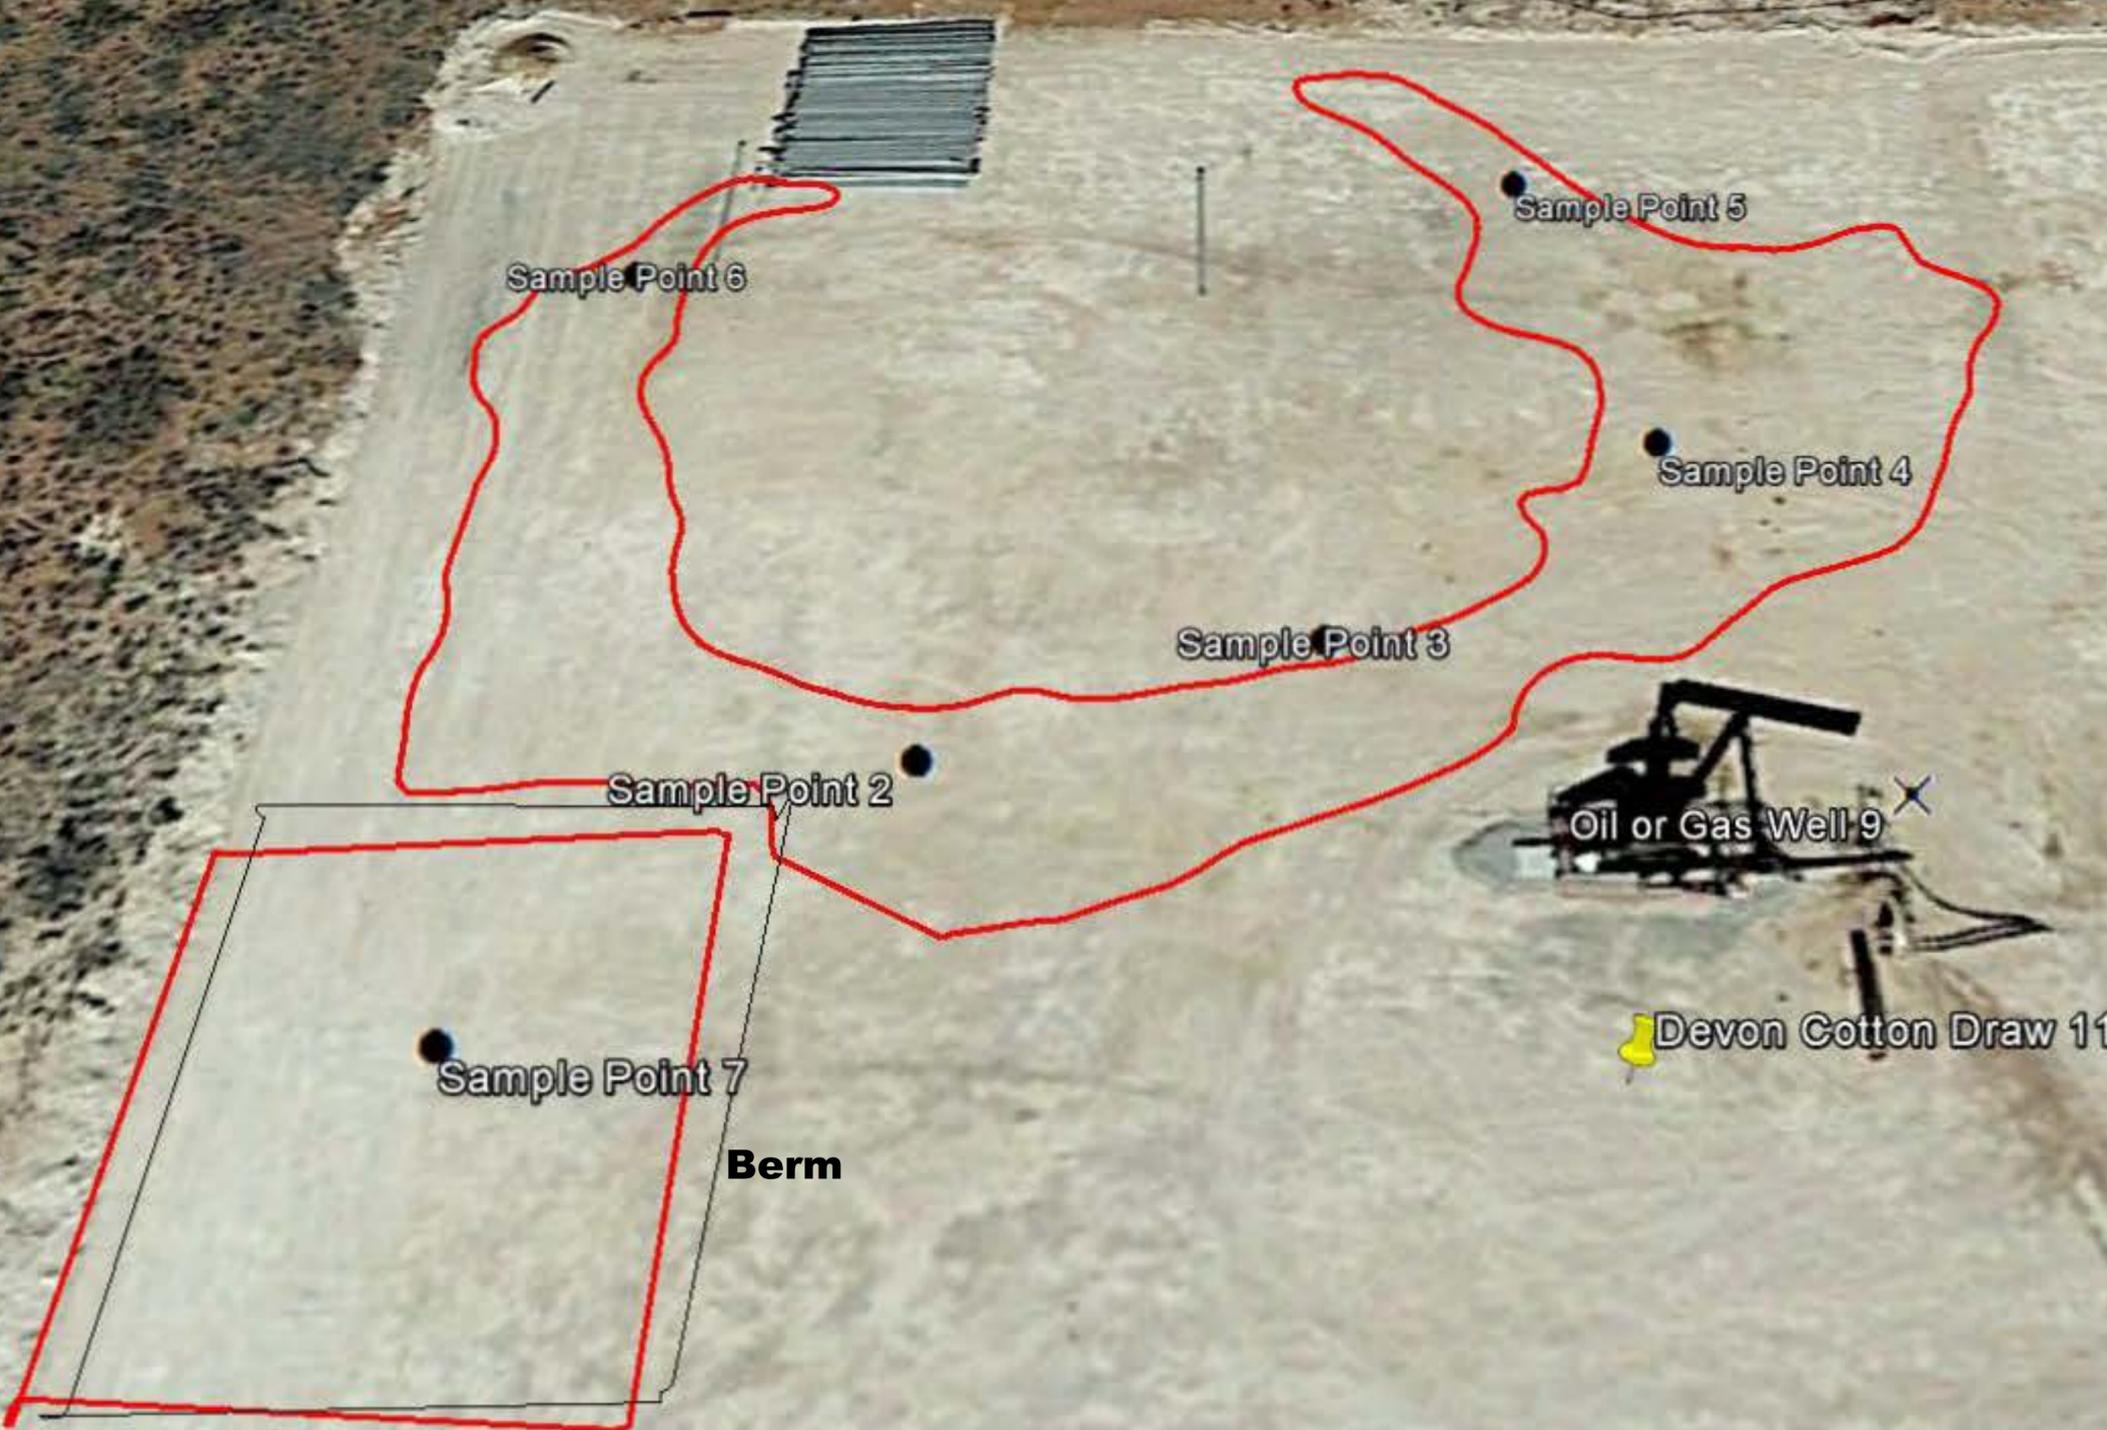
Figure 2 Site Plan

Devon Cotton Draw 11 Fed 2H

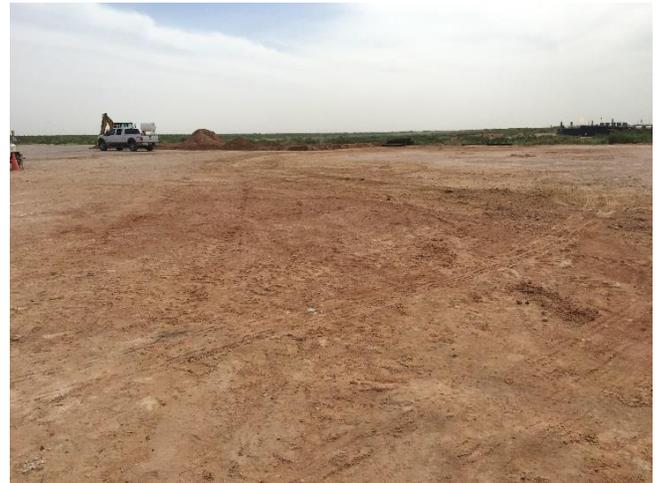
Spill Run looking SW

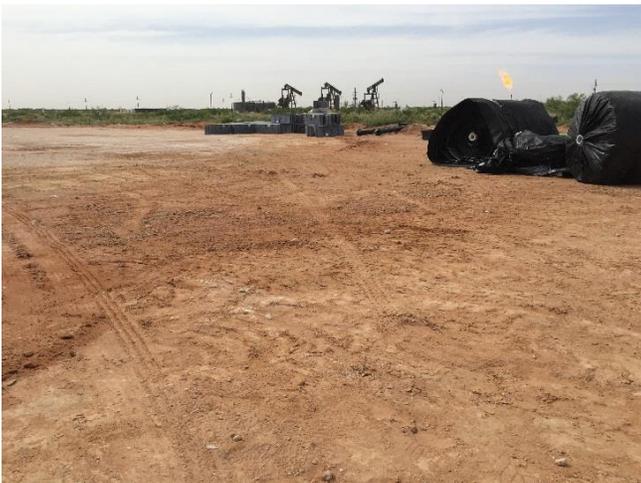
Surface impact 05-12-15

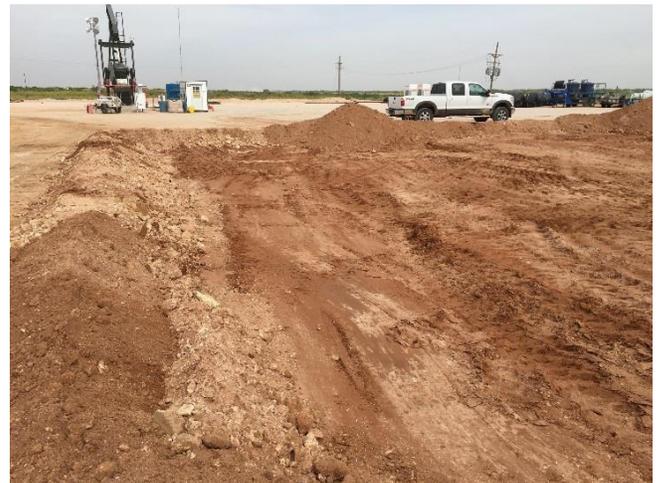
Excavated area NW corner looking East

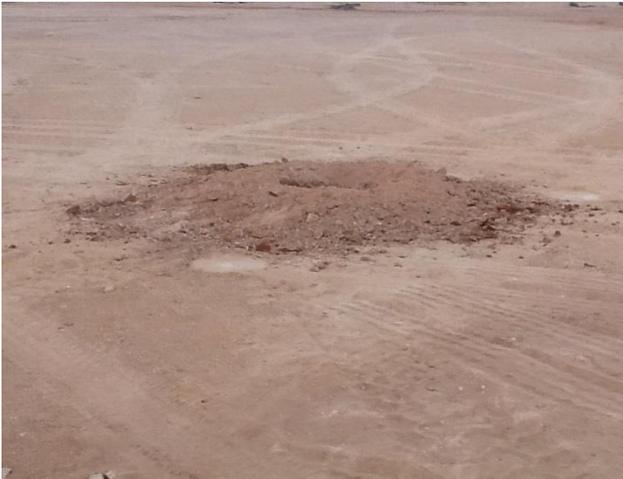
Soil Bore 08-14-15

On August 14, 2015, SESI personnel returned to the location with Hobbs Anchor in order to retrieve a representative soil bore, confirming the vertical extent of chloride impact. The soil bore was extracted between the previously sampled areas of AH=2 and AH-3 respectively, as this area indicated the deepest impact from the previous analytical results. The soil bore was transported to Cardinal Laboratories, Hobbs, NM for Chloride constituents. The following is a recap of the results (Appendix B).

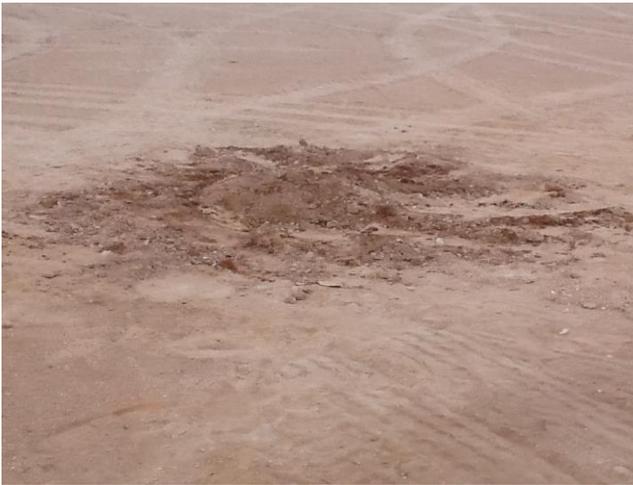
Bore Hole Backfilled 08-14-15

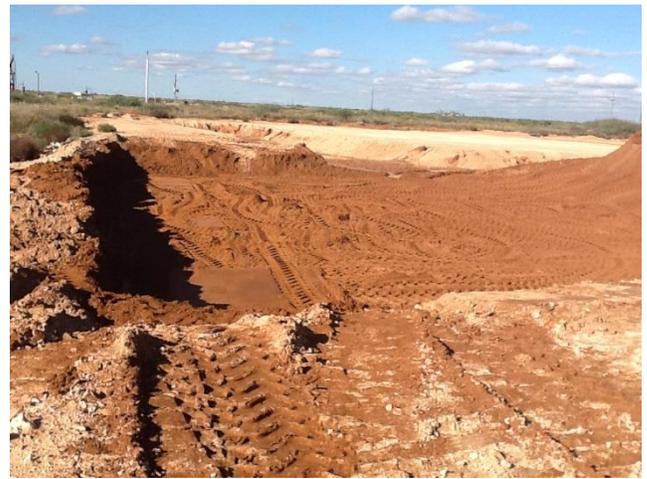
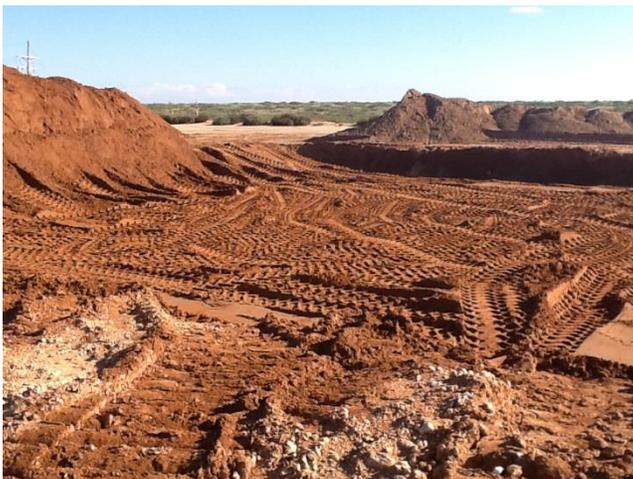
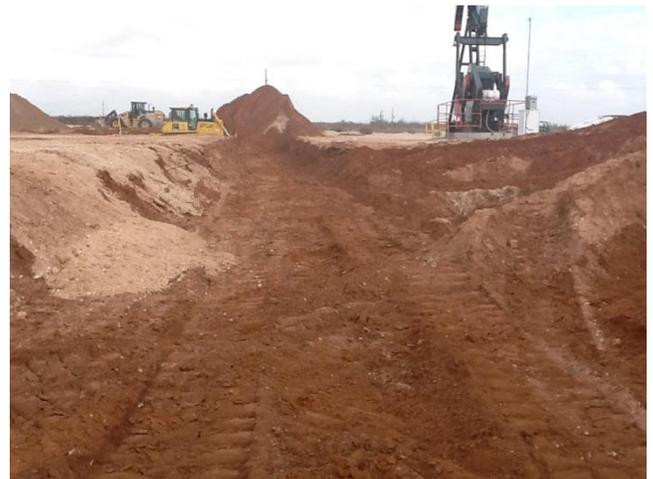
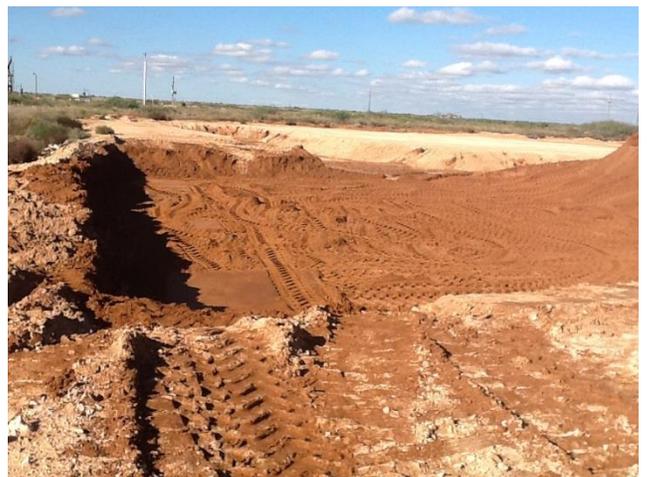
Excavated area 10-22-15

On October 20, 2015 the exaction activities were completed and confirmed by retrieving five (5) bottom and sidewall soil samples of the excavated area. The representative soil samples were properly packaged, preserved and transported to Cardinal Laboratories, Hobbs, NM and analyzed for Chloride constituents. The returned analyses for Cl⁻ is recapped in the following table:

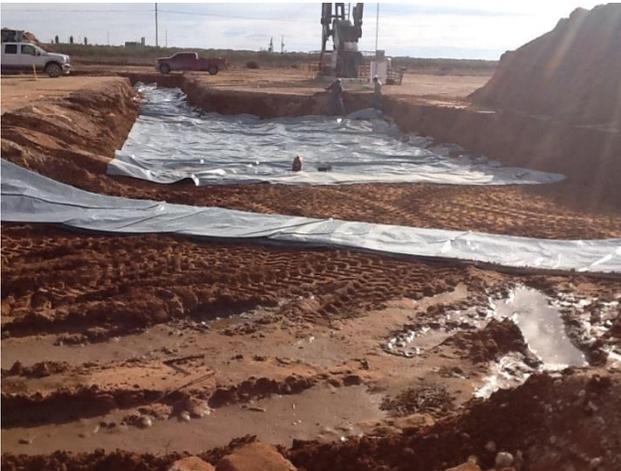
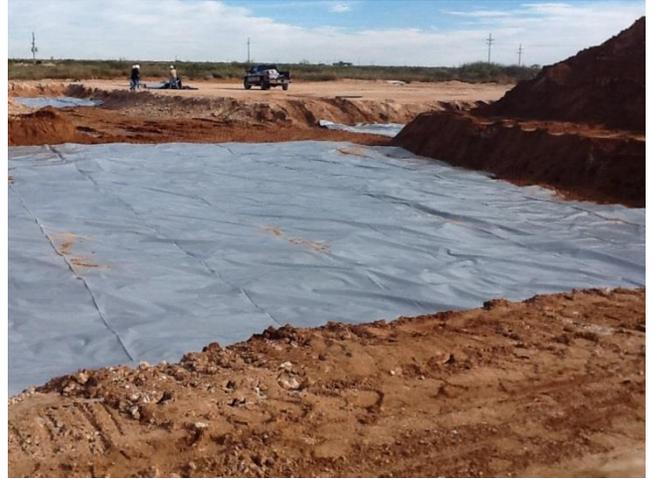
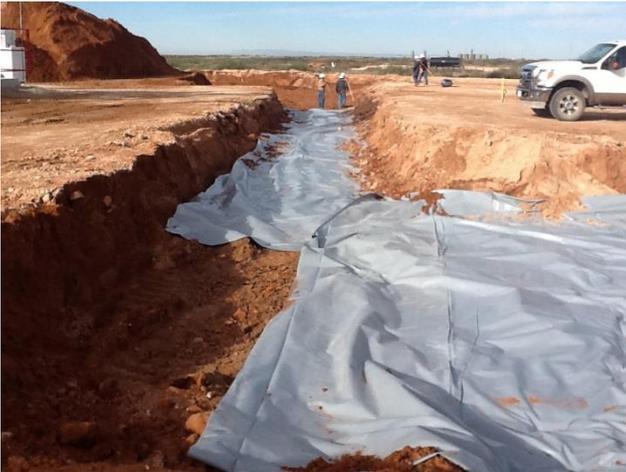
Liner Installation 10-23-15

Based on the above confirmation of field analysis; the 4' bgs. excavation was lined with a 20 mil. Liner, backfilled with fresh topsoil and the area returned to grade with a fresh caliche cap. According to disposal manifest; a total of 3,319.53 tons of impacted soils were disposed of at an NMOCD approved facility.

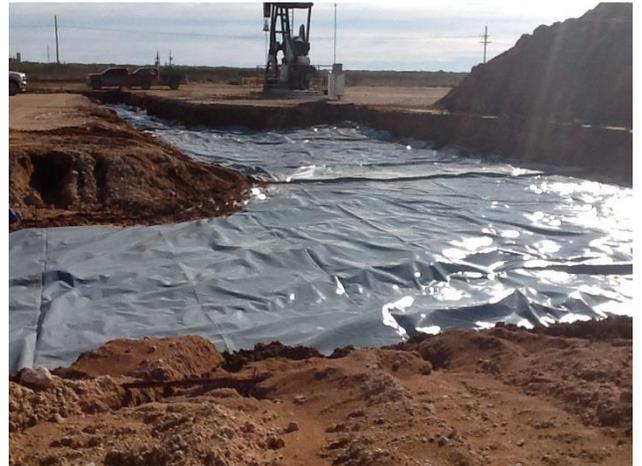
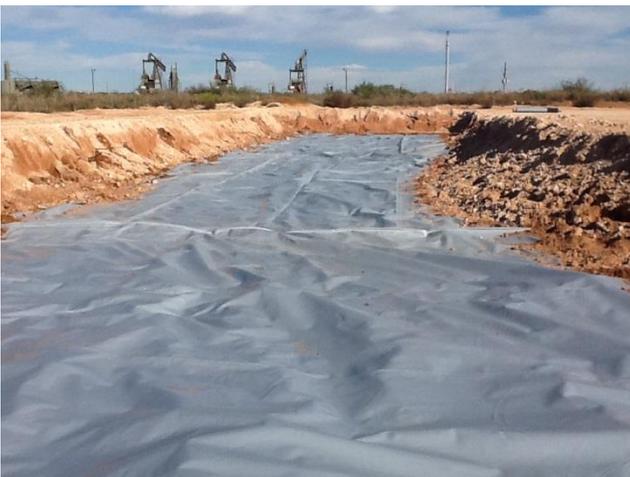
Liner Completion 10-26-15

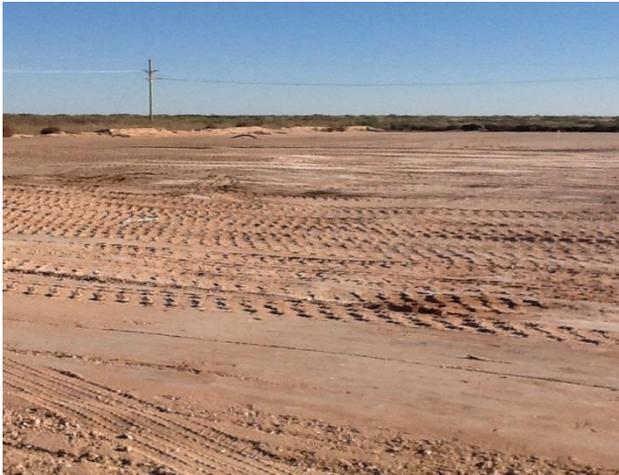
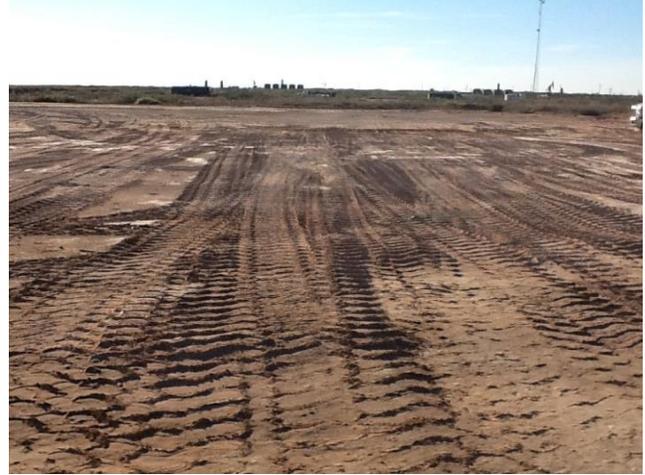
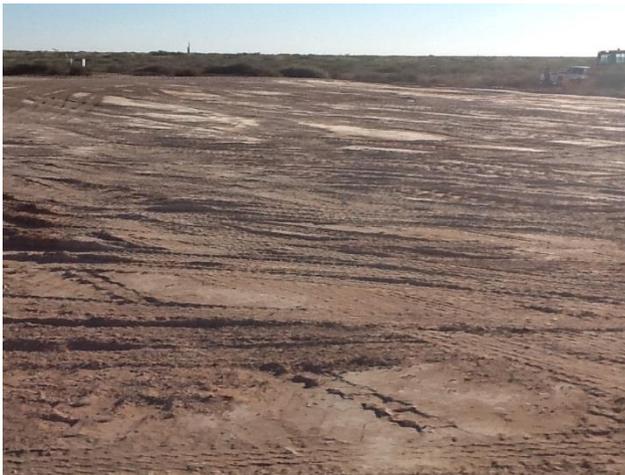
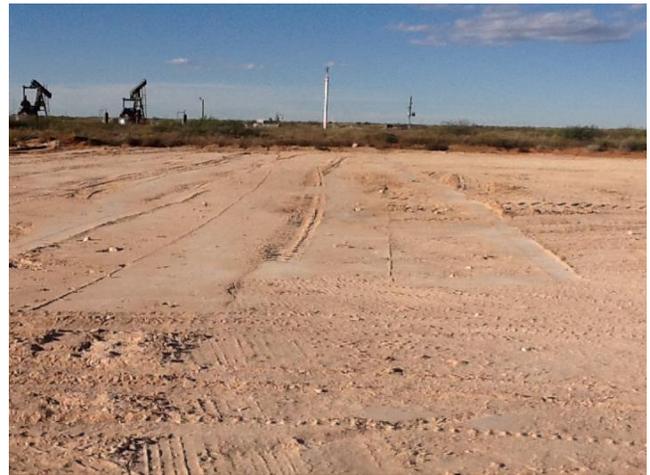
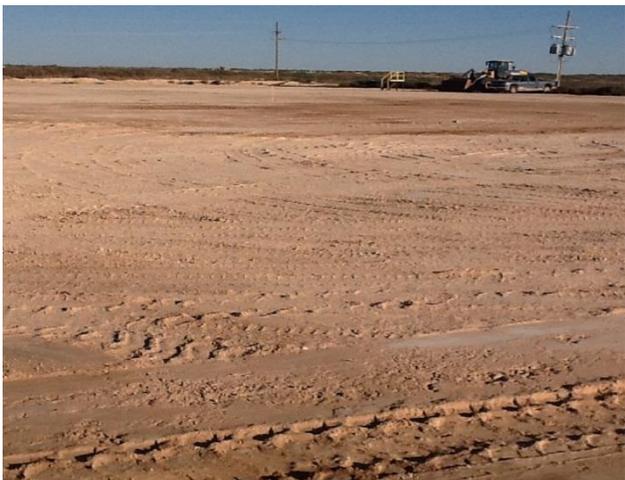
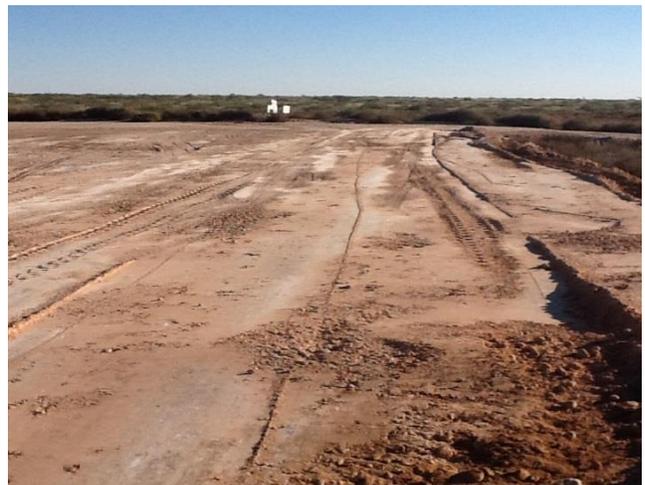
NW Corner looking SE completion 10-27-15
