R. T. HICKS CONSULTANTS, LTD.

April 18, 2016

RE: Final Closure Report
Atoka San Andres Unit No.141 Release Site, Lime Rock Resources II-A, L.P.
T19S R26E Section 13 Unit Letter J, Eddy County NM

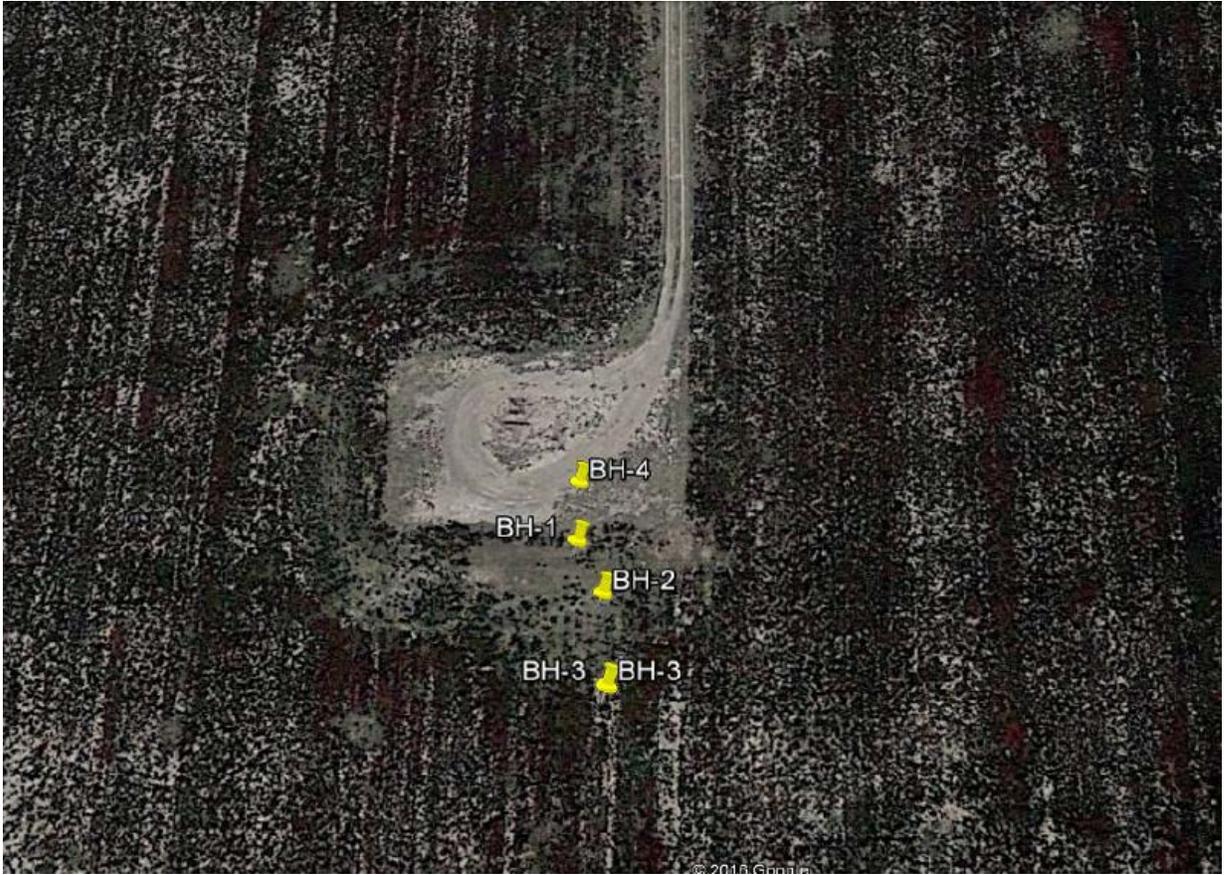
Figure 1: *Diagram for soil samples collected for field testing. North is up the page.*

On March 29, 2016, Hicks Consultants collected soil samples from the impacted area. Sample locations are shown on Figure 1. Soil samples were tested on location using the Field Titration test method for chloride.

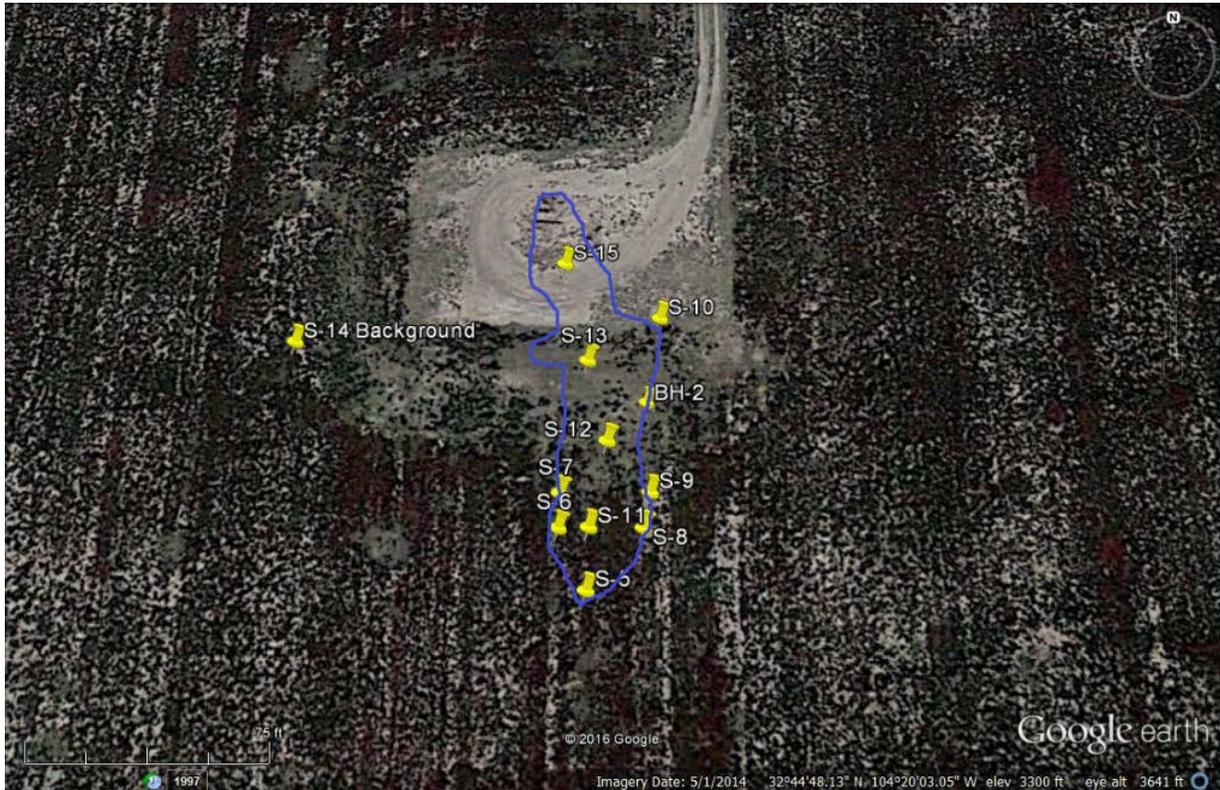
Figure 1: Blue out lined area is the impacted area. North is up the page.

On April 5, 2016, Hicks Consultants collected soil samples from the excavated area. Sample locations are shown on Figure 1. Soil samples were transported to Cardinal Laboratories located in Hobbs, N

- Impacted material in the release area located with-in the alfalfa was excavated to a depth of 2-foot (bgs) and then transported to Lea Land LLC and NMOCD approved Landfill.

- Impacted material in the release area located on location was excavated to a depth of .5-foot (bgs)
- On April 5, 2016 soil sample was collected from the excavated area of release and submitted to Cardinal Laboratories. (Appendix A).

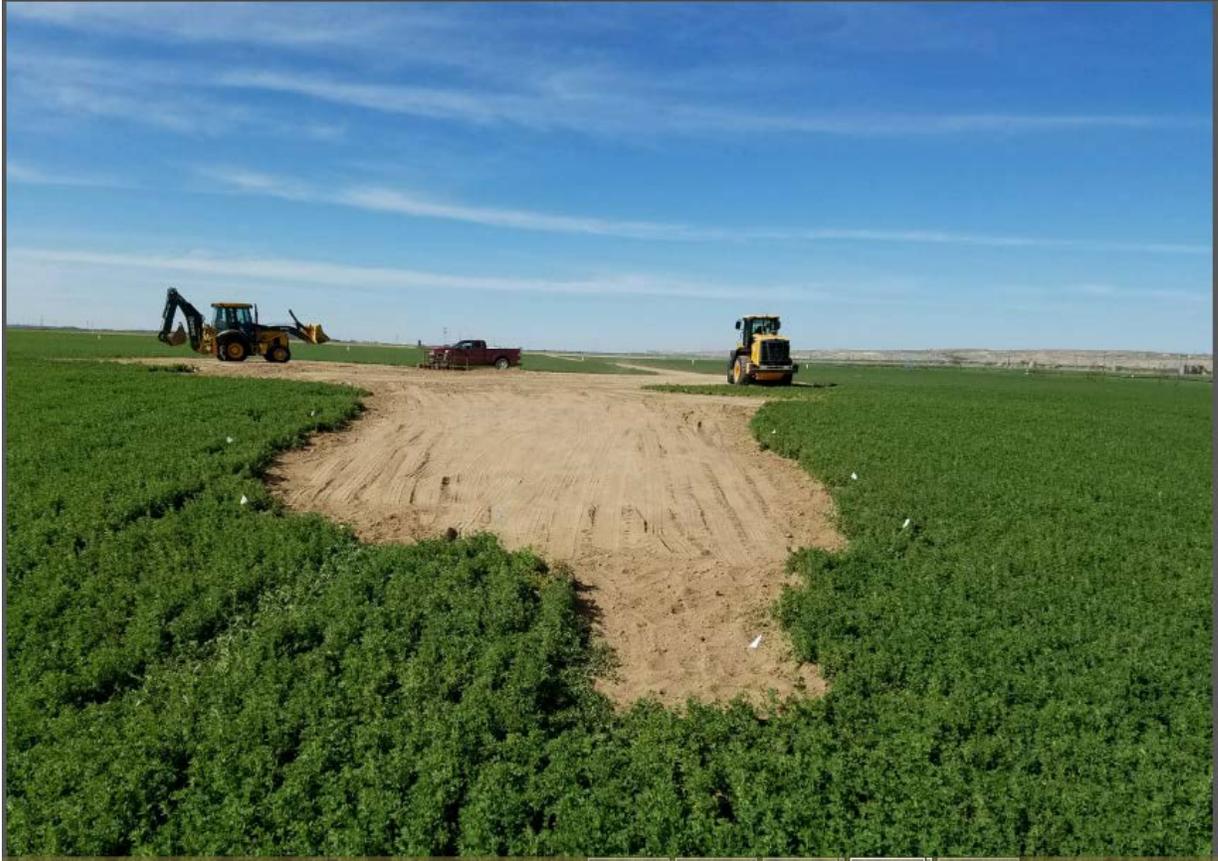
Photo 1 Excavated area after backfilling looking to north.

- The excavated material from the release was transported to Lea Land LLC for disposal.
- The excavated area will be backfilled using like material for the surrounding area.
