H E West A #035

CLOSURE REPORT

API No. 30-015-29346

NMOCD Case #: 2R-3019

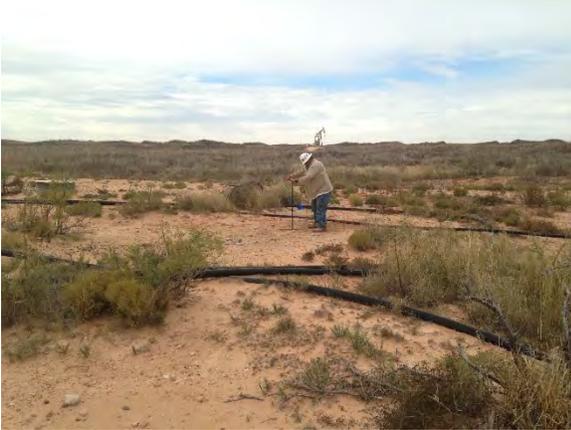
Collecting sample, facing northwest 11/23/2015

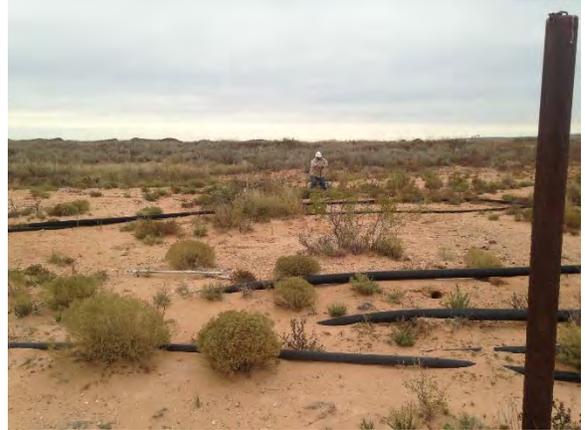
Collecting sample, facing north 11/23/2015

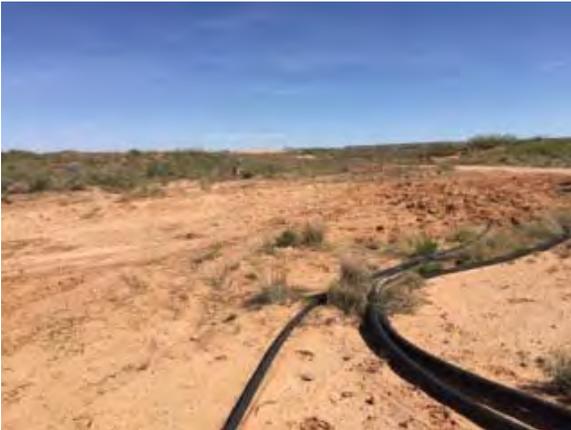
Backfill completed, facing northeast 4/1/2016

A work plan was submitted to and approved by NMOCD and BLM on January 21, 2016. Beginning February 18, 2016, DFSI personnel were on site to excavate the area surrounding SP-4 to 1' bgs and excavate the area around SP-5 to 4' bgs (Appendix IV). At 4 ft bgs, a 20-mil, reinforced poly liner was installed. The excavations were backfilled with native topsoil to ground surface and contoured to the surrounding area. Contaminated soil was properly disposed of at an NMOCD approved facility. The site was seeded with a blend of native vegetation (Appendix V).

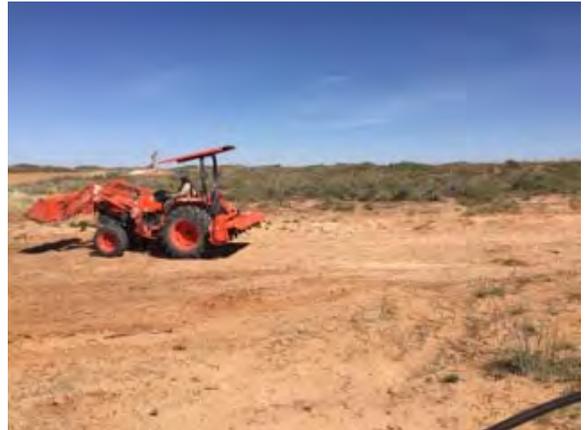
Seeding site, facing northwest 4/1/2016

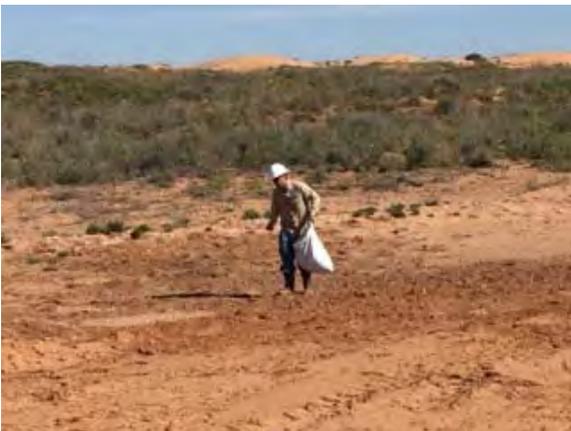
Seeding site, facing east 4/1/2016

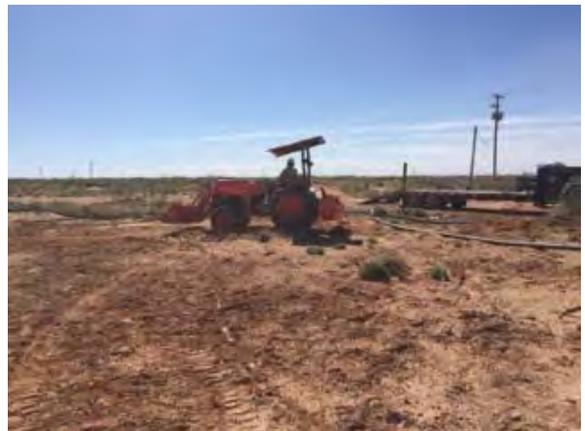
Seeding site, facing southeast 4/1/2016
