RE: Final Closure Report
XTO Energy – Goldenchild 006 State 1H
UL-P, Section 6, Township 25 South, Range 29 East
Eddy County, New Mexico
NMOCD Reference # 2RP-3677

The following *Final Closure Report* serves as a condensed update on closure activities for the above referenced Site.

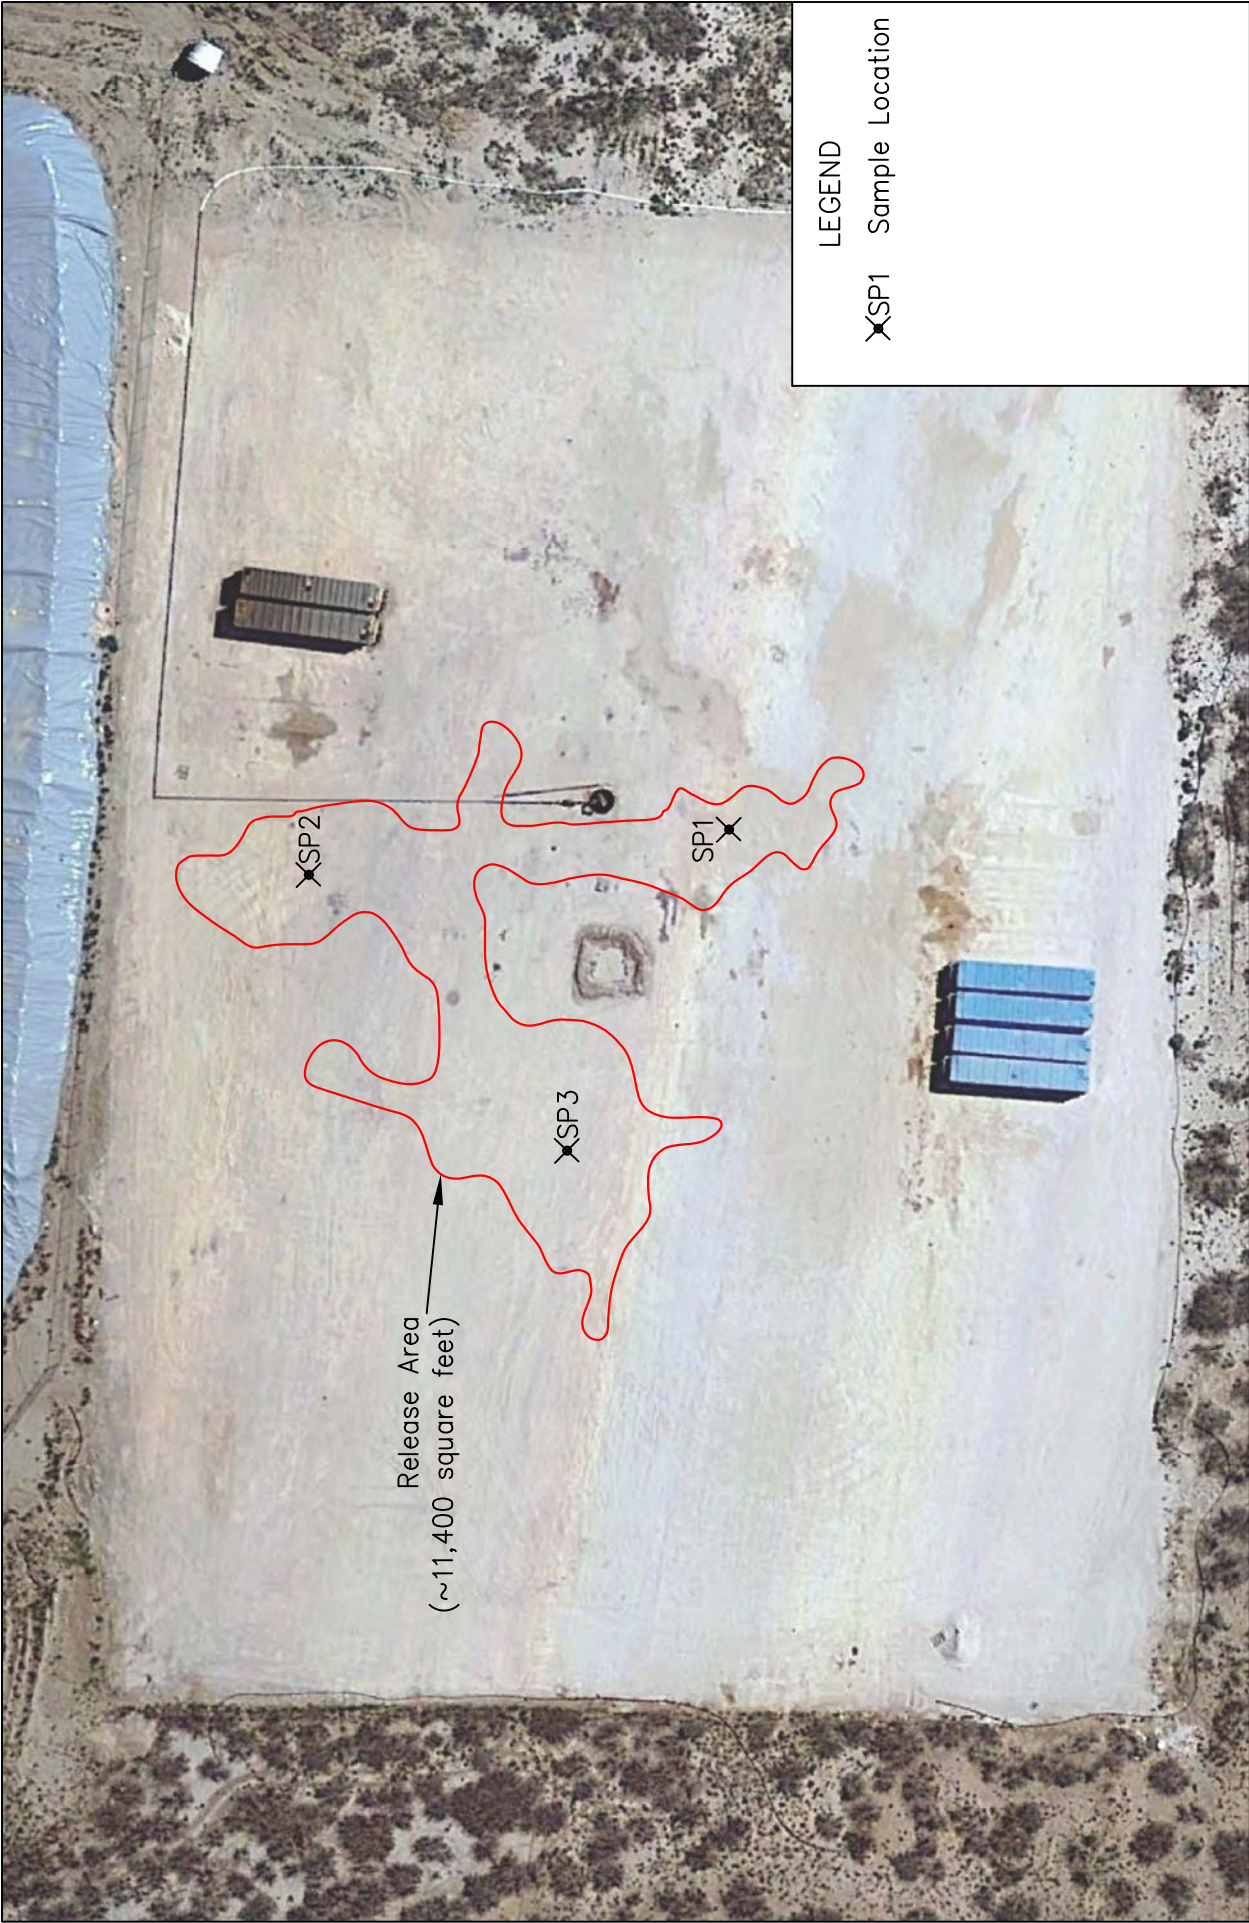
Figure 3
Sample/Site Map
XTO Energy
Goldenchild 006 State 1H

EPI personnel mobilized on the site on May 9, 2016 to collect soil samples to determine the vertical extent of contamination. A total of nine (9) soil samples were collected at varying depths from three (3) sample location; SP1 – SP3. Six (6) representative samples, two (2) from each sample point, were sent to Cardinal Labs for testing. Laboratory analytical results indicate Benzene, BTEX, TPH, and Chloride concentrations do not exceed NMOCD Recommended Remedial Action Levels (NMOCD RRALs) of 10 mg/Kg, 50 mg/Kg, 1,000 mg/Kg, and 500 mg/Kg respectively (reference *Figure 3* and *Table 2*).

The release area around SP1 and SP3 was excavated approximately one (1) foot bgs; the release area around SP2 was excavated approximately two (2) feet bgs. Approximately 424 cubic yards of contaminated material were excavated and transported to a state approved facility for disposal.

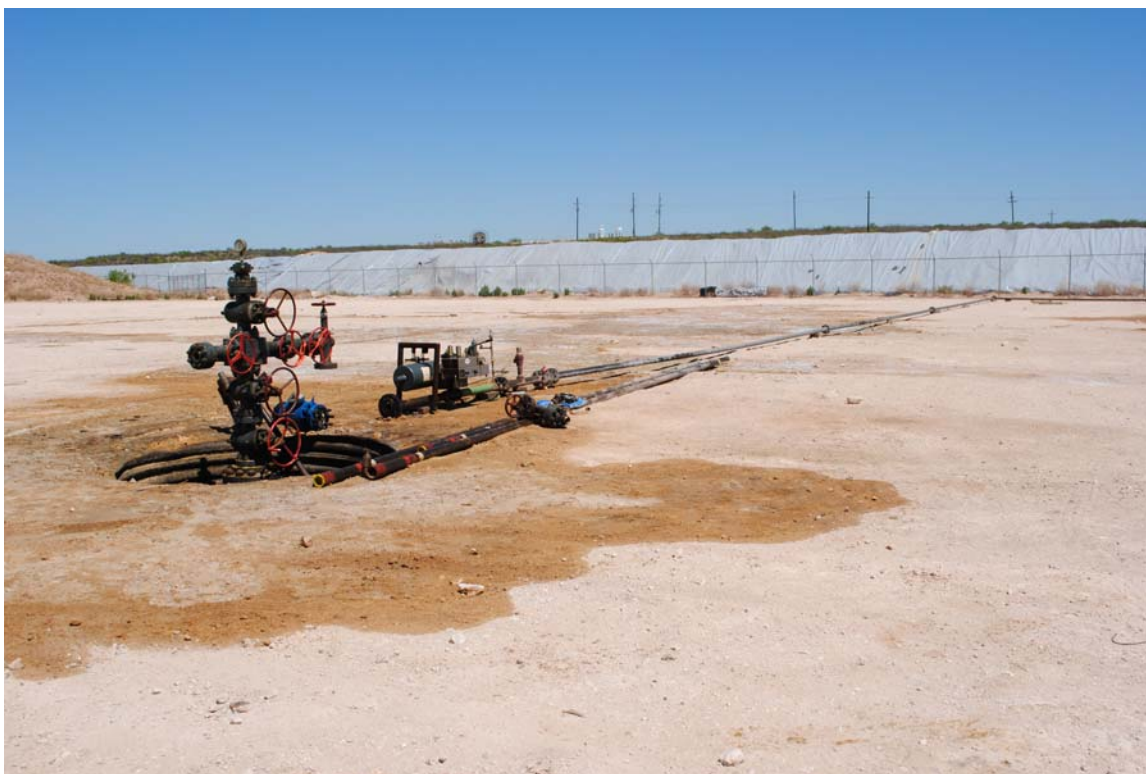
Photograph #1 – Release area

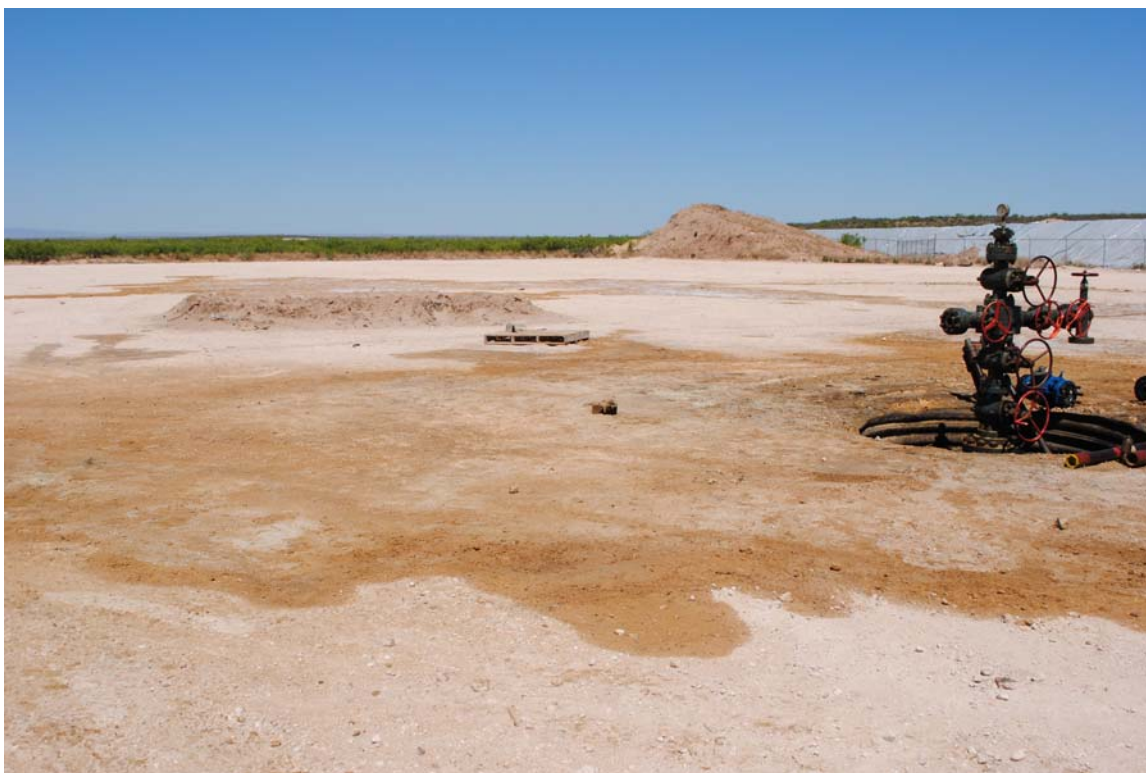
Photograph #2 – Release area

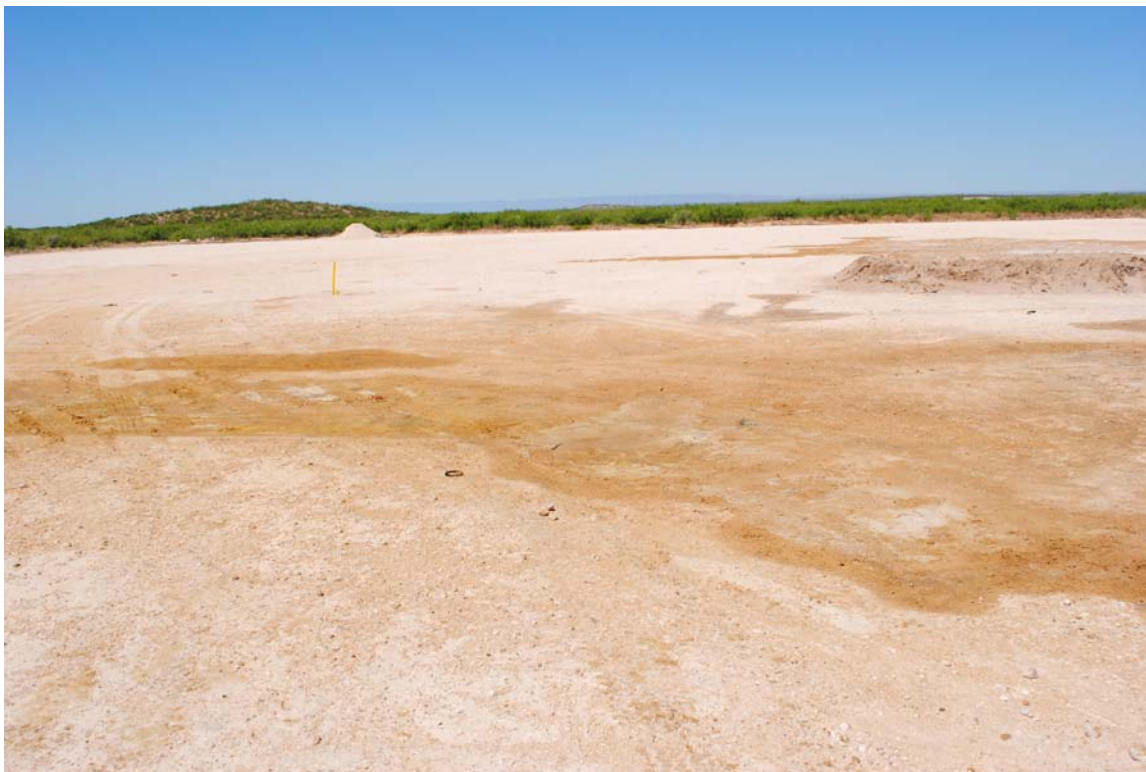
Photograph #3 – Release area

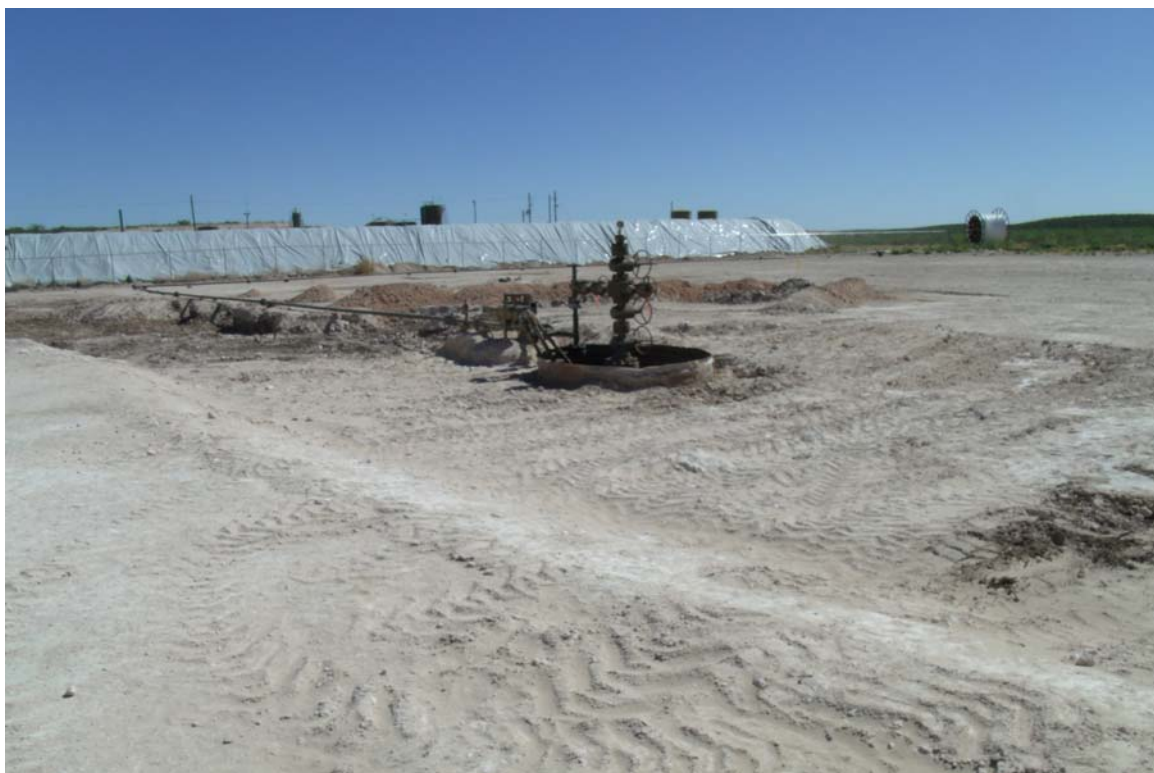
Photograph #4 – Excavated area

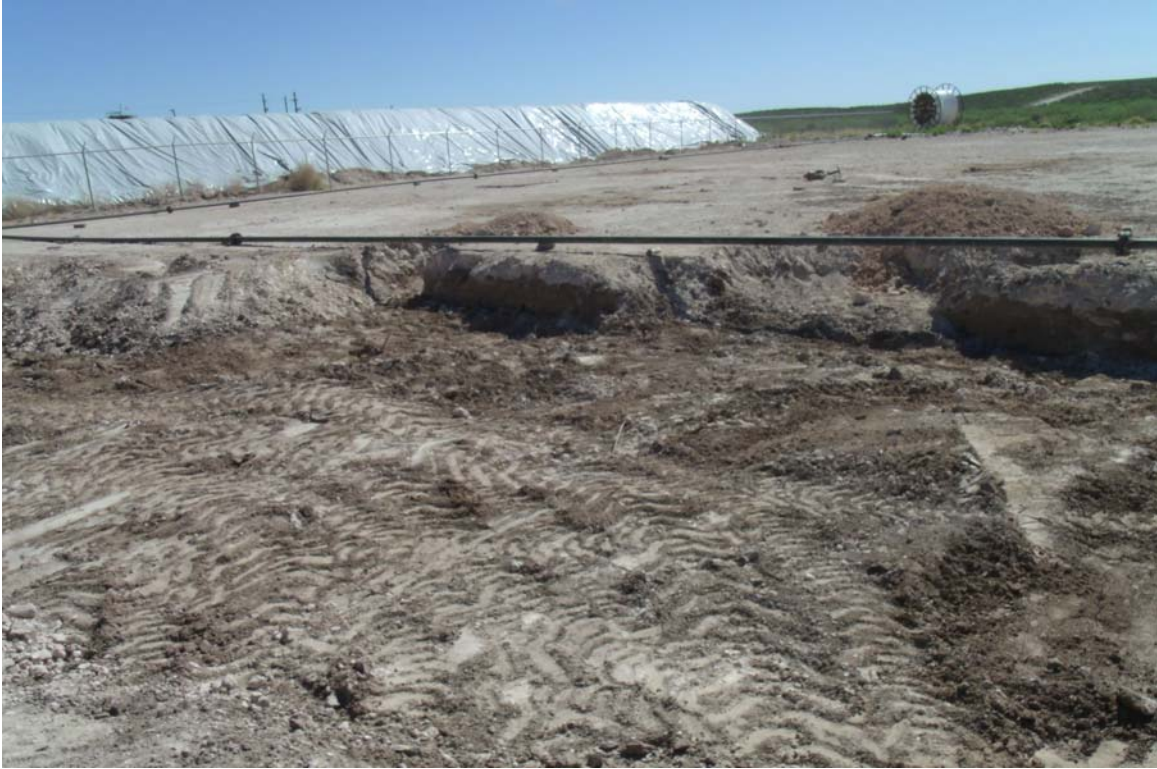
Photograph #5 – Excavated area

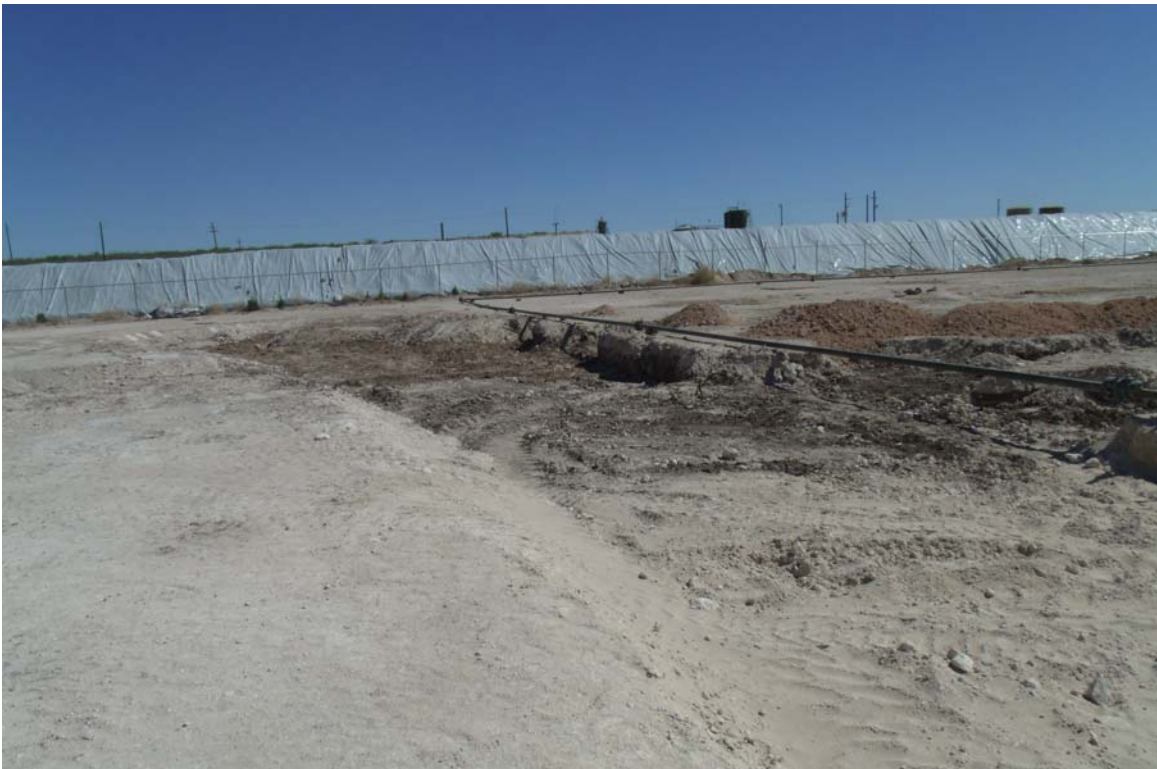
Photograph #6 – Excavated area

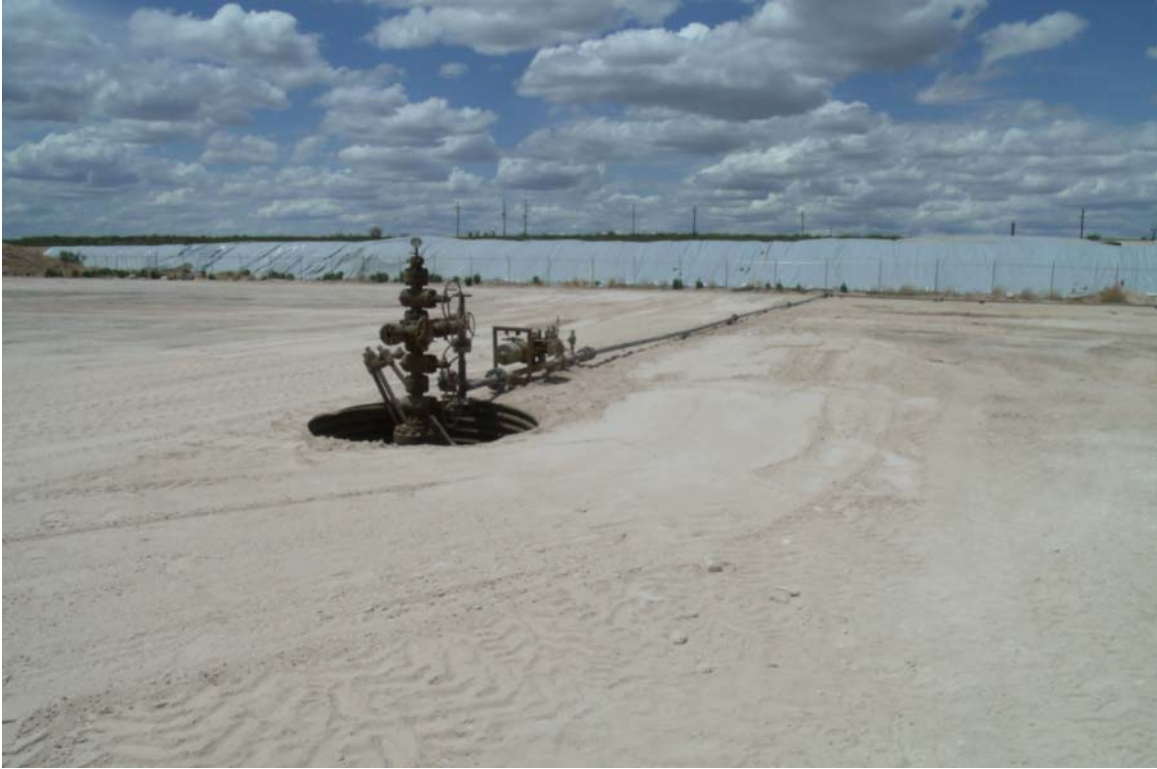
Photograph #7 – Backfilled

Based on laboratory analytical results and with NMOCD approval, the excavation has been backfilled with approximately 424 cubic yards of clean soil; soil was free of deleterious material or rocks or large clumps.

Backfilling continued until the entire excavation was closed. Upon completion of backfill activities, the entire disturbed area was contoured to blend with existing pad area and protected against wind/water erosion.

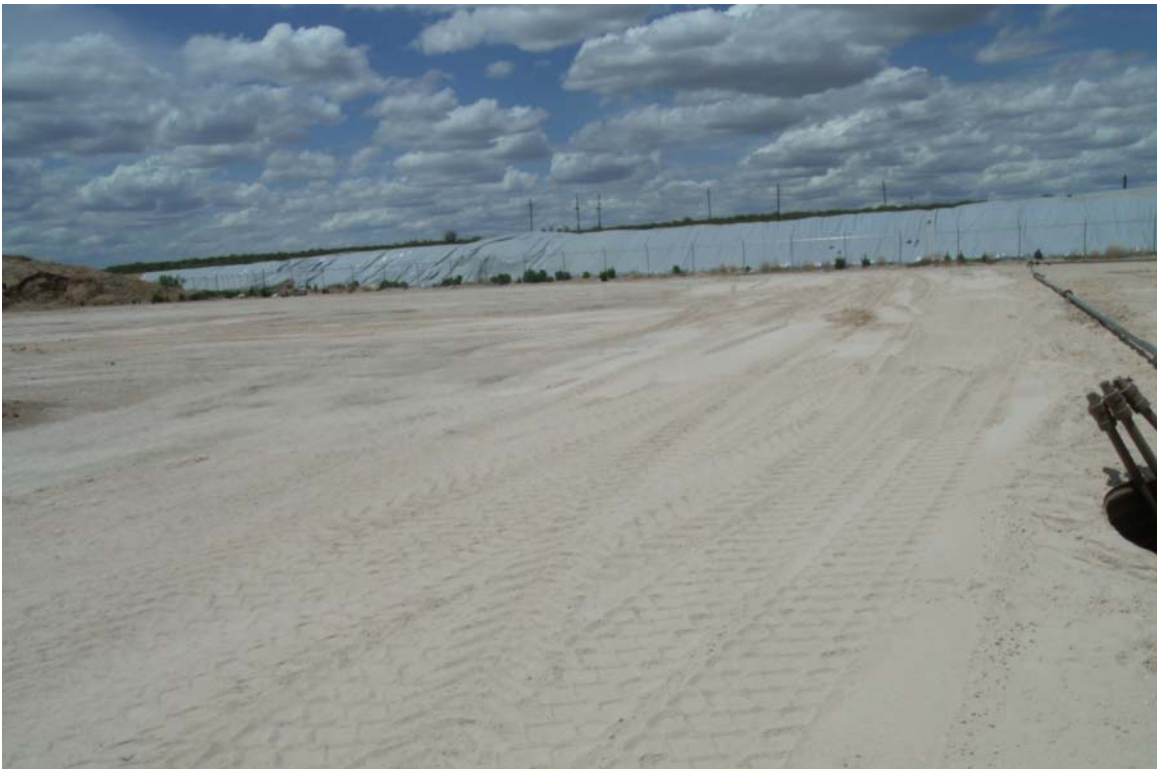
Photograph #8 – Backfilled
