CLOSURE REPORT

**BOPCO, L.P.
PLU #261 Tank Battery
Eddy County, New Mexico
Unit Letter "J", Section 21, Township 24 South, Range 30 East
Latitude 32.201808 North, Longitude 103.883505 West
NMOCD Reference #2RP-1012
NMOCD Reference #2RP-2333
NMOCD Reference #2RP-2957**

RE: Final Closure Report
Bopco – PLU #261 Tank Battery
UL-J, Section 21, Township 24 South, Range 30 East
Eddy County, New Mexico
NMOCD Reference's #2RP-1012, #2RP-2333, #2RP-2957

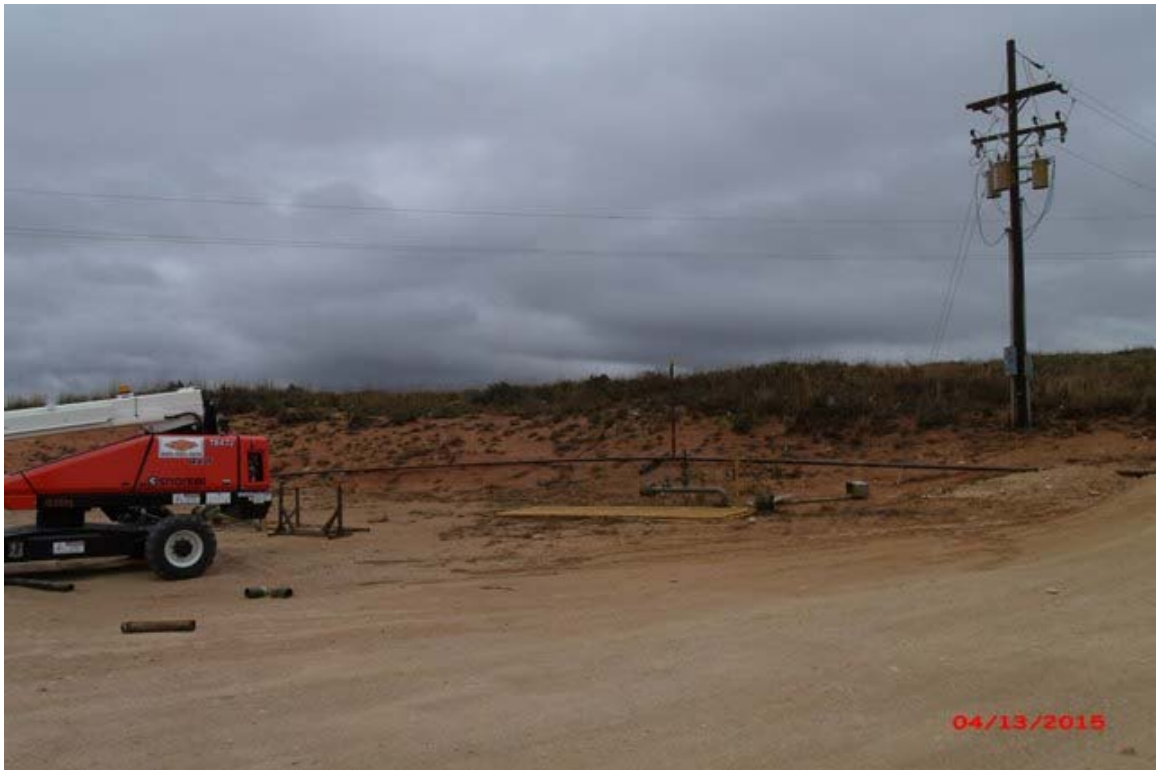
Photograph #1 – Overspray area

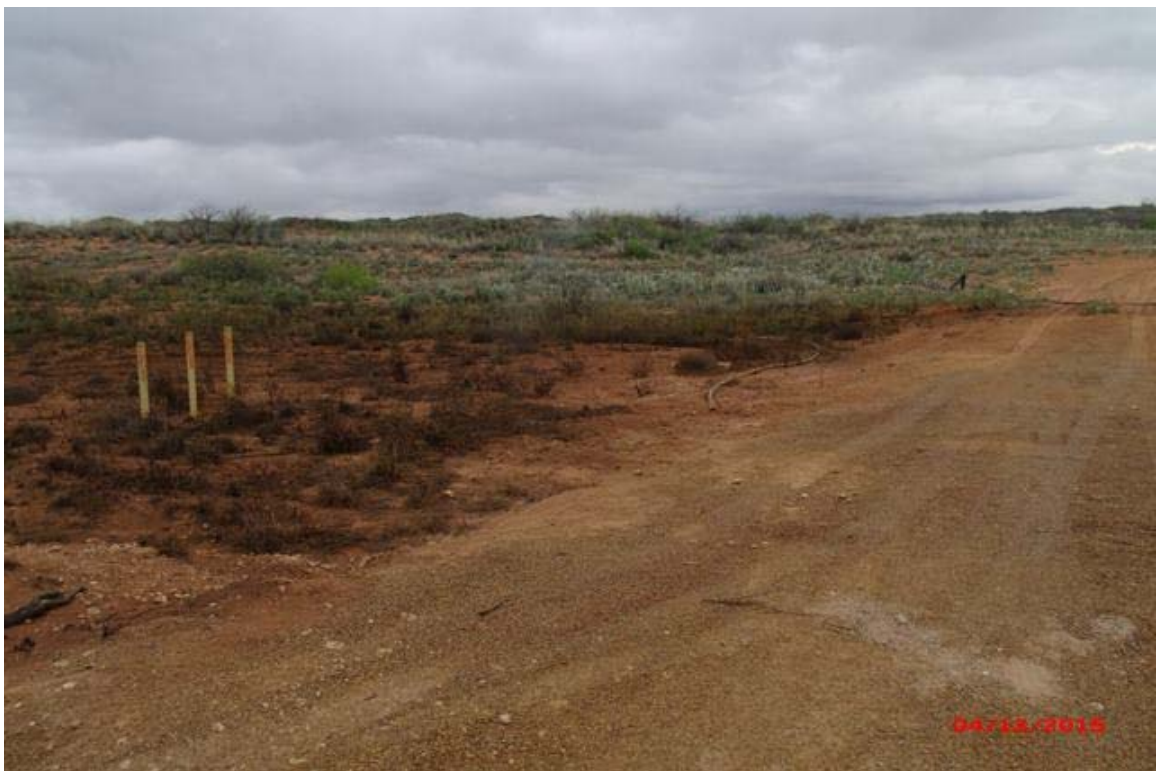
Photograph #2 – Overspray area

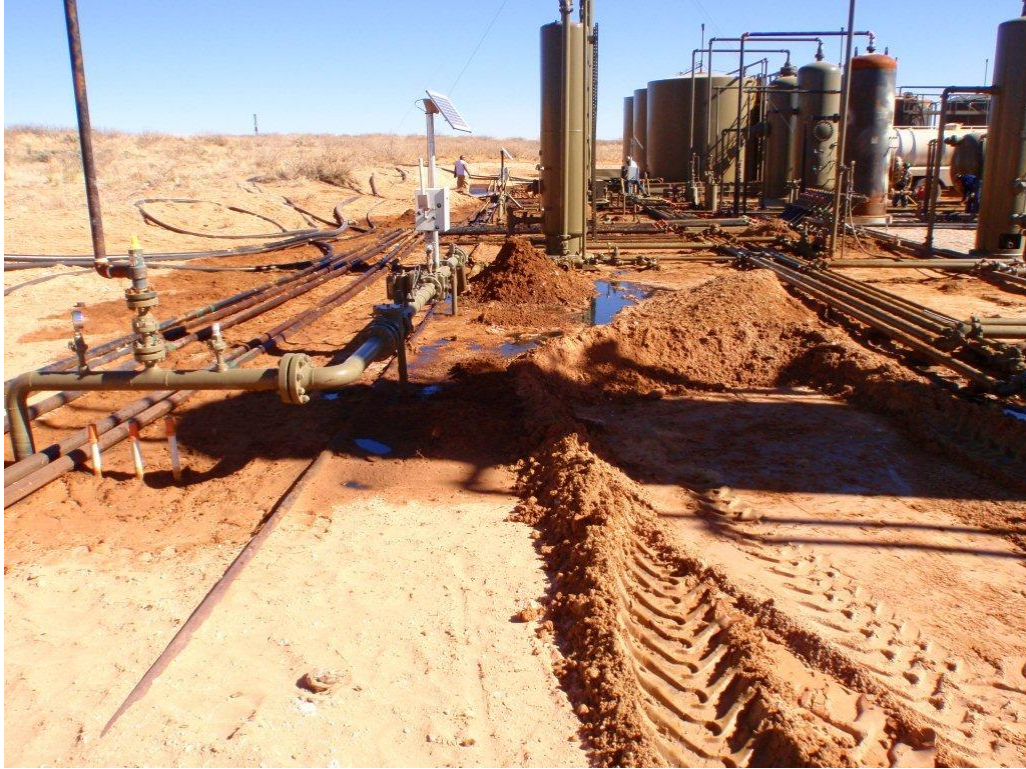
Photograph #3 – Looking across release area

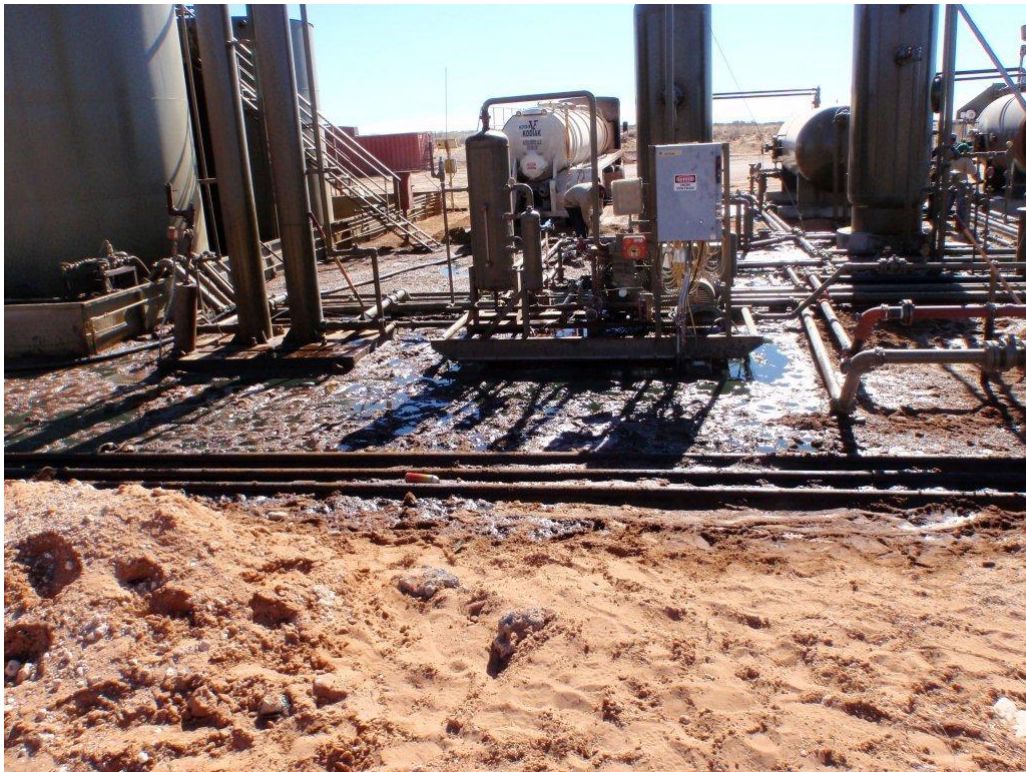
Photograph #4 – Looking across release area

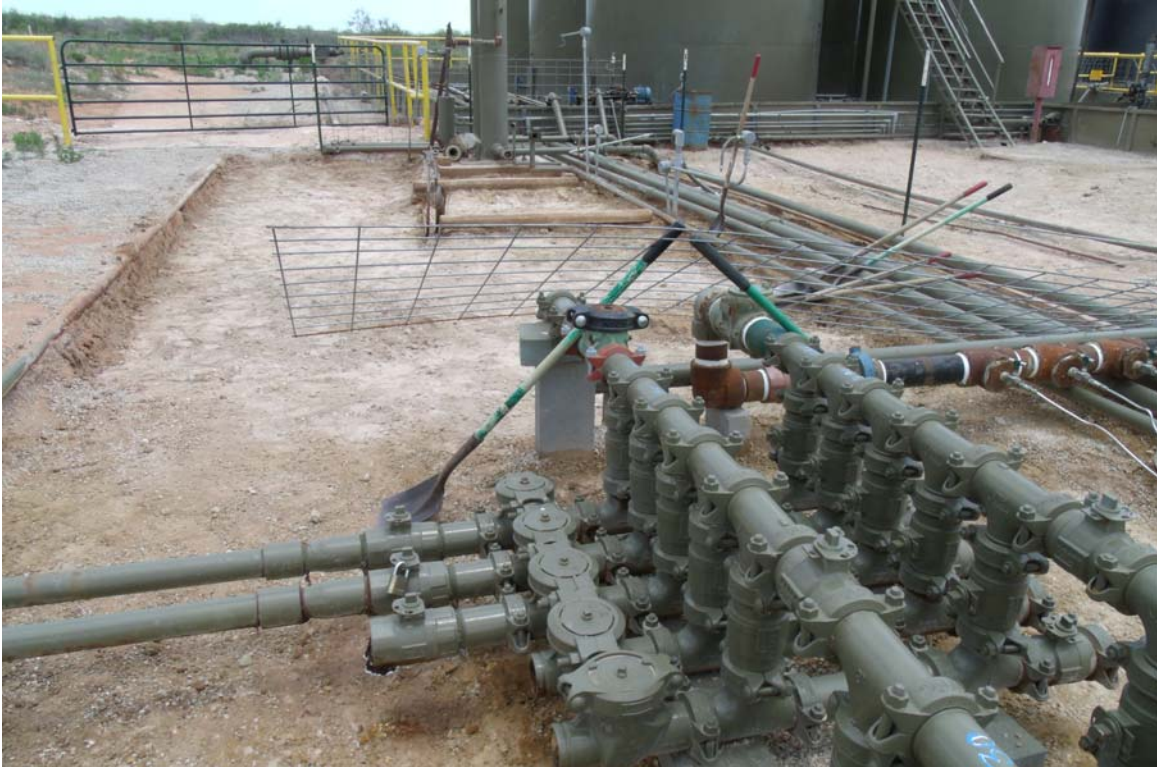
Photograph #5 – Excavated area

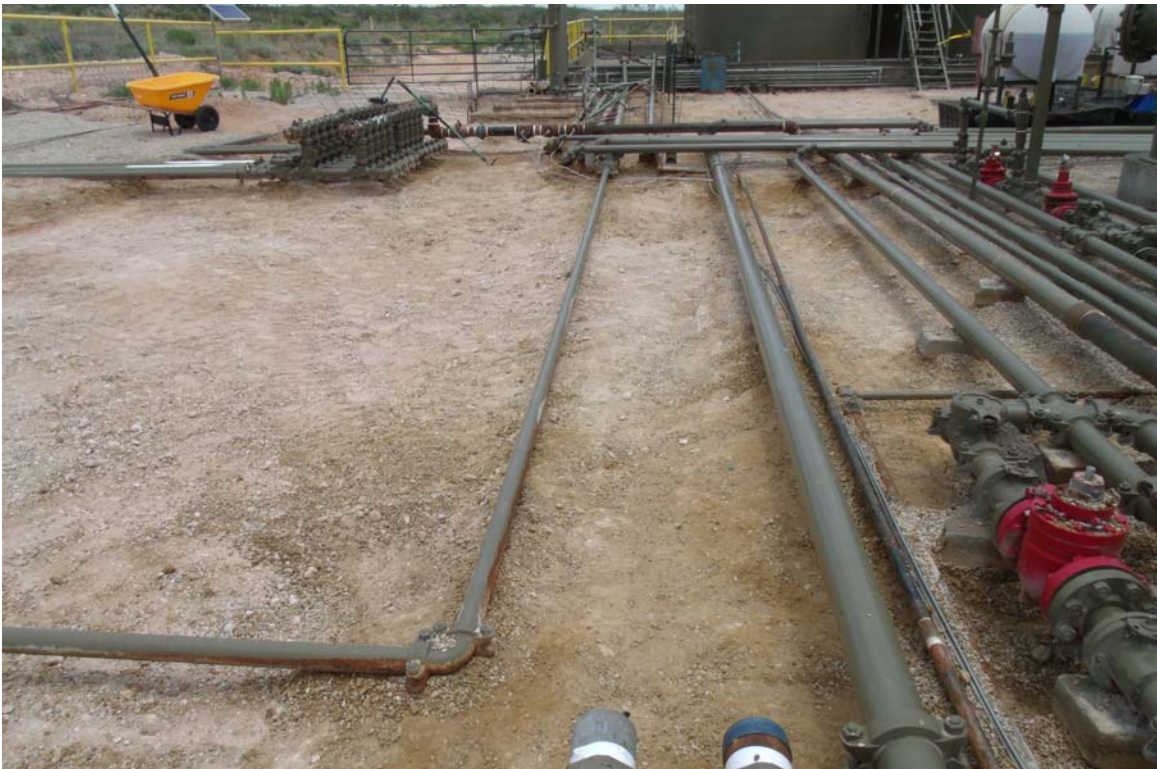
Photograph #6 – Excavated area

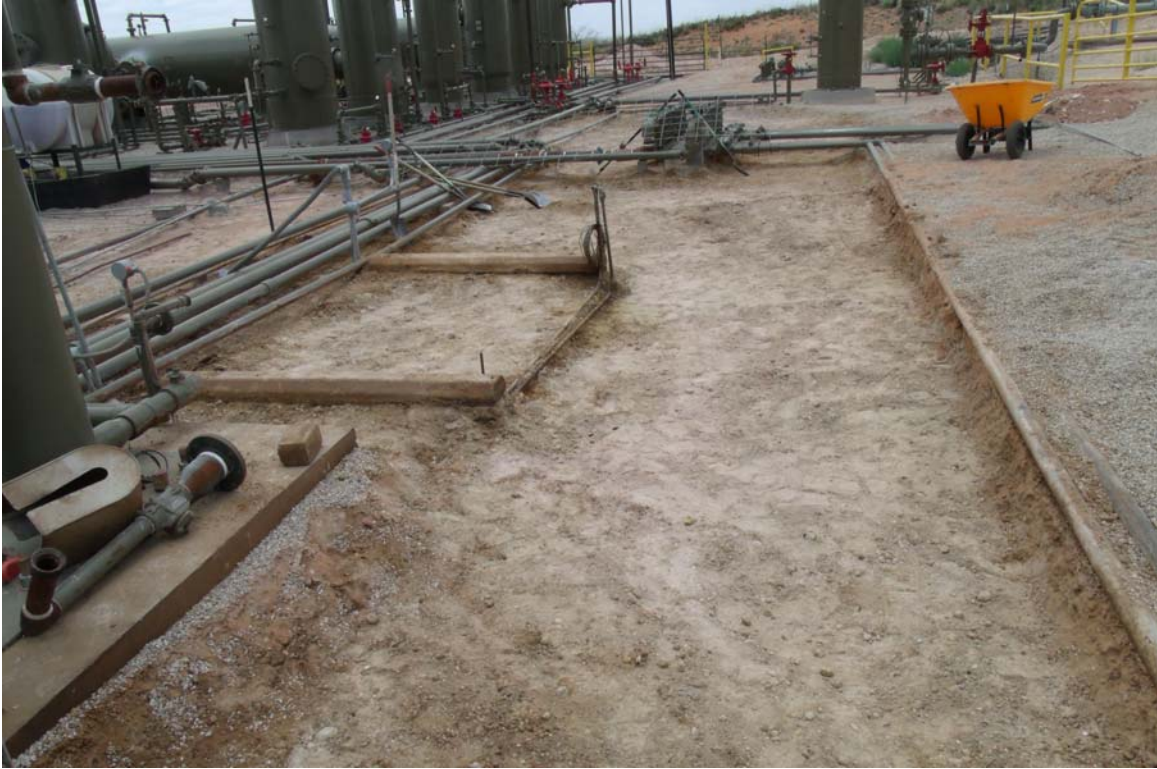
Photograph #7 – Excavated area

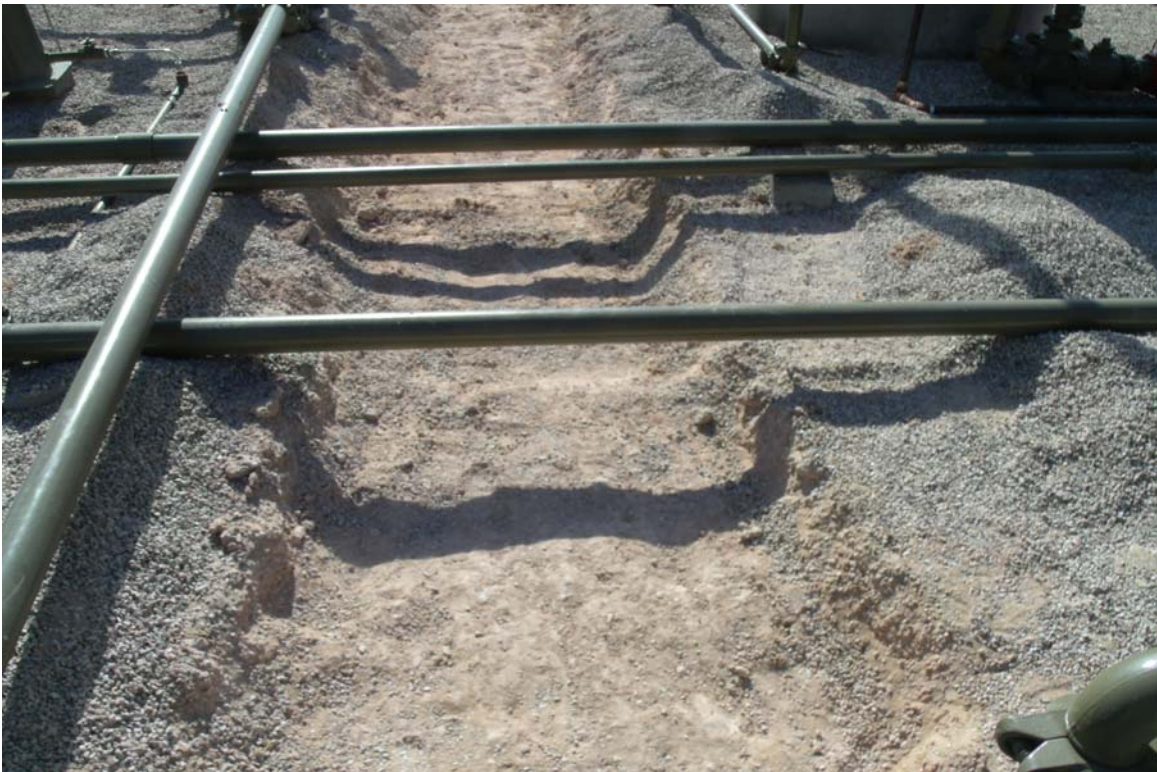
Photograph #8 – Excavated area

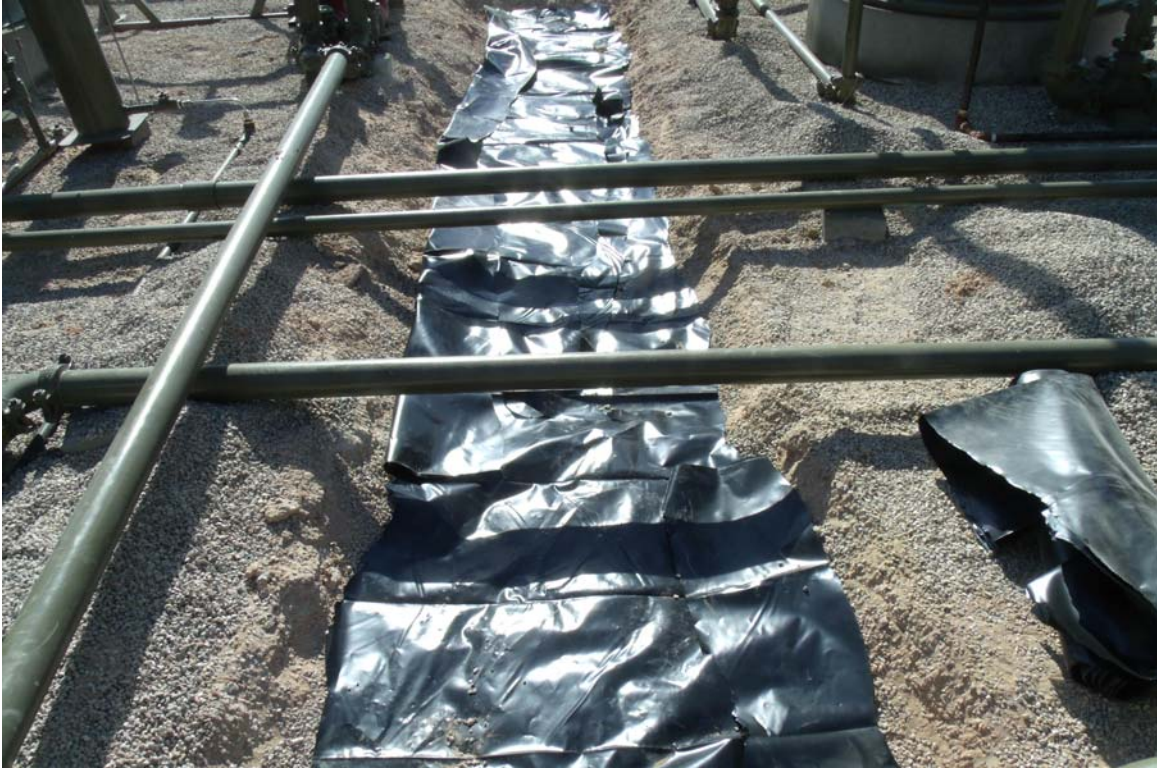
Photograph #9 – Liner installed

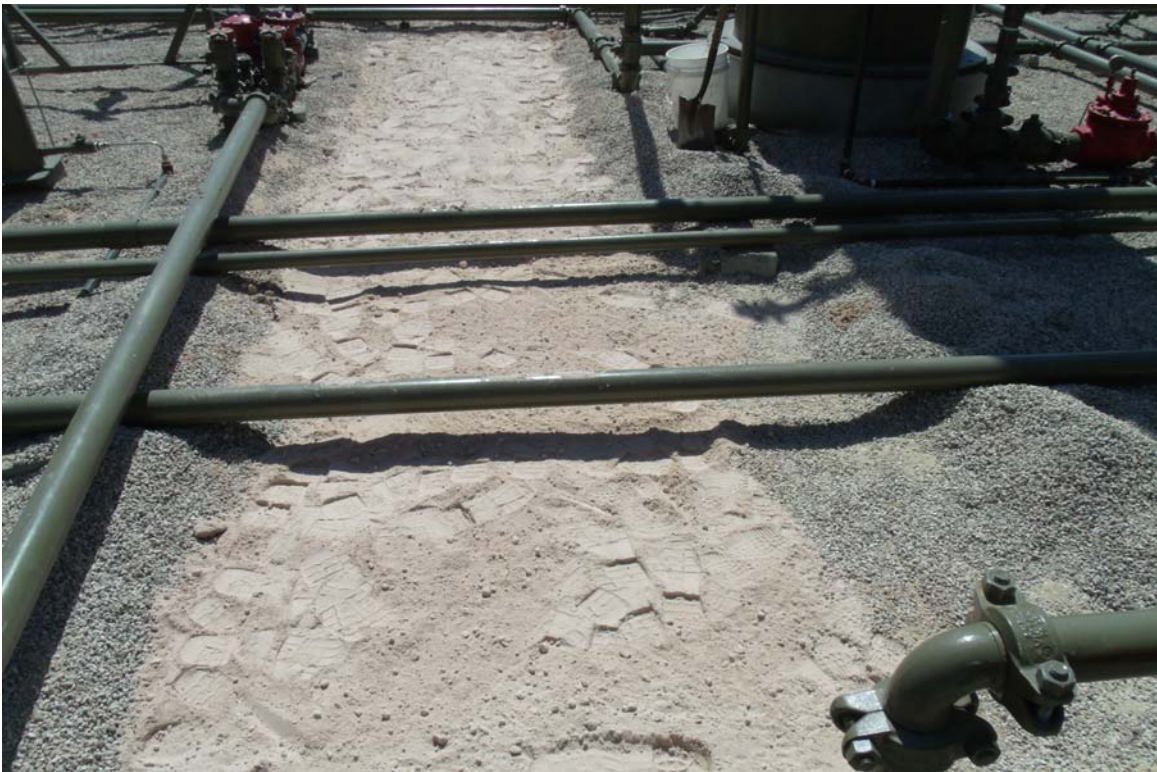
Photograph #10 – Backfilled area

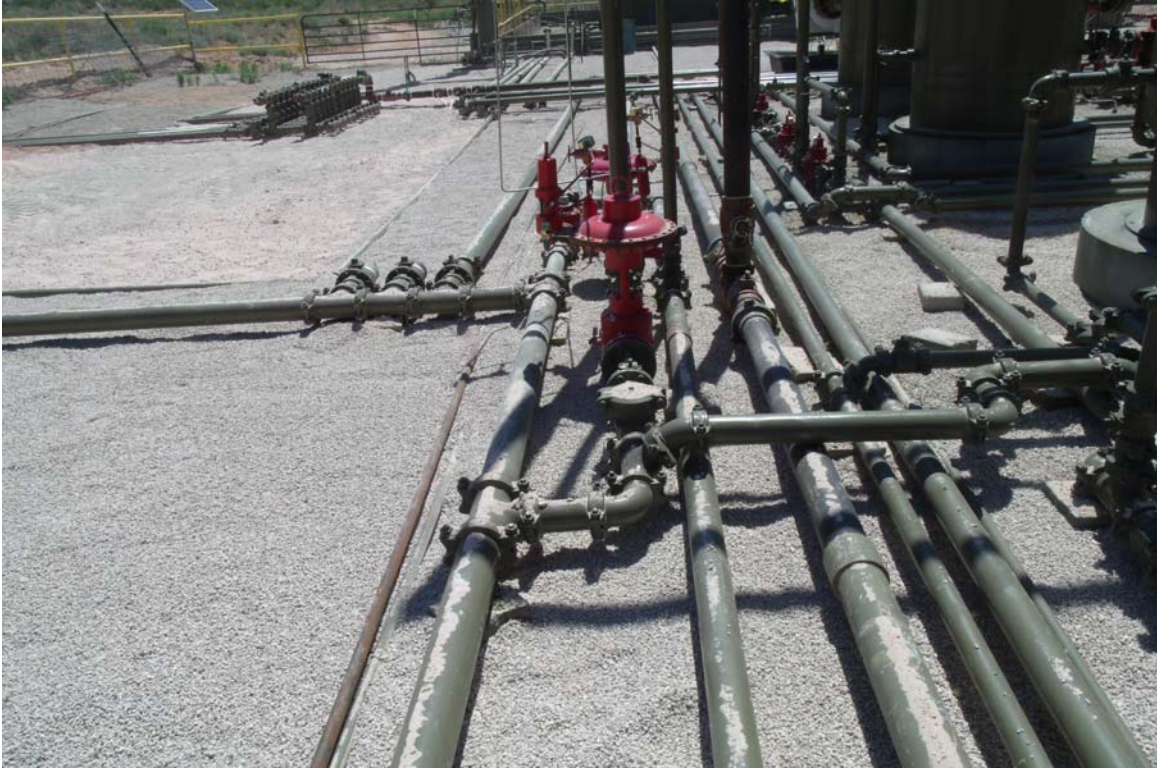
Photograph #11 – Backfilled area

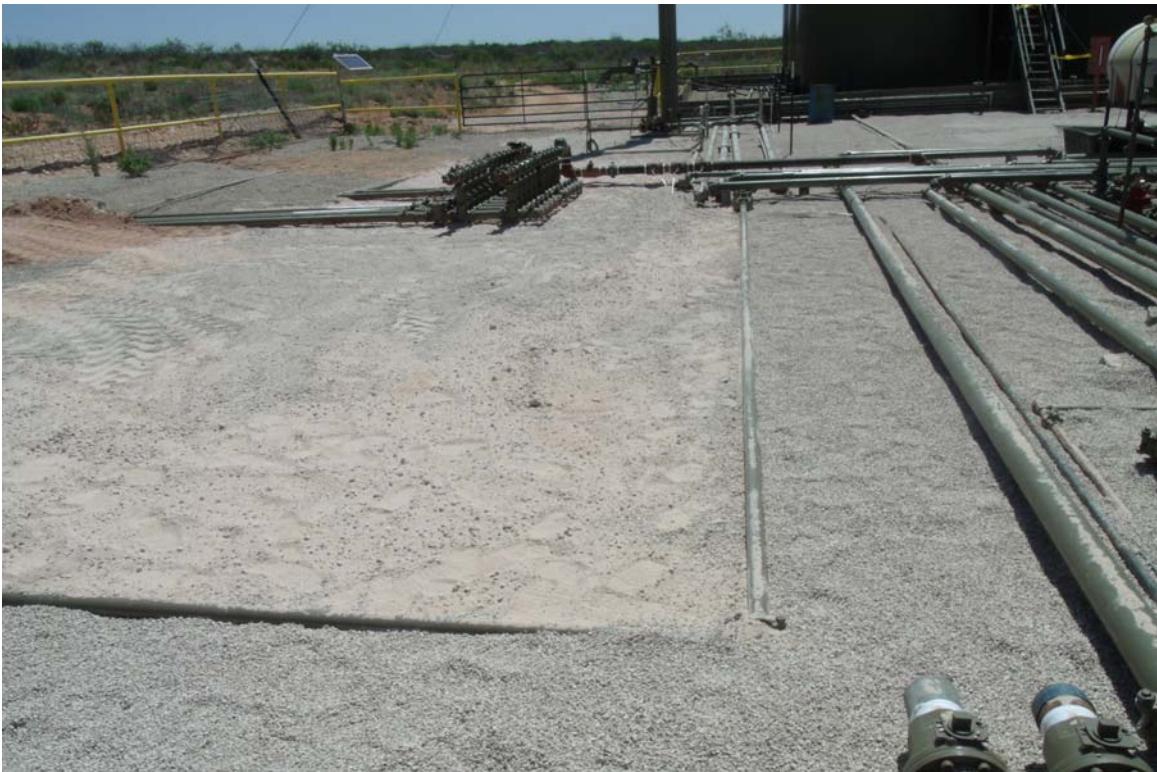
Photograph #12 – Backfilled area

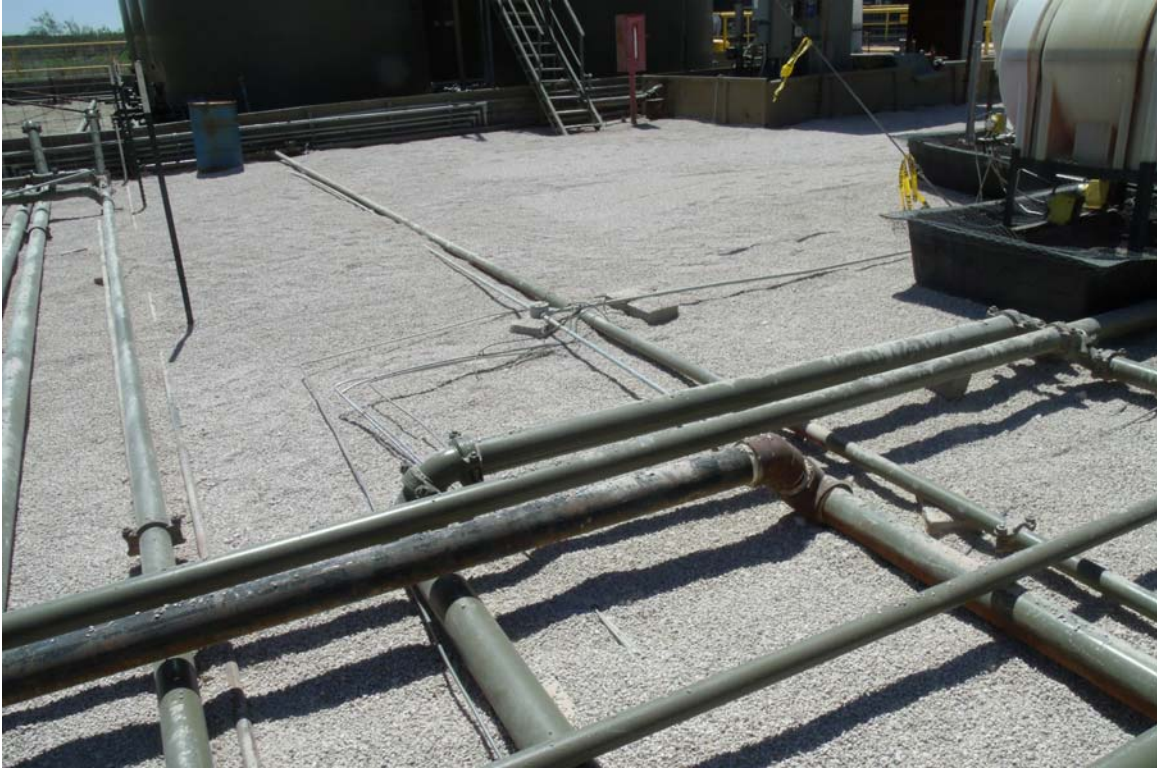
Photograph #13 – Backfilled area

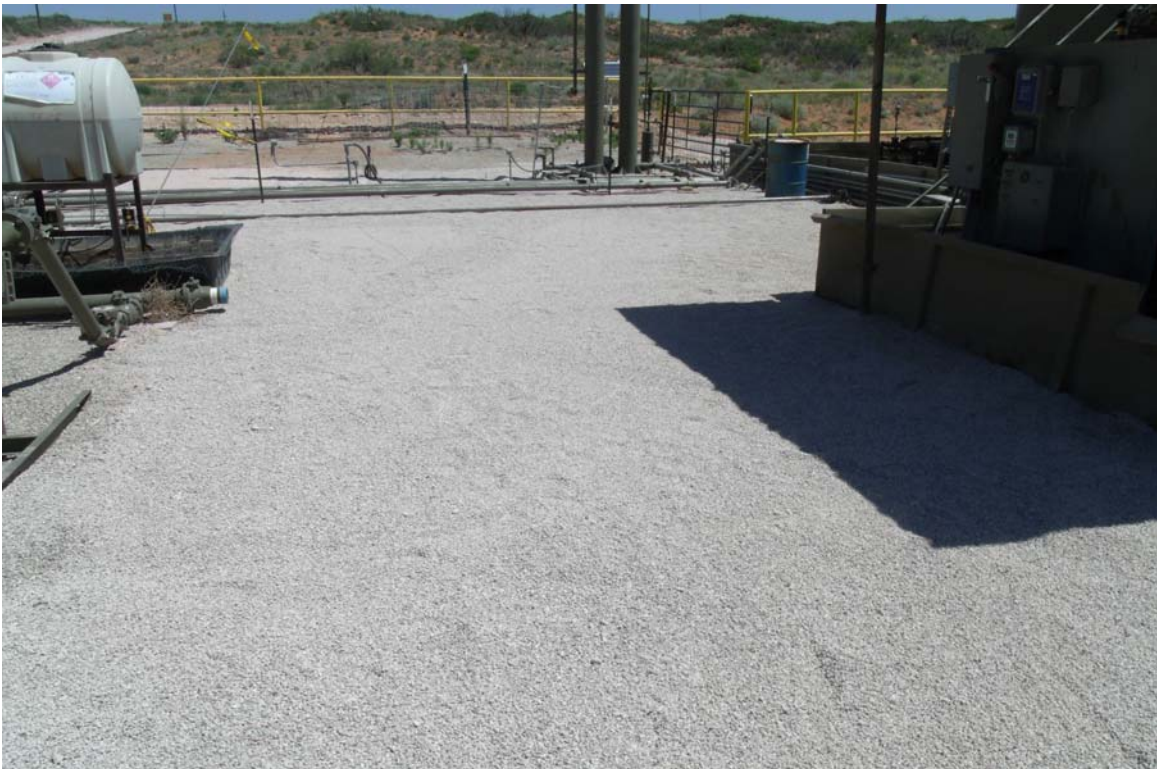
Photograph #14 – Backfilled area
