REMEDIATION SUMMARY & SITE CLOSURE REQUEST

BOPCO, LP
Fenton 7, Federal #1
Eddy County, New Mexico
Unit Letter "E", Section 6, Township 21 South, Range 28 East
Latitude 32.49660° North, Longitude -104.13235° West

March 2016

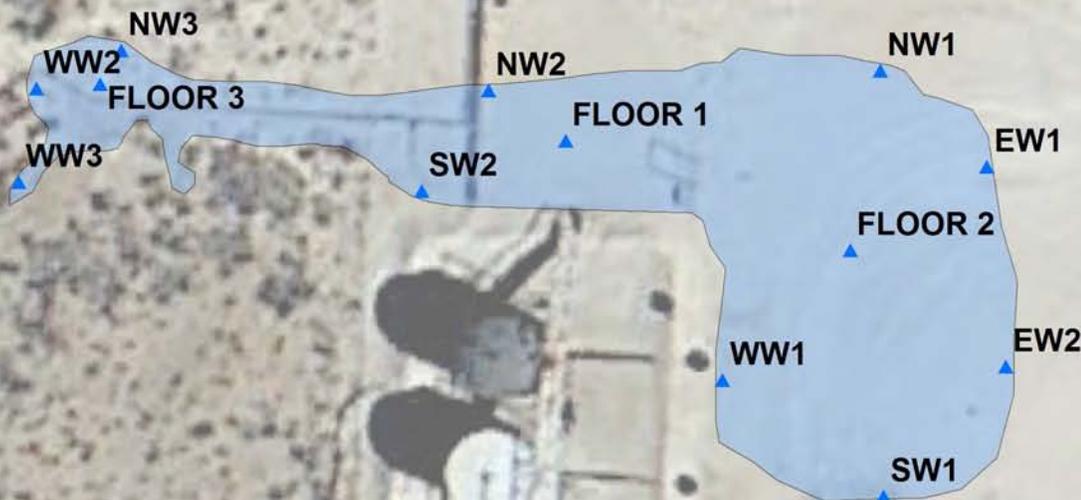
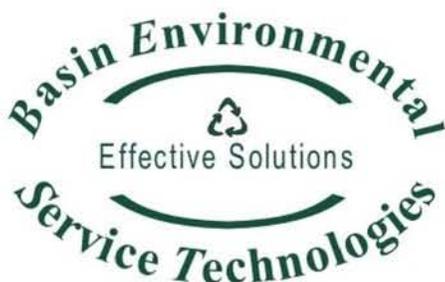
Figure 2

Excavation

Sample Point	Cl-	GRO	DRO	EXT DRO	B	T	E	X	Total
SW 1	64	<10	<10	<10					
SW 2	<16								
WW 1	<16								
WW 2	544	<10	<10	<10					
WW 3	176								
NW 1	32								
NW 2	624	<10	<10	<10					
NW 3	96								
EW 1	224								
EW 2	128	<10	<10	<10					
FLOOR 1	<16	<10	45	24.9	<0.05	<0.05	<0.05	<0.15	<0.3
FLOOR 2	144	<10	<10	<10	<0.05	<0.05	<0.05	<0.15	<0.3
FLOOR 3	144	<10	<10	<10	<0.05	<0.05	<0.05	<0.15	<0.3

Landowner: BLM
DGW: 110 ft

- ▲ SAMPLE POINT
- STAIN - 2,900 SQ FT

Numerous discrete wall soil samples (SW #1, SW #2, WW #1, WW #2, WW #3, NW #1, NW #2, NW #3, EW #1, EW #2) were taken at a depth of approximately eight (8) inches and submitted to an approved NMOCD laboratory for concentration analysis of chlorides utilizing method SM4500CL-B and total petroleum hydrocarbons (TPH). Laboratory analysis confirms that the boundaries of the release were encompassed within the excavated area. Laboratory analysis shows the impacted areas of the release met the criteria necessary for closure of the release.

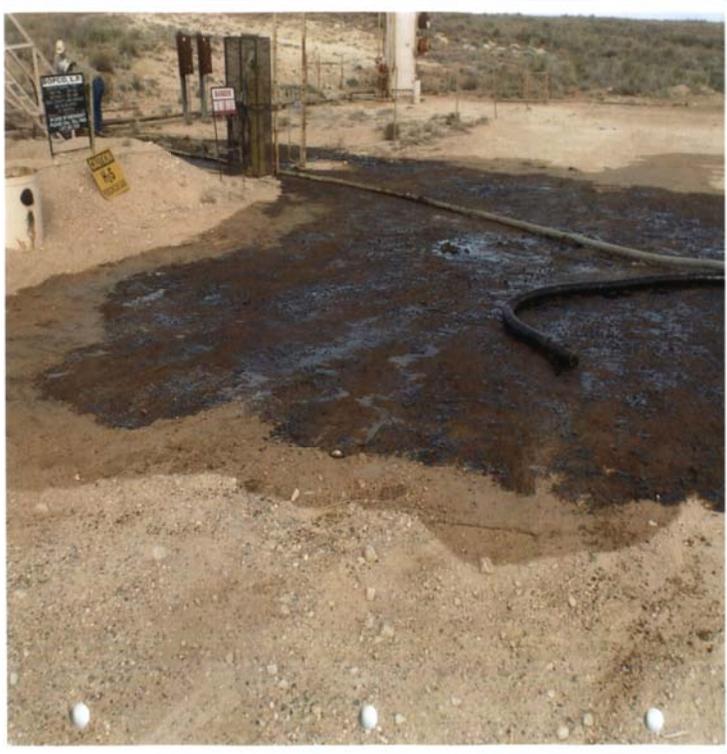
Fenton 7 Federal #1 – Initial Release

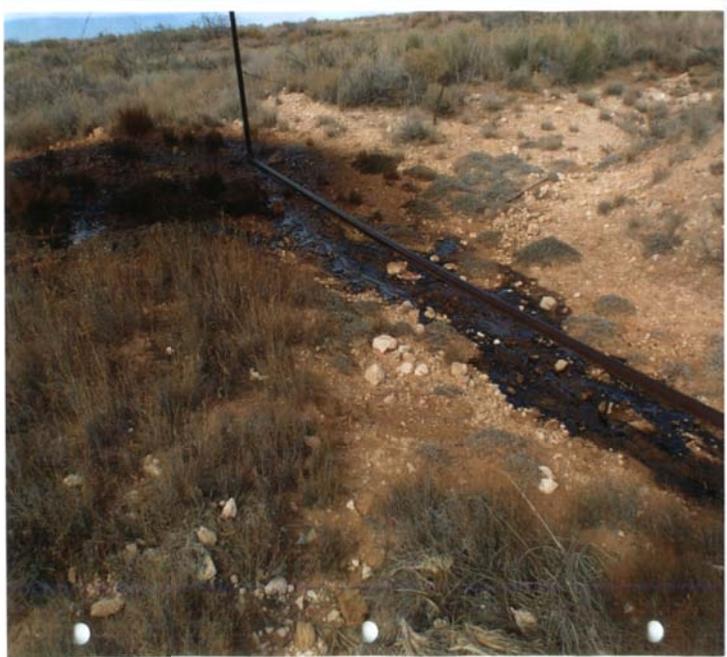
Fenton 7 Federal #1 – Initial Release

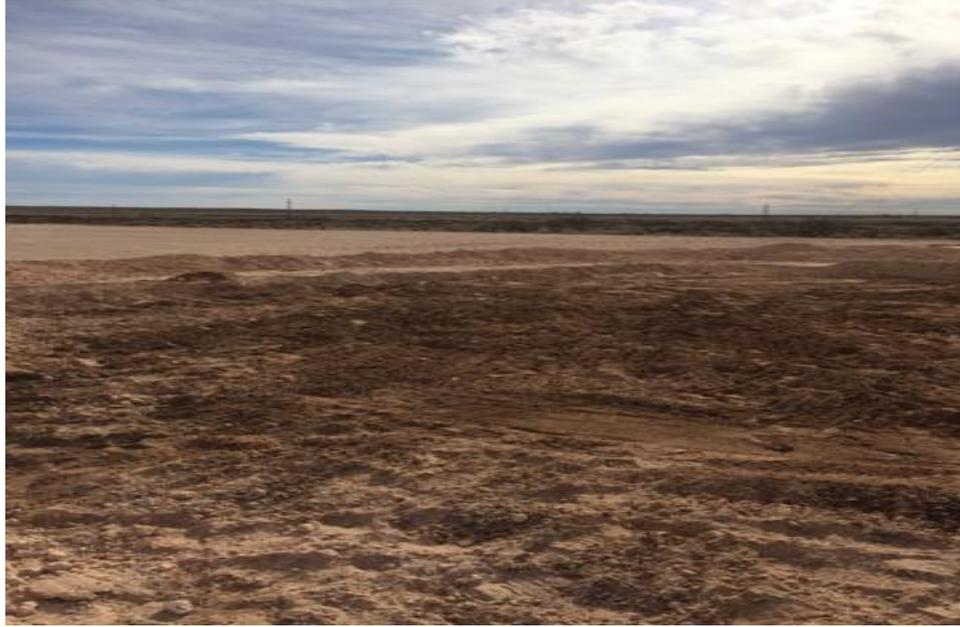
Fenton 7 Federal #1 – Excavation

Basin personnel were on site beginning December 21st, 2015, to begin remediation activities. The impacted area was excavated down to approximately one (1) foot bgs. Three (3) discrete floor soil samples (Floor #1, Floor #2, Floor #3) from different areas were retrieved and submitted to a certified NMOCD approved commercial laboratory for confirmatory analysis of gasoline range organics (GRO), diesel range organics (DRO), extended diesel range organics (oil range organics [ORO]) utilizing method TPH 8015M as well as benzene, toluene, ethylbenzene, and xylenes (BTEX) utilizing method BTEX 8021B.

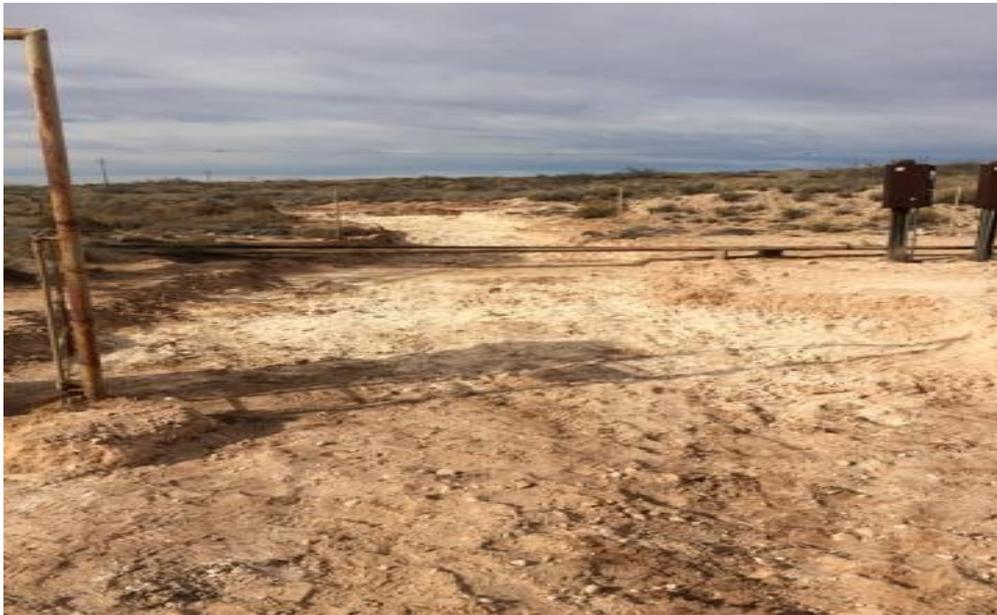
Fenton 7 Federal #1 – Excavation

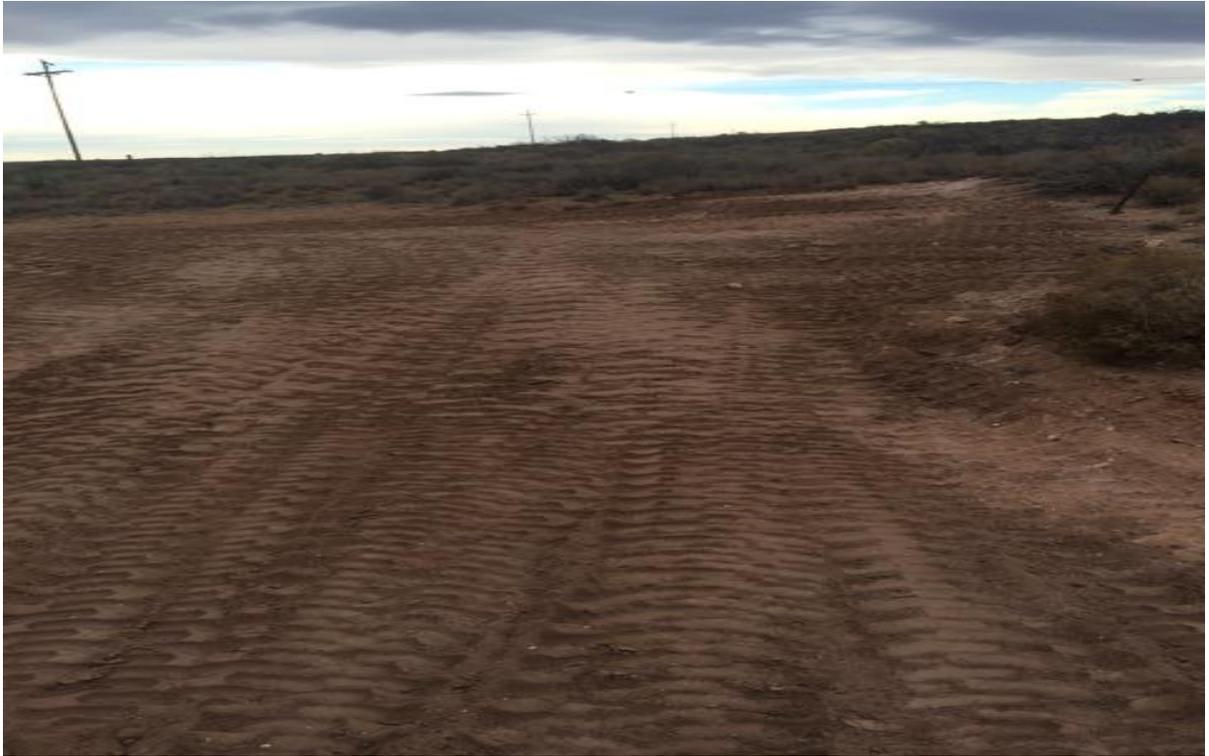
Fenton 7 Federal #1 - Excavation backfilled

The excavated area was backfilled with clean, non-impacted soils and contoured to the surrounding area. The pasture area will be seeded with a BLM approved seed mix free from noxious weeds at a time when it is conducive for germination.

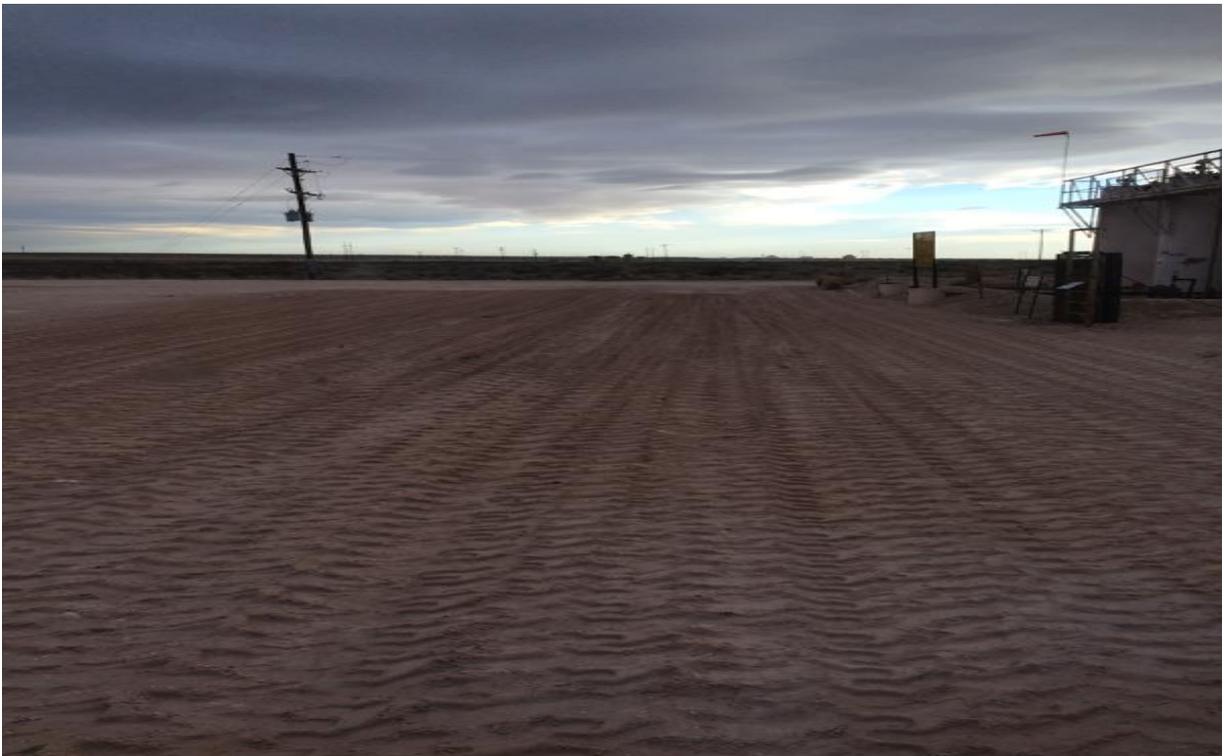
Fenton 7 Federal #1 – Excavation backfilled
