Apache Corporation

**State SWD Flowline
Remediation
Plan Proposal**

Eddy County, New Mexico

August 6, 2016

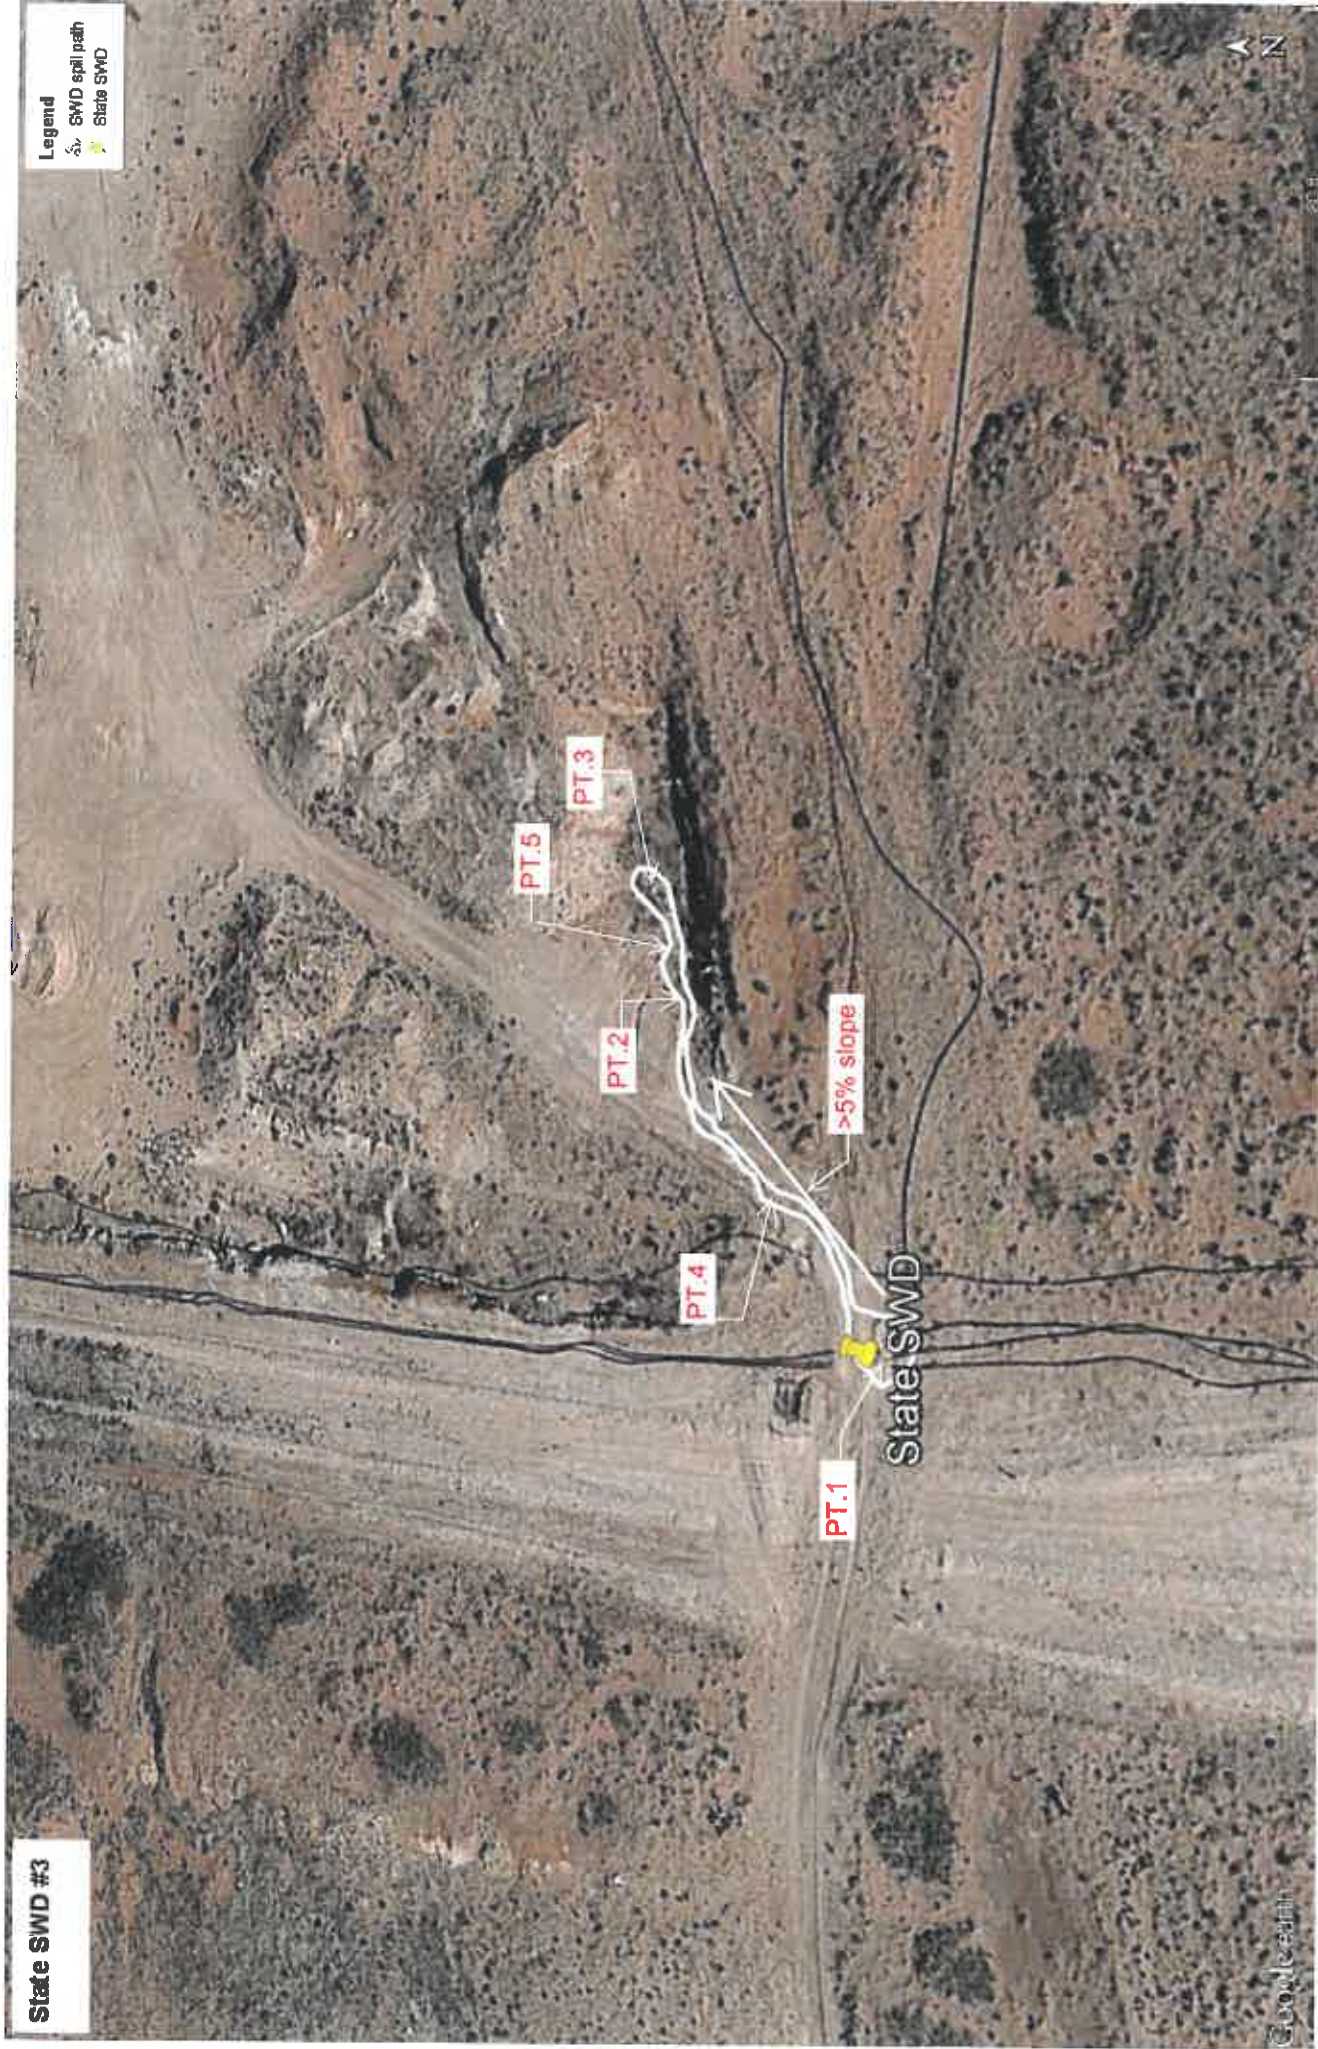
State SWD #3

The release was reported to have had a 3 inch metal transition in the flowline developed a hole resulting in the release. The flow line was isolated and repaired. The release affected a total of 695 square feet with 100 square feet in pasture and 595 square feet on lease road and NM state pit 337. The release site was mapped and initial field sampling was conducted. The state land office was notified due to the contamination inside caliche pit. (Attachment 1 in Appendix A)

- SWD spill path
- State SWD
