CORRECTIVE ACTION REPORT

Chinaberry #3 Leak
32.328837 N, 104.310943 W
NE ¼ SE ¼, S5 T23S R26E
Eddy County, New Mexico
2RP-3603

August 2016

Apex Project No. 725010112143

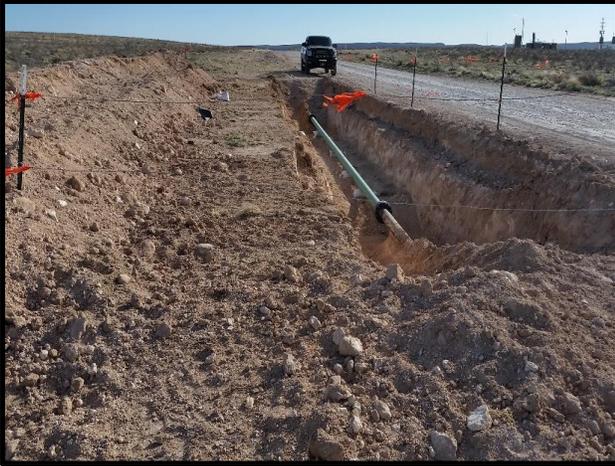
View of initial excavation facing south

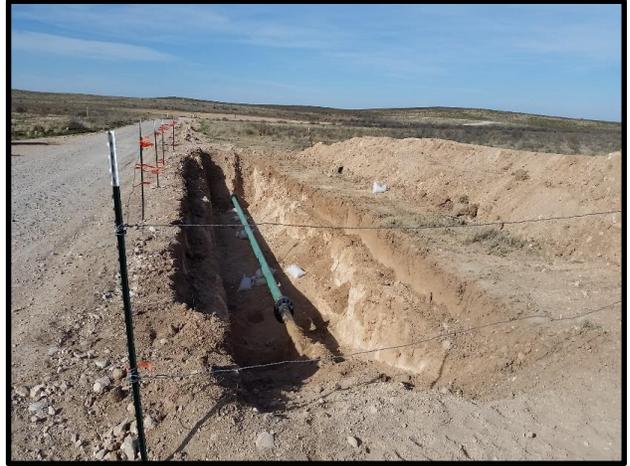
View of initial excavation facing north

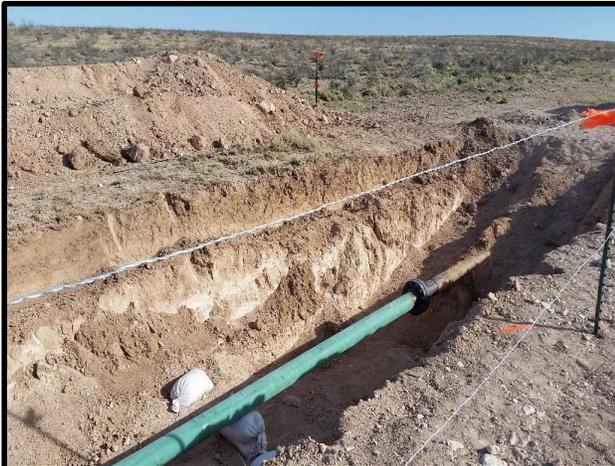
View of initial excavation facing southeast in the vicinity of the release point

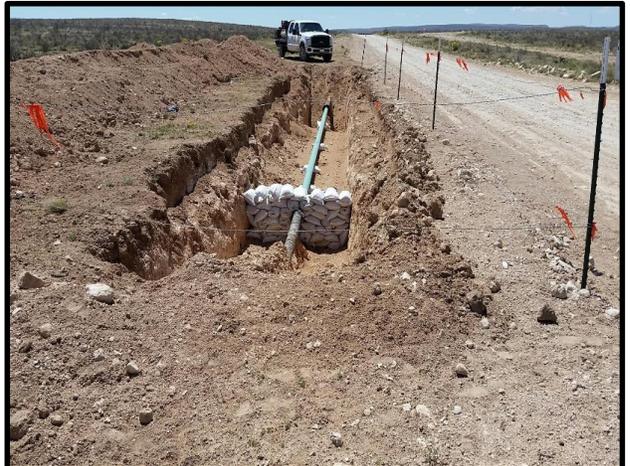
View of final excavation facing south

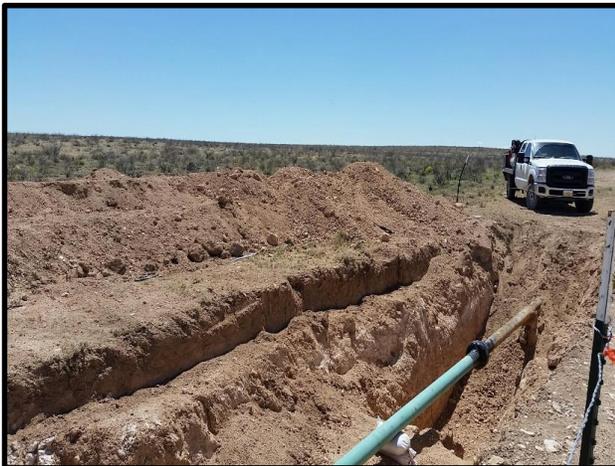
View of final excavation facing southeast in the vicinity of the release point

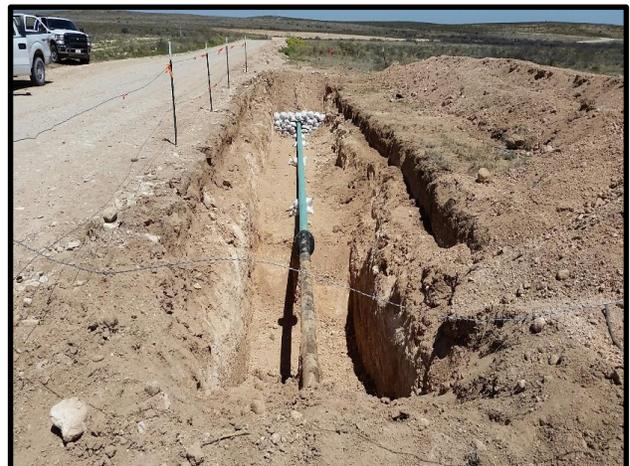
View of final excavation facing north
