CLOSURE REPORT

BOPCO, L.P.
Big Sinks 2-24-30 State #1H
Eddy County, New Mexico
Unit Letter "E", Section 2, Township 24 South, Range 30 East
Latitude 32.248886 North, Longitude 103.859261 West
NMOCD Reference #2RP-3625

RE: Final Closure Report
Bopco – Big Sinks 2-24-30 State #1H
UL-E, Section 2, Township 24 South, Range 30 East
Eddy County, New Mexico
NMOCD Reference # 2RP 3625

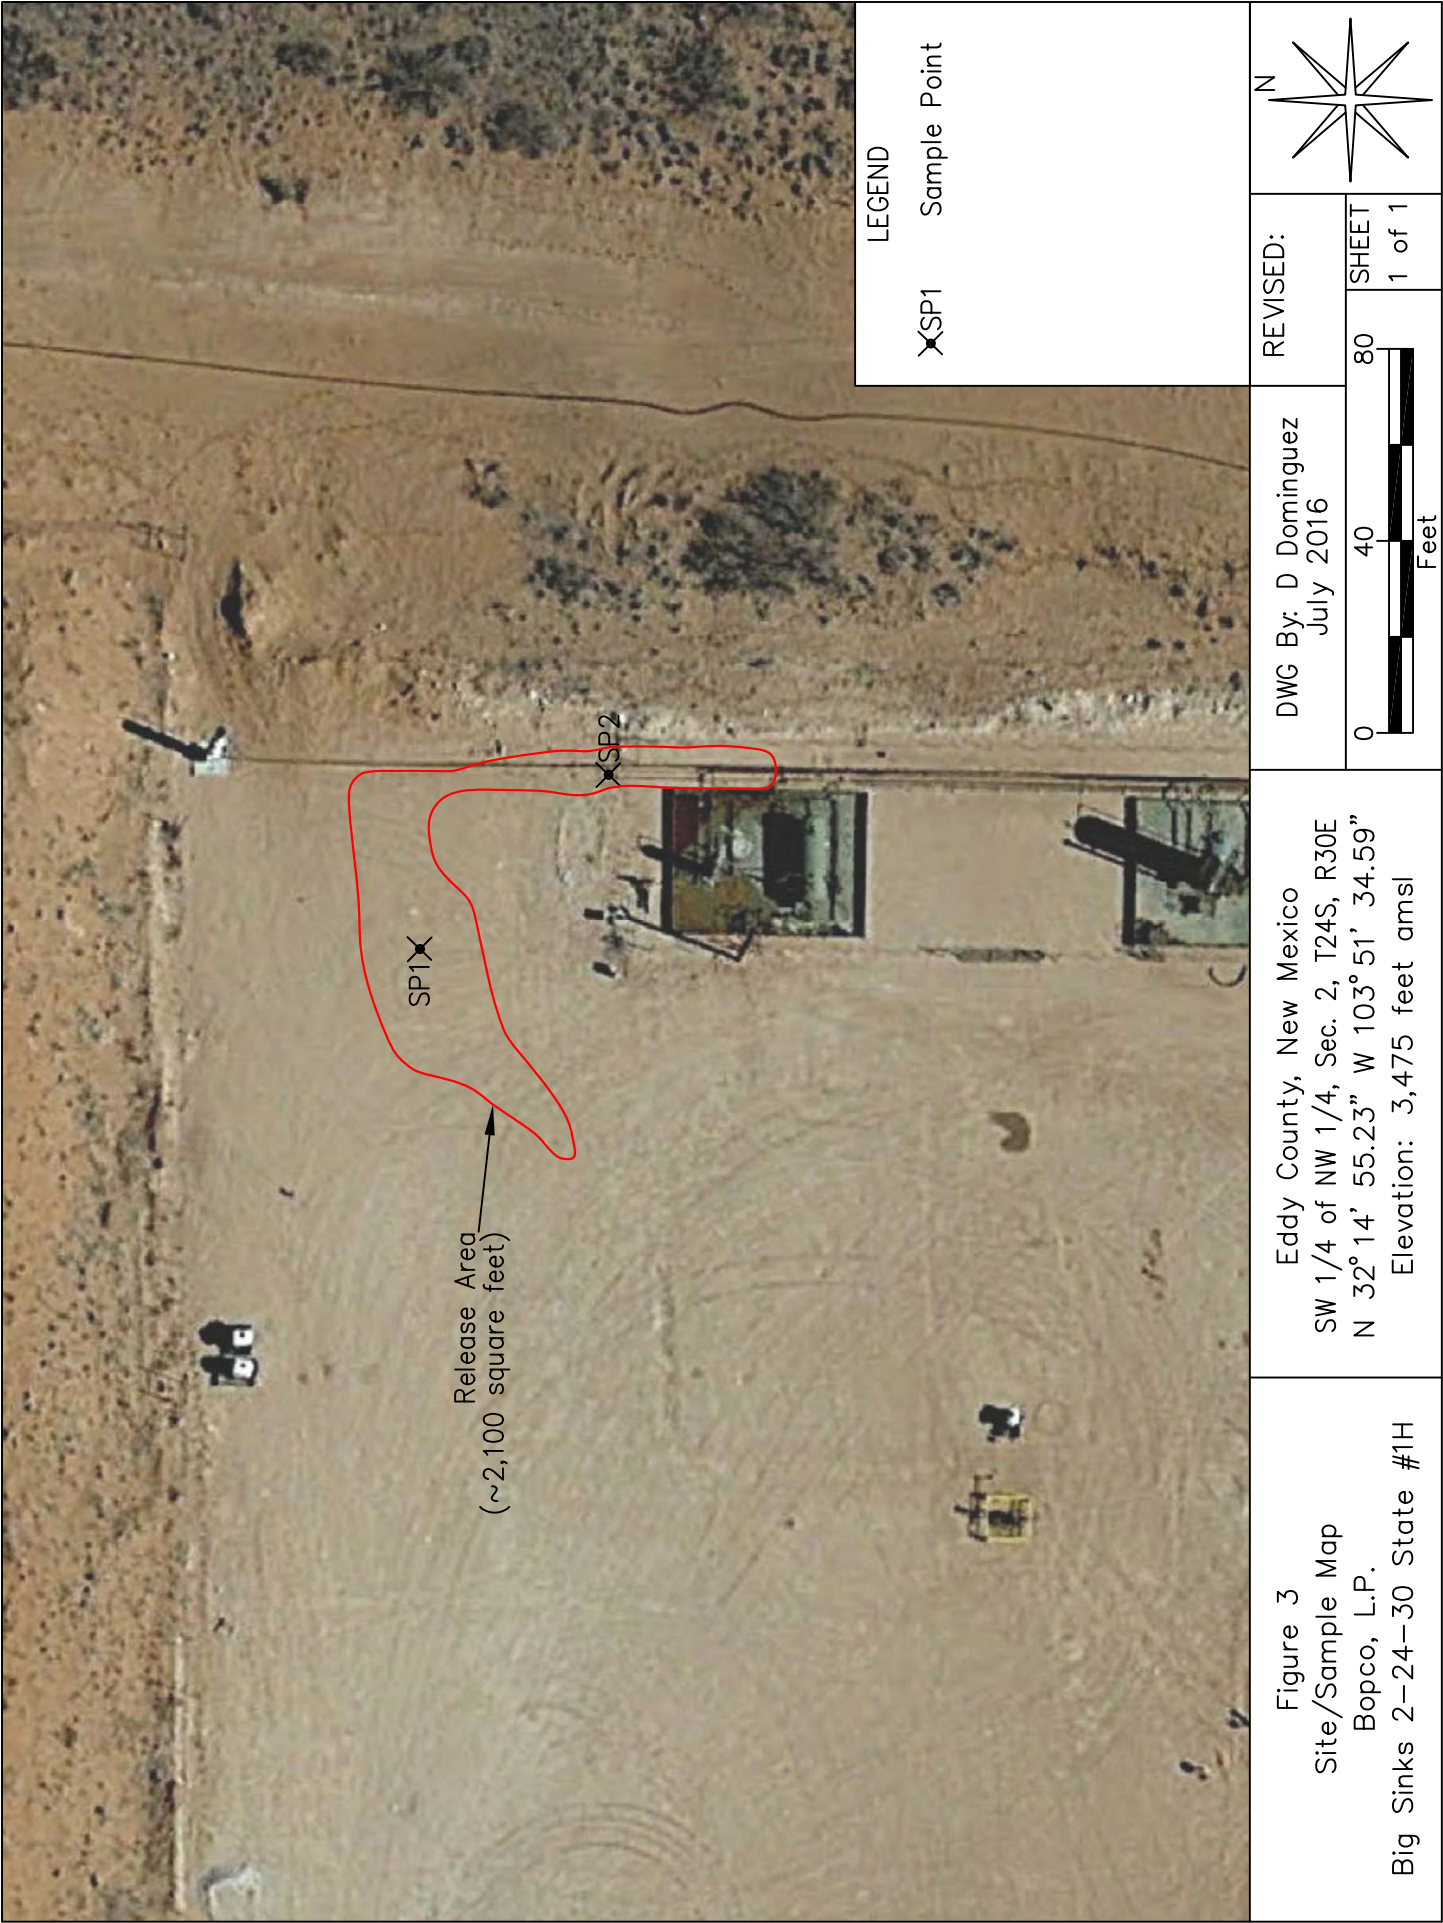
EPI personnel mobilized on the site on April 7, 2016 to collect soil samples to determine the vertical extent of contamination. A total of nine (9) soil samples were collected from two (2) sample locations; SP1 – SP2. Two (2) representative samples were sent to Cardinal Labs in Hobbs, New Mexico, for testing. Laboratory analytical results indicate the release area is void of BTEX, TPH and Chloride concentrations in excess of NMOCD Recommended Remedial Action Levels (RRALs) of 50 mg/Kg, 5,000 mg/Kg, and 1,000 mg/Kg, respectively (reference *Figure 3* and *Table 2*).

The entire release area was excavated to a depth of approximately six (6) inches bgs. The area around SP2 was excavated to approximately three (3) foot bgs. Approximately 59 tons of contaminated soil were excavated and hauled to a state approved facility for disposal.

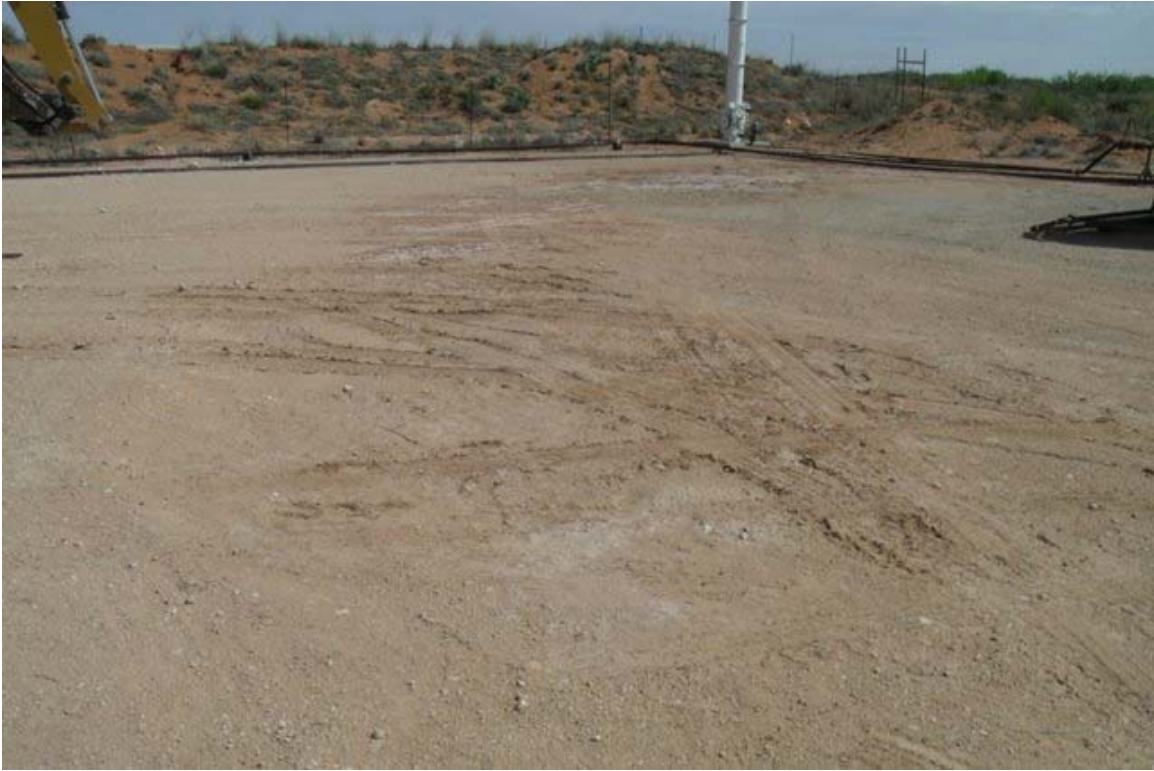
Pipe threads failed due to corrosion causing line to leak. Produced water was released to the well-pad and along the containment wall. A vacuum truck was called to the location and recovered 10 barrels of produced water from the ground surface. A contract gang replaced the failed piping.

Photograph #1 – Looking across release area

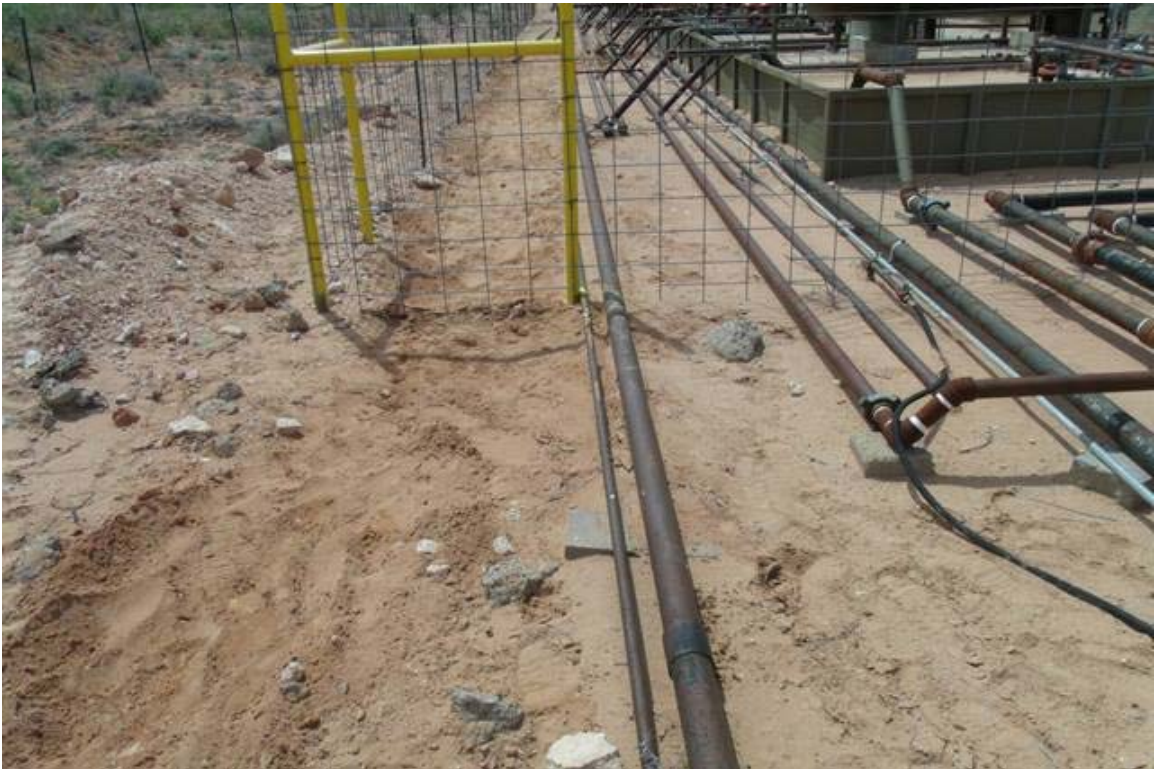
Photograph #2 – Looking across release area

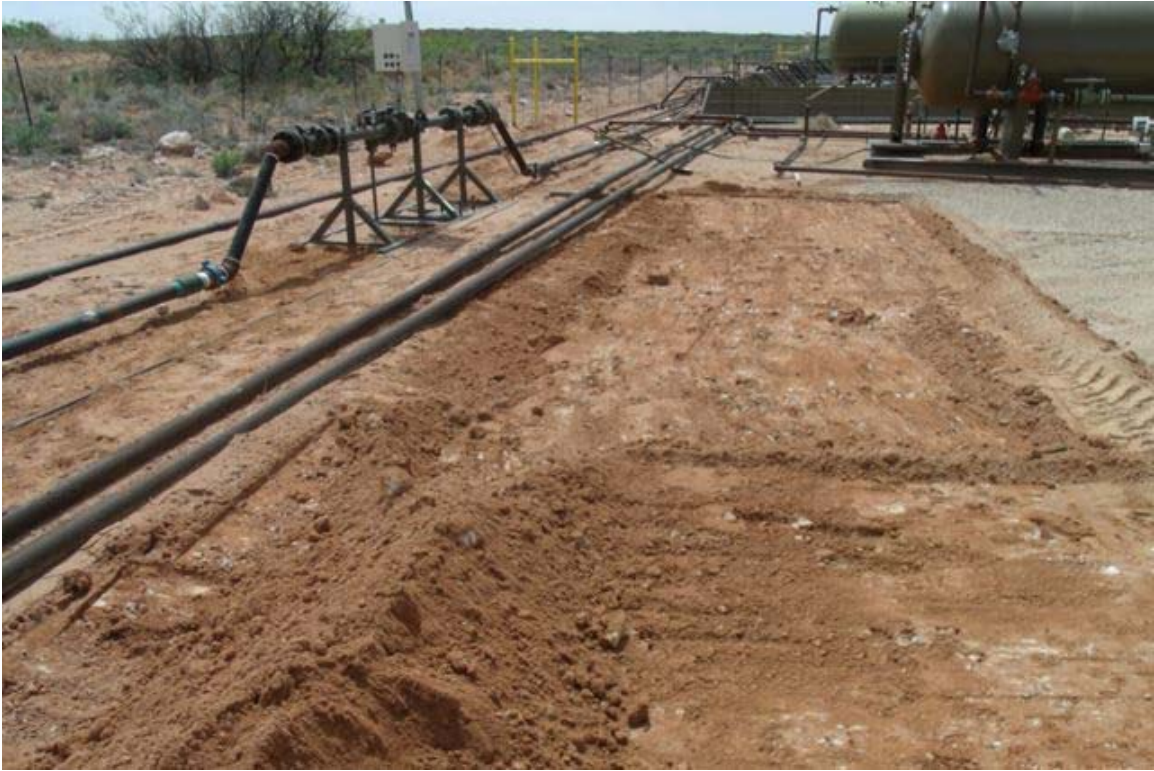
Photograph #3 – Excavated

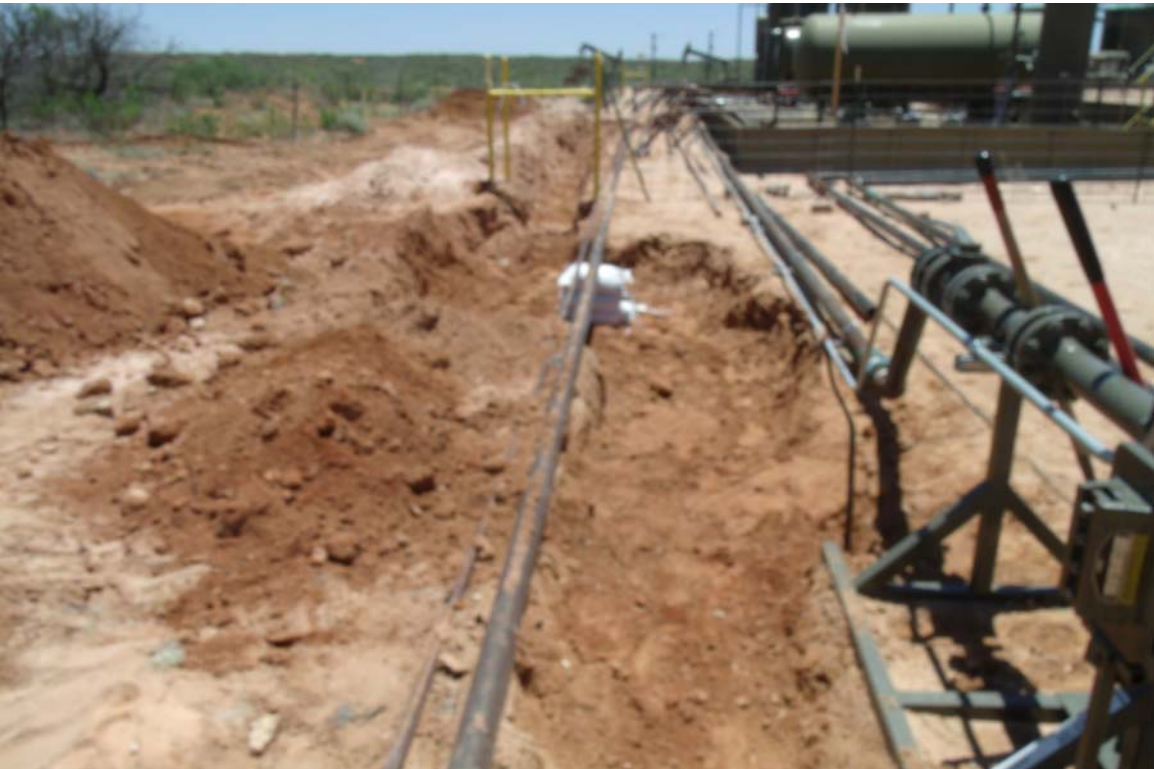
Photograph #4 – Excavated

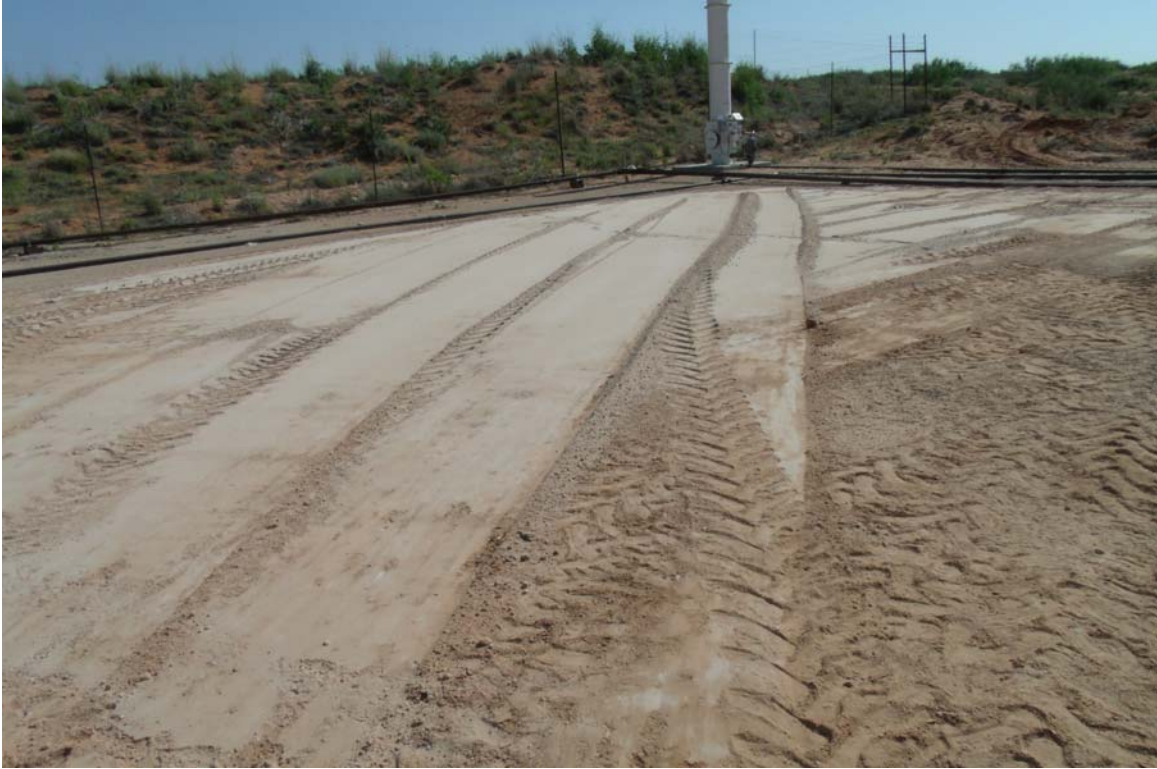
Photograph #5 – Backfilled

Based on laboratory analytical results and with NMOCD approval the excavation was backfilled with approximately 59 tons of clean soil. All soil was free of rocks, clumps or deleterious material. The entire disturbed area was then contoured to blend with existing well-pad area and protected against wind/water erosion.

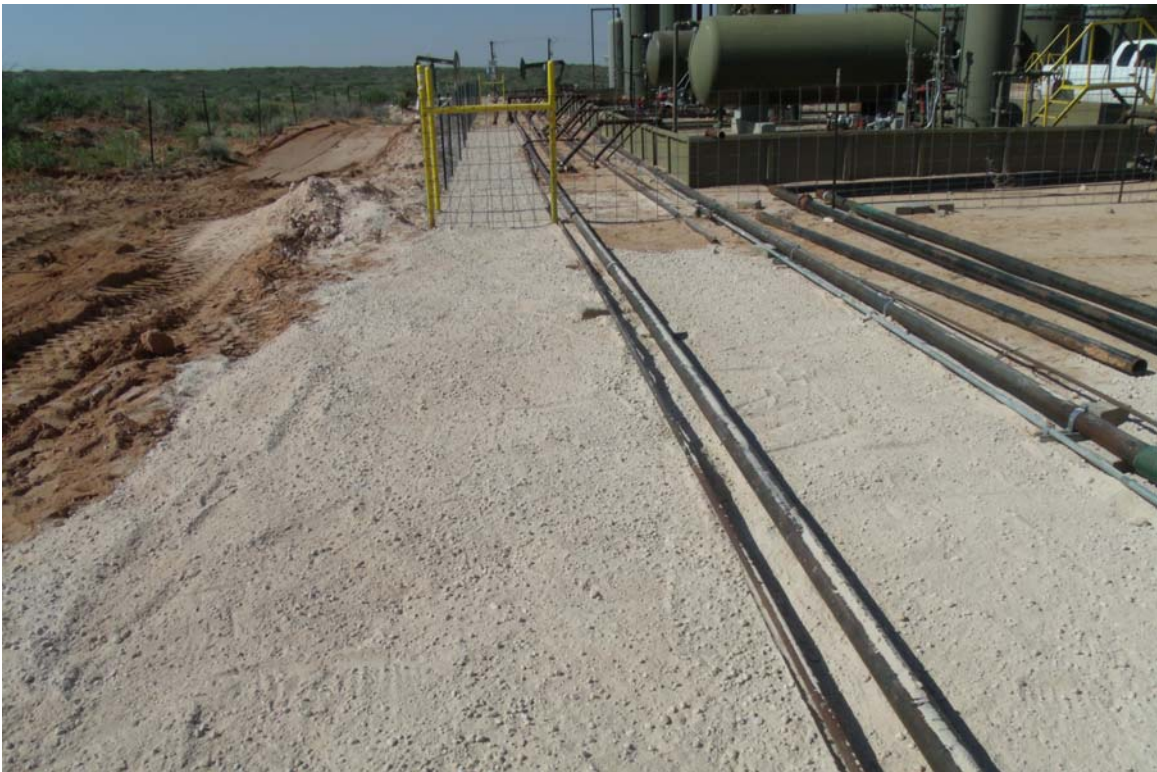
Photograph #6 – Backfilled
