# *Final Closure Report*

*Crawford #26-2 Reserve Drilling Pit, API: 30-015-33228  
Sec. 26 24S 26E – Eddy County, New Mexico  
(OCD Case #2R0059)*

Re: Cimarex Energy's Crawford #26-2 Reserve Drilling Pit **Final Closure Report**  
API: 30-015-33228 – Sec. 26 24S 26E – Eddy County, New Mexico  
**(OCD Case #2R0059)**

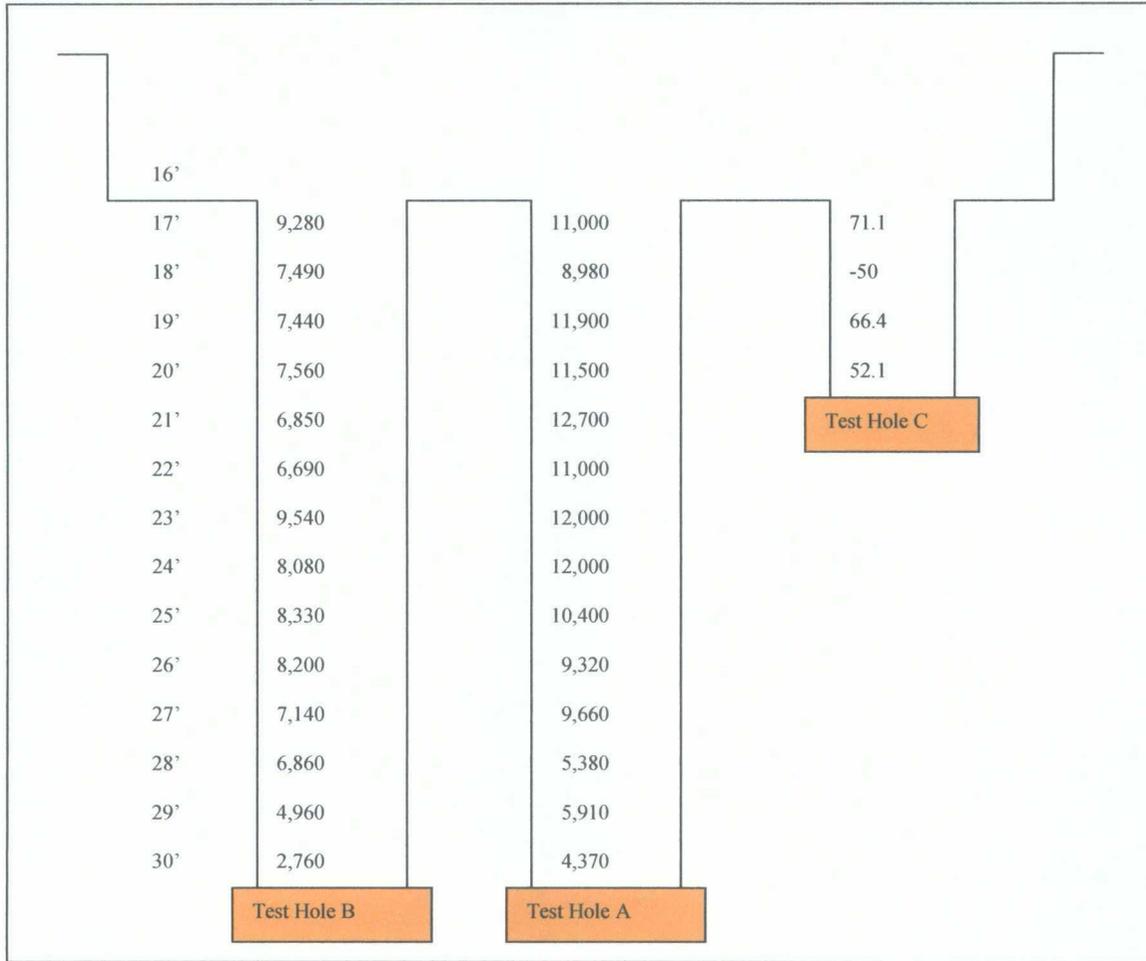
**Table #5 – Trace Analysis Bore Hole Results** (Please refer to Table #2 for locations)

Trace #	Field Code and Depth	Total Cl- (mg/kg)	SPLP (mg/L)	% Leachable
108545	1A-21'	12,700	1,330	10
108550	6A-26'	9,320	873	9
108554	10A-30'	4,370	488	11
108555	1B-21'	6,850	695	10
108560	6B-26'	8,200	783	10
108564	10B-30'	2,760	342	12

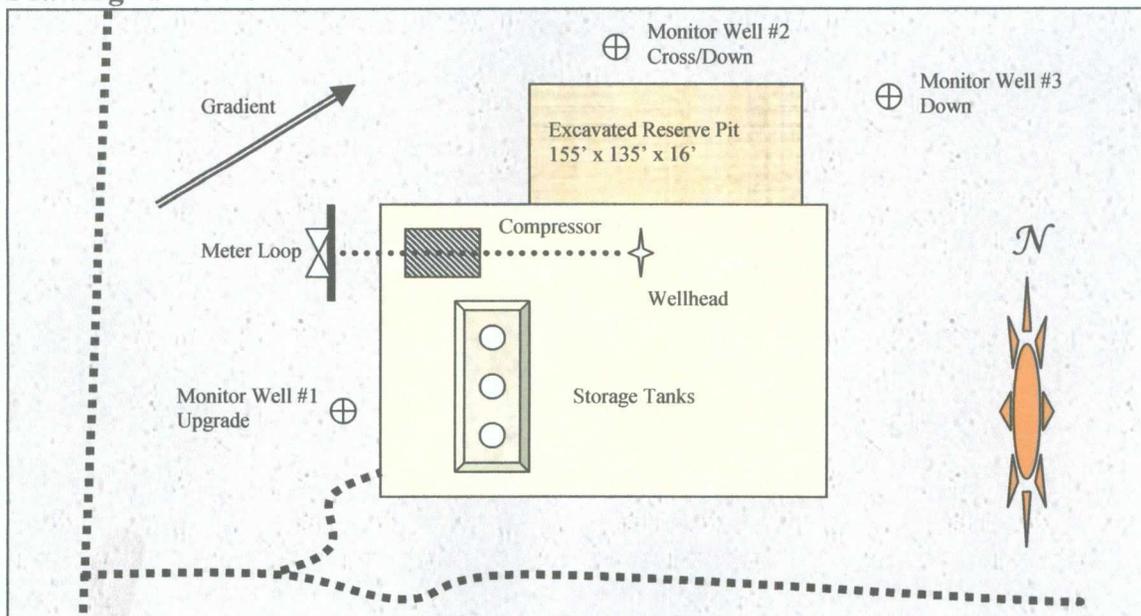
**Drawing #1 – Orientation of Monitor Wells at Location**

Boring #	X:Coordinate	Y:Coordinate	Depth to H <sub>2</sub> O	Total Depth	Position
1	433881.3 N	522313.3 E	22.0 Feet	40.0 Feet	Upgrade
2	433861.3 N	522313.3 E	18.0 Feet	40.0 Feet	Cross/Down
3	433881.3 N	522313.3 E	19.0 Feet	40.0 Feet	Down

Boring #	Location	Chloride (mg/L)
1	Upgrade	13.3
2	Cross/Down	14.2
3	Down	45.5

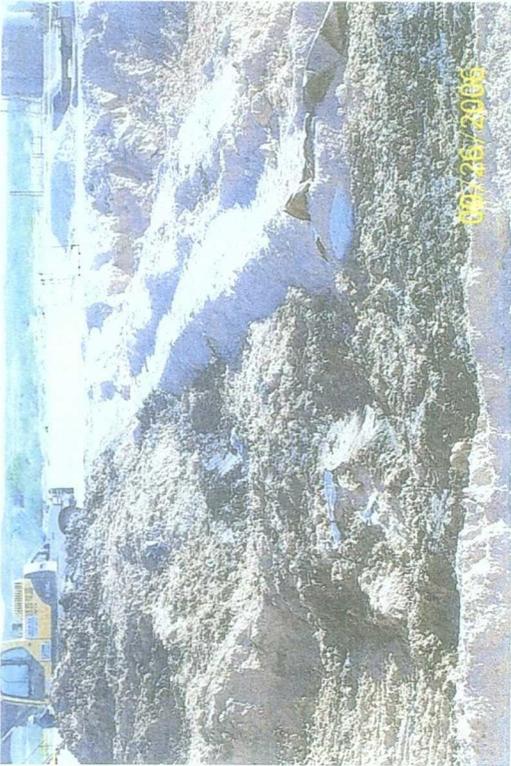
**Photo #3 – Blending Soils With Wet Contents**

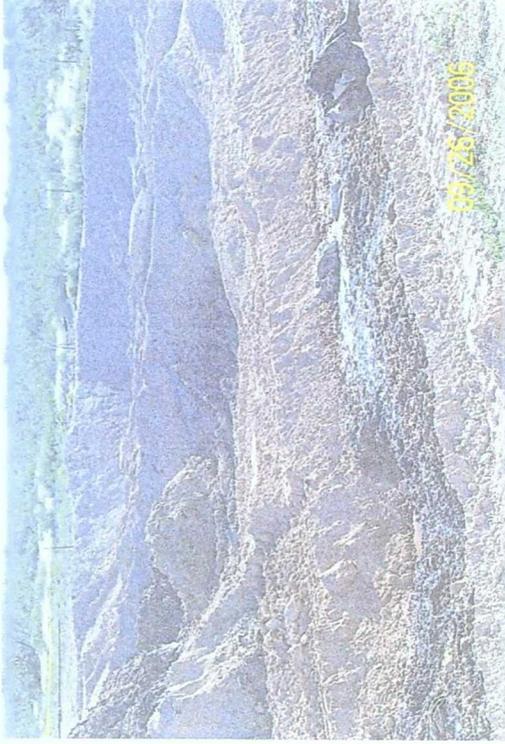
**Photo #4 – Blending Soils with Wet Contents**

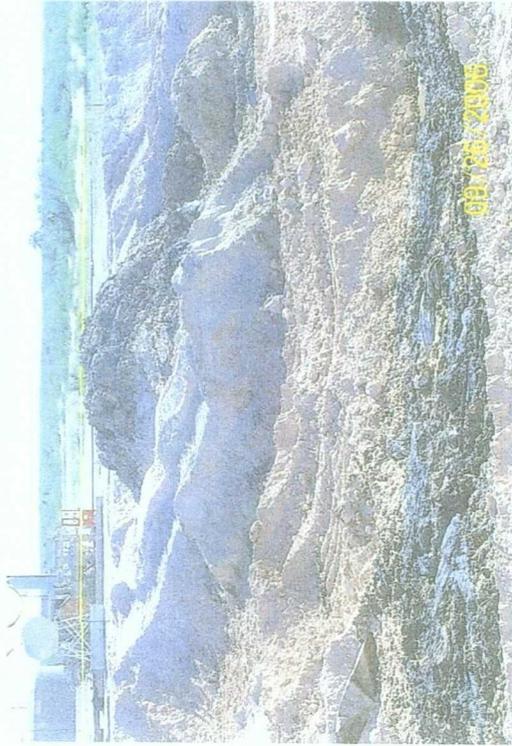
**Photo #1 – Reserve Drilling Pit (Contents)**

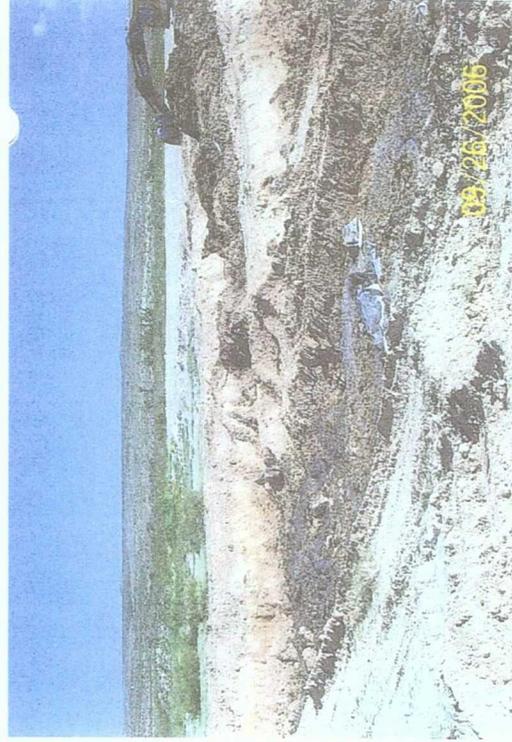
**Photo #2 – Reserve Drilling Pit (Contents)**

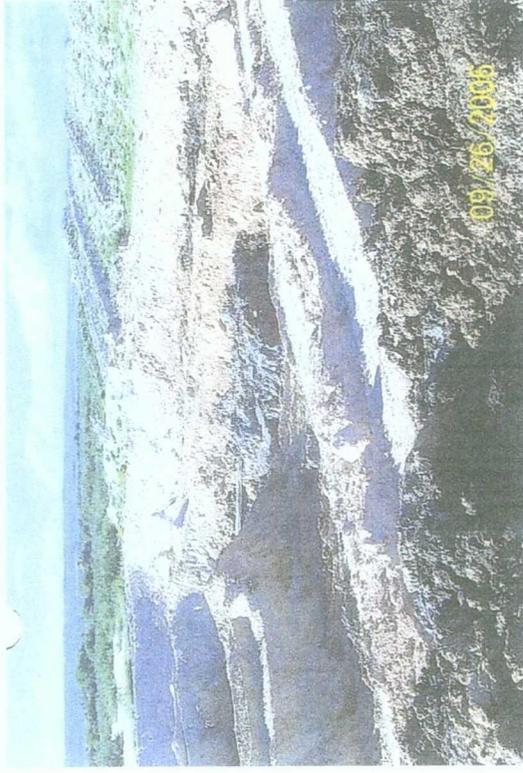
*Photo #10 View of Horseshoe*

10/04/06 - The pit floor is now at 16' with removal of additional 14" of the horseshoe soils removed. Additional field samples were analyzed and the remainder of the horseshoe was removed.

10/10/06 - Finished removing remainder of horseshoe and began squaring up the side of the pit and continued transporting contaminated soils to disposal.

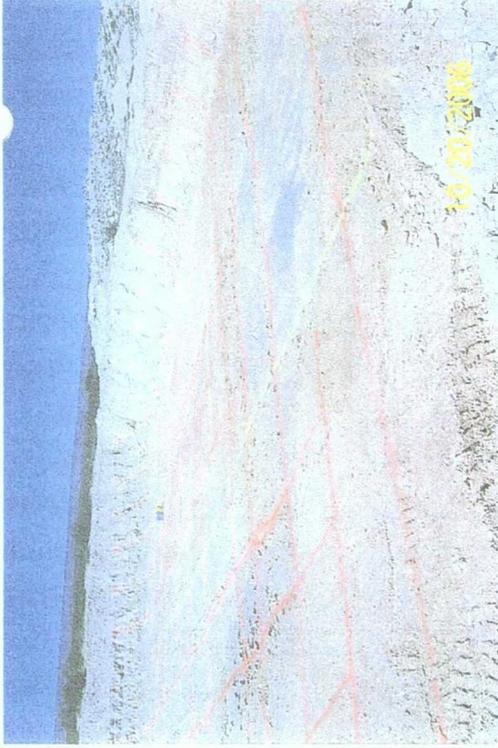
*Photo #24 - Laying Out Sampling Grid*

10/19/06 - Grid was laid out for verification laboratory sampling. NMOCD was notified of sampling intent for 10/20/06.

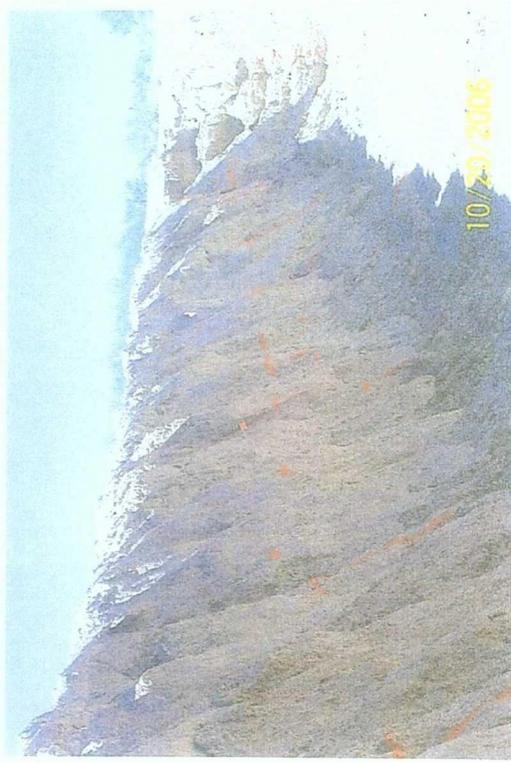
*Photo #21 - Laying Out Sampling Grid*

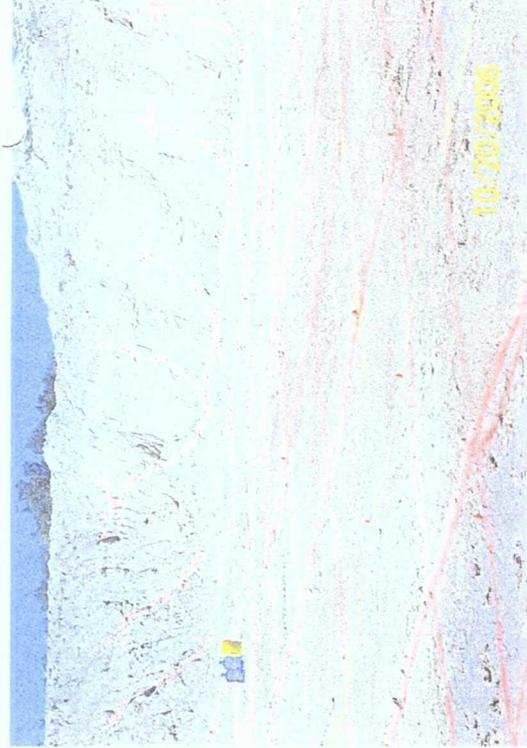
*Photo #22 - Laying Out Sampling Grid*

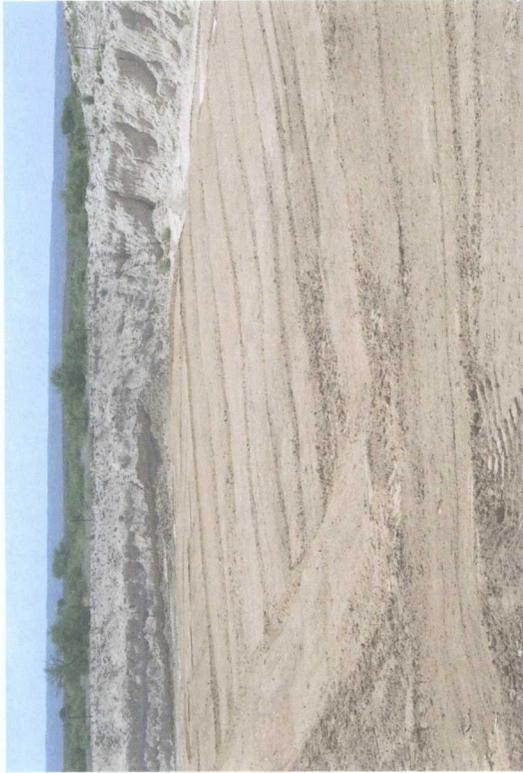
**Photo #27 – Building Bottom Crown For Liner**

- 06/25/07 - NMOCD District Office was notified and Phoenix mobilized onto site and began building a crown in the pit with clean soils for placement of the subsurface liner.
- 06/26/07 - Finished crowning procedure in the bottom of the pit and pushed up backfill for the pit closure.
- 06/27/07 - Installed subsurface liner in the bottom of the pit over the crown with a 20 mil Reinforced HDPE Geomembrane liner which was trench anchored on the outside edge of the excavated pit to encourage shedding of any hydrostatic water permeating down to the liner to the outside of the affected area. Put a foot of clean soil over the liner and hauled in 34 loads of clean backfill material.
- 06/28/07 - Pushed up backfill and backfilled clean soils into the reserve drilling pit.
- 06/29/07 - Hauled in 37 loads of clean backfill and continued backfilling reserve drilling pit.

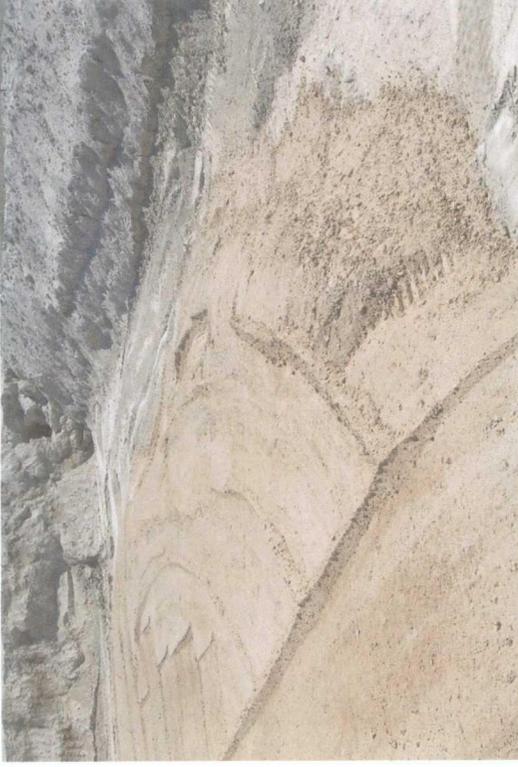
**Photo #28 – Building Bottom Crown For Liner**

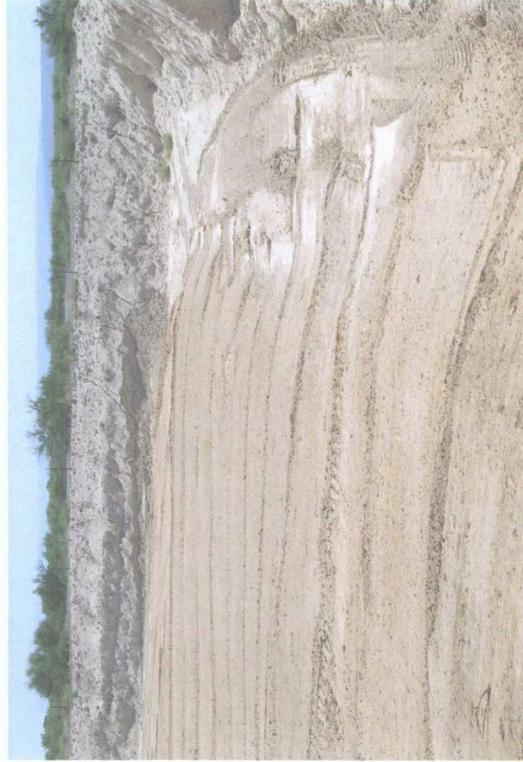
**Photo #25 – Building Bottom Crown For Liner**

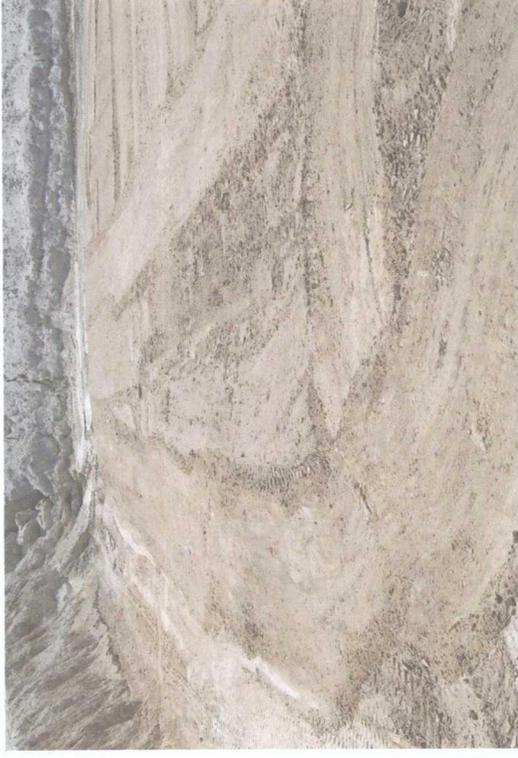
**Photo #26 – Building Bottom Crown For Liner**

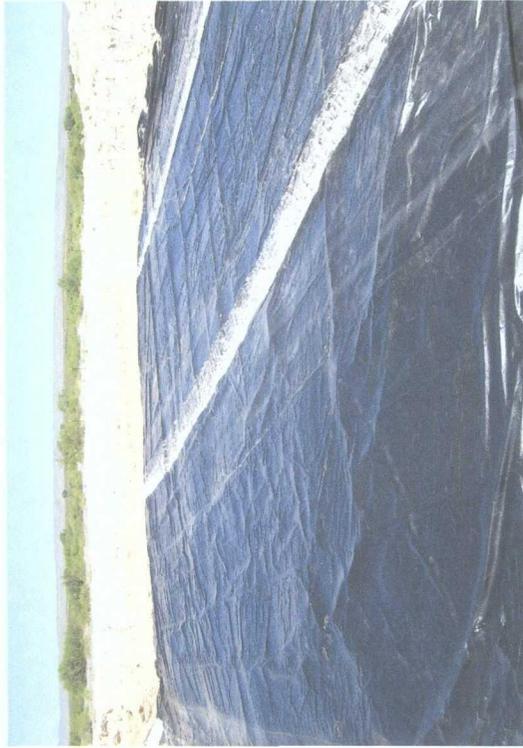
*Photo #31 – Installing Liner Over Crown*

As directed by the NMOCD, Cimarex installed three monitor wells to verify that area groundwater had not be impacted and the pit closure could proceed with the installation of a 20 mil subsurface liner at the bottom of the excavation. Phoenix Environmental completed the closure and installed the industry standard liner to alleviate any secondary environmental impact to groundwater.

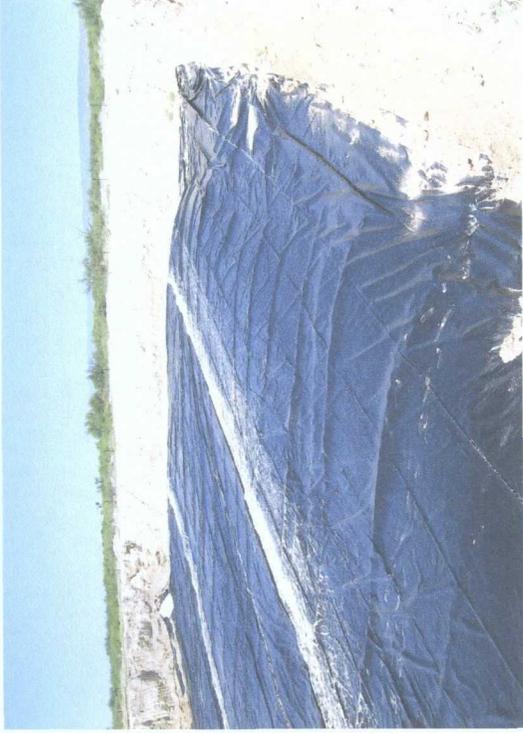
*Photo #32 – Installing Liner Over Crown*

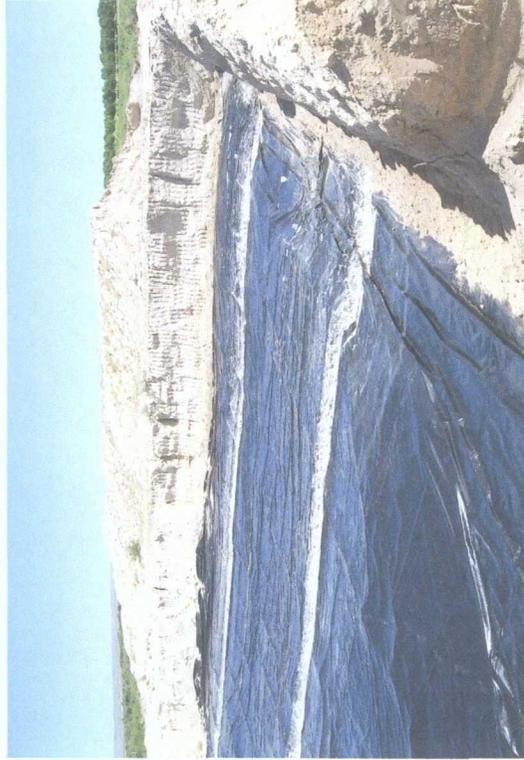
*Photo #29 – Installing Liner Over Crown*

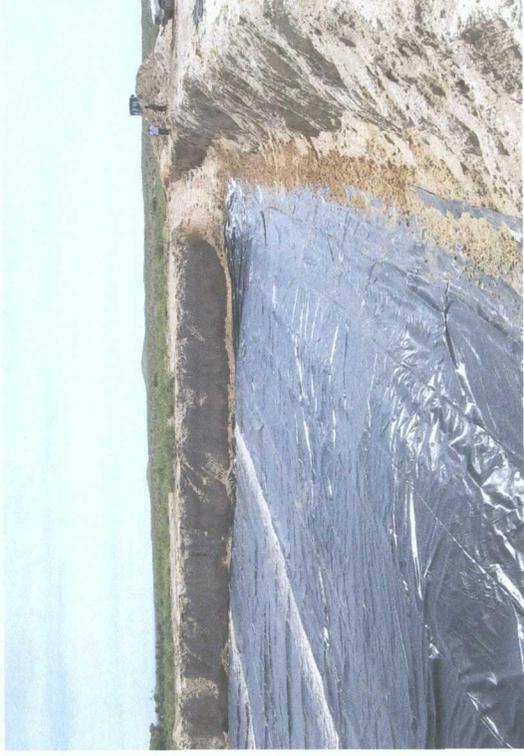
*Photo #30 – Installing Liner Over Crown*

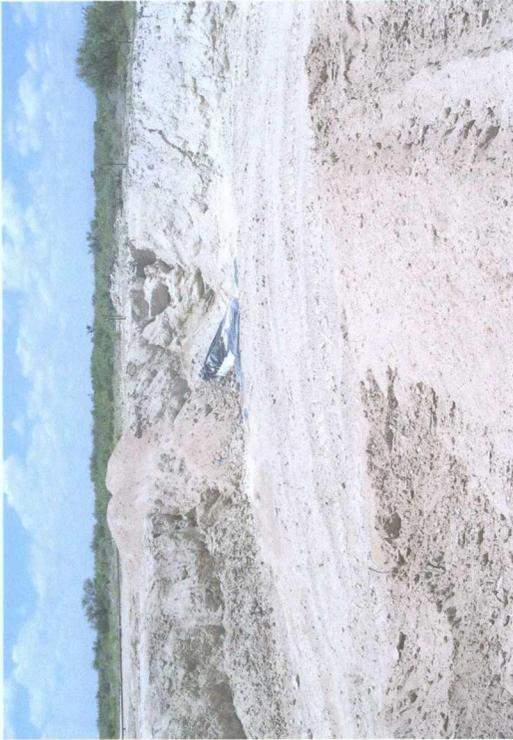
*Photo #35 - Backfilling Over Liner Crown*

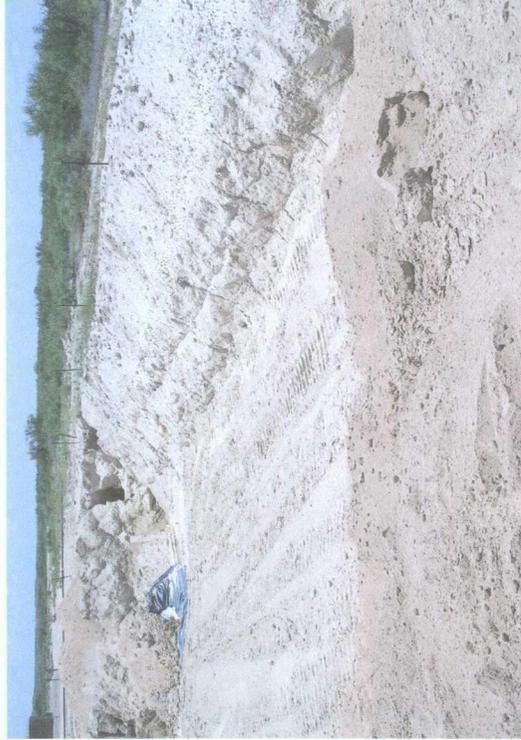
*Photo #33 - Backfilling Over Liner Crown*

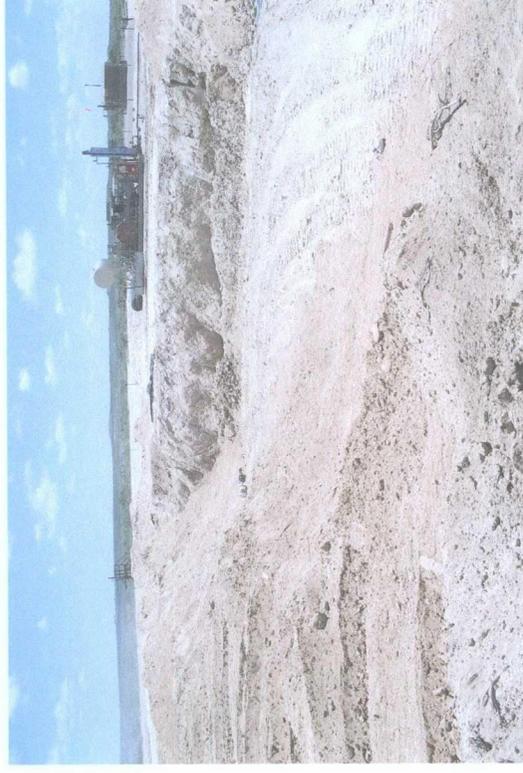
*Photo #34 - Backfilling Over Liner Crown*

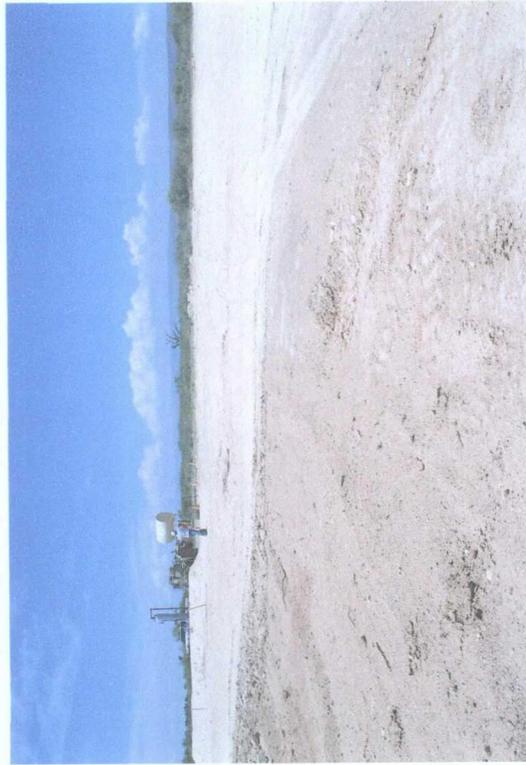
*Photo #39 – Dressing Location*

- 07/25/07 - Hauled in 88 loads of clean backfill and continued backfilling reserve drilling pit and began dressing the location with a slight crown on the surface to impede any ponding problems due to rain.

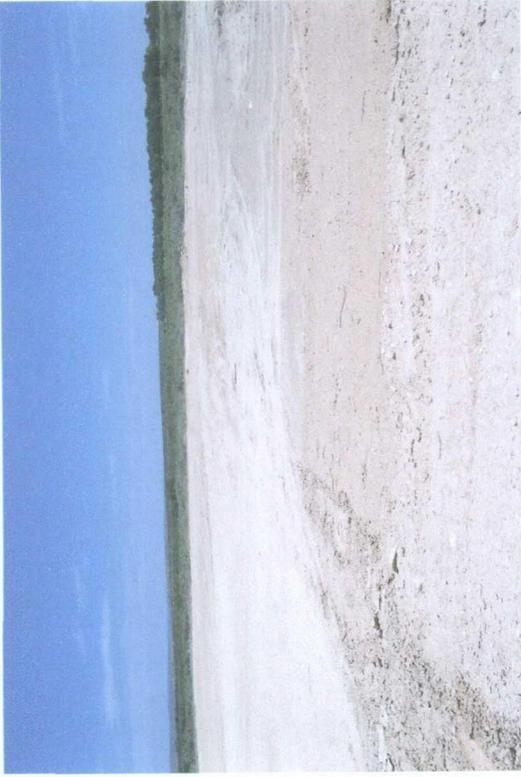
*Photo #40 – Dressing Location*

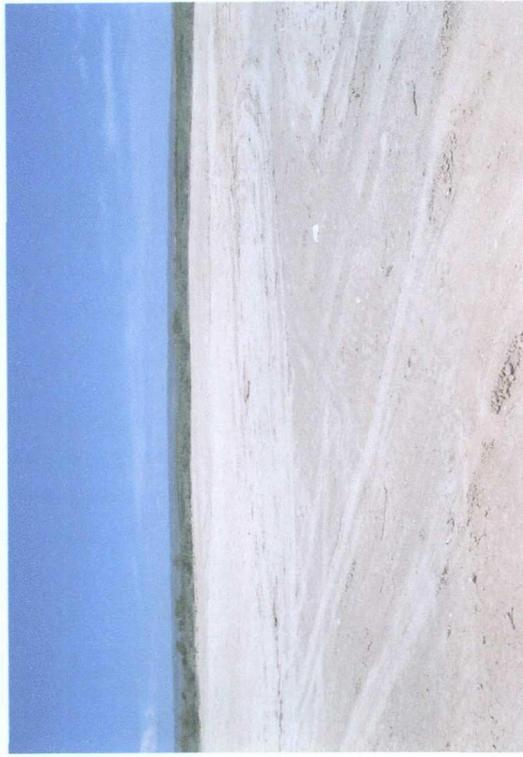
*Photo #37 – Dressing Location*

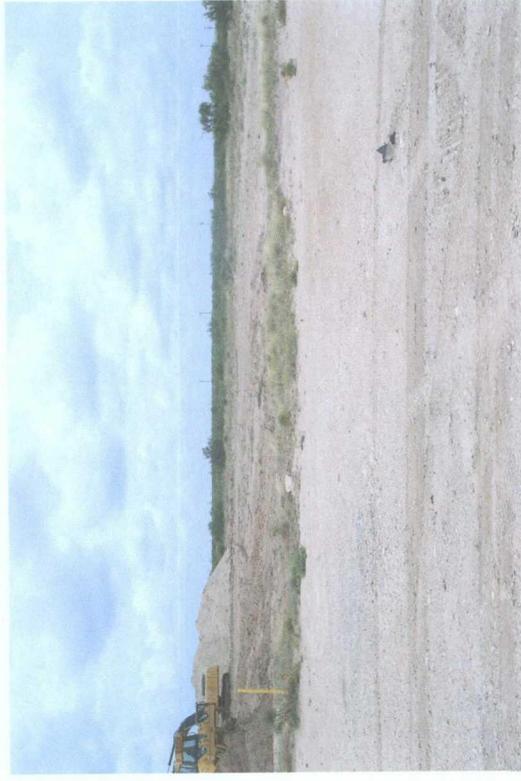
*Photo #38 – Dressing Location*
