SUBJECT: REPORT OF THE CLOSURE OF INCIDENT 2RP- 3684 NEAR THE NORTH BRUSHY DRAW 35-12, EDDY COUNTY, NEW MEXICO,

# CLOSURE REPORT FOR INCIDENT 2RP-3684

KO CONSTRUCTION/WPX ENERGY  
NEAR NORTH BRUSHY DRAW 35-12  
UNIT A SECTION 1, T26S R29E, NMPM  
EDDY COUNTY, NM

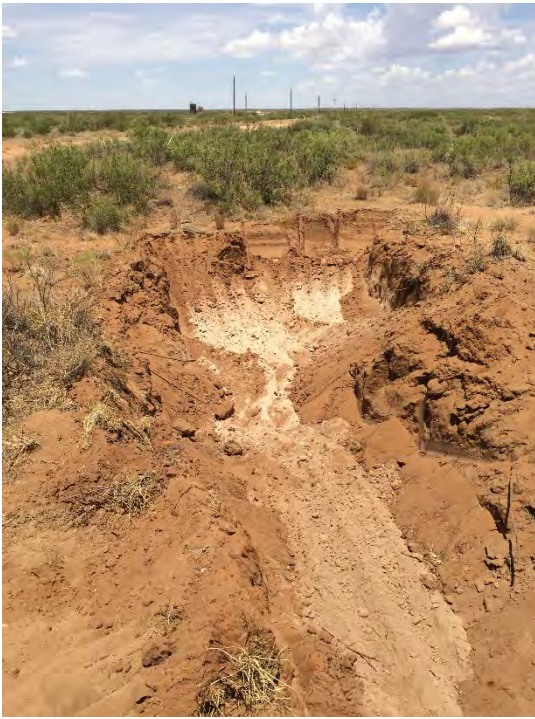
**Photo 1:** Excavation on West side

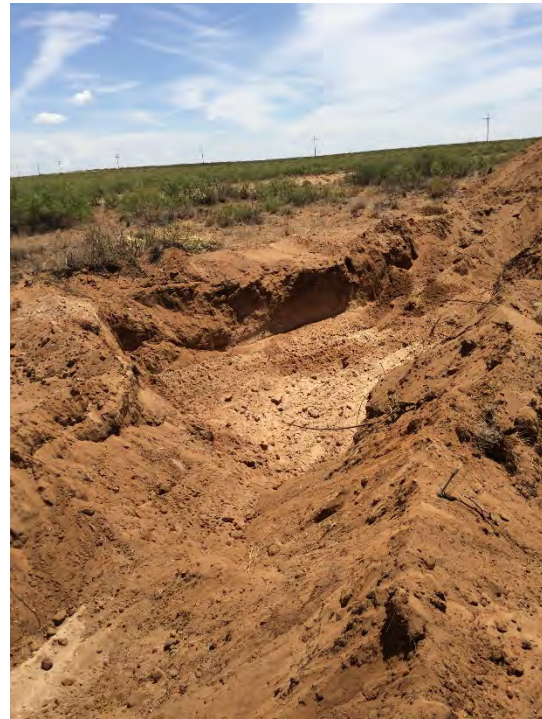
**Photo2:** Excavation on East side

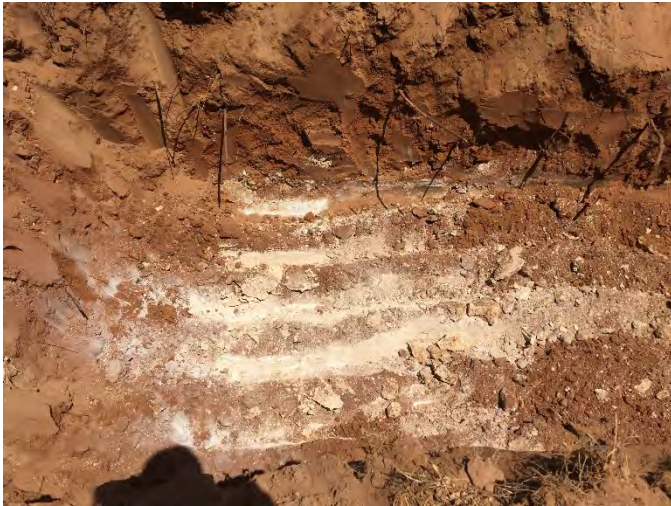
**Photo 3:** Bottom of Excavation

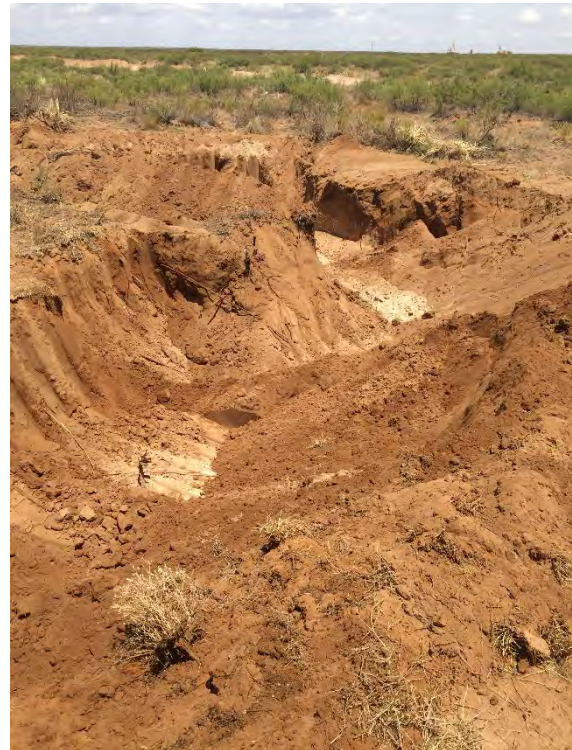
**Photo 4:** Excavation on South end

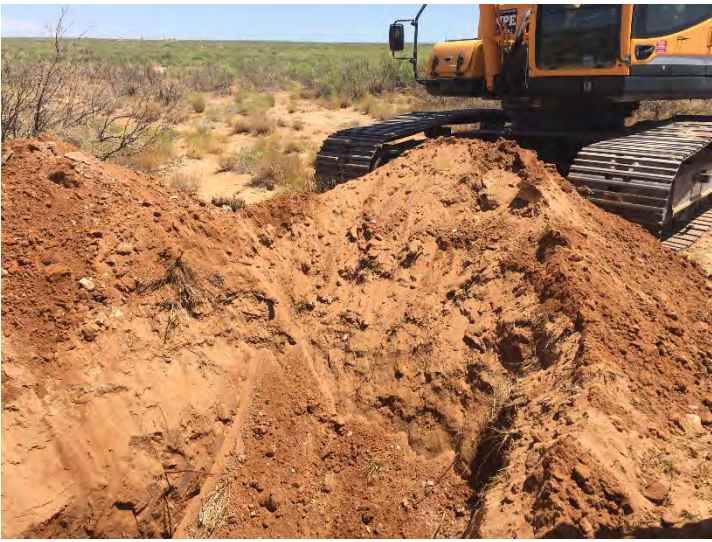
**Photo 5:** Spill Pile

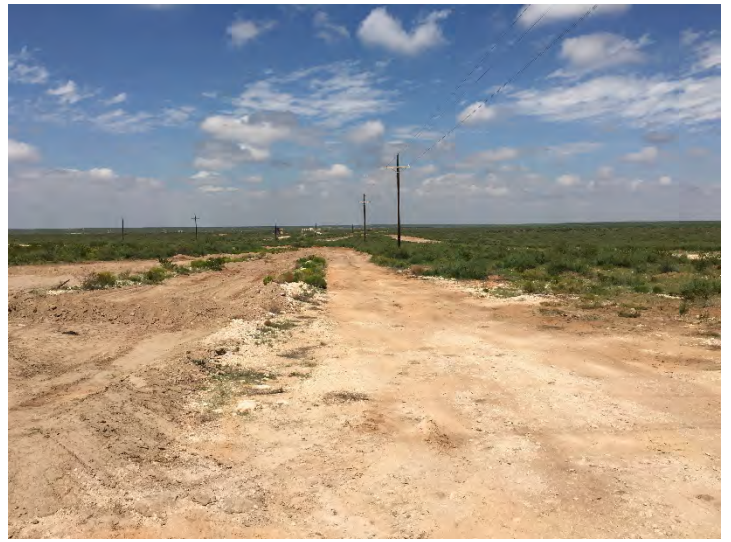
**Photo 6:** Central Area Back filled

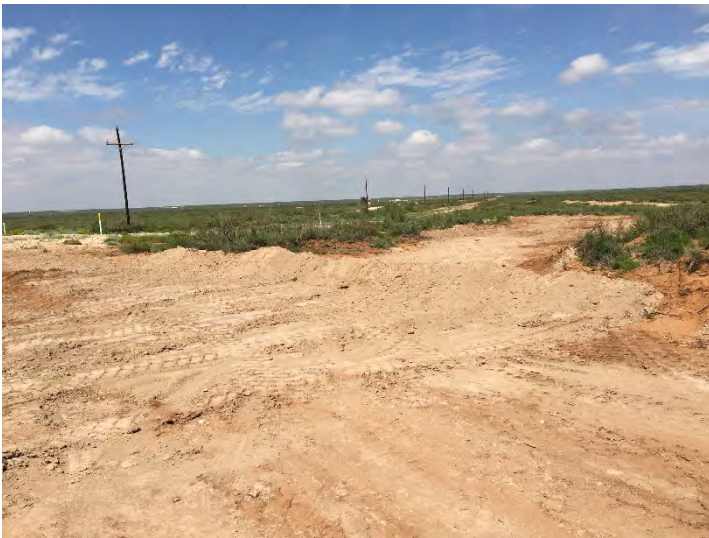
**Photo 7:** Southern Area Back filled

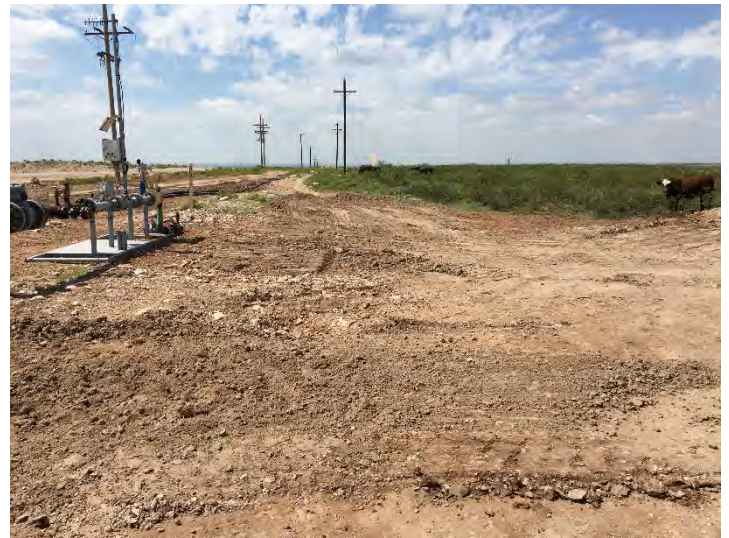
**Photo 8:** Northern Area Back filled
