CLOSURE REPORT

**BOPCO, L.P.
PLU #211
Eddy County, New Mexico
Unit Letter "J", Section 18, Township 24 South, Range 30 East
Latitude 32.215775 North, Longitude 103.918663 West
NMOCD Reference #2RP-3705**

RE: Final Closure Report
Bopco – PLU #211
UL-J, Section 18, Township 24 South, Range 30 East
Eddy County, New Mexico
NMOCD Reference # 2RP 3705

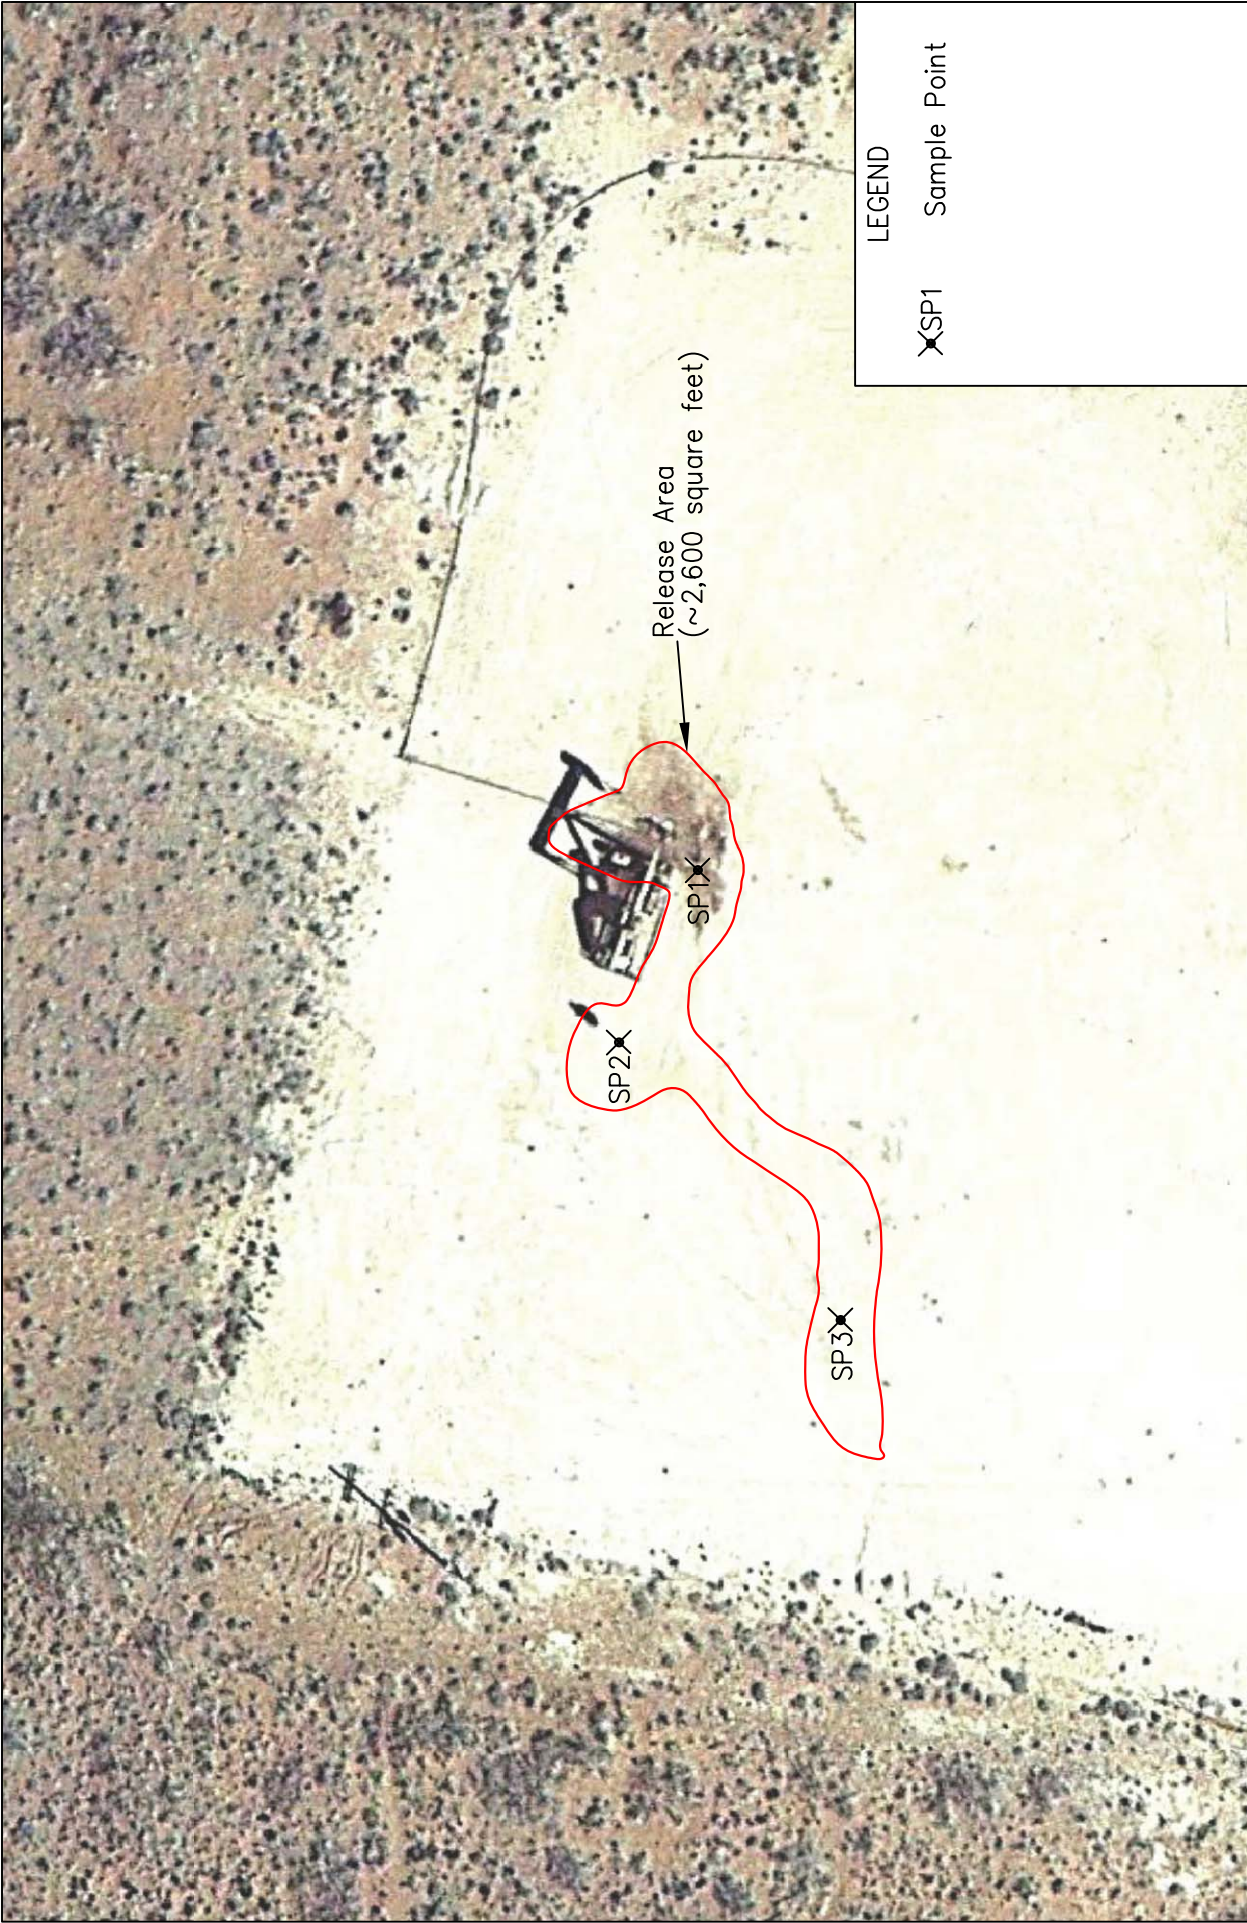
| <p>Figure 3 Site/Sample Map Bopco, L.P. PLU #211</p> | | <p>Eddy County, New Mexico NW 1/4 of SE 1/4, Sec. 18, T24S, R30E N 32° 12' 56.66" W 103° 55' 06.87" Elevation: 3,181 feet amsl</p> | |

EPI personnel mobilized on the site on June 23, 2016 to collect soil samples to determine the vertical extent of contamination. A total of eight (8) soil samples were collected from three (3) sample locations; SP1, SP2, SP3. All samples were field tested for organic vapors and chloride concentrations. A portion from each soil sample were placed in self-sealing polyethylene bags and allowed to equilibrate to ~70° F. Soil samples were then tested for organic vapors utilizing a Mini-Rae™ Photoionization Detector (PID) equipped with a 10.6 electron-volt (eV) lamp calibrated for benzene response. Chloride concentrations were determined via use of a LaMotte Chloride Kit (Titration Method).

Six (6) representative samples were jarred, chilled and sent to Cardinal Labs in Hobbs, New Mexico for testing. Laboratory analytical data indicates that, other than Chlorides at surface level, the release area is void of Benzene, BTEX, TPH, and Chloride concentrations in excess of NMOCD Recommended Remedial Action Levels (RRALs) of 10 mg/Kg, 50 mg/Kg, 5,000 mg/Kg, and 1,000 mg/Kg, respectively (reference *Figure 3* and *Table 2*).

The release area was excavated to a depth of approximately six (6) inches bgs. Approximately 25 tons of contaminated soil was excavated and hauled to a state approved facility for disposal.

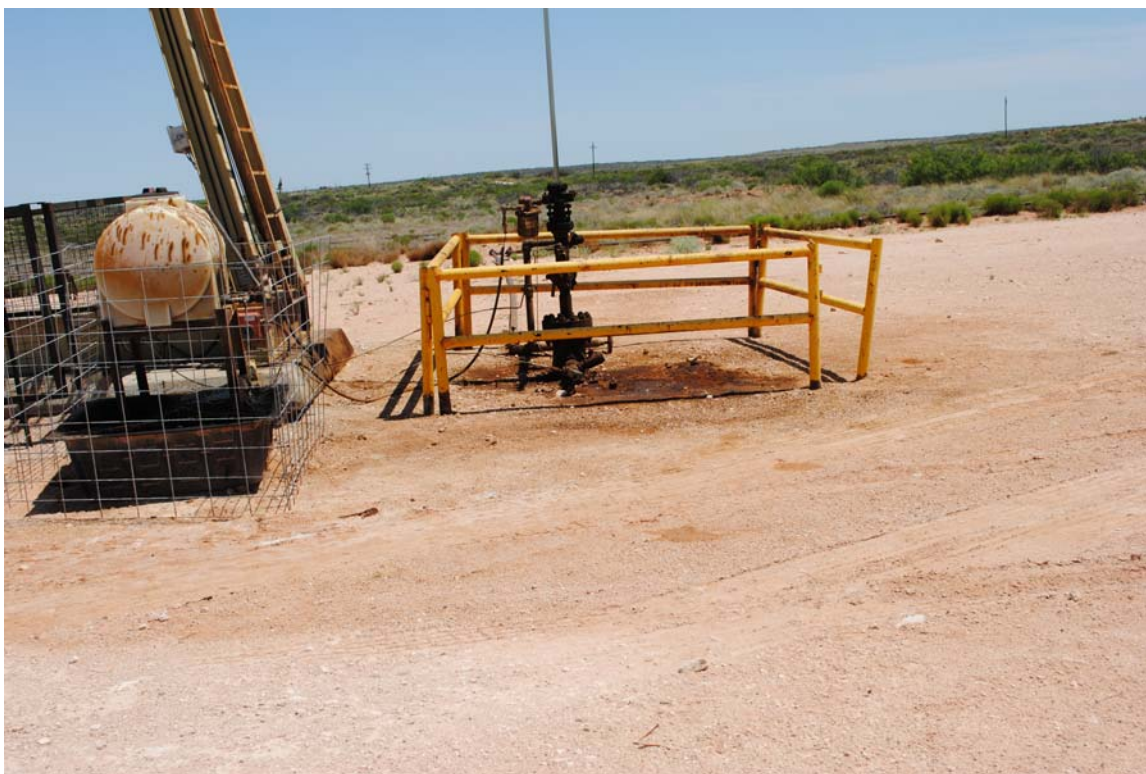
Photograph #1 – Looking across release area

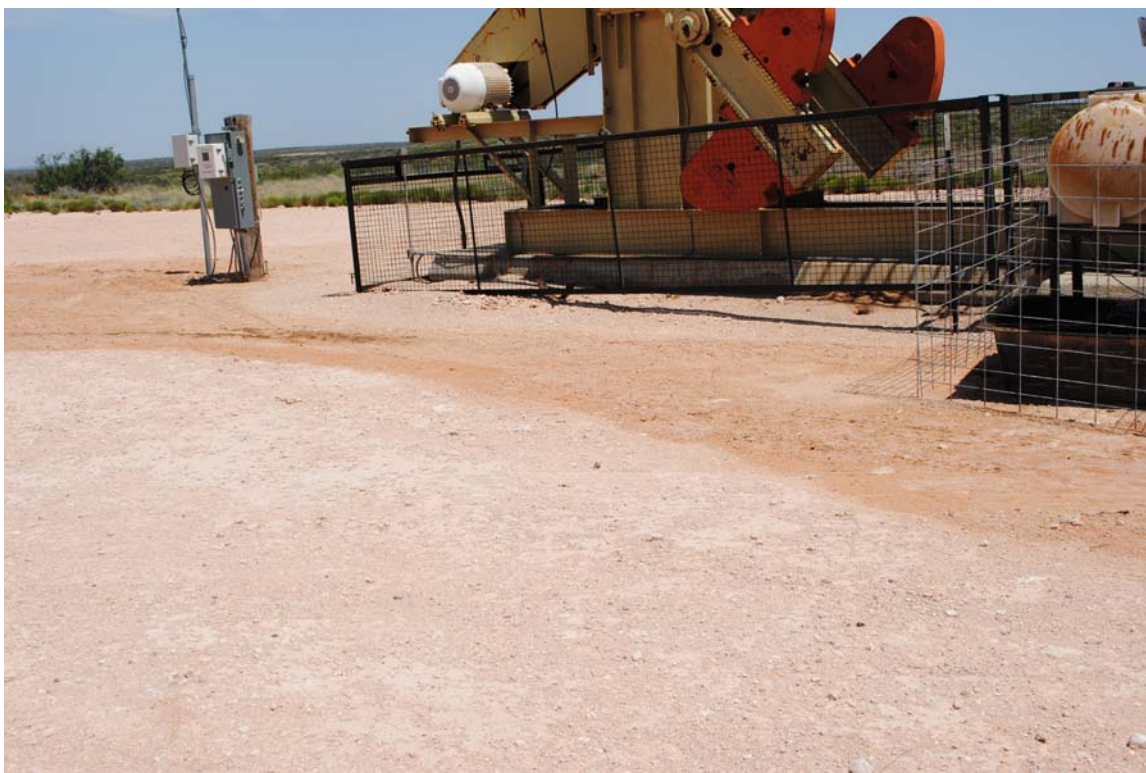
Photograph #2 – Looking across release area

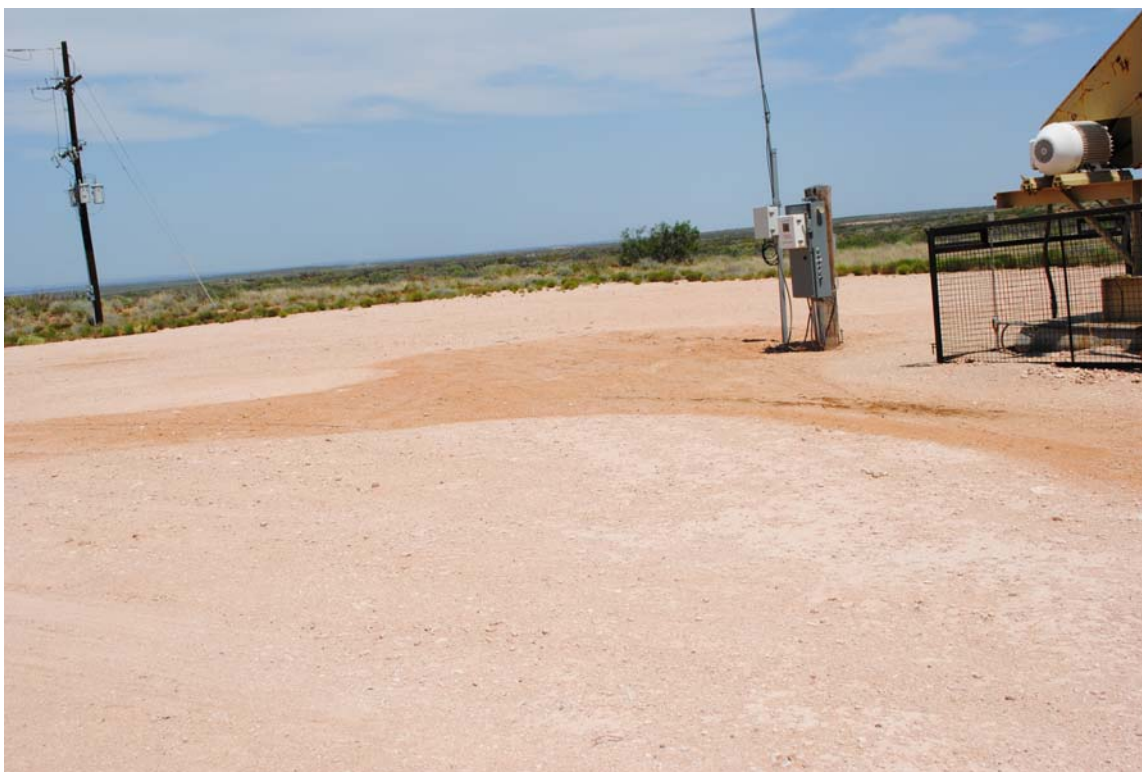
Photograph #3 – Looking across release area

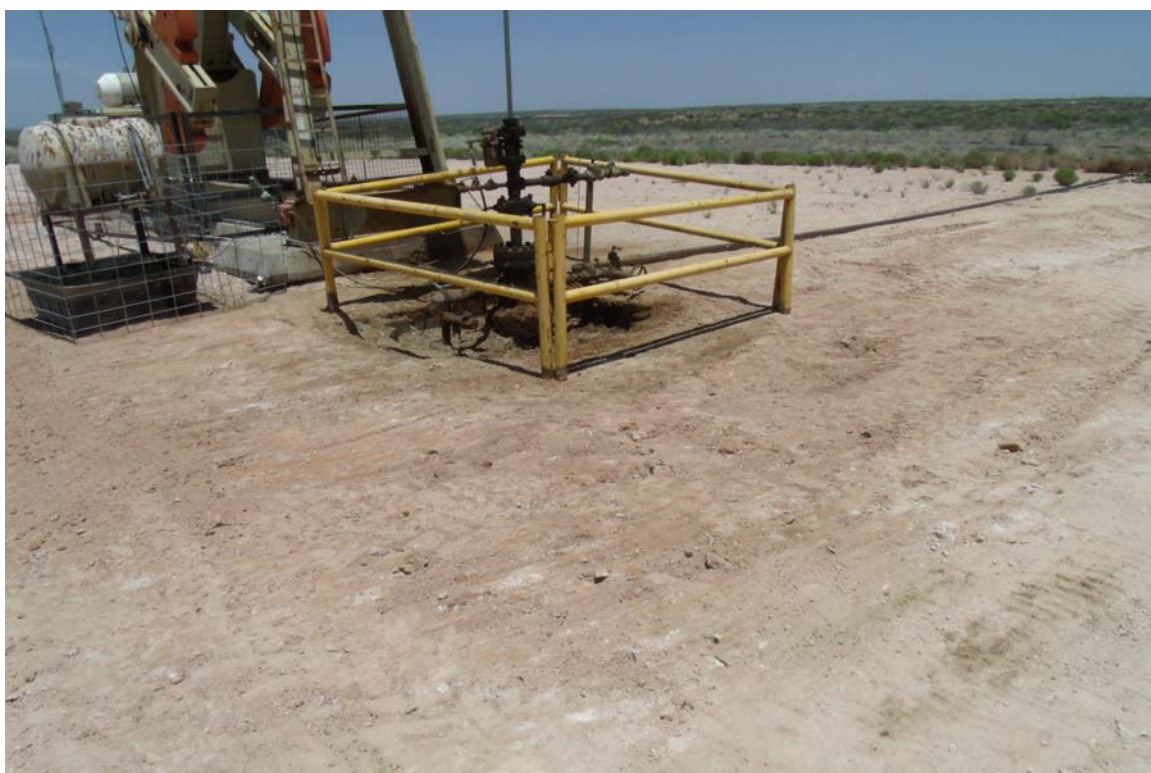
Photograph #4 – Excavated area

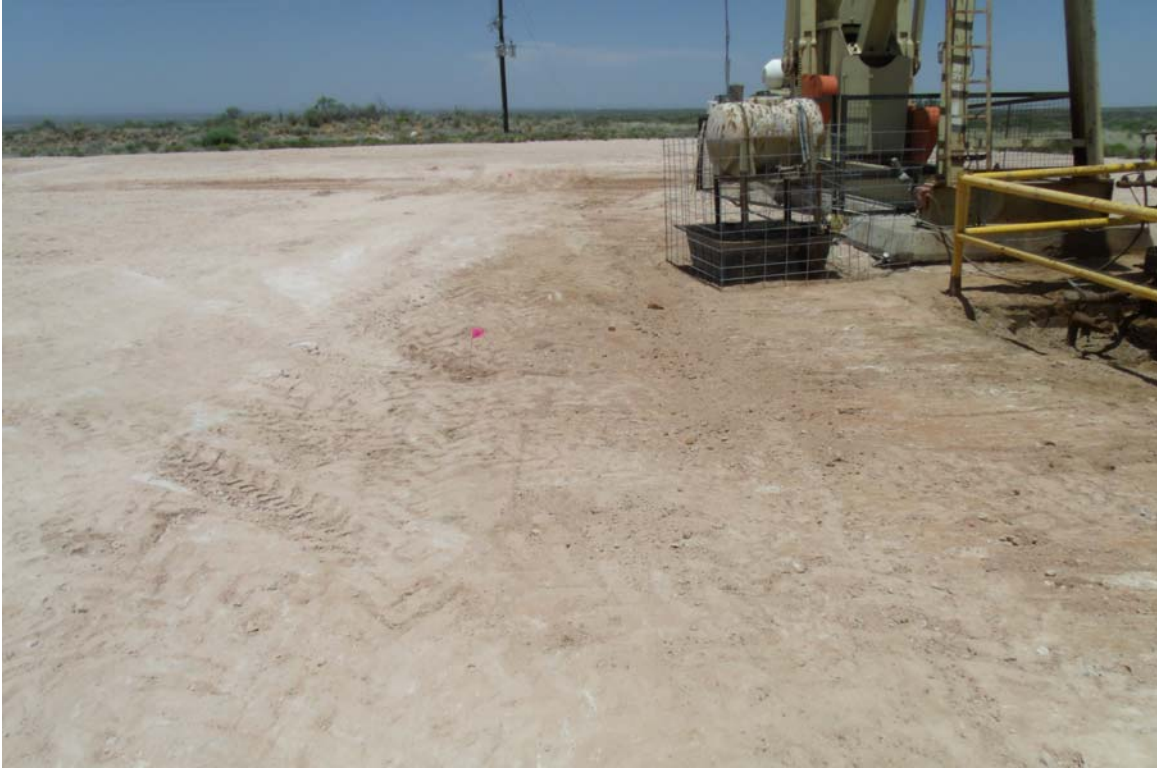
Photograph #5 – Excavated area

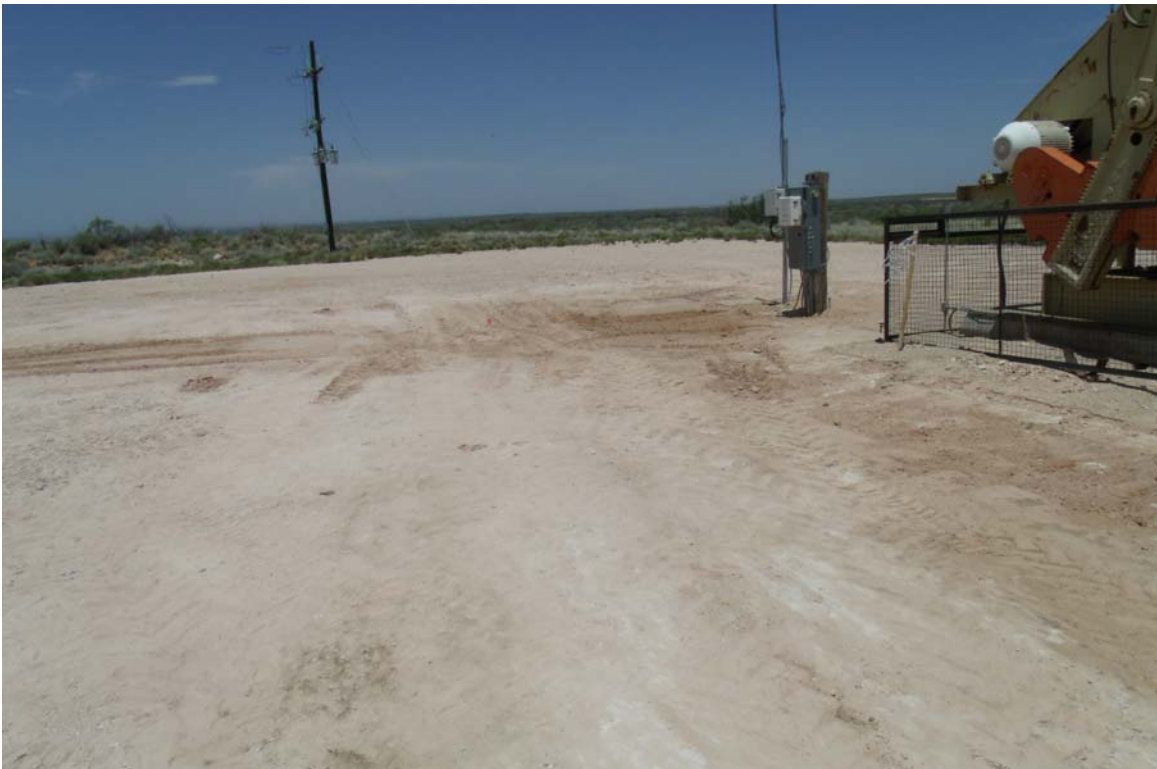
Photograph #6 – Excavated area

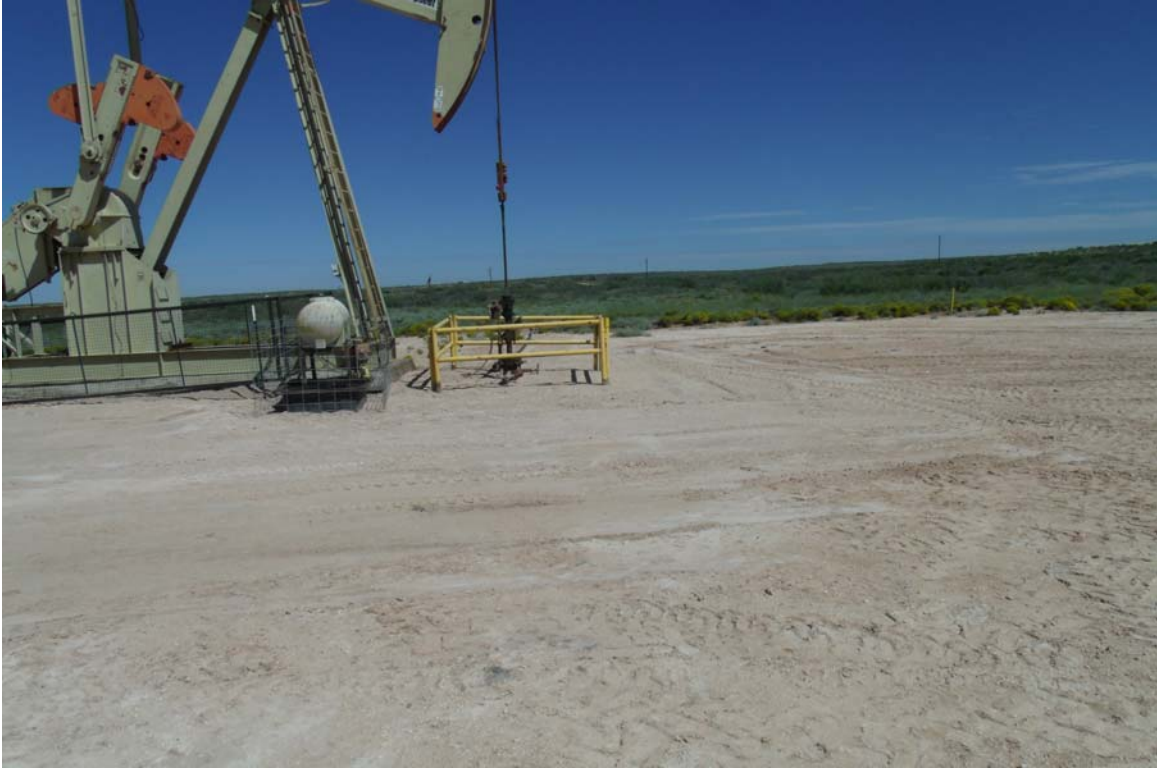
Photograph #7 – Backfilled area

With NMOCD approval the excavation was backfilled with approximately 25 tons of clean soil. All soil was free of rocks, clumps or deleterious material. The entire disturbed area was then contoured to blend with existing pad area and protected against wind/water erosion.

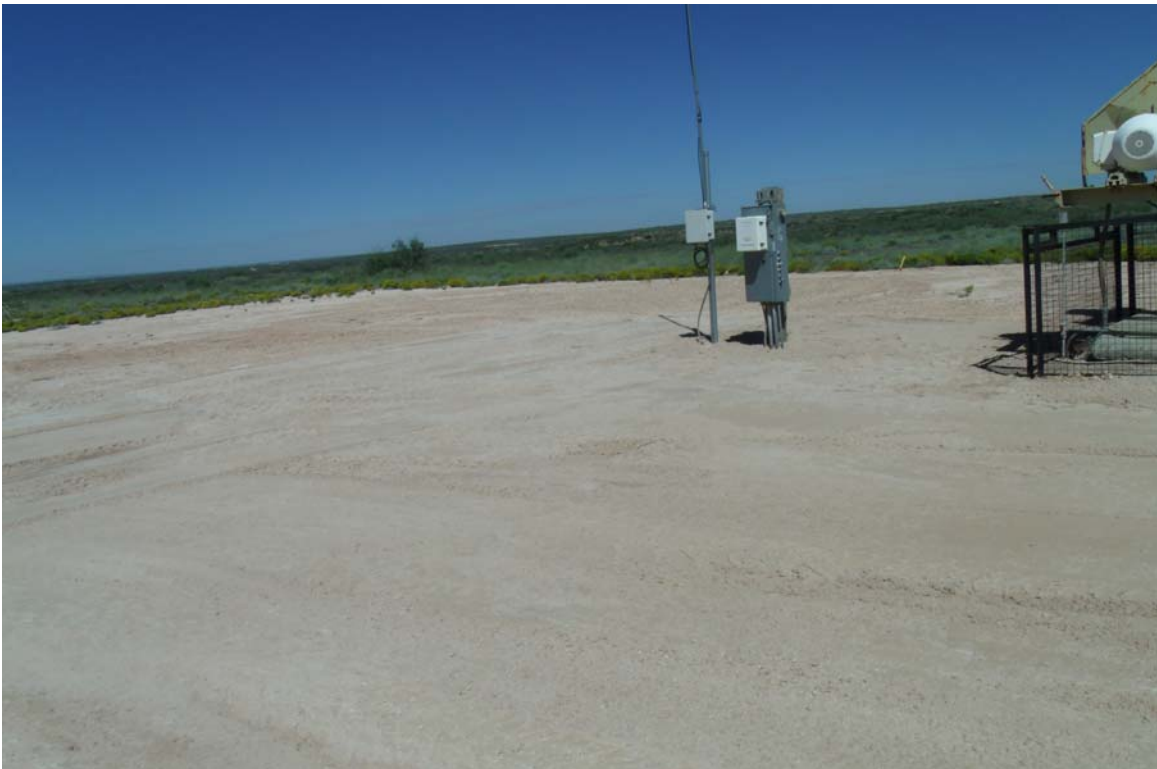
Photograph #8 – Backfilled area
