Holly Energy Partners

Henshaw Station

Delineation Report & Work Plan

**Section 23, Township 17S, Range 30E
Eddy County, New Mexico**

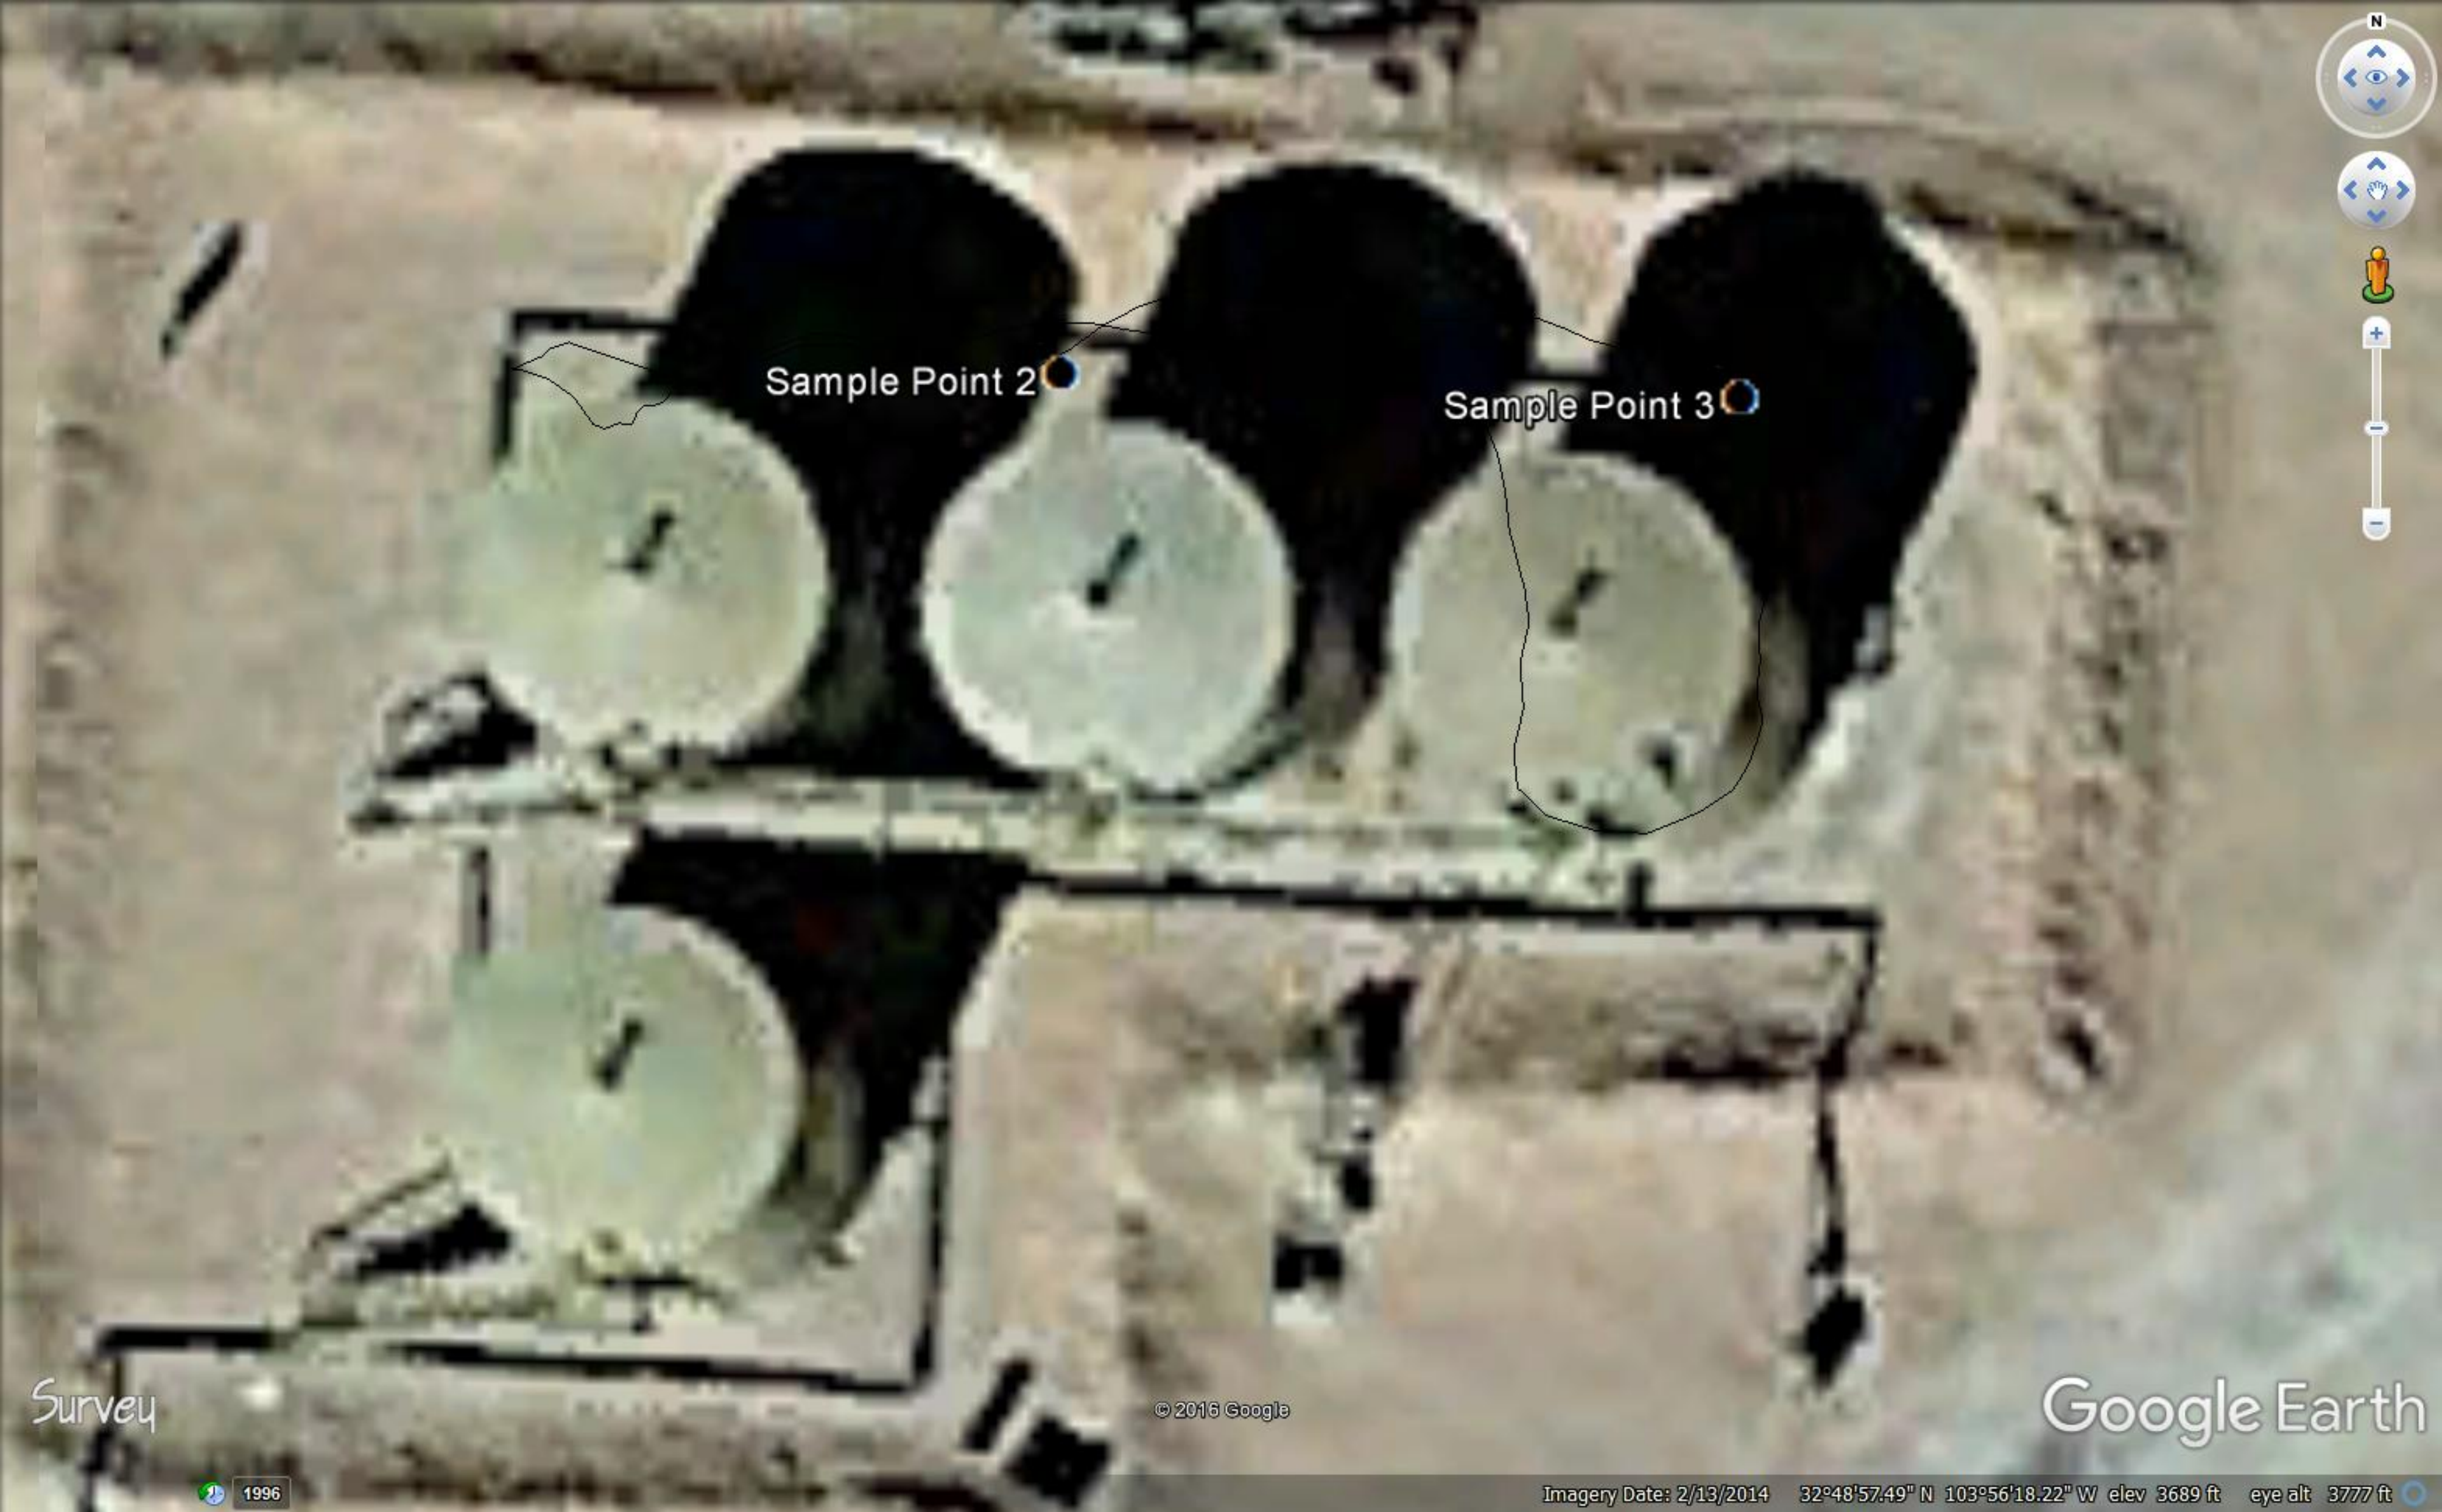
Figure 2
Site Plan

Sample Point 2

Sample Point 3

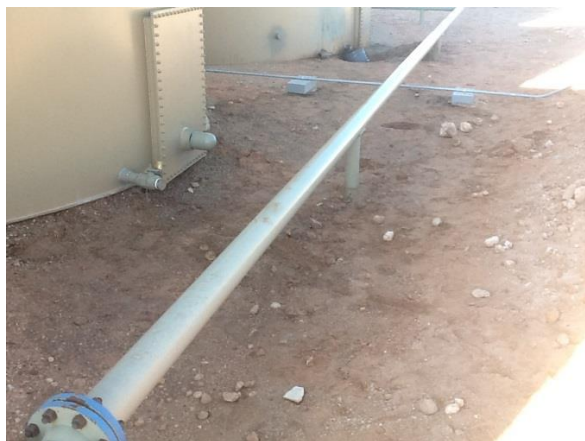
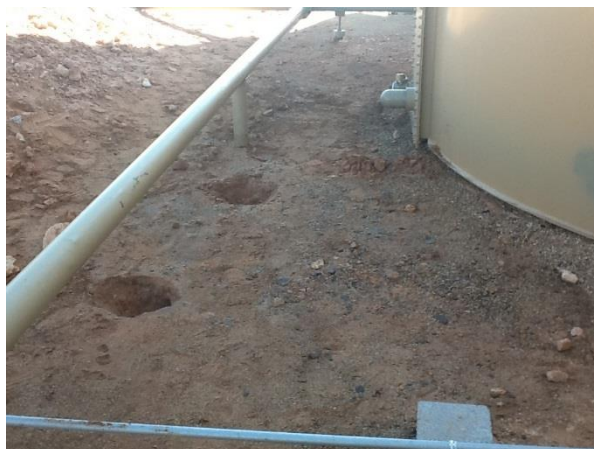
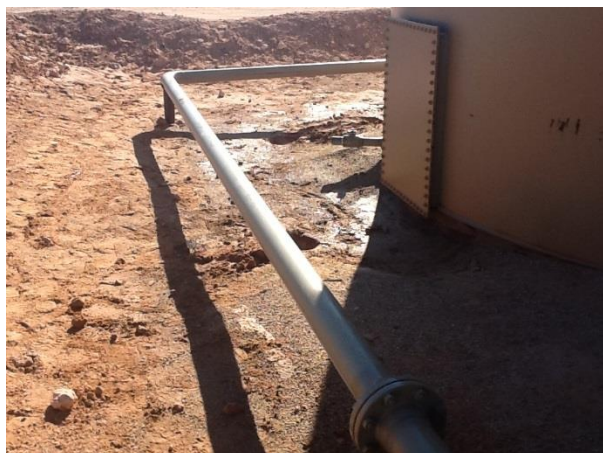
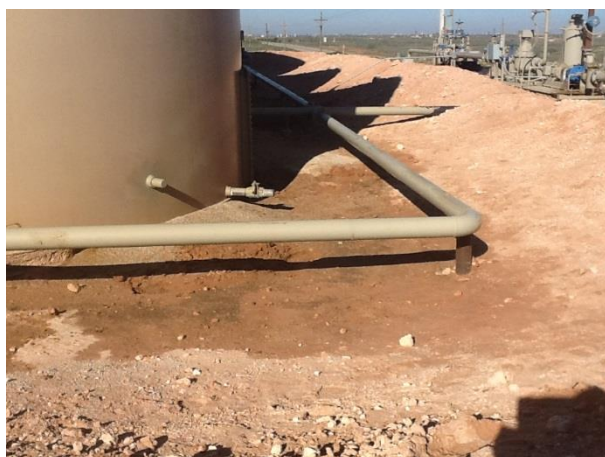
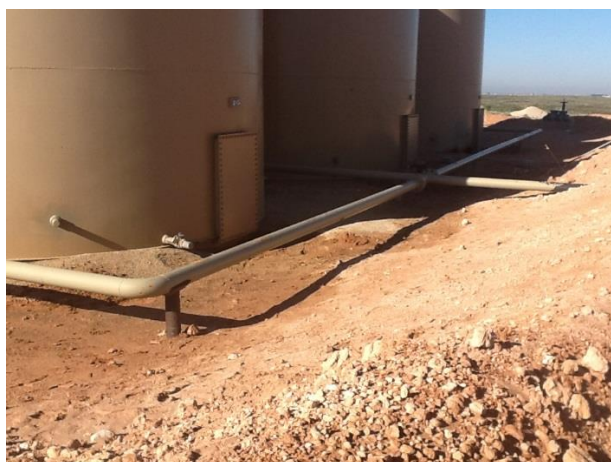
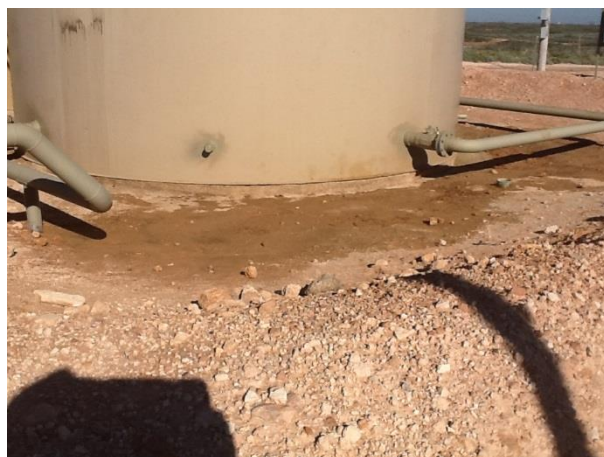
Spill Area

According to the C-141: approximately five (5) barrels of water and oil was released from the tank bottom, due to an internal corrosion of the of the factory tank penetration collar. A majority of the spill was water from the tank bottom, and only about one (1) barrel was oil. All liquids were vacuumed up and contained within the tank berm area. Soil sampling will be conducted and a remediation plan determined upon receipt of sampling results.

The NMOCD site ranking requires a 5,000 ppm TPH cleanup, and no BTEX is present in any of the samples taken at this site. Vertical extent of contamination was found at all sample points. Holly Energy Partners is proposing to excavated and remove the impacted soil where Chloride levels are >500 mg/kg, and TPH levels are >1,000 mg/kg. All impacted soils will be transported to an NMOCD approved facility. Upon completion of remediation activities: all surface areas off of the location area will be re-seeded according New Mexico State Land Office Guidelines. All closure documentation will be drafted and submitted to the proper parties of concern.

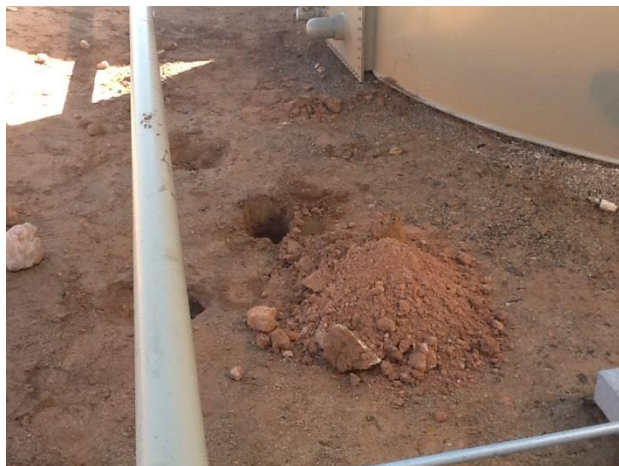
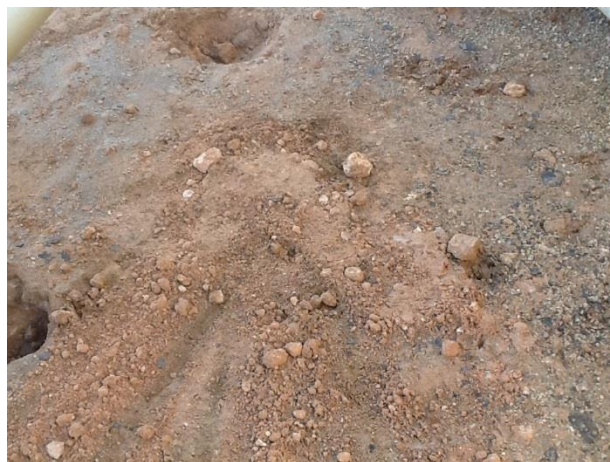
Auger Hole 1

Soil Sample Results: Cardinal Laboratories 10-11-16								
SAMPLE ID	Benzene	Toluene	Ethylbenzene	Total Xylenes	Total BTEX	Chlorides	TPH GRO	TPH DRO
AH-1 Surface	<0.050	0.060	0.135	<0.150	<0.300	10000	<10.0	170
AH-1 1'	<0.050	0.212	1.65	5.37	7.24	80.0	94.7	883
AH-1 2'	<0.050	<0.050	0.452	0.425	0.877	432	<50.0	349
AH-1 3'	<0.050	<0.050	<0.050	<0.150	<0.300	48.0	<10.0	<10.0
AH-2 Surface	<0.050	<0.050	0.063	<0.150	<0.300	3440	<50.0	233
AH-2 1'	<0.050	<0.050	<0.050	<0.150	<0.300	64.0	<10.0	<10.0
AH-2 2'	<0.050	<0.050	<0.050	<0.150	<0.300	32.0	<10.0	<10.0
