Release Notification and Corrective Action

Name of Company <i>Enterprise Field Services LLC</i>	Contact <i>Alena Miro</i>
<i>PO Box 4324, Houston, TX 77210</i>	Telephone No. <i>575-628-6802</i>
Facility Name <i>Pipeline ROW, Lateral A-1 2RP-3433</i>	Facility Type: <i>Gas Gathering Pipeline</i>
Surface Owner <i>Donald Sanders</i>	Mineral Owner <i>NA - Pipeline</i>
	Lease No. <i>NA</i>

CORRECTIVE ACTION REPORT

October 2016
Apex Project No. 7250715105

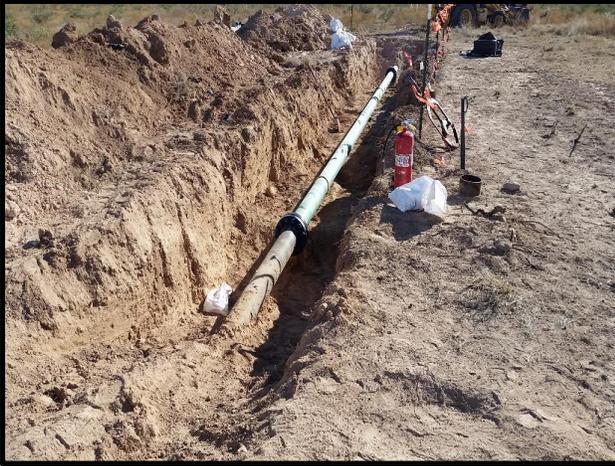
View of initial excavation facing south

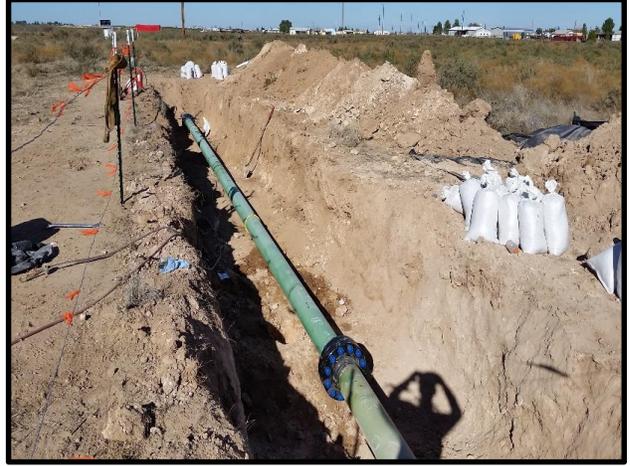
View of initial excavation facing north

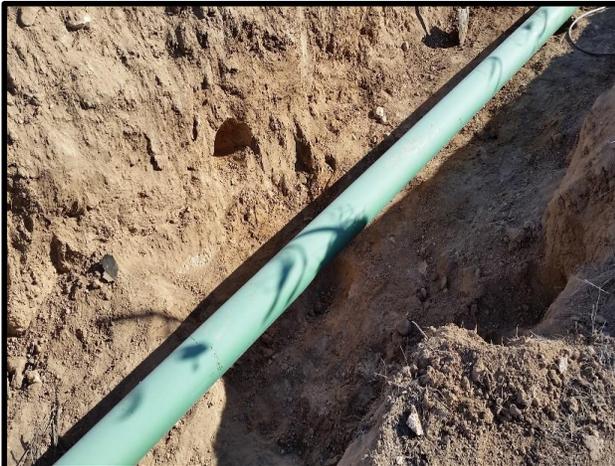
View of initial excavation facing southeast in the vicinity of the release point

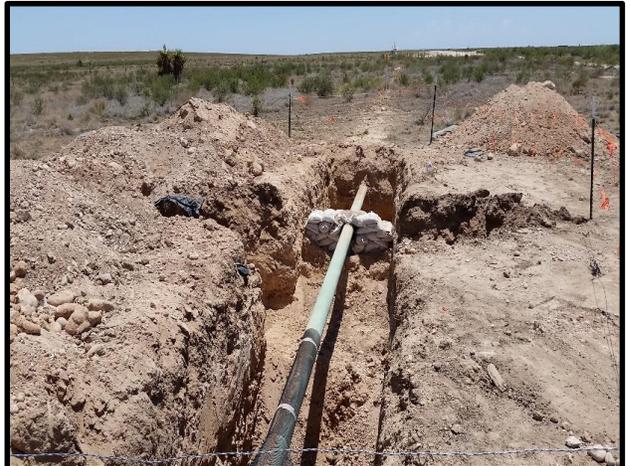
View of final excavation facing south

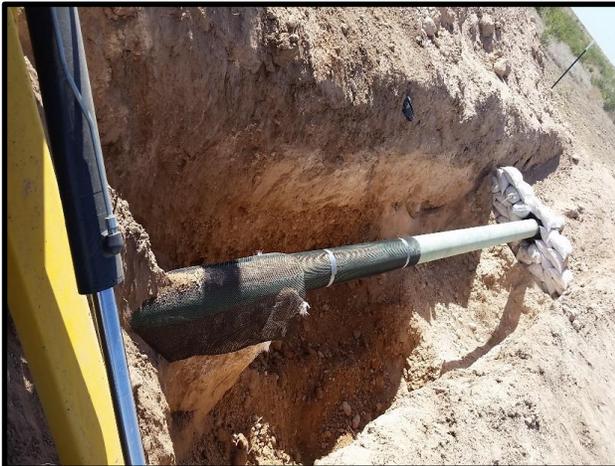
View of deeper portions of the final excavation facing southeast

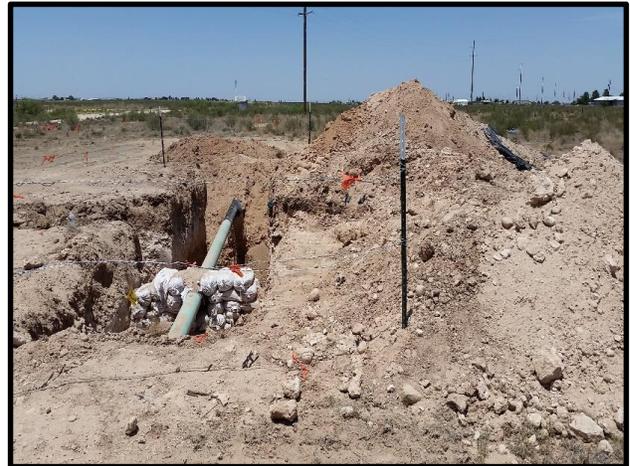
View of final excavation facing north
