CLOSURE REPORT

**BOPCO, L.P.
PLU CVX JV BS #026H
Eddy County, New Mexico
Unit Letter "A", Section 23, Township 24 South, Range 30 East
Latitude 32.210419 North, Longitude 103.846107 West
NMOCD Reference #2RP-3745**

RE: Final Closure Report
Bopco, L.P. – PLU-CVX-JV-BS #026H
UL-A, Section 23, Township 24 South, Range 30 East
Eddy County, New Mexico
NMOCD Reference # 2RP 3745

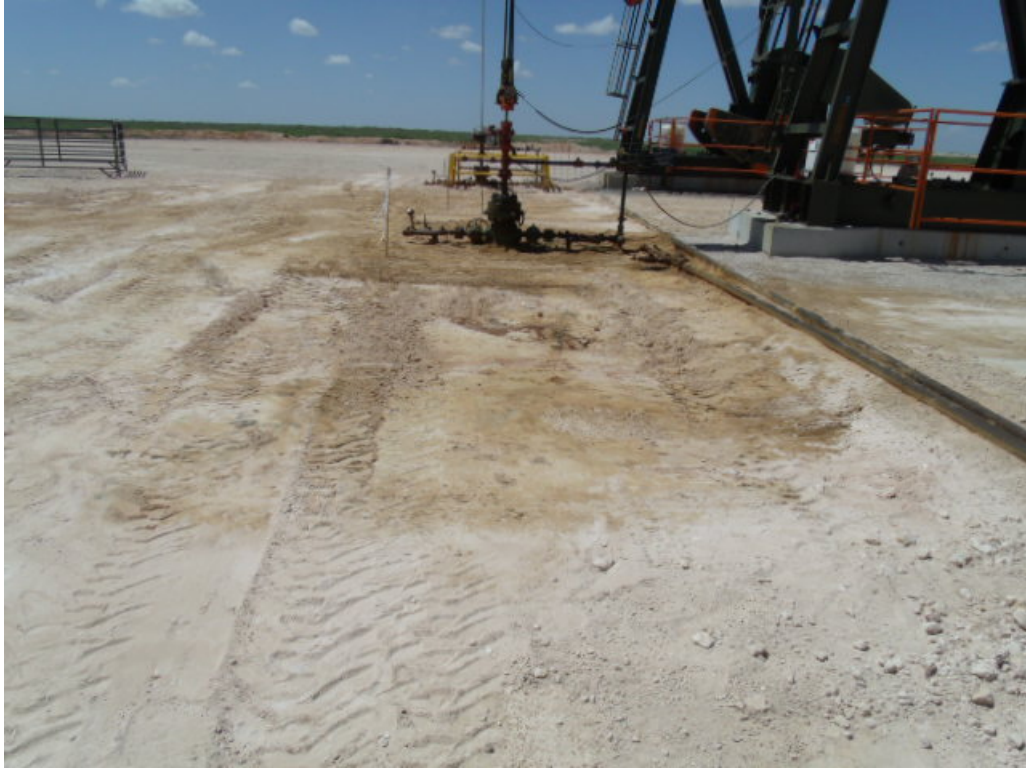
Photograph #1 – Excavated release area

The release area was excavated to a depth of approximately six (6) inches bgs; approximately 10 tons of contaminated soil was excavated and hauled to a state approved facility for disposal.

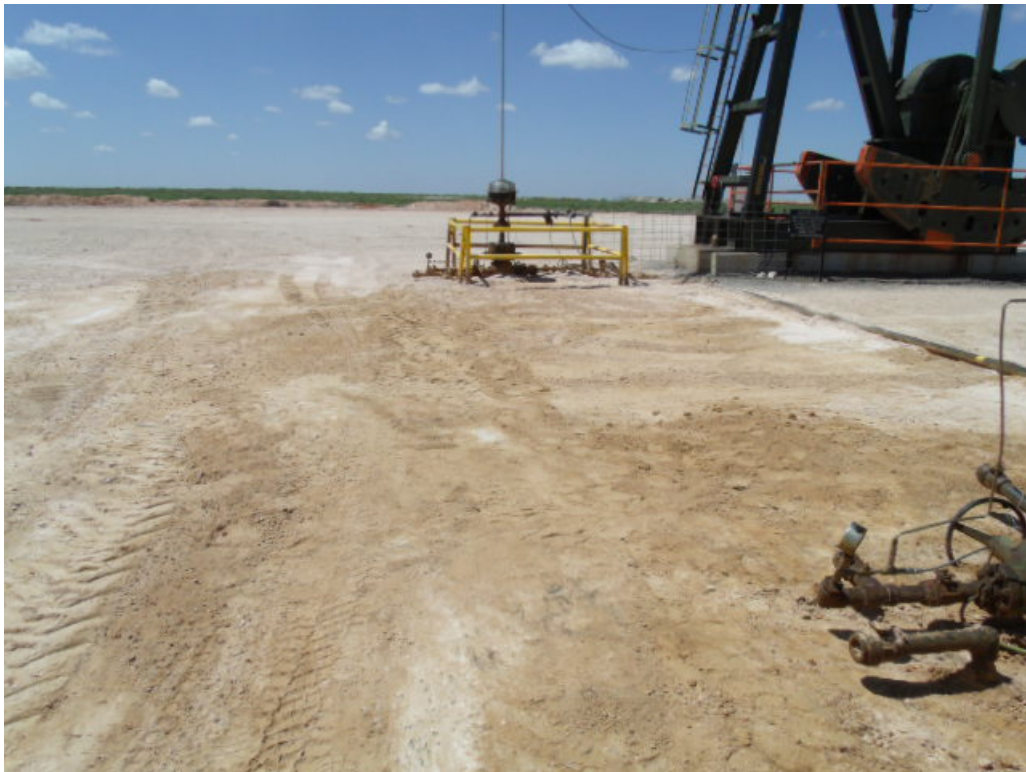
Photograph #2 – Excavated release area

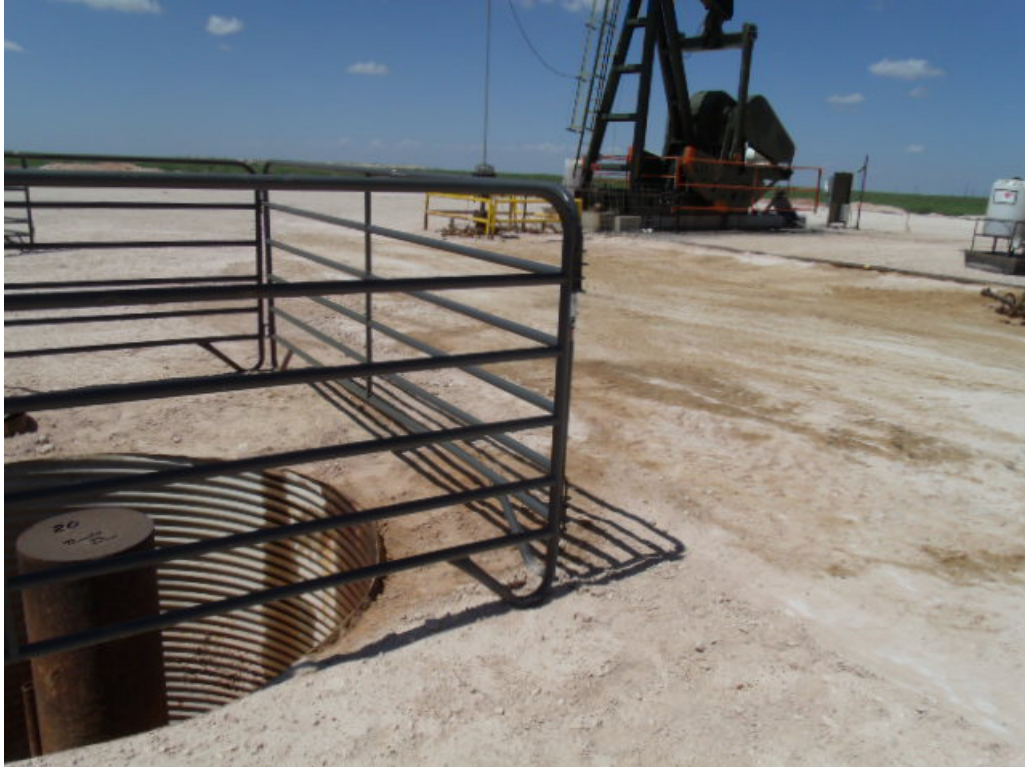
Photograph #3 – Excavated release area

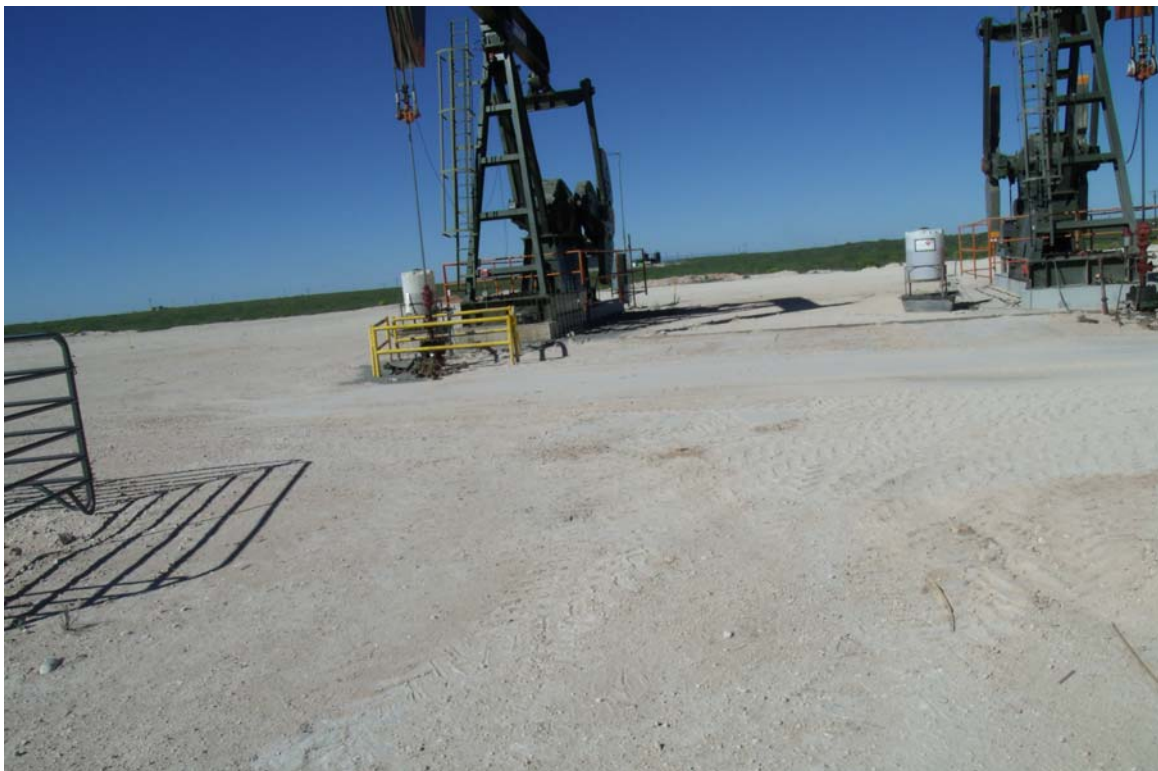
Photograph #4 – Backfilled

Based on laboratory analytical data and NMOCD approval, the excavation was backfilled with approximately 10 tons of clean soil. The entire disturbed area was then contoured to blend with existing pad area and protected against wind/water erosion.

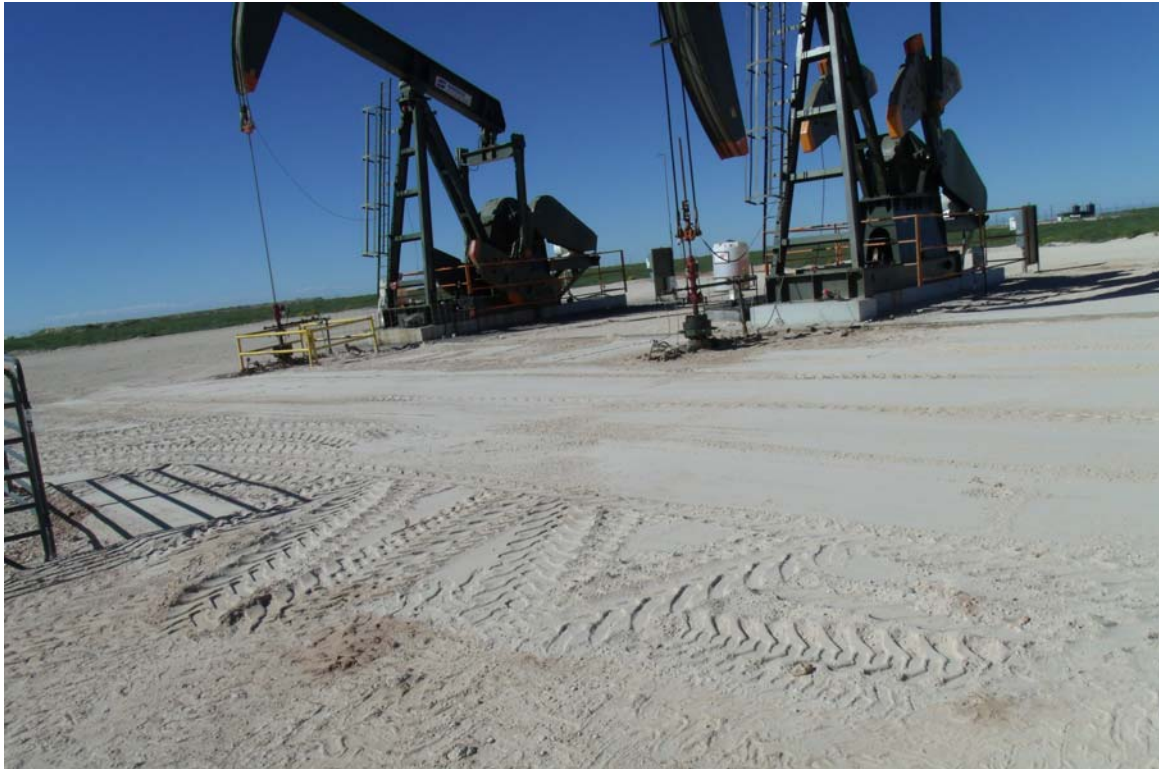
Photograph #5 – Backfilled

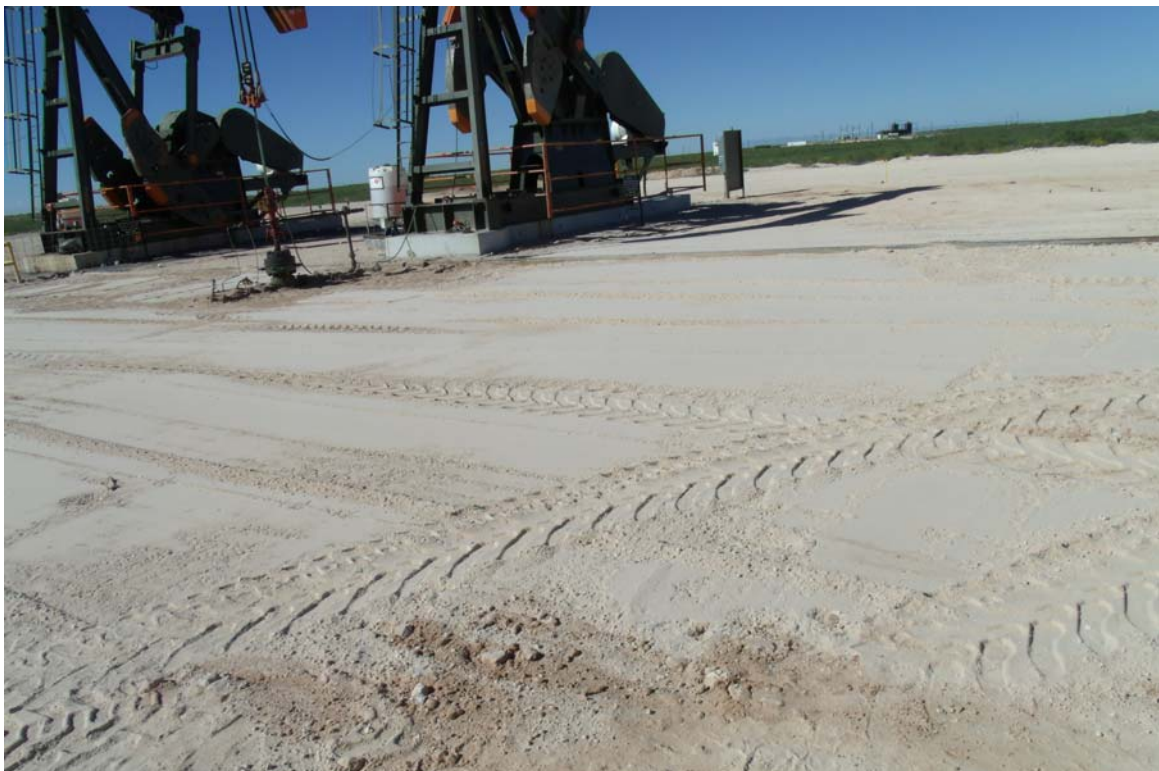
Photograph #6 – Backfilled
