# Nash Unit No 042H

## WORK PLAN

**RE: XTO – Nash Unit No. 042H – Remediation Work Plan**  
UL/E, Section 18, T23S, R30E  
API No. 30-015-37194  
NMOCD Score: 0

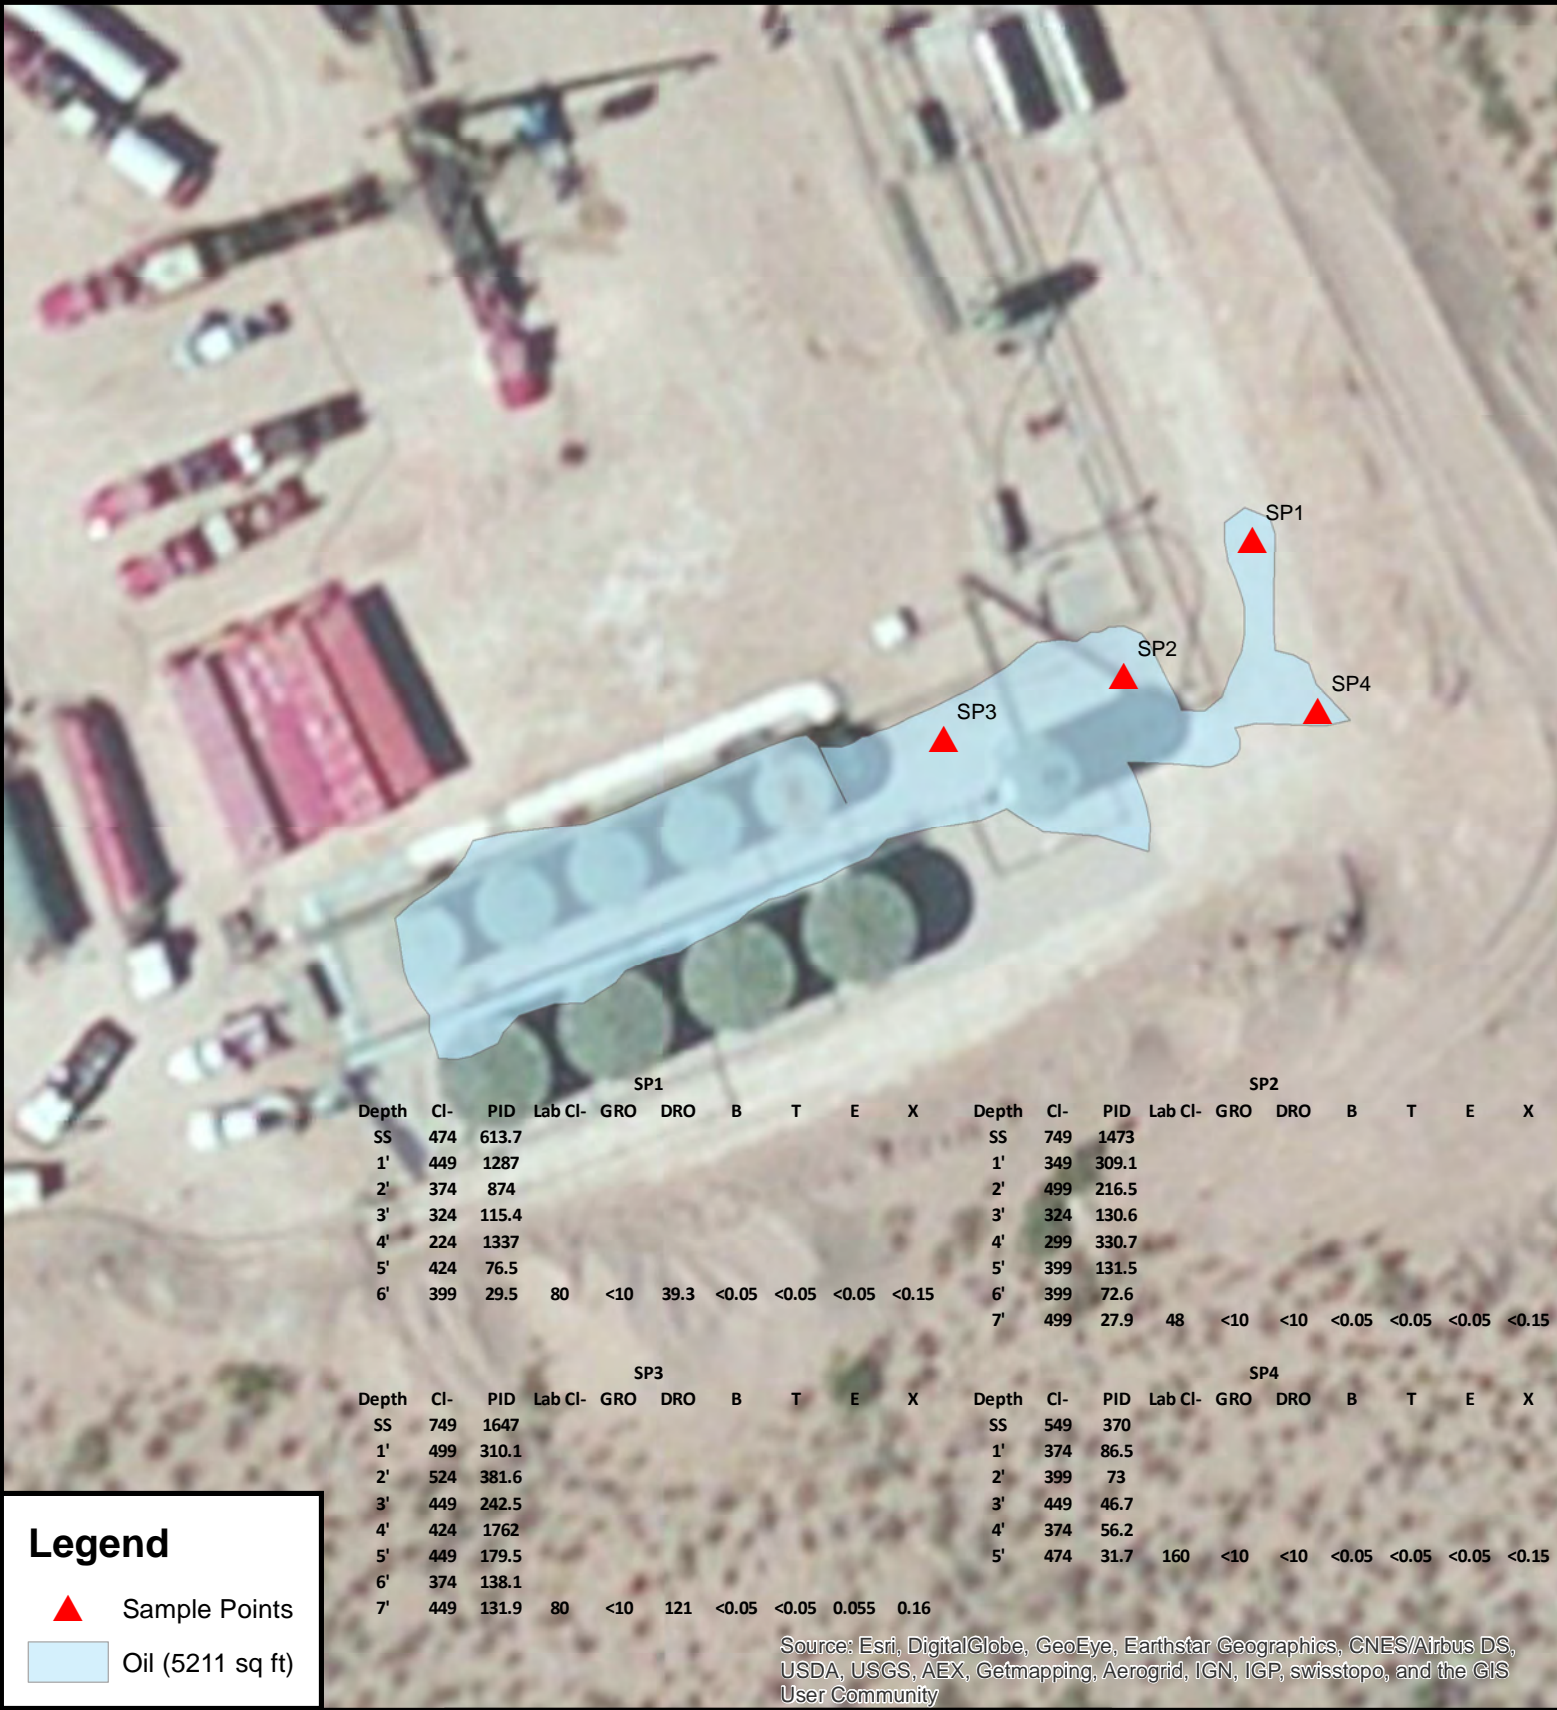
**Figure 1**

On November 2, 2016 DFSI personnel were on site to obtain samples within the leak area (Figure 1). Four samples were obtained and field sampled for chloride levels, as well as BTEX (Appendix II). The BTEX samples were performed using a Mini Rae Photoionization Detector (PID). Clean field samples were submitted for laboratory analysis at Cardinal Laboratory of Hobbs, NM to obtain confirmation (Appendix III).

Site Map

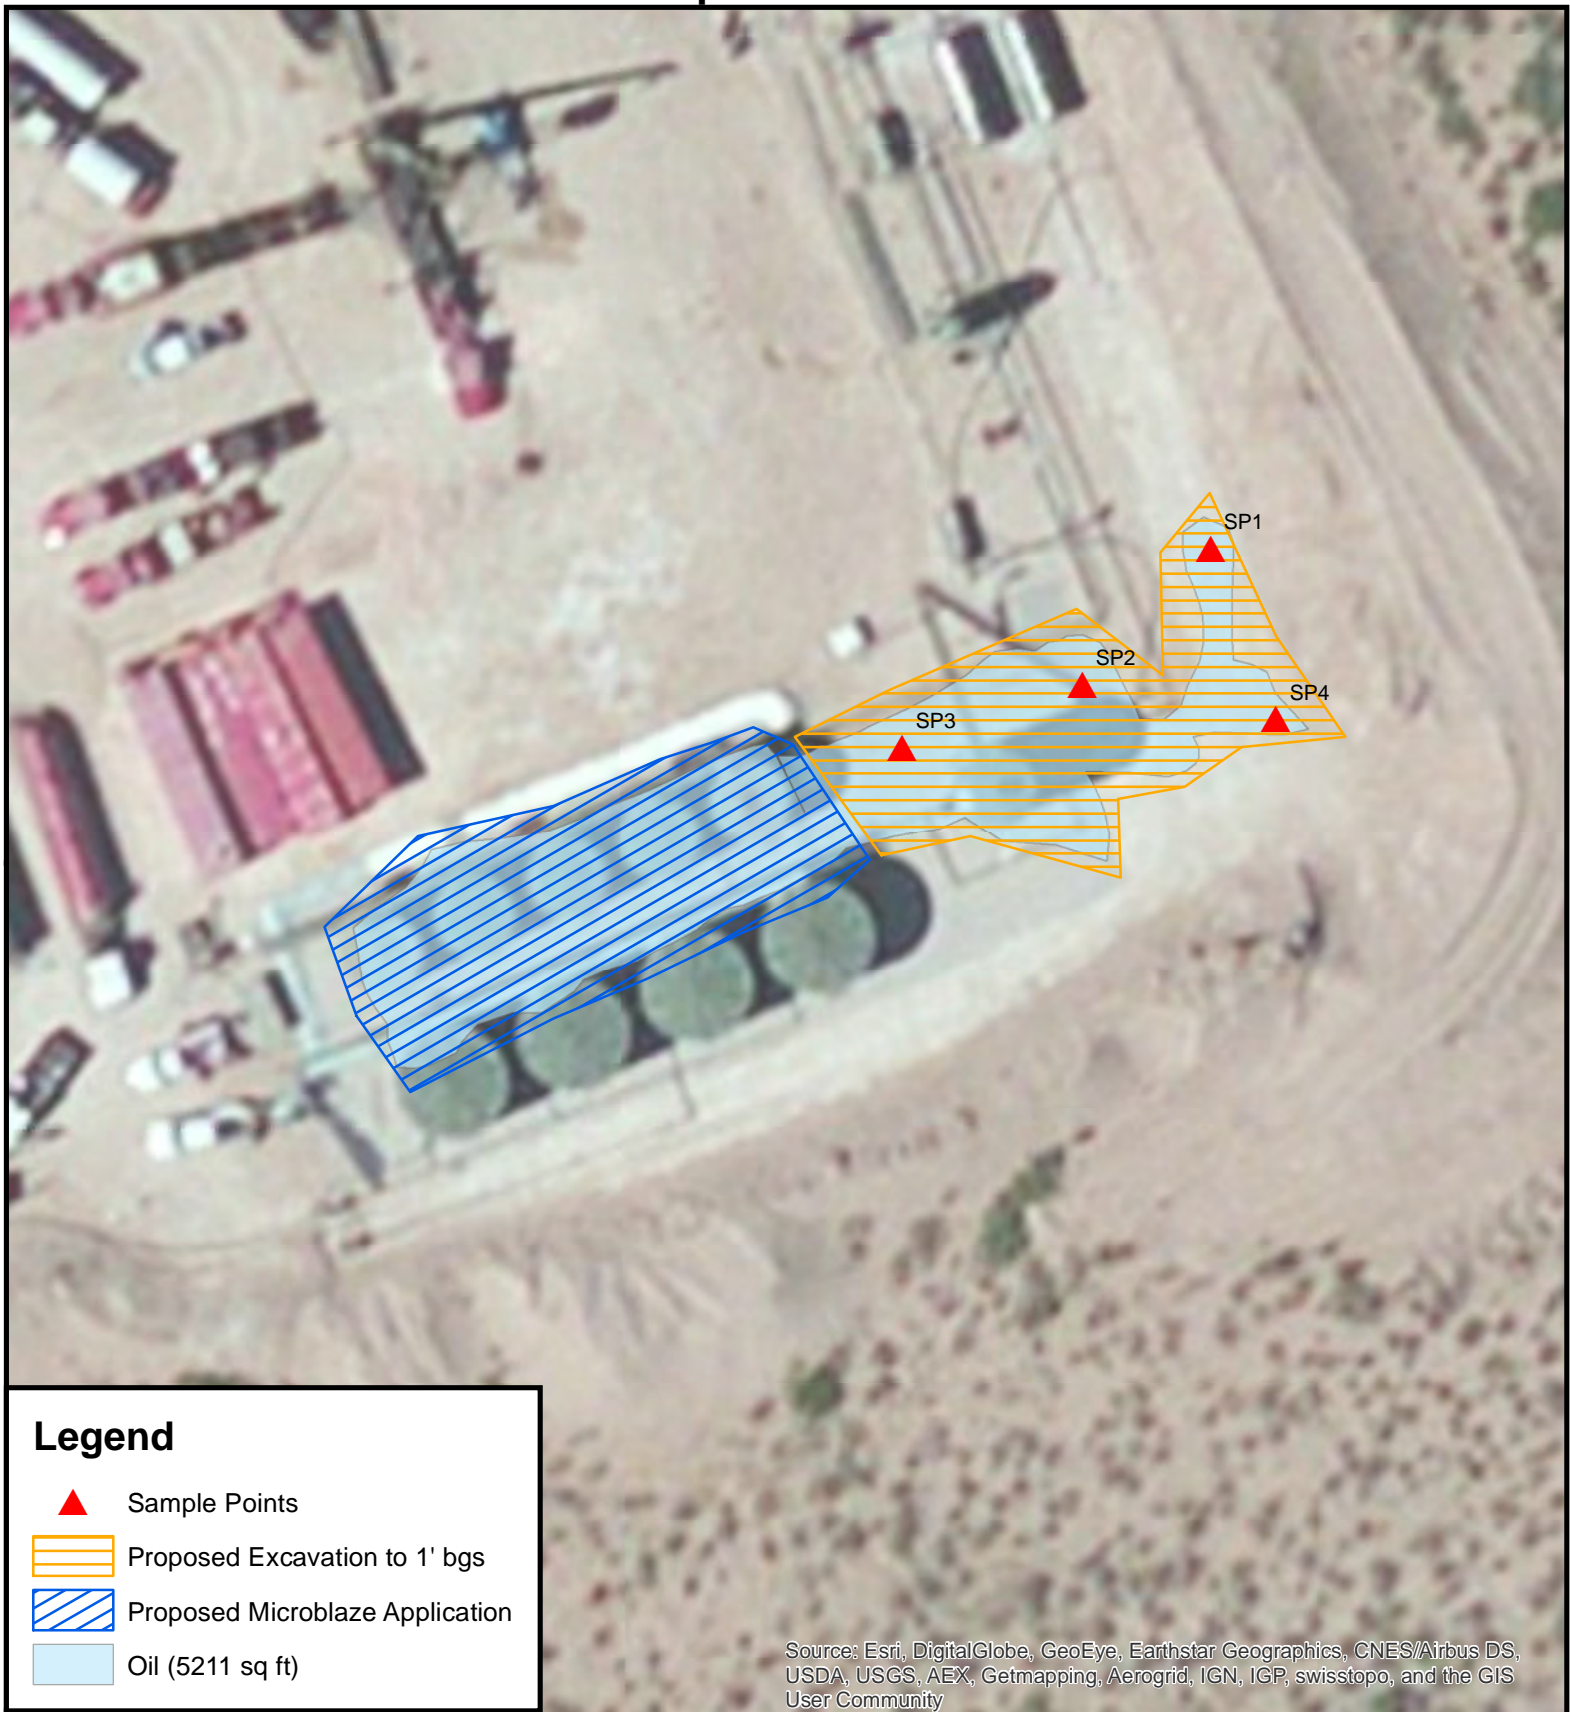
## Figure 2

# Proposed Work

Due to the bermed area being lined, the area located within the battery will be treated with an application of microblaze. Outside of the battery, the release area will be excavated to a depth of 1' bgs. Site remediation activities will be addressed at site abandonment.

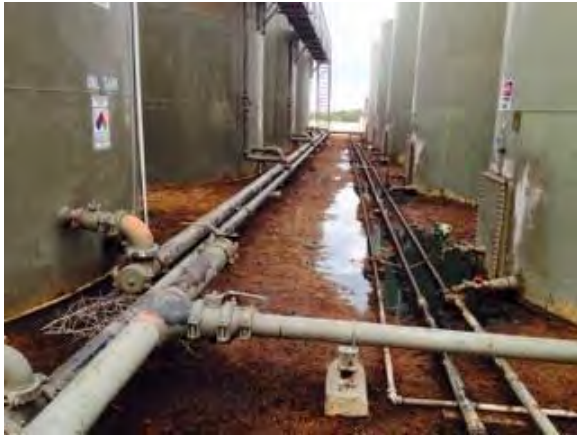
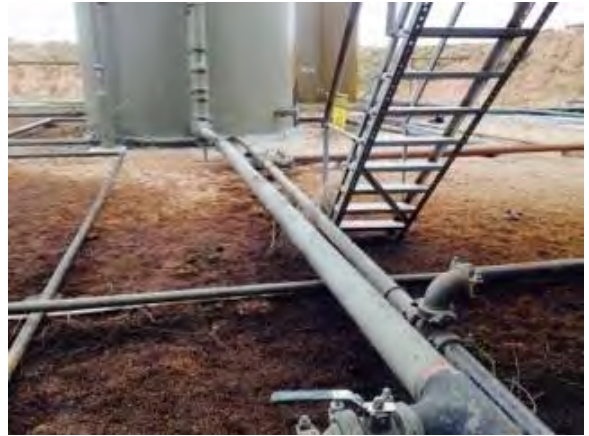
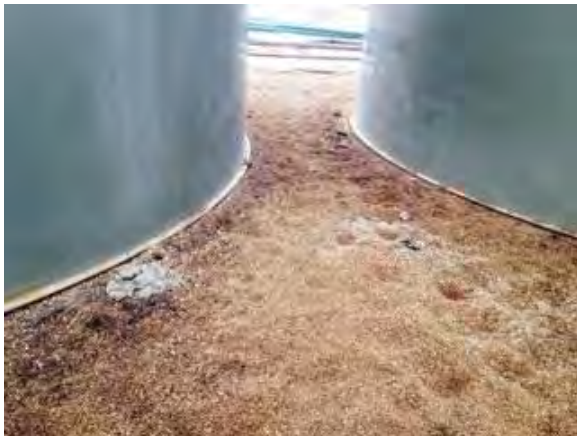
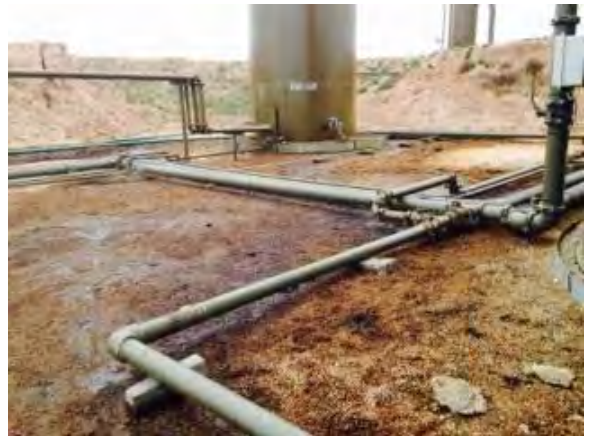
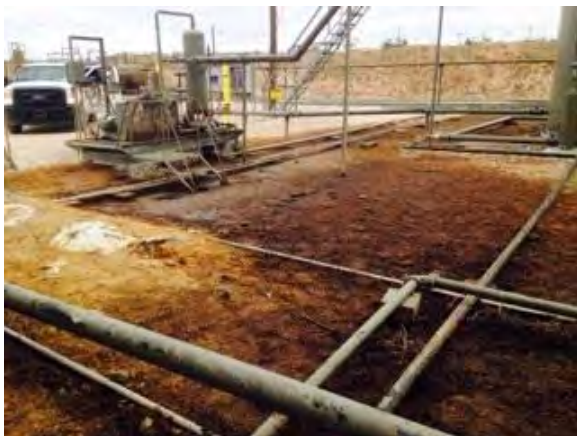
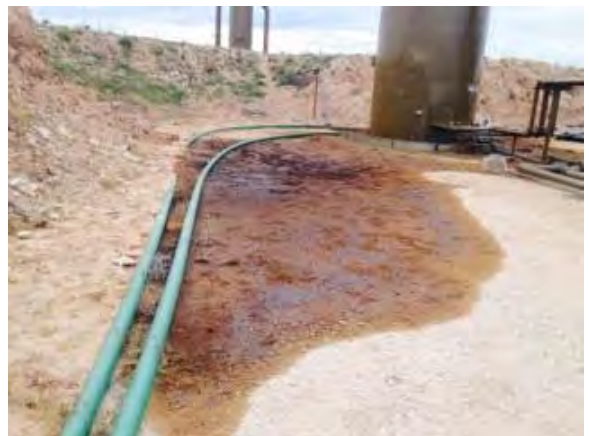
## PHOTO PAGE

The site is located east of Loving, NM, in Eddy County. The spill site resulted from a broken rod, causing an overflow of a pop off tank. A total of approximately 124.71 barrels of produced water was released with 121 barrels of produced water recovered. An initial C-141 was submitted to NMOCD on November 3, 2016 (Appendix I).
