# SITE CHARACTERIZATION AND REMEDATION WORK PLAN

BE-7-4 Loop  
Eddy County, New Mexico

**December 20, 2016**

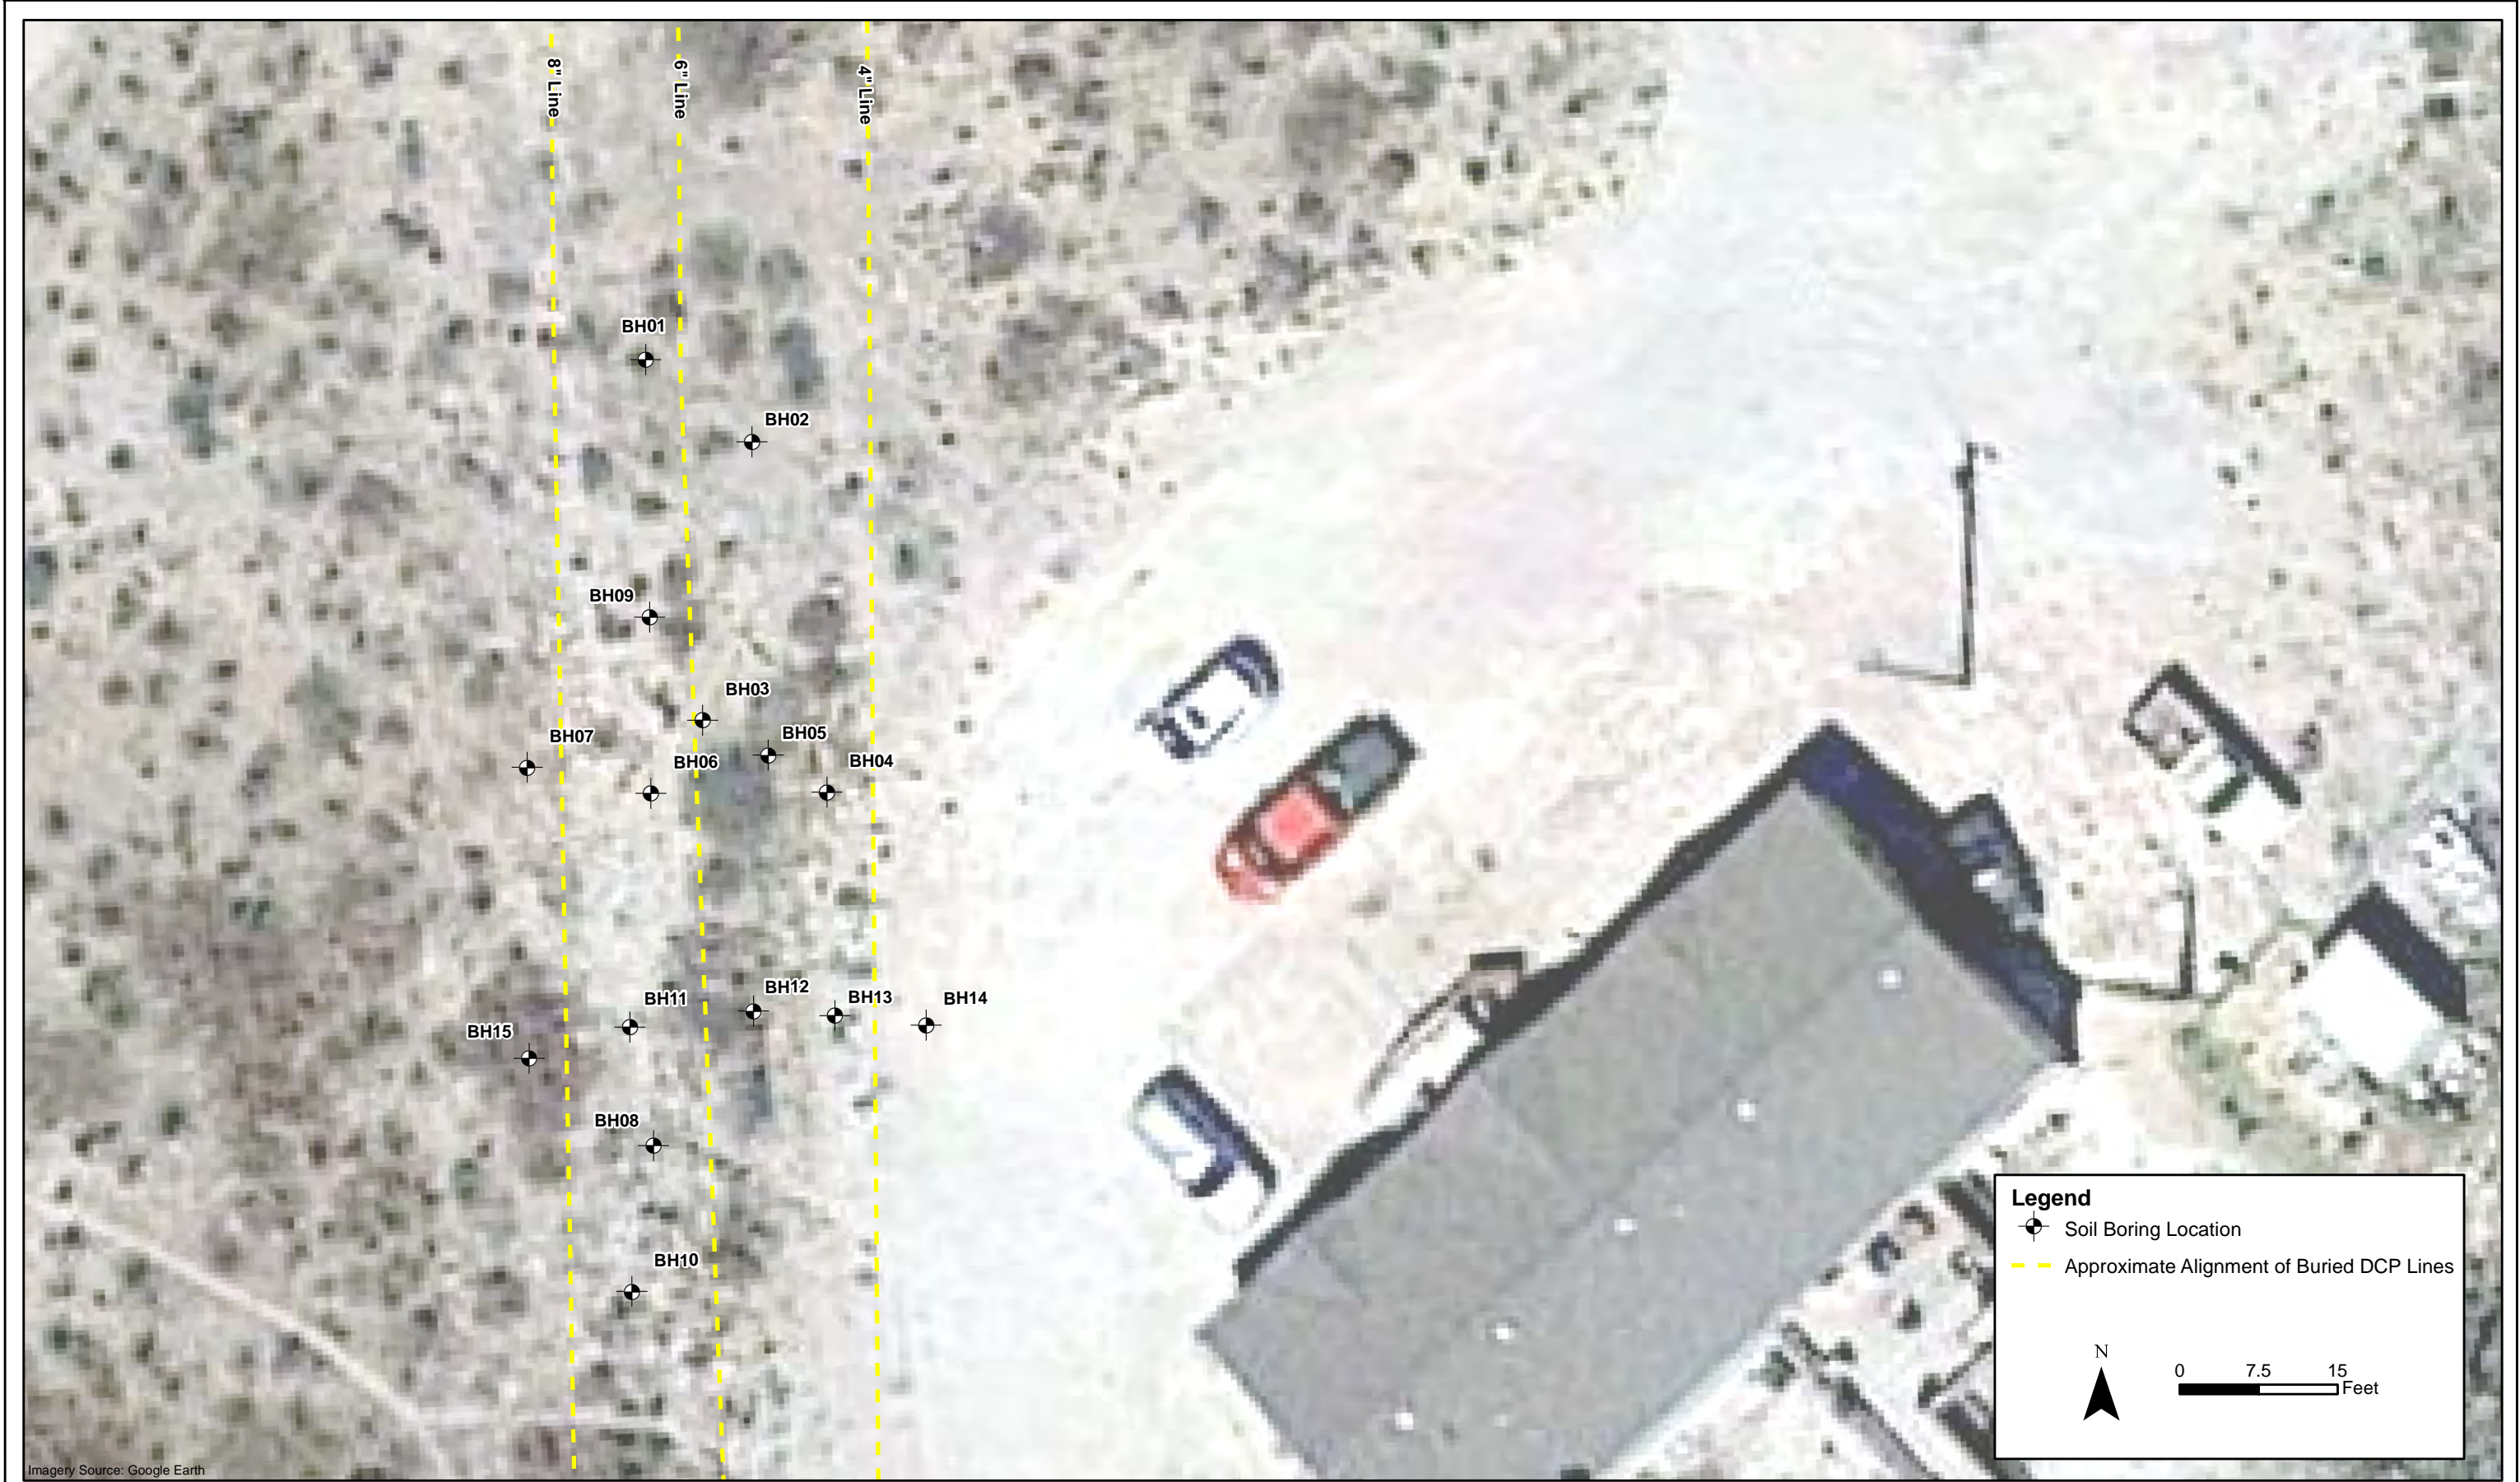
Figure  
2

On December 6 and 7, 2016, drilling activities at the Site were conducted using a combination of direct push and hand augur drilling methods. Major soil types were identified using the Unified Soil Classification System (USCS) and secondary characteristics such as grain size distribution, moisture content, density/plasticity, and visual/olfactory impacts were noted during borehole logging and soil sampling activities. Soil boring logs are included in Appendix B and the borehole global positioning system (GPS) coordinate locations were collected and are illustrated on Figure 2. Based on drilling and soil sampling, the Site subsurface typically consists of fine sand, silt, and some clay. Groundwater was not encountered within any of the borings that were conducted.

Site And Borehole Location  
Map

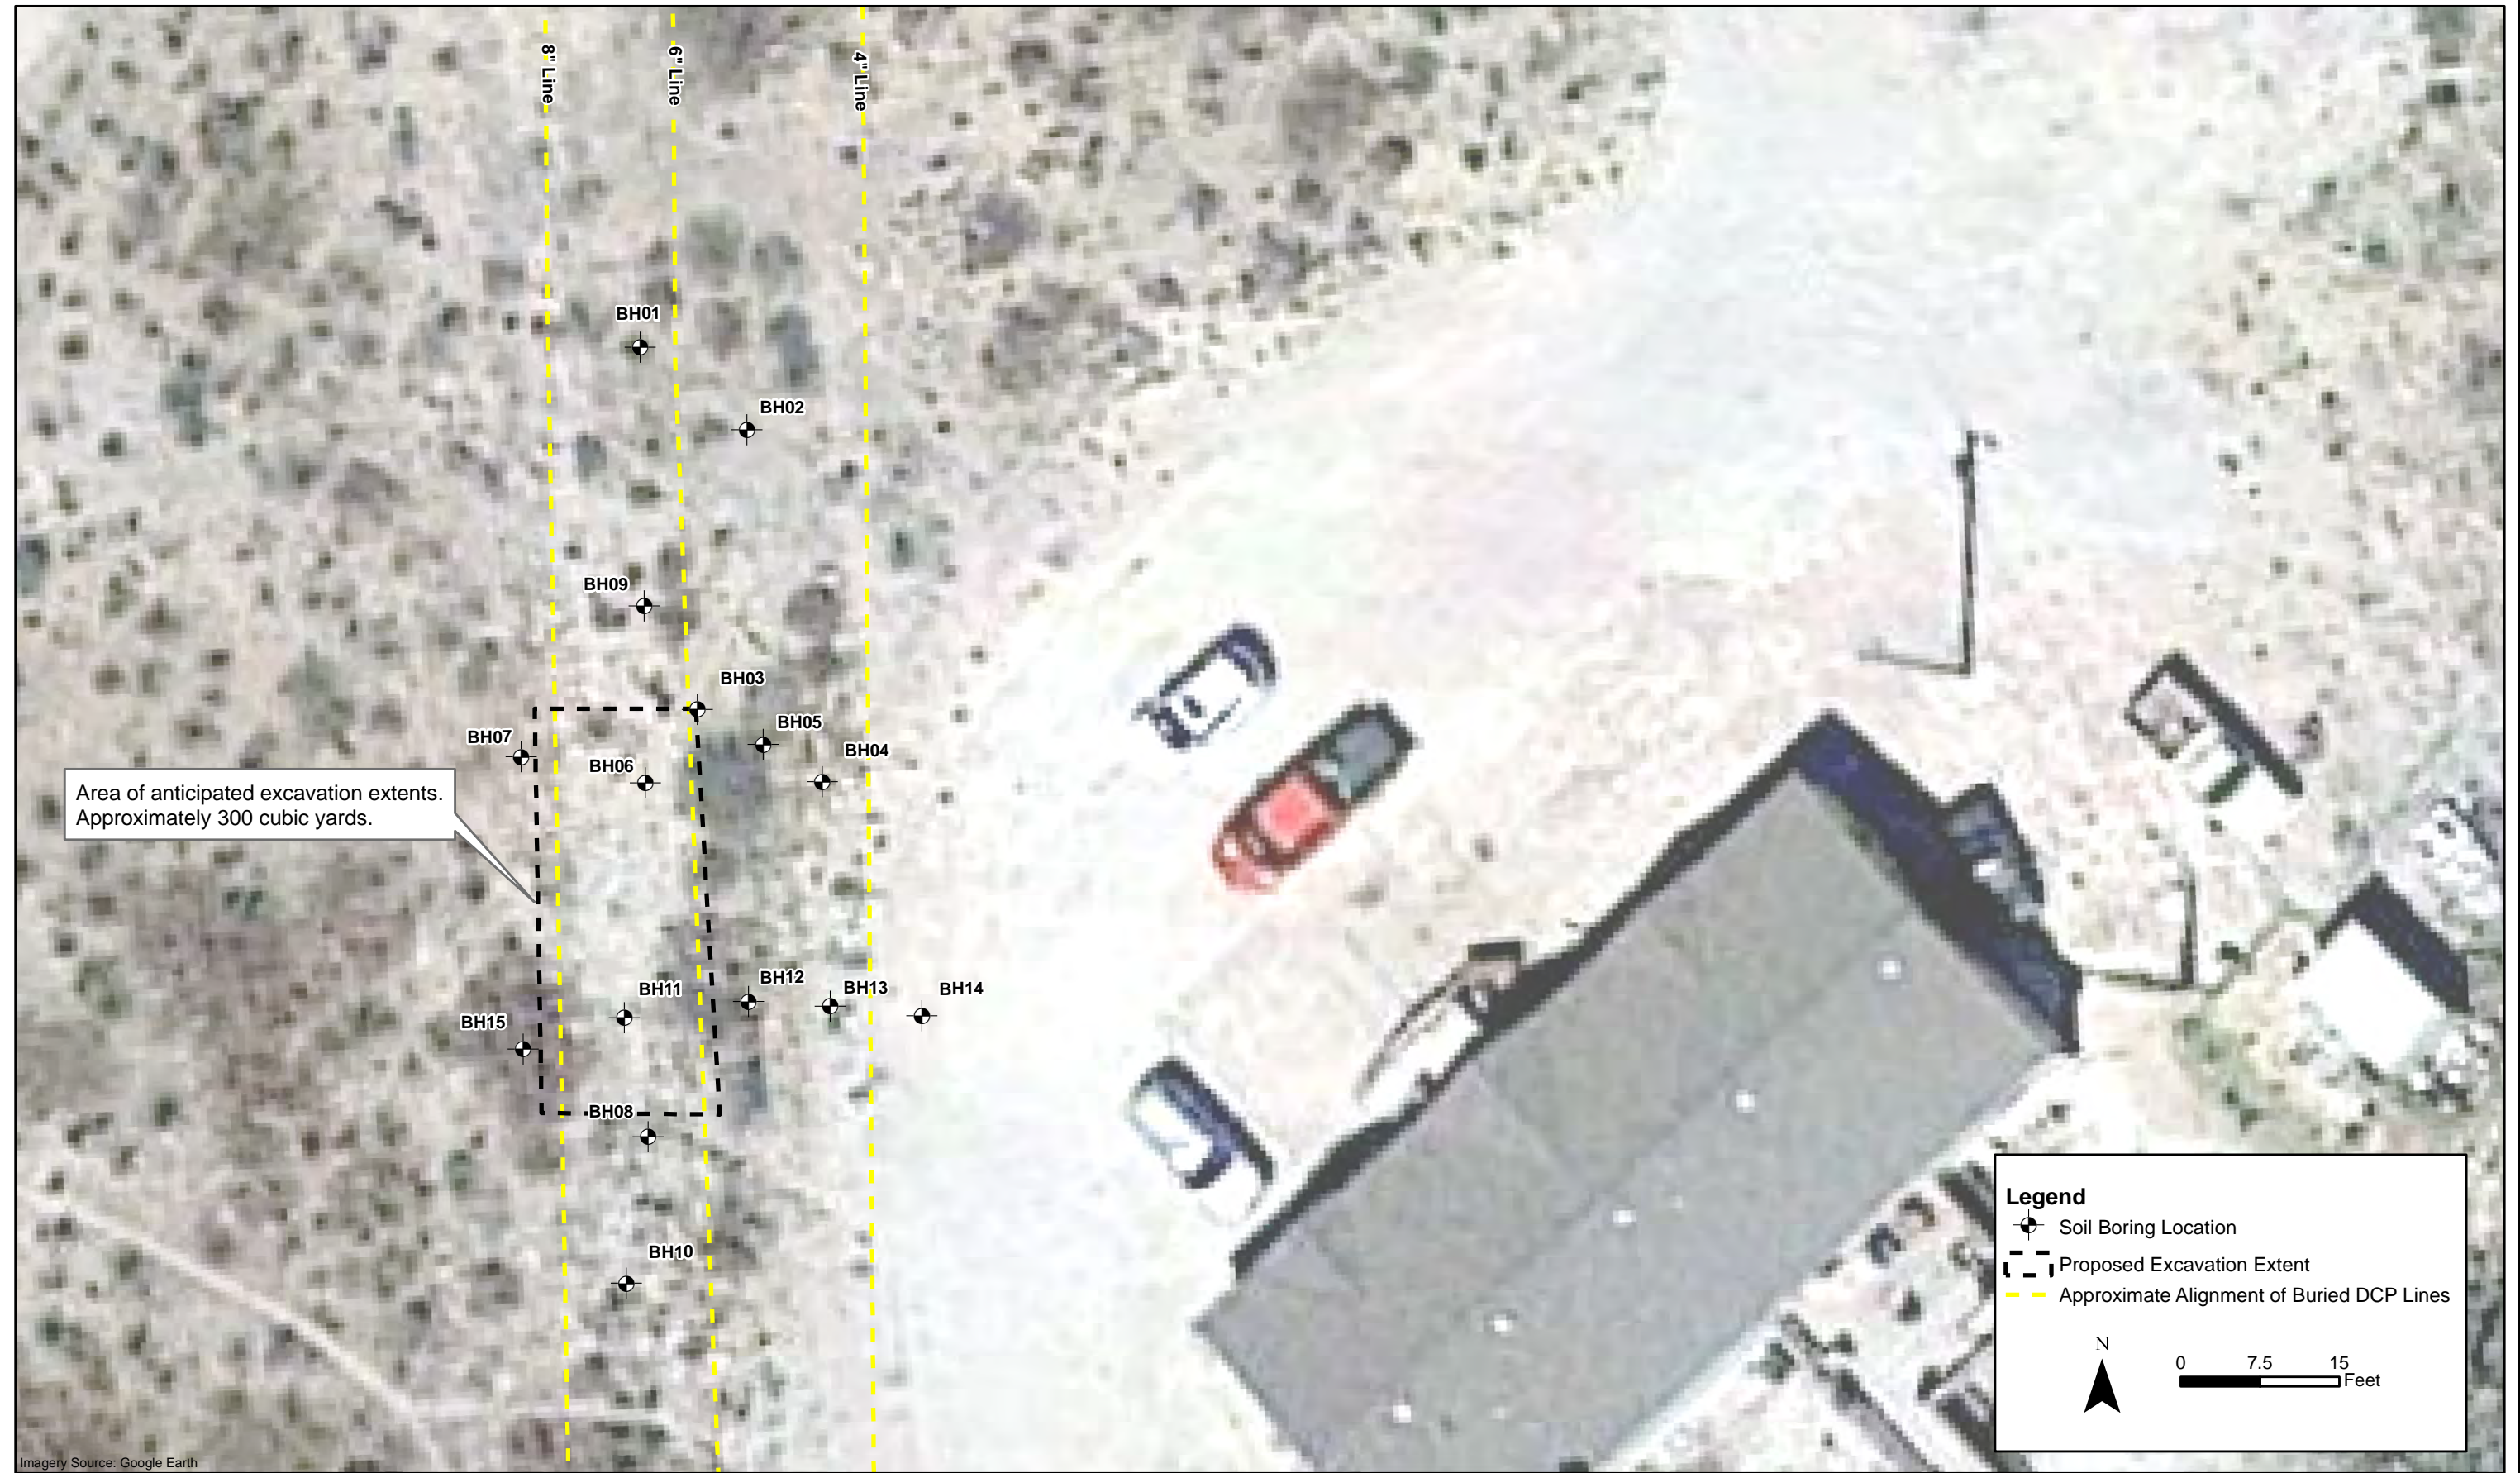
Figure  
4

Physical and laboratory analysis confirm that soil impacts exceeding one or more of the NMOCD Cleanup Goals for the Site were exceeded. As summarized on Table 1 and presented on Figure 3, BTEX and TPH exceedances were observed between just below the surface to approximately 14 feet bgs in the vicinity of BH06 and to approximately seven feet bgs within the vicinity of BH11. However, the vertical extents of petroleum hydrocarbon impacts were confirmed through laboratory analysis and PID readings that were collected at those locations. Chlorides were observed above the NMOCD guideline of 250 mg/kg within borehole BH06 at 5-feet bgs but were below the guideline at BH03. Based on the information that has been gathered through the field activities described herein and the estimated extent of BTEX and TPH impacted soils, approximately 300 cubic yards (cy) of petroleum hydrocarbon impacted material is present at the Site.

Anticipated Extents of Impacted  
Soil Excavation Area

Due to the relatively small amount of petroleum hydrocarbon impacted soil as well as the location and lateral and vertical extents of the impacts, mechanical excavation and subsequent disposal at an approved facility has been chosen as the preferred remedial alternative for this Site. Excavated soil will be transported under manifesting procedures to the Lea Land Inc. Landfill in Eddy County, NM. Excavated soil will be field screened using PID headspace sampling techniques and soil samples from the excavation sidewalls and base will be collected to verify that impacted soil is completely removed. Soil samples will be submitted to Cardinal for laboratory analysis of BTEX using USEPA Method 8021B and TPH-GRO/DRO using USEPA Method 8015. Once clean extents have been verified through laboratory analysis, clean backfill material will be backfilled and compacted within the open excavation in 1-foot lifts.
