CORRECTIVE ACTION REPORT

BC Cass
32.309828, -104.197419
NE ¼, NW ¼, S16 T23S R27E
Eddy County, New Mexico
NMOCD RP No.: 2RP-3907

December 21, 2016
Apex Project No. 725010112169

Enterprise Field Services LLC
PO Box 4324
Houston, TX 77252
Attention: Dina Ferguson

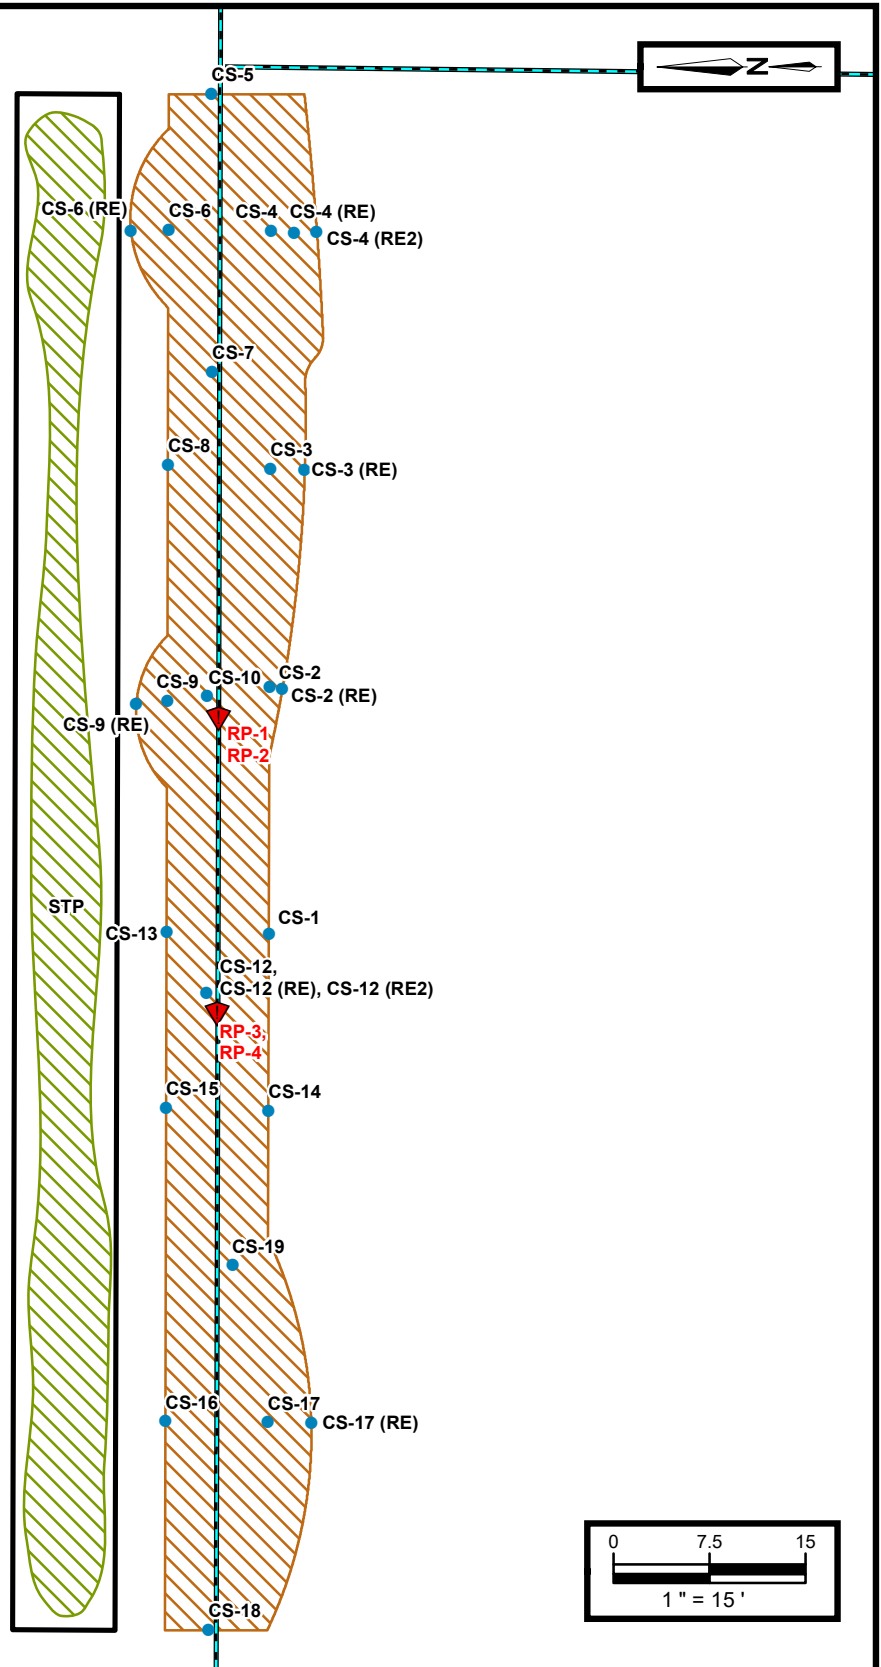
Release Points 1,2 and 3, 4 Were Observed to be 1 Foot Apart and are Represented as One Point for Visualization. A Small Stockpile on a 12'x12' Liner Was Observed 40' Southeast of Eastern Edge of Excavation on Initial Site Visit

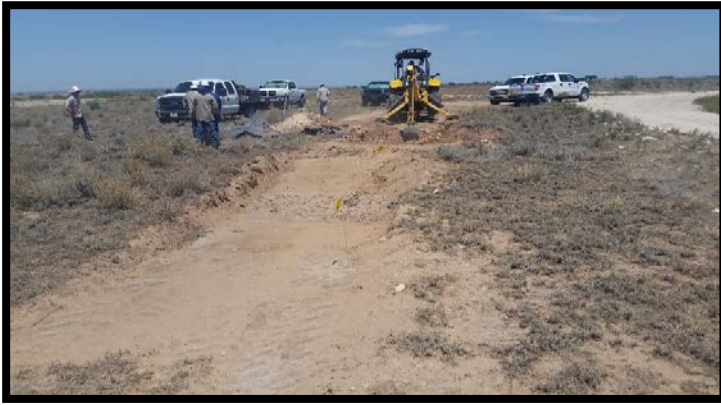
View of initial soil removal, facing east along pipeline ROW during remediation activities.

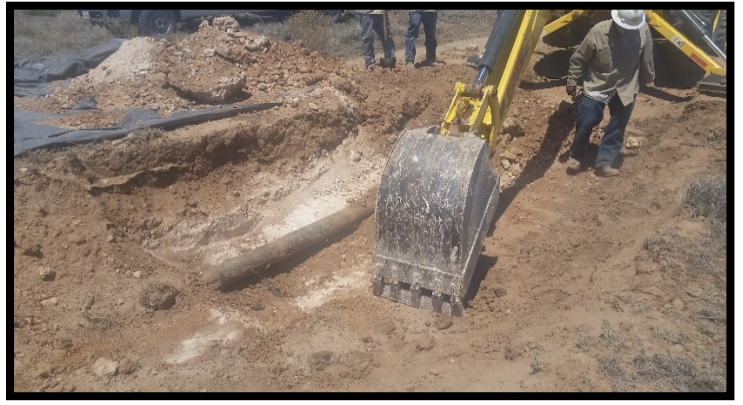
View of exposed pipeline during remediation activities, facing northeast.

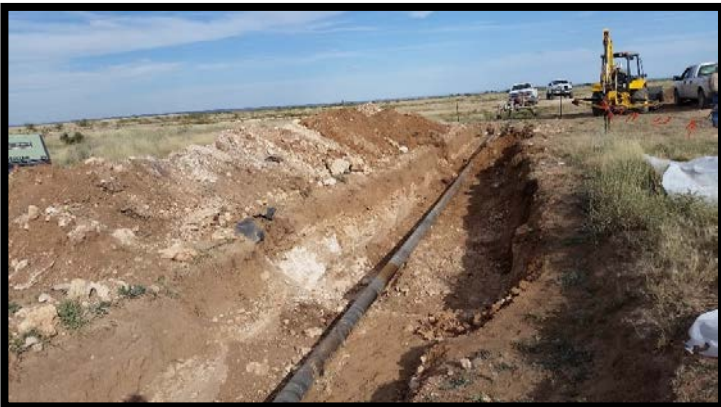
View of the length of the excavation during remediation activities, facing east.

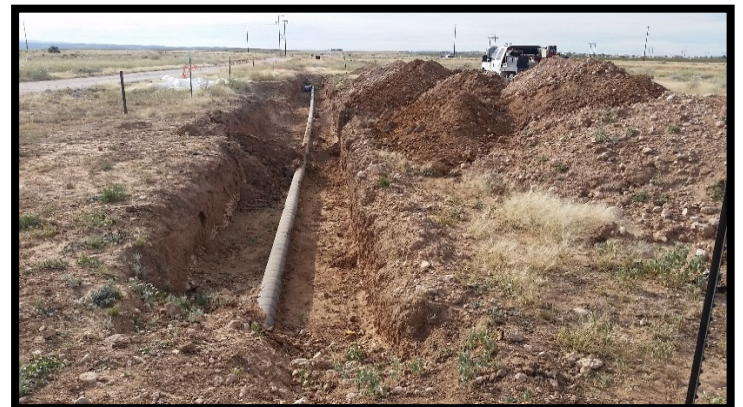
View of excavation and stockpile during remediation activities, facing west.

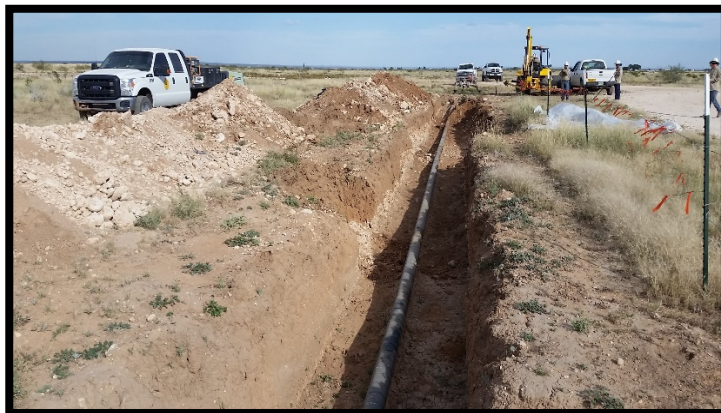
View of excavation during remediation activities, facing east.

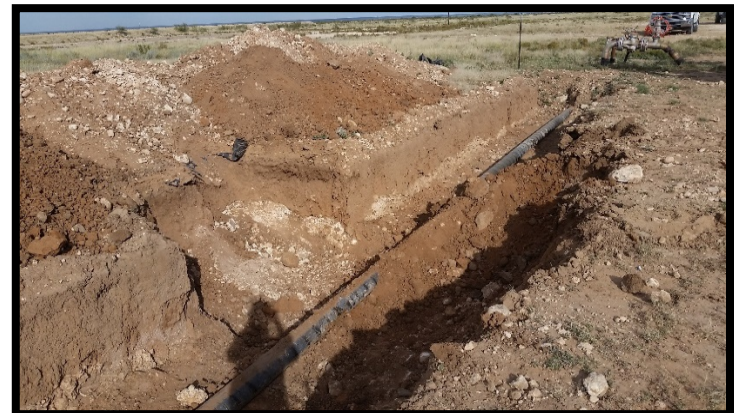
View of excavation during remediation activities, facing northeast.
