## CORRECTIVE ACTION REPORT

**Potash Line 1002**  
**32.082736, -104.050094**  
**NE ¼, SE ¼, S35 T25S R28E**  
**Eddy County, New Mexico**  
**2RP-3393**

November 29, 2016  
Apex Project No. 7250715102

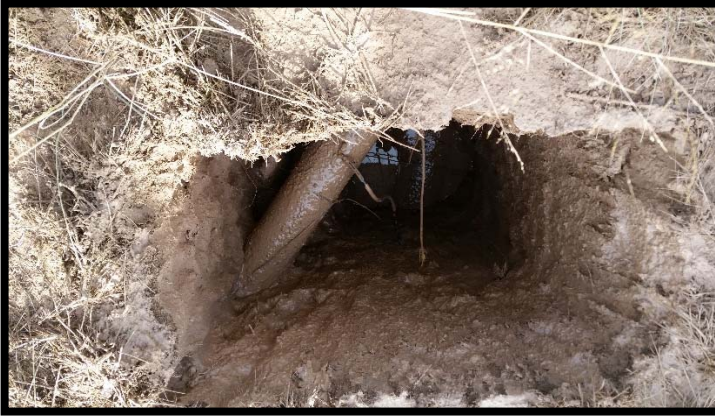
Close up view of exposed Enterprise Potash 1002 pipeline during initial hydroexcavation activities.

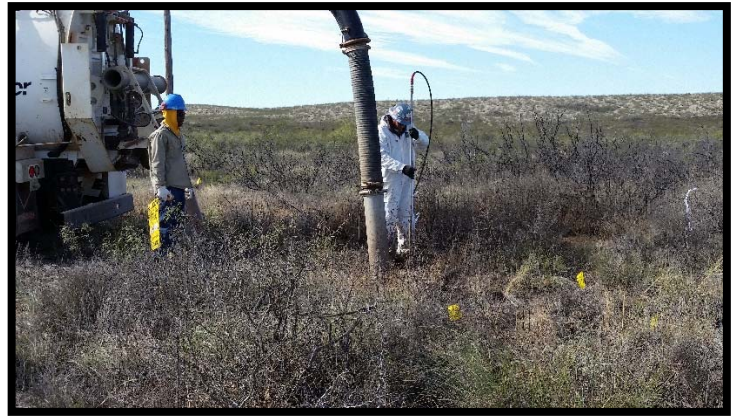
View of release point during initial hydroexcavation activities.

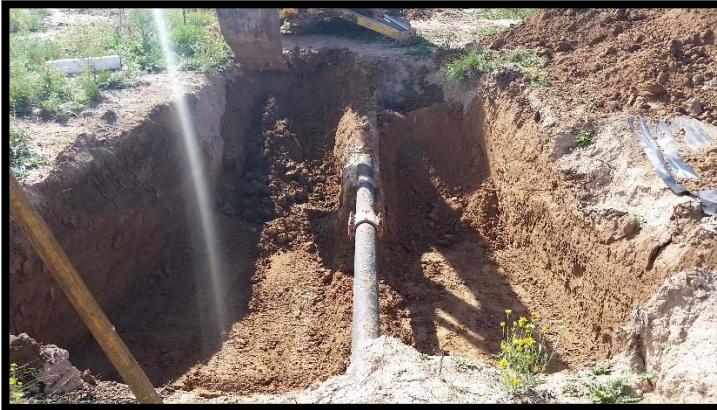
View of the length of the excavation during remediation activities, facing south.

- The Site was excavated utilizing heavy equipment to remove soils affected by the pipeline liquids. The final excavation dimensions measured approximately 10 feet wide by 20 feet long by five (5) feet deep. Approximately 45 tons of impacted soil was excavated and removed from the area impacted by the pipeline release.

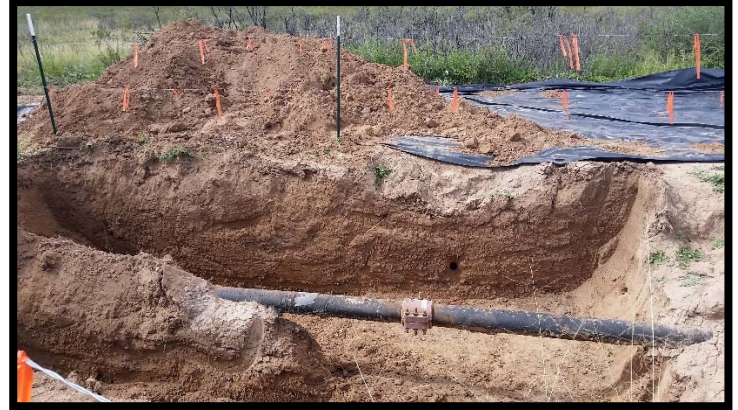
View of clamped pipeline and stockpiled soil during remediation activities, facing west.

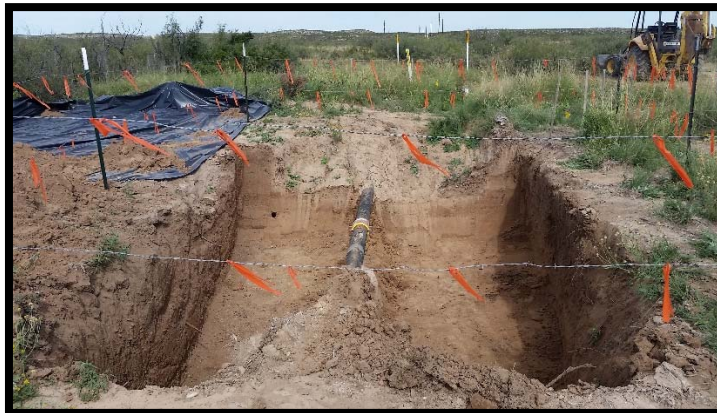
View of excavation during remediation activities, facing north.

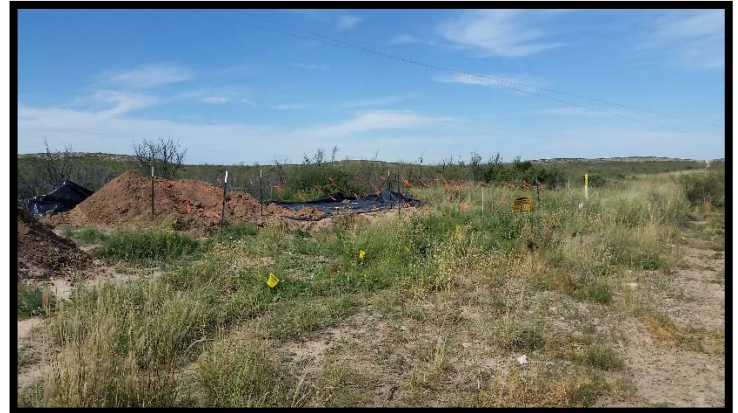
View of excavation and stockpile area during remediation activities, facing northwest.
