SUBJECT: Final Closure Report for Incident 2RP-3822 Brainard #008, API 30-015-10453, Unit O, Section 34-Township 18S-Range 29E NMPM, Eddy County, New Mexico

**FINAL CLOSURE FOR INCIDENT 2RP-3822**  
**REMNANT OIL OPERATING, LLC**  
**BRAINARD #008**

**UL O, SECTION 34, T18S R29E, NMPM**  
**EDDY COUNTY, NM**  
**NOVEMBER 18, 2016**

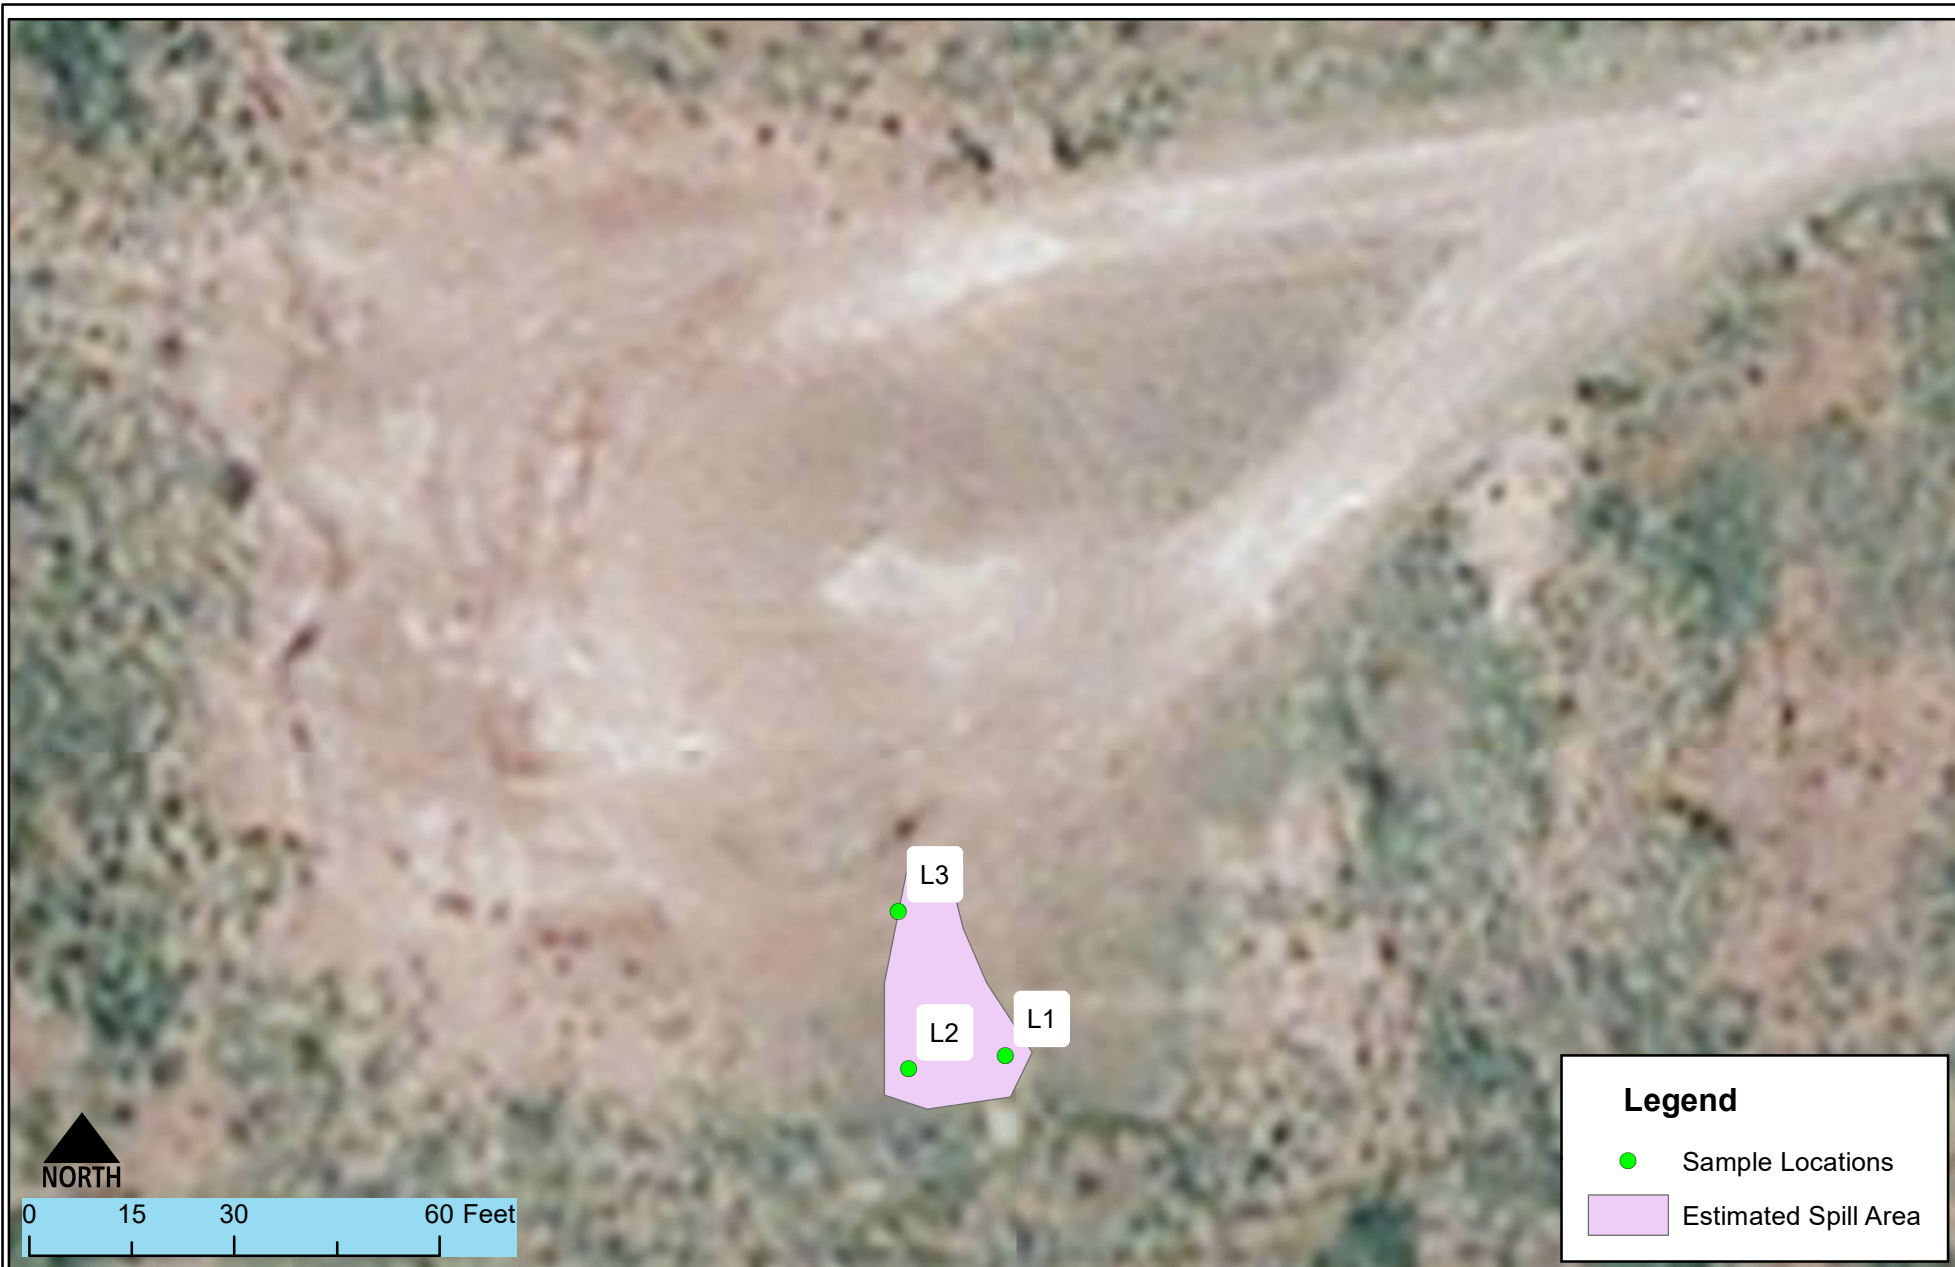
On October 20, 2016 after receiving 811 clearance, SMA field personnel reassessed the release area. Samples were collected to depths of one foot bgs. Specific sample locations for all samples are depicted on Figure 2 (Sample Location Map). All samples were collected and processed per NMOCD soil sampling procedures. The samples were sent under chain-of-custody protocols to Hall Environmental Analysis Laboratory for analysis for Total Chlorides using EPA Method 300.0.

- Sample Locations
- Estimated Spill Area

Site and Sample Map  
Brainard #8 - Remanant  
Loco Hills, New Mexico
