SUBJECT: WORK PLAN FOR INCIDENT 2RP-4051, Paul 25 24S 28E RB #221H, UNIT D SECTION 25-T24S-R28E NMPM,
API# 30-015-43018, EDDY COUNTY, NEW MEXICO

SOIL REMEDIATION WORK PLAN FOR INCIDENT 2RP-4051

MATADOR RESOURCES COMPANY

PAUL 25 24S 28E RB #221H
UL D, SECTION 25, T24S R28E, NMPM
API #30-015-43018
EDDY COUNTY, NM

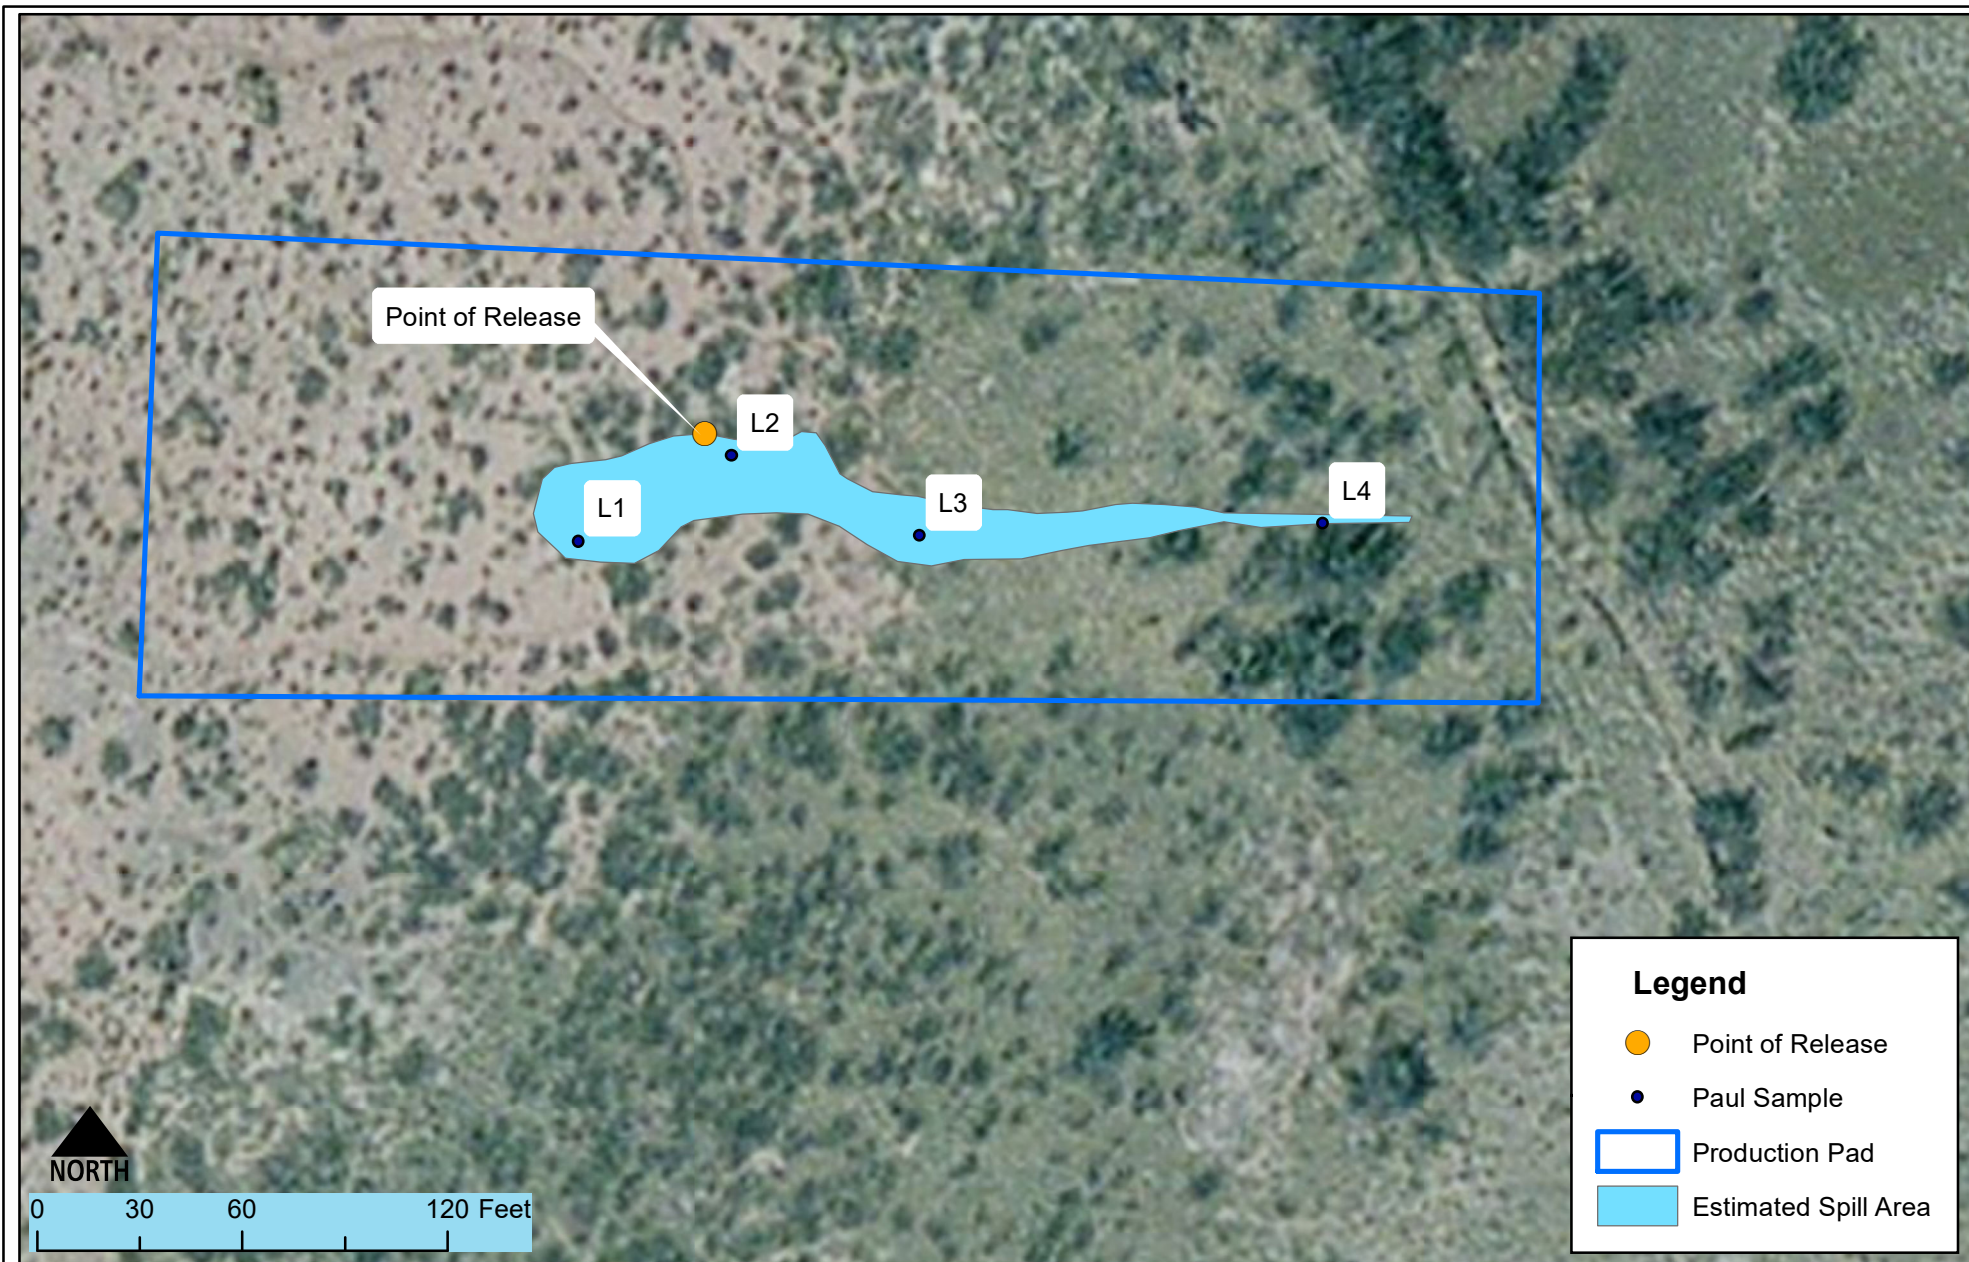
FIGURE 2

Soil contaminant concentrations found during the initial delineation are illustrated in Figure 2. A summary of the field analyses is included in Table 2. Laboratory reports are included in Appendix A.

DETAILED SITE AND SAMPLE LOCATION MAP

SMA will begin the excavation of affected soils, with approval from area utilities owners via 811 and NMOCD. SMA will continuously guide the excavation activities by collecting composite soil samples for field screening with a mobile titration unit (EPA 4500) and a calibrated PID. Excavation will occur to depths of up to 1 foot bgs sufficient to remove the impacted materials to NMOCD requirements as indicated by the sample results in Table 2. Affected soils will be removed from these areas before closure samples are collected at the final depth of excavation and from the sidewalls. Approximately 30 cubic yards of contaminated soil are projected to be removed and replaced with clean backfill material to return the surface to previous contours. The contaminated soil will be transported for proper disposal at Lea Land, near Carlsbad, NM, an NMOCD permitted disposal facility.
