Closure Report

Site Name:	CCAP State Com #002
Company:	COG Operating LLC
Legal Description:	U/L O, Section 16, T22S, R27E
County:	Eddy County, NM
GPS Coordinates:	N 32.38799° W 104.19135°

Date of Release:	09/06/2016
Type of Release:	Oil and produced water
Source of Release:	Oil tank
Volume of Release:	5 bbls oil, 50 bbls produced water
Volume Recovered:	5 bbls oil, 50 bbls produced water

Remediation Parameters:	In the area of SP1, the excavation will be 3 feet or as practicable. The rest of the leak area will be excavated to a depth of 2 feet. The entire site will then be backfilled with clean soil.	
Remediation Activities:	02/17/2017 to 02/23/2017	
Plan Sent to OCD:	02/07/2017	Email from Cliff Brunson to Mike Bratcher
OCD Approval of Plan:	02/09/2017	Email from Mike Bratcher to Cliff Brunson
Plan Sent to BLM:	n/a	n/a
BLM Approval of Plan:	n/a	n/a

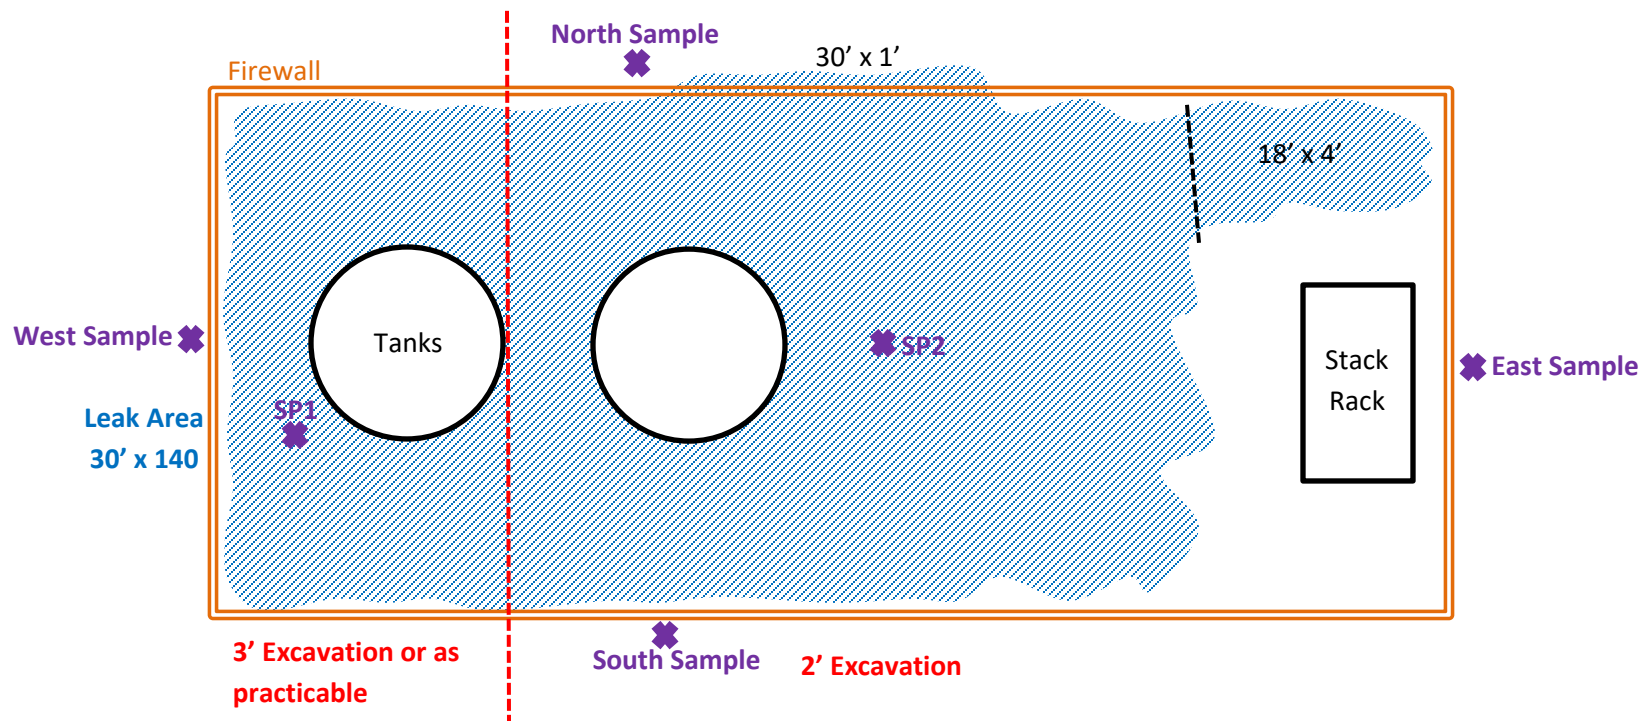
COG, CCAP State Com #002

Leak Date: 09/06/2016
Eddy County, NM
API# 30-015-31567
RP# 2RP-3881

East Sample, Hand Auger
-

Leak Point
-

North Sample, Hand Auger
-

Sample Points, Hand Auger
-

South Sample, Hand Auger
-

Spill Area, 2 ft Excavation
-

Spill Area, 3 ft Excavation as practicable
-

West Sample, Hand Auger
