Closure Report

Site Name:	Big Walt CTB
Company:	Oxy Permian Ltd.
Legal Description:	U/L H, Section 2, T22S, R24E
County:	Eddy County, NM
GPS Coordinates:	N 32.42237° W 104.46065°

Date of Release:	12/19/2016
Type of Release:	Oil
Source of Release:	Tank spill due to battery PLC failure
Volume of Release:	10 bbls
Volume Recovered:	8 bbls

Oxy, Big Walt CTB

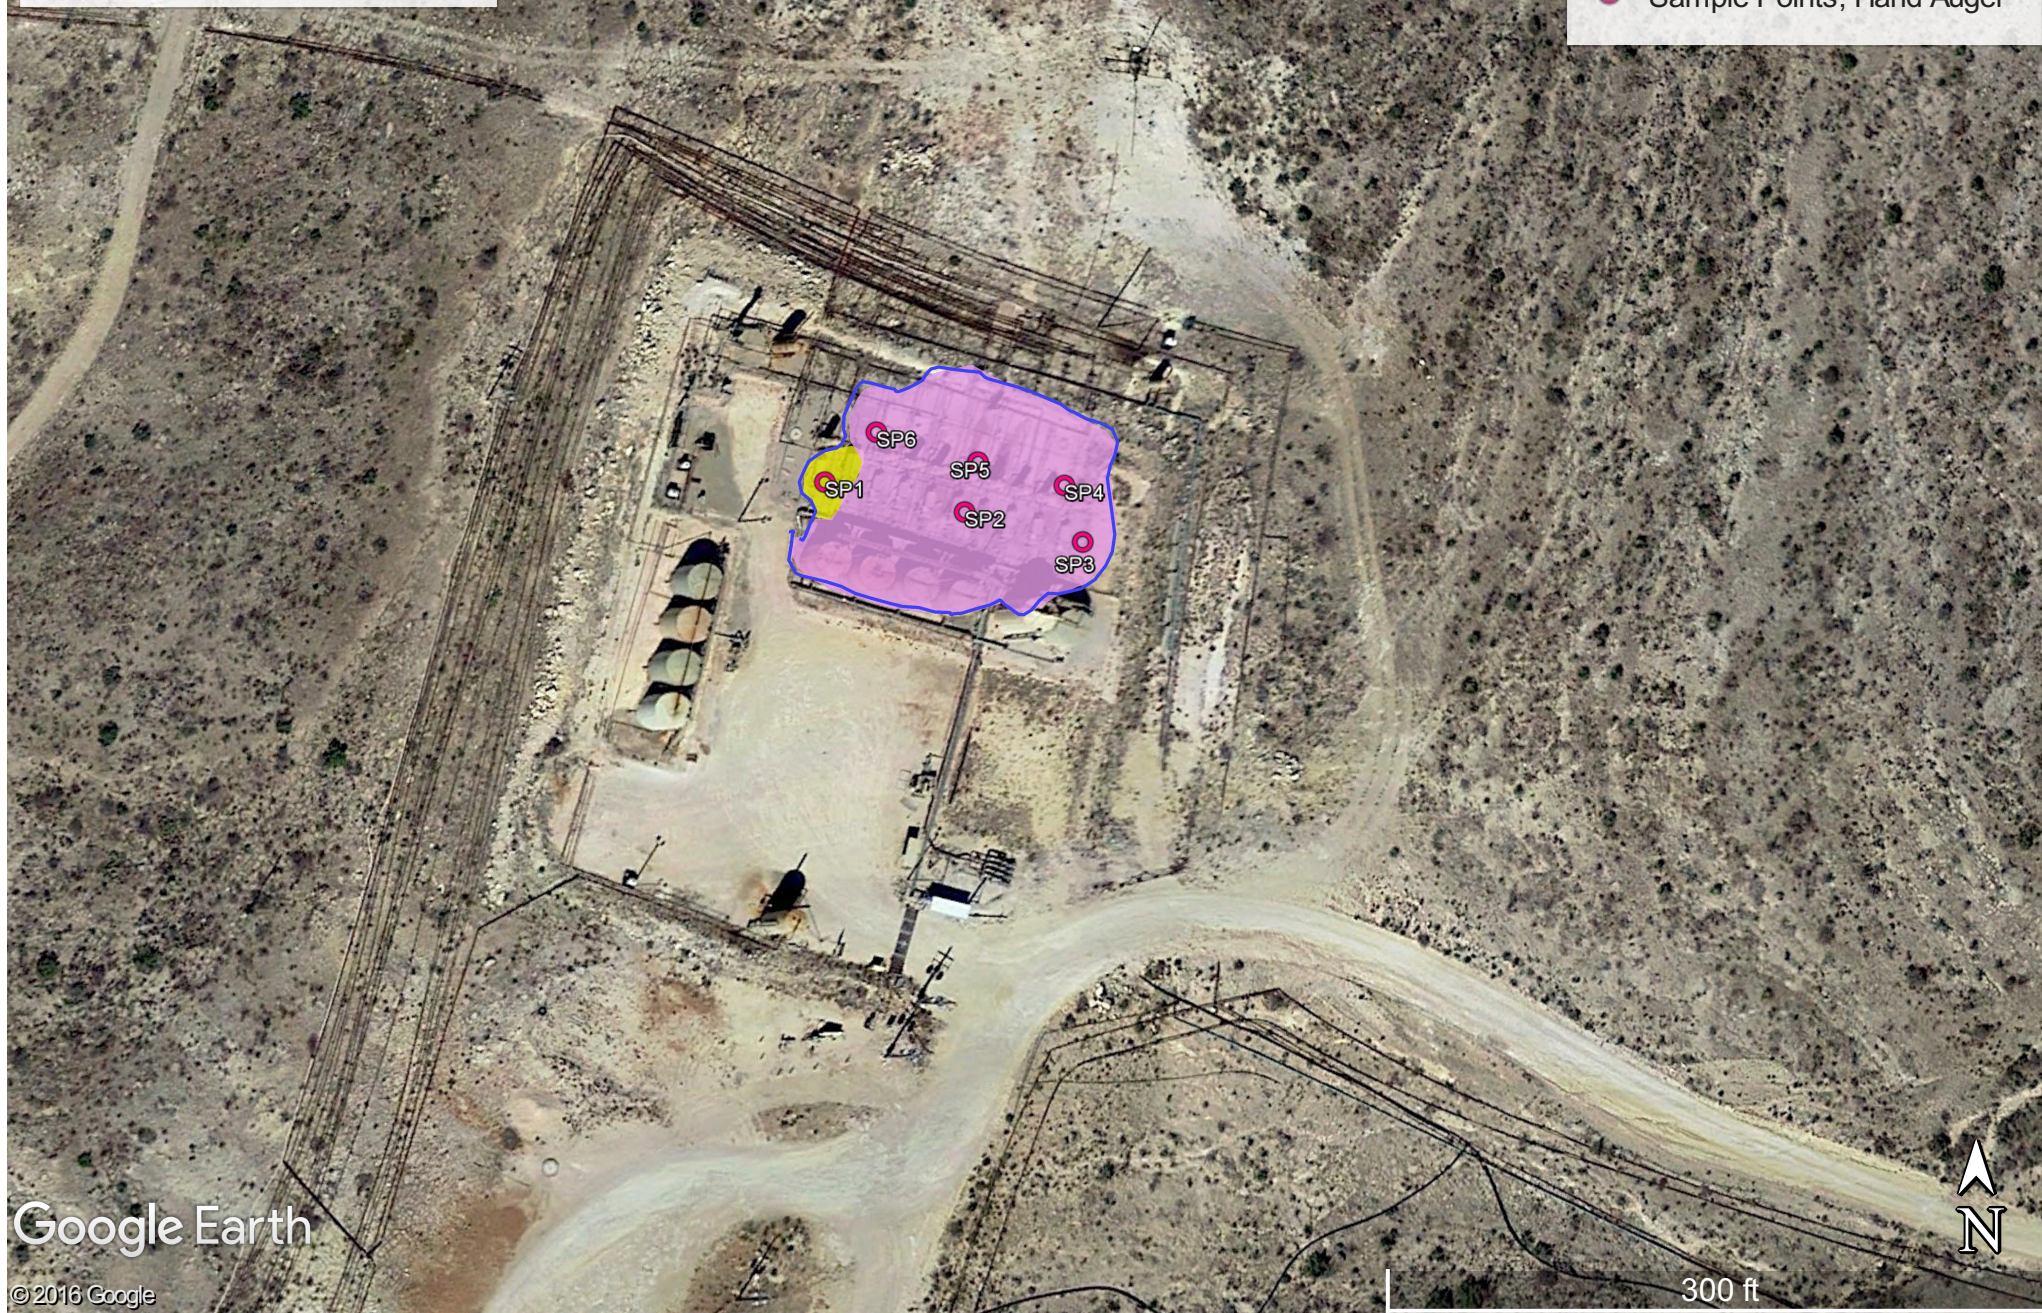
Leak Date: 12/19/2016
Eddy County, NM
API# 30-015-33442
RP# 2RP-4069

1' Excavation
-

6" Excavation
-

Spill Area
-

Sample Points, Hand Auger

Samples, Hand Auger

SP1, N 32.42267 W-104.46115

SP2, N 32.42264 W-104.46095

SP3, N 32.42260 W-104.46079

SP4, N 32.42267 W-104.46082

SP5, N 32.42270 W-104.46094

SP6, N 32.42273 W-104.46108

Remediation Parameters:	Excavate the entire leak to a depth of 6 inches, except in the area of SP1 which will be excavated to a depth of 1 foot. Backfill the site with clean soil.	
Remediation Activities:	April 2017	
Plan Sent to OCD:	02/07/2017	Email from Cliff Brunson to Mike Bratcher
OCD Approval of Plan:	02/15/2017	Email from Mike Bratcher to Cliff Brunson
Plan Sent to SLO:	02/07/2017	Email from Cliff Brunson to Amber Groves
SLO Approval of Plan:	02/27/2017	Email from Amber Groves to Cliff Brunson
