Report Type: Work Plan 2RP-3927

Site:	Blue Thunder 4 Federal #1					
Company:	COG Operating LLC					
Section, Township and Range	Unit M	Sec. 04	T 19S	R 31E		
Lease Number:	API No. 30-015-34125					
County:	Eddy County					
GPS:	32.684022° N			103.881225° W		
Surface Owner:	Federal					
Mineral Owner:						
Directions:	From the intersection of 126A (Maljamar Rd) and Lusk Plant Rd. in rural Eddy County, turn west on Lusk Rd for approximately 6.20 mi, turn west onto lease road for 0.4 miles, turn south for 0.6 mi to location.

Re: Work Plan for the COG Operating LLC., Blue Thunder 4 Federal #1, Unit M, Section 04, Township 19 South, Range 31 East, Eddy County, New Mexico. 2RP-3927

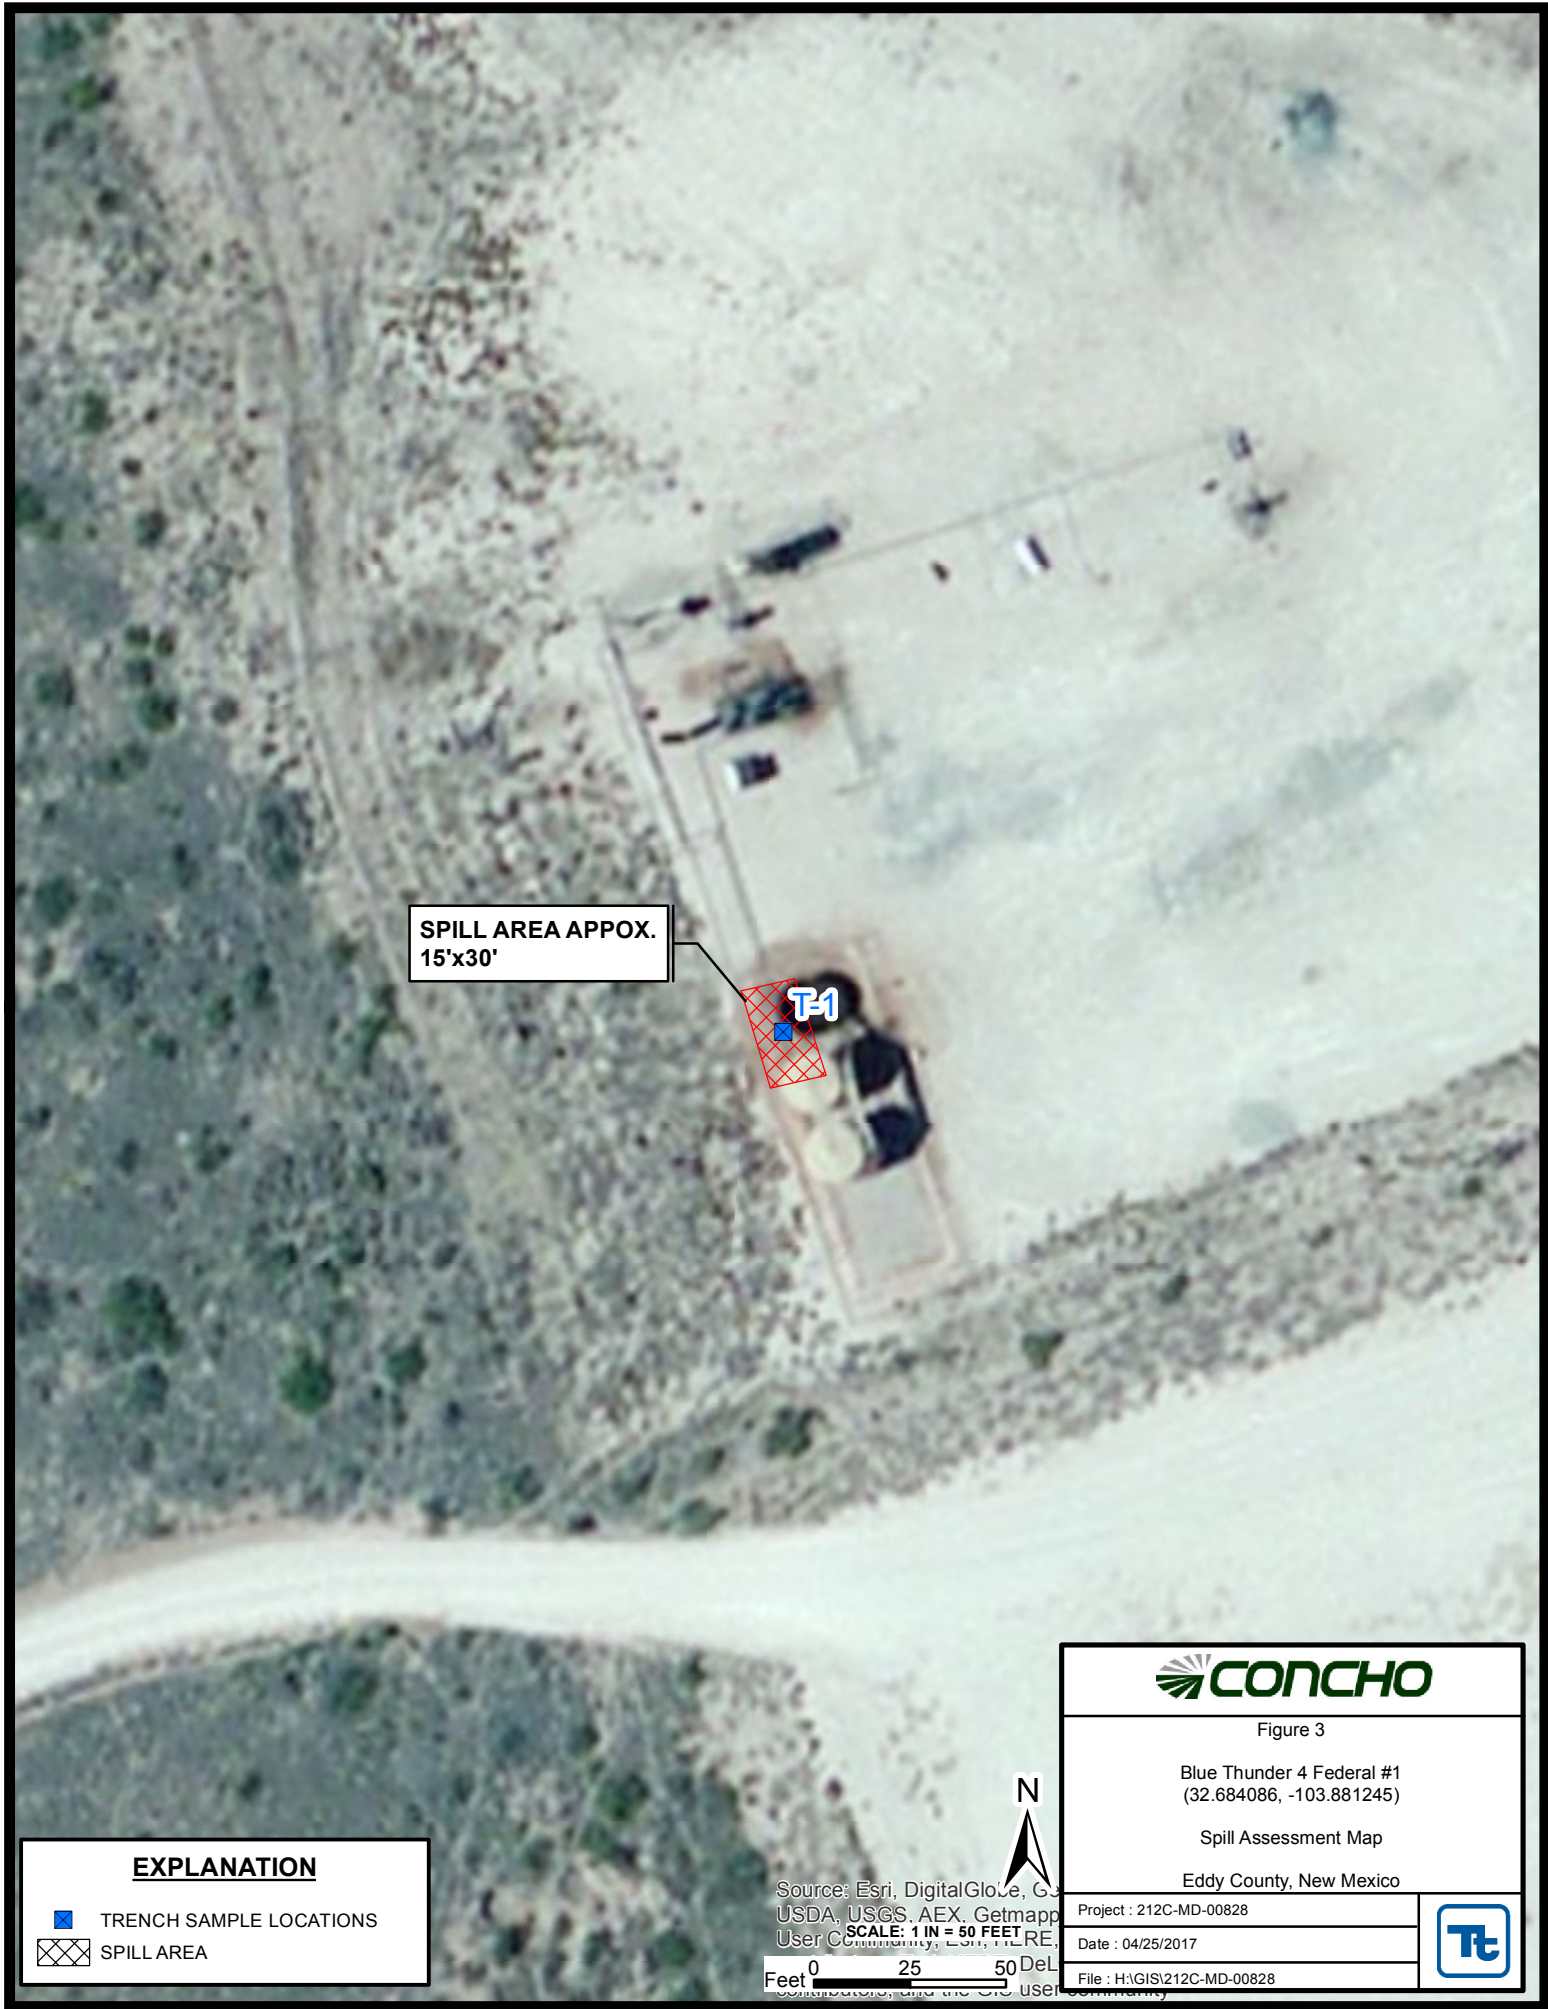
Prior to sampling the location, COG personnel performed a surficial scrape of the impacted area in order to prevent vertical migration of the impact. On December 19, 2016, COG personnel returned to the site to evaluate and sample the release area. Using a backhoe, one (1) trench (T-1) was installed to a total depth of 4.0' below surface within the release footprint, which measured approximately 15'x25'. Selected samples were analyzed for TPH analysis by EPA method 8015 modified, BTEX by EPA Method 8021B, and chloride by EPA method 300.0. Copies of the laboratory analysis and chain-of-custody documentation are included in Appendix C. The results of the sampling are summarized in Table 1. The trench location is shown in Figure 3.

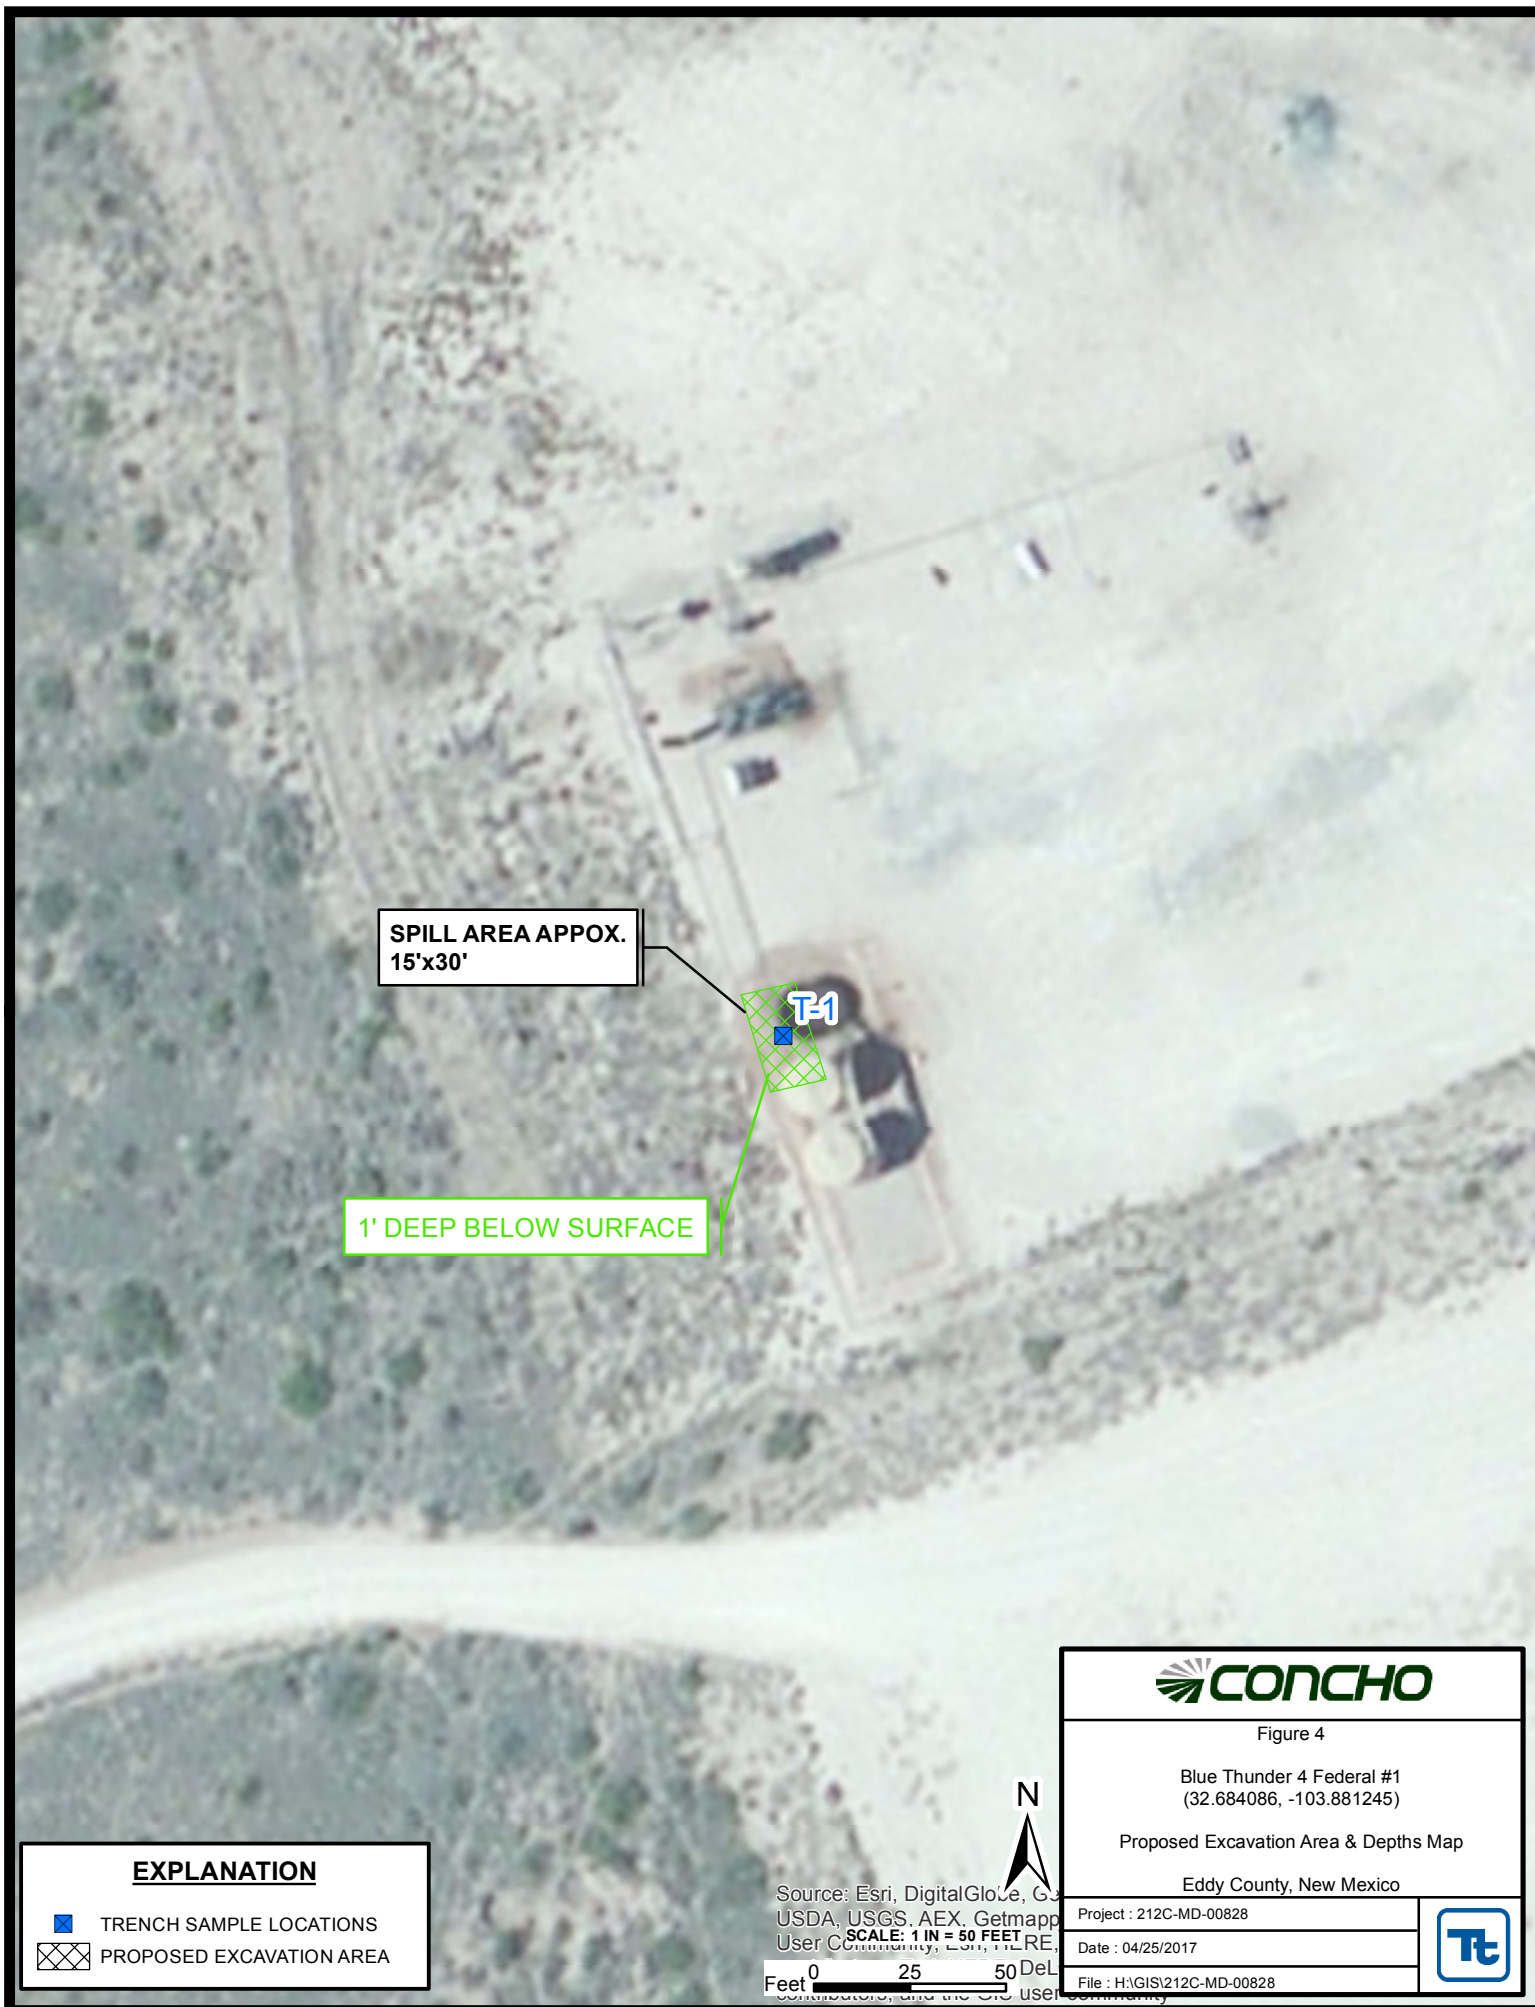
Figure 4

SPILL AREA APPROX.
15'x30'

T-1

1' DEEP BELOW SURFACE

PROPOSED EXCAVATION AREA

Proposed Excavation Area & Depths Map

Based on the laboratory results, COG proposes to remove the impacted material as highlighted (green) in Table 1 and shown on Figure 4. The area of trench (T-1) will be excavated to a depth of approximately 1.0' below surface to remove the elevated TPH concentrations in the shallow soils. Once excavated to the appropriate depth, the area will be backfilled with clean material to surface grade. All of the removed material will be transported offsite for proper disposal.

The proposed excavation depths may not be reached due to wall cave ins and safety concerns for onsite personnel. In addition, impacted soil around oil and gas equipment, structures or lines may not be feasible or practicable to be removed due to safety concerns for onsite personnel. As such, COG will excavate the impacted soils to the maximum extent practicable.
