**Apache Corporation**

**State SWD Flowline  
Remediation  
Completion**

Eddy County, New Mexico

April 3, 2017

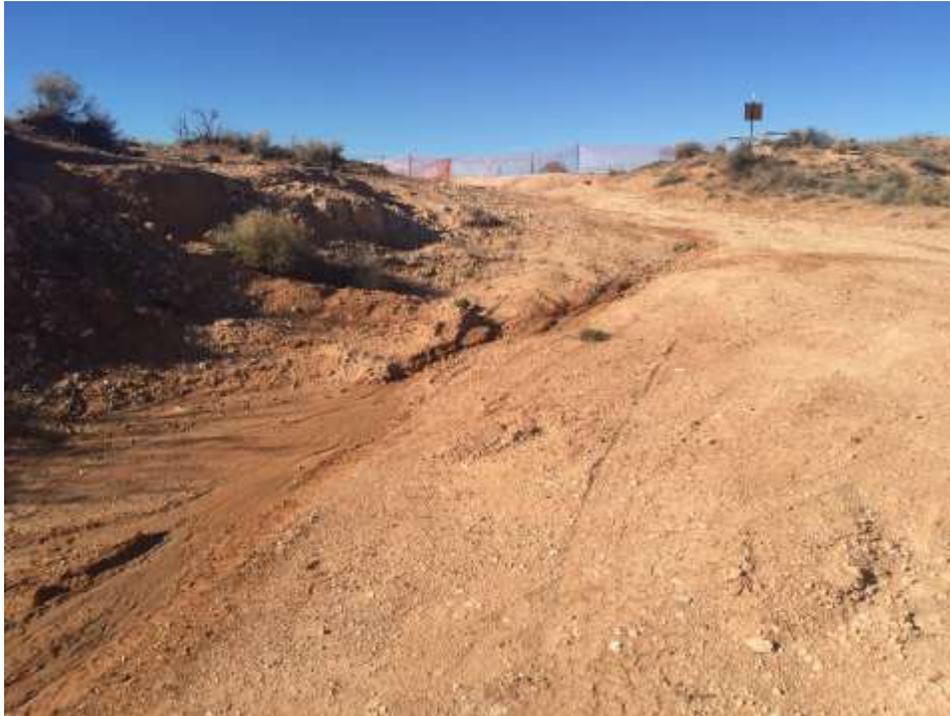
**Photograph: 1**

**Description:**  
Overview

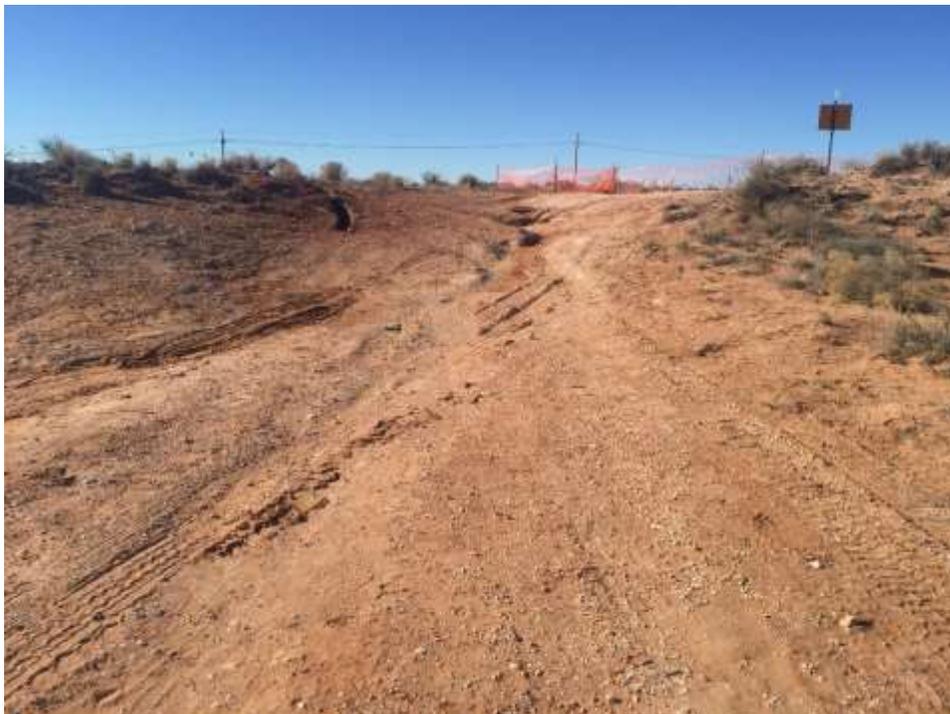
**Photograph: 2**

**Description:**  
Overview

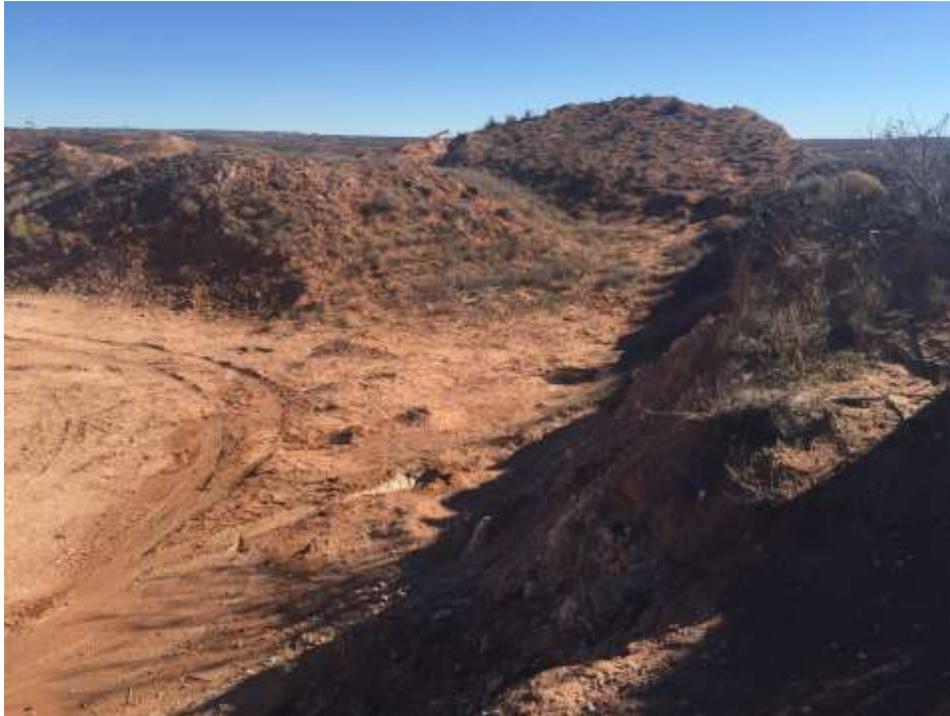
**Photograph: 5**

**Description:**  
Overview

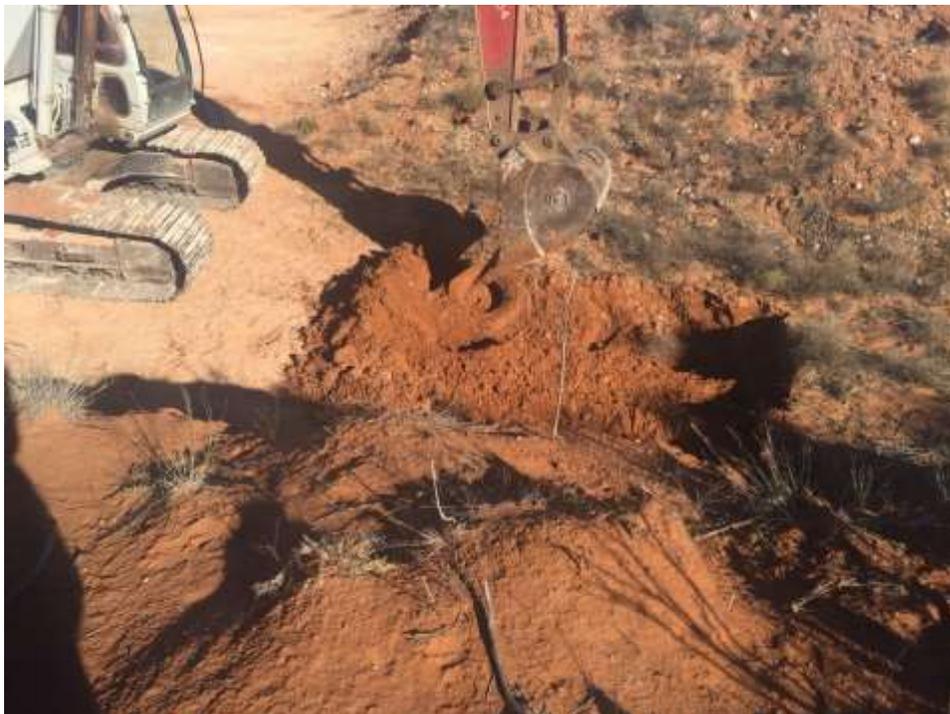
**Photograph: 6**

**Description:**  
Excavating

Apache, Arcadis, and EPI met on location to review plan, complete JSA, and clear any buried lines in the areas of excavation. An area was cleared and leveled for plastic liner to be positioned for stockpiling of the excavated soils. Two liners were laid for impacted soils and clean soils removed to reach impacted soils. Soils were analyzed with a Hanna GroLine Direct Soil EC Tester - Electrical Conductivity (EC) meter to ensure that soils were kept separately as soils were excavated.

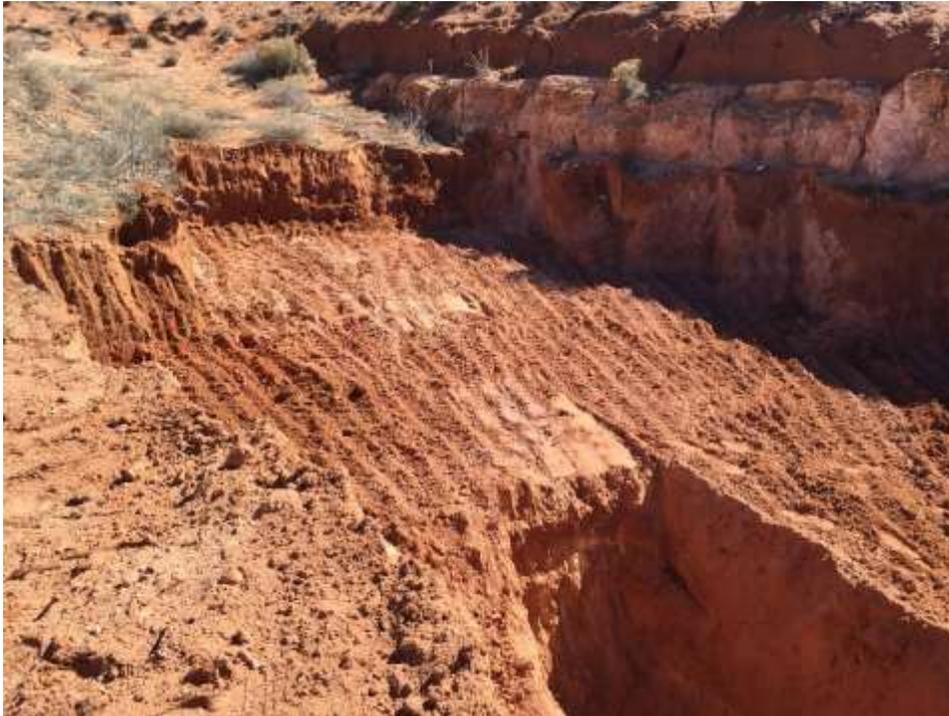
**Photograph: 7**

**Description:**  
Excavating

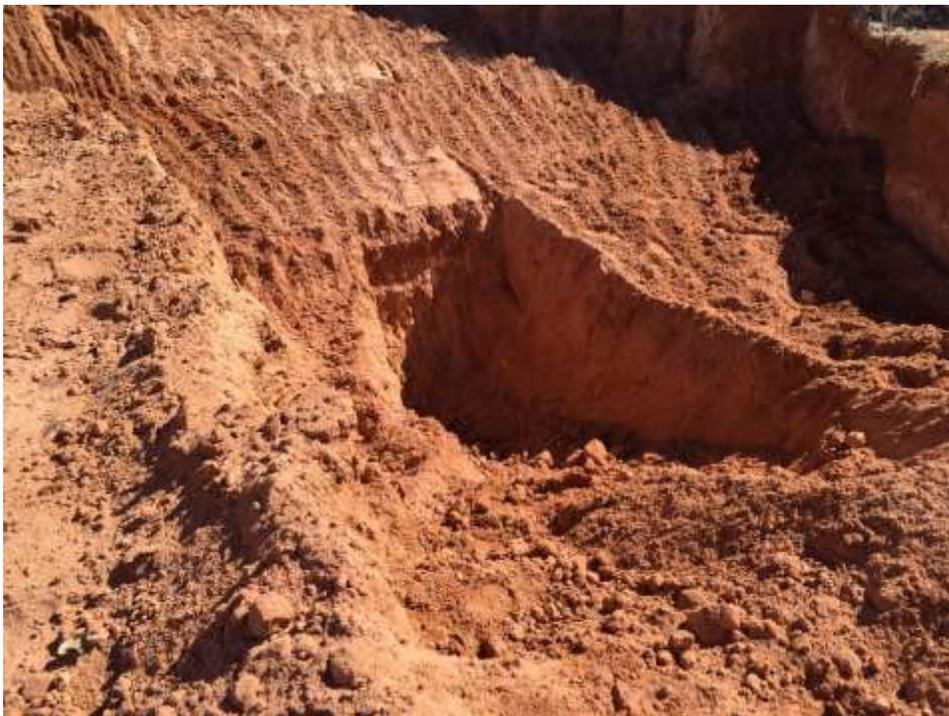
**Photograph: 8**

**Description:**  
Excavating

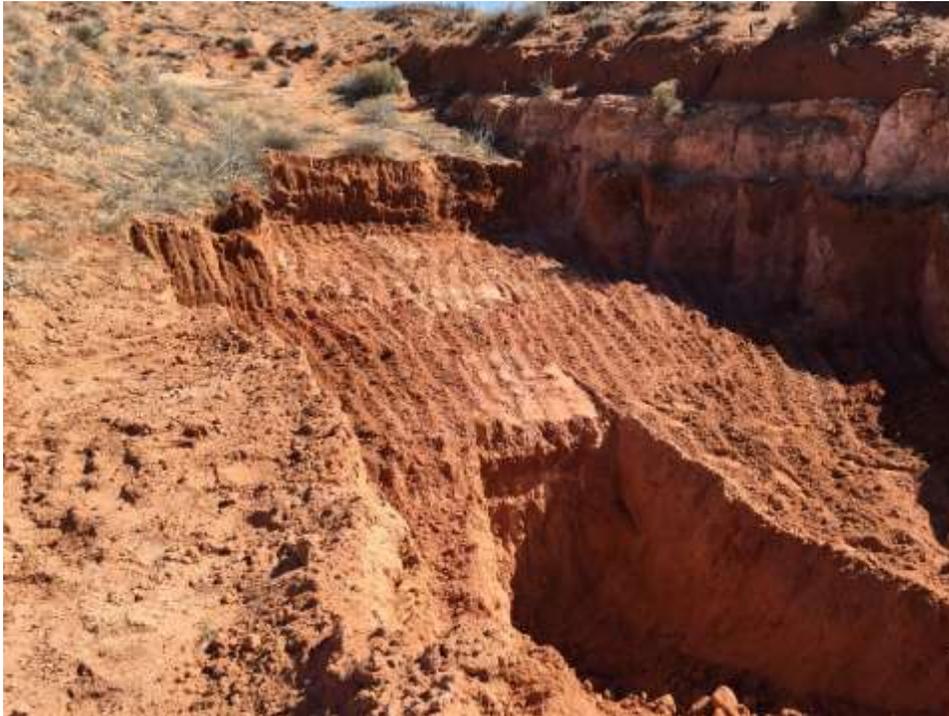
**Photograph: 9**

**Description:**  
Excavating

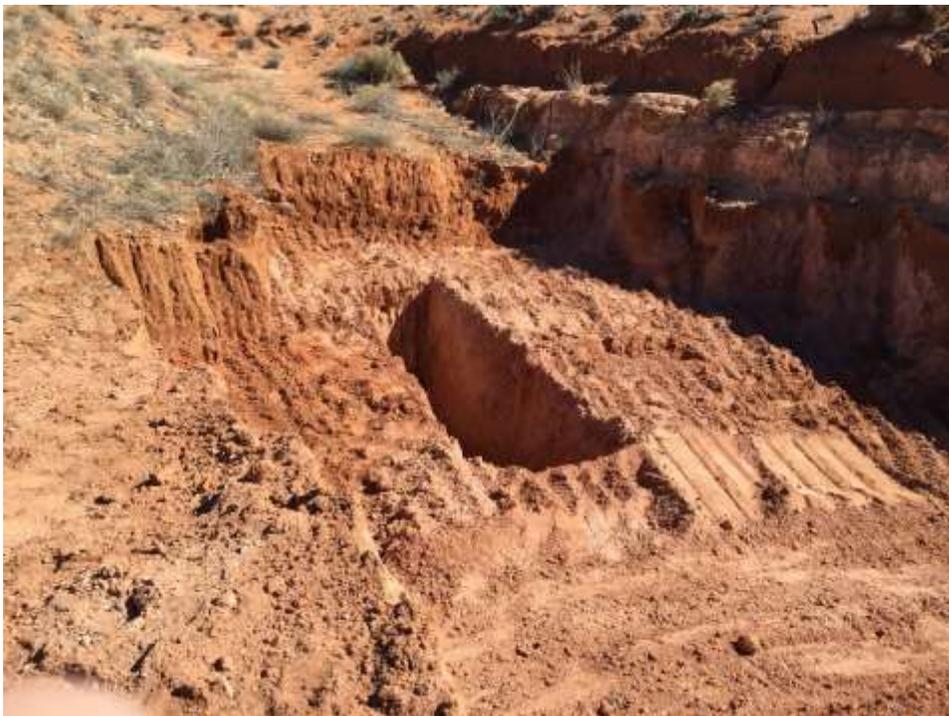
**Photograph: 10**

**Description:**  
Excavating

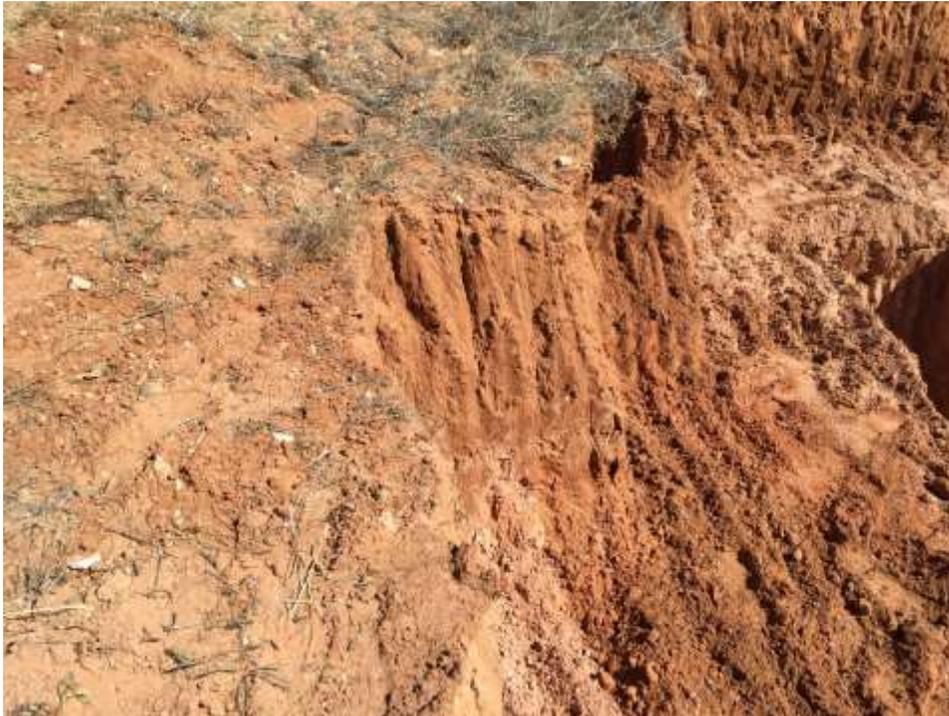
**Photograph: 11**

**Description:**  
Excavating

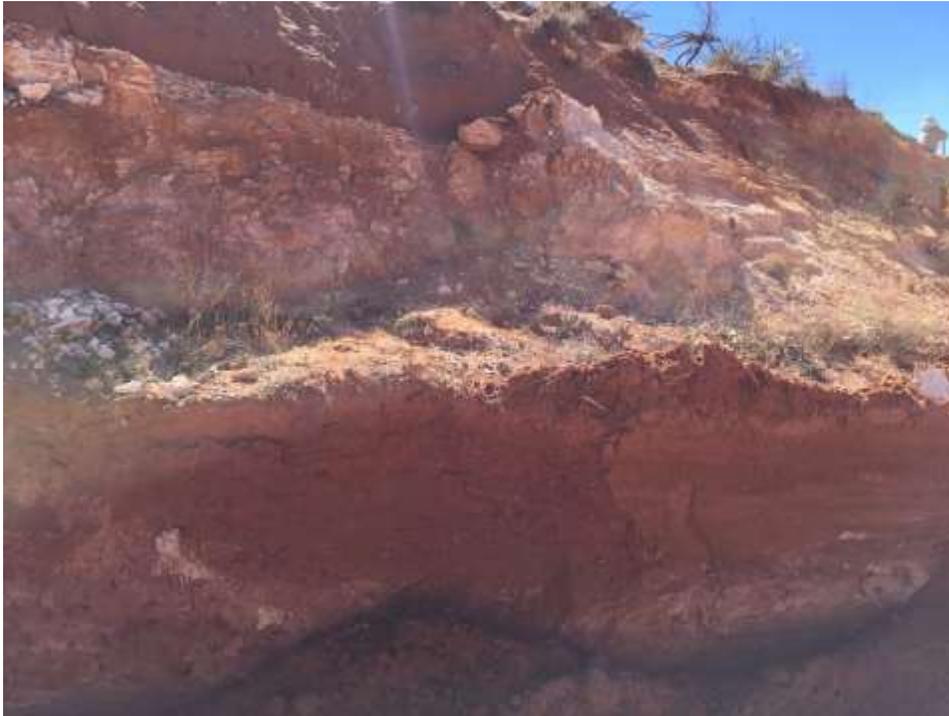
**Photograph: 13**

- OCD will be notified once remedial activities have been scheduled – Complete.
- A representative sample will need to be obtained and tested for hydrocarbon constituents - Completed.
- The target goal for chloride delineation is 250 mg/kg or background levels at SP1 – Completed.
- Sidewall samples will be required in excavations where lateral extent of impact has not been previously defined. – Completed.
- BLM and OCD must be contacted prior to liner placement or backfilling – Completed.
- SLO will be contacted with locations utilizing caliche with less than 1000 mg/kg from this release site prior to moving to locations – This action was not needed as there was no caliche located in south cell of state pit.

**Description:**  
Excavating  
No caliche in cell

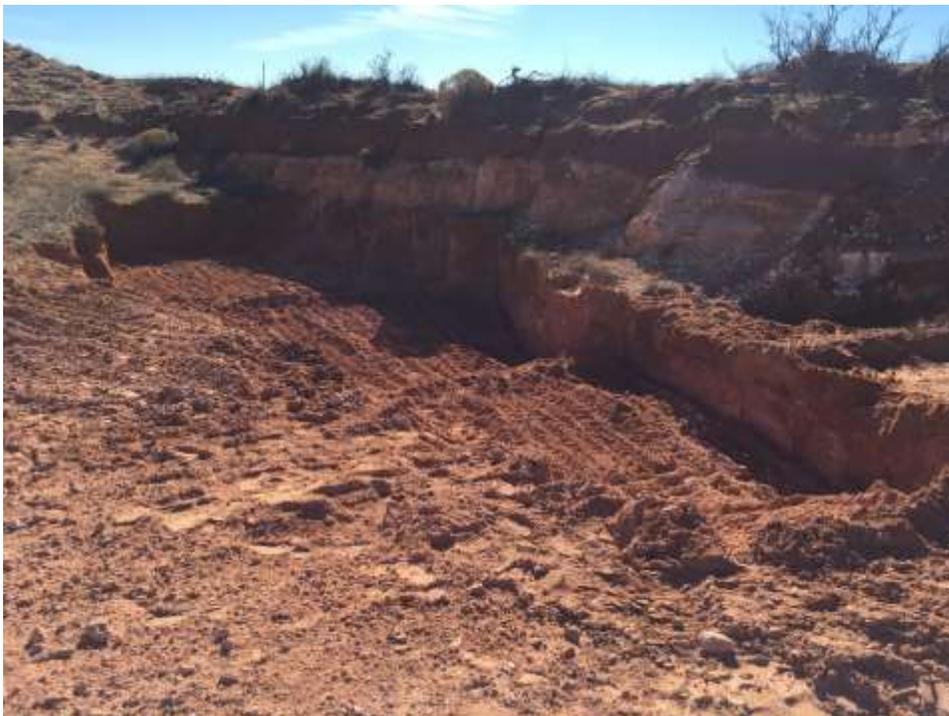
**Photograph: 14**

**Description:**  
Excavating

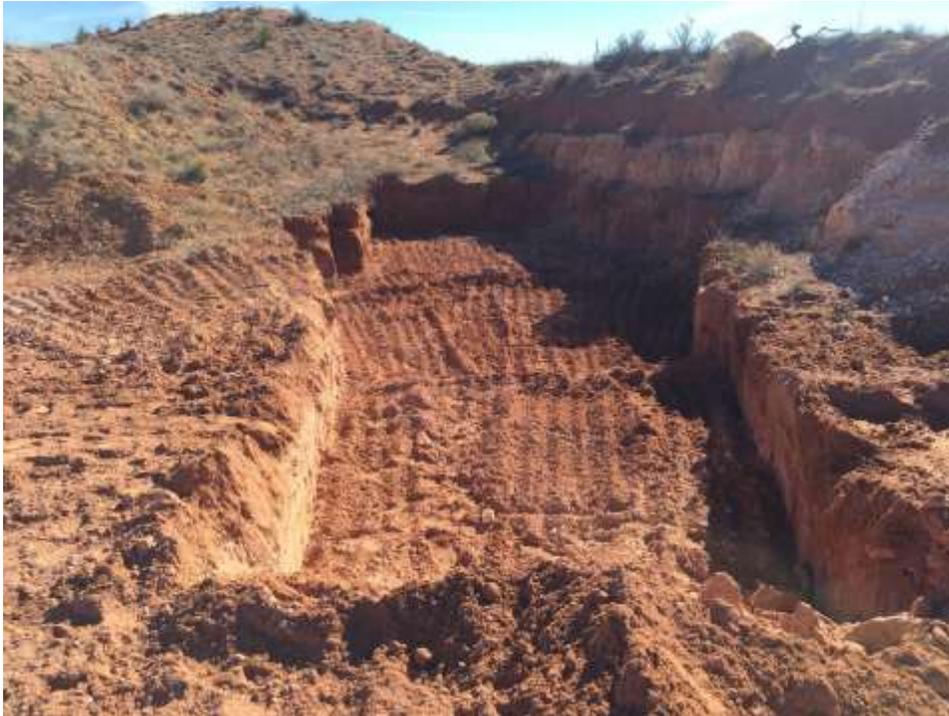
**Photograph: 15**

**Description:**  
Excavating

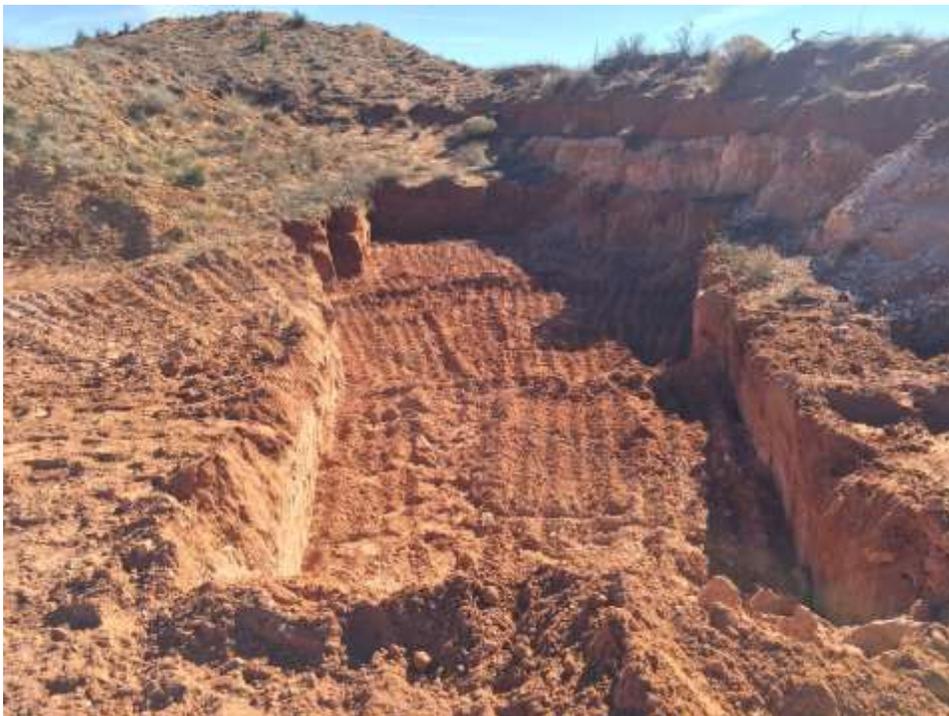
**Photograph: 16**

**Description:**  
Excavating

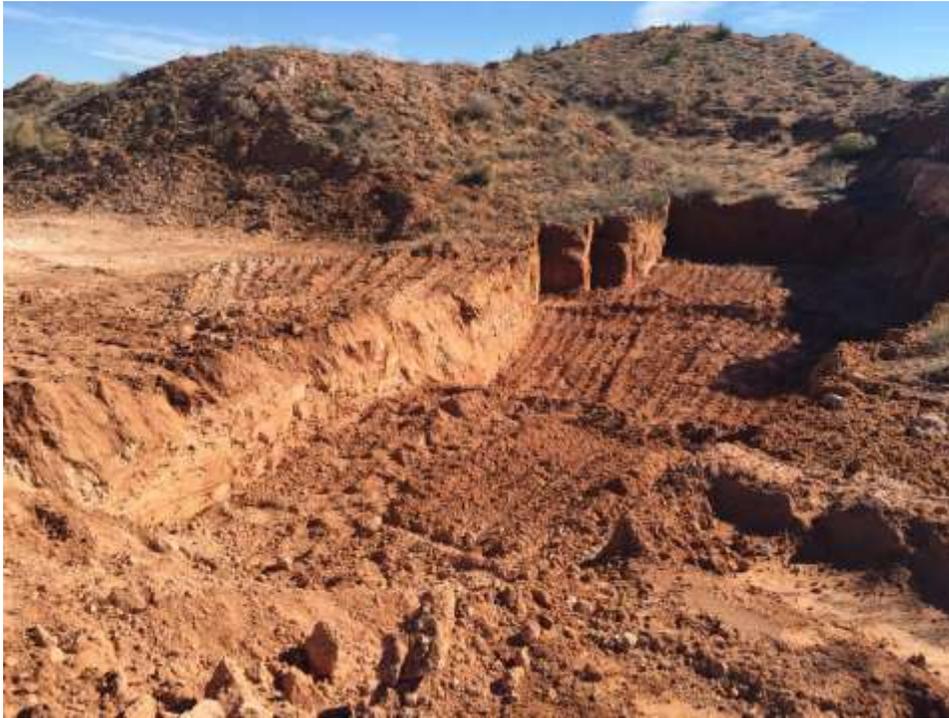
**Photograph: 17**

**Description:**  
Excavating

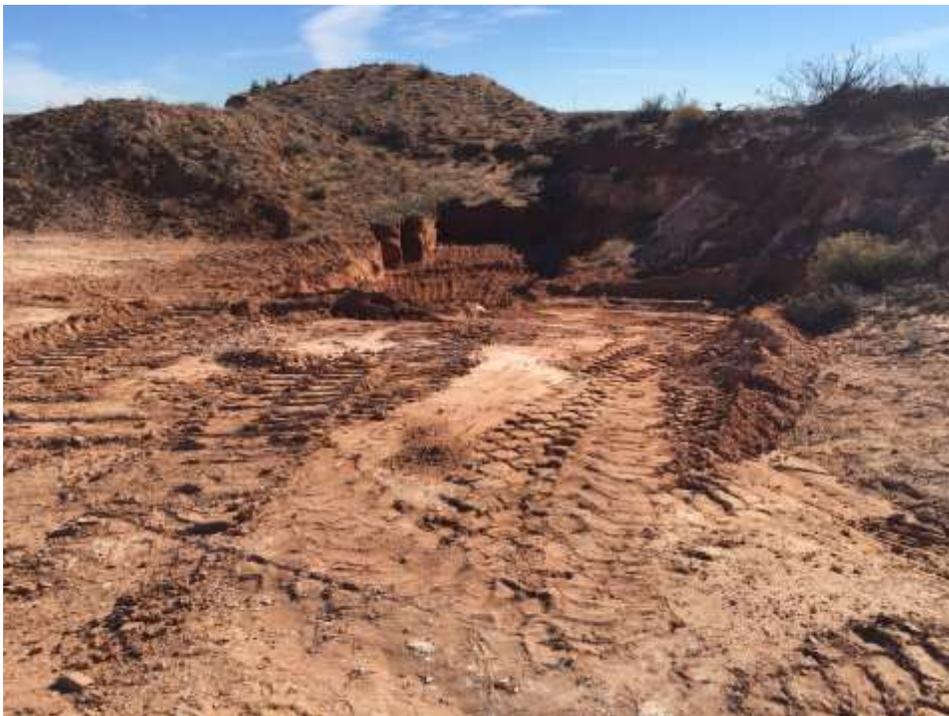
**Photograph: 18**

**Description:**  
Excavating

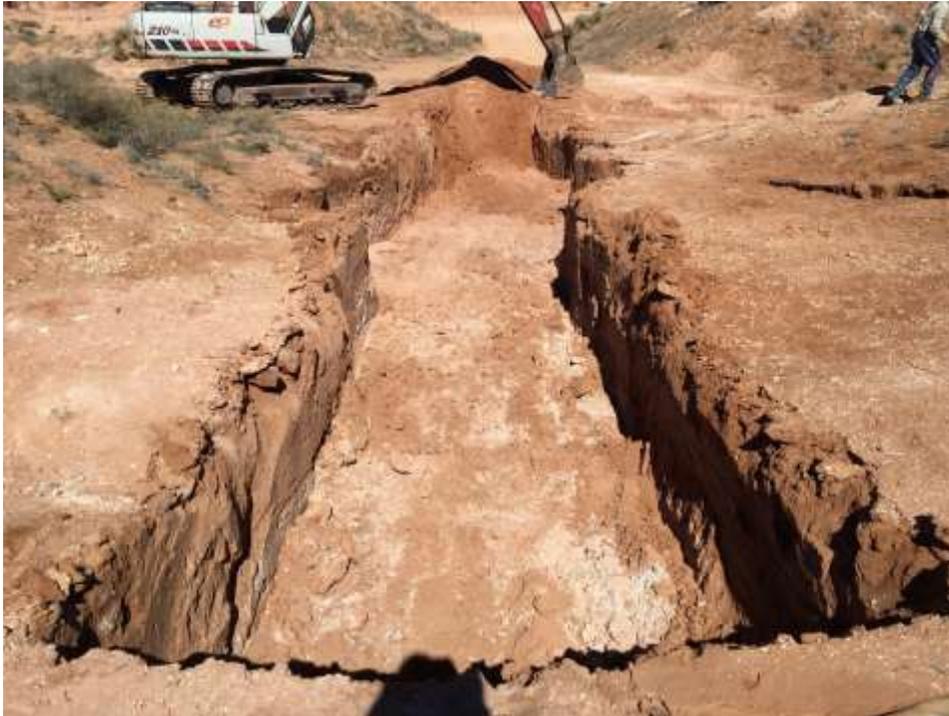
**Photograph: 19**

**Description:**  
Excavating

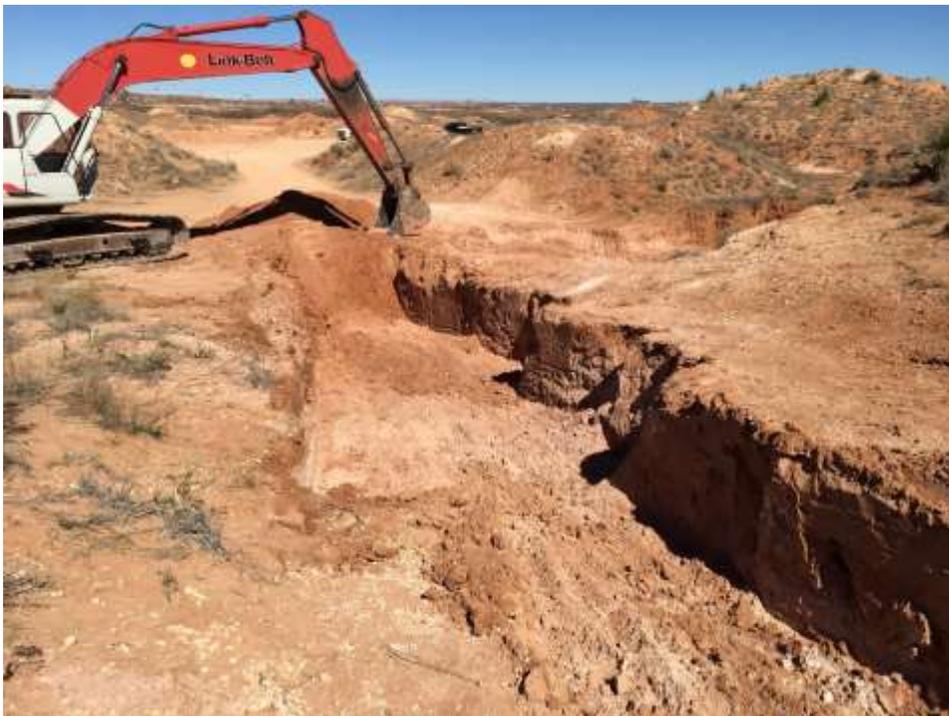
**Photograph: 20**

**Description:**  
Excavating

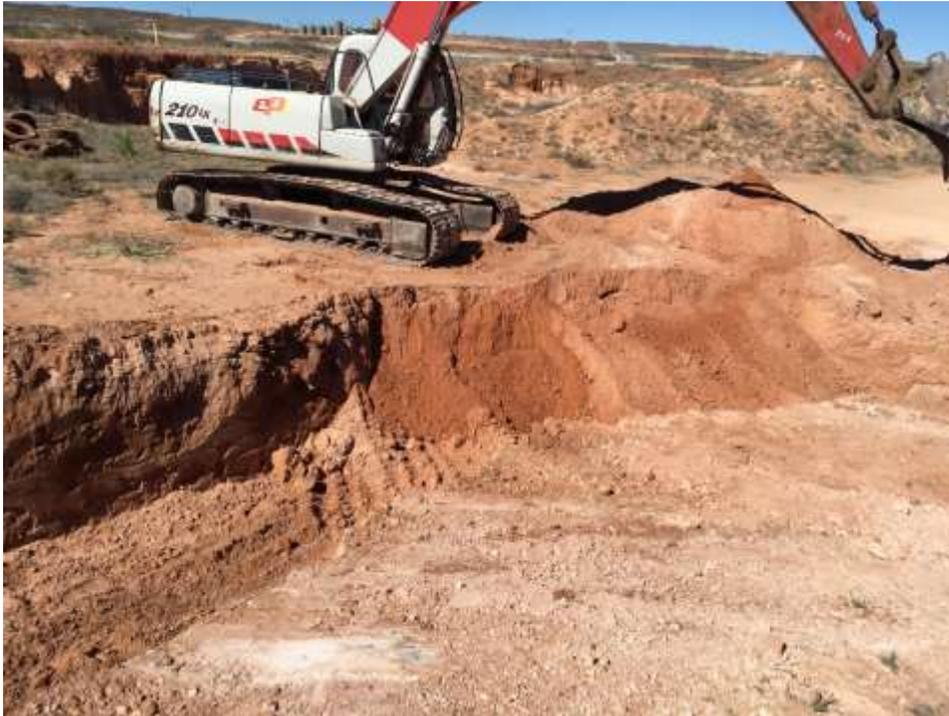
**Photograph: 21**

**Description:**  
Excavating

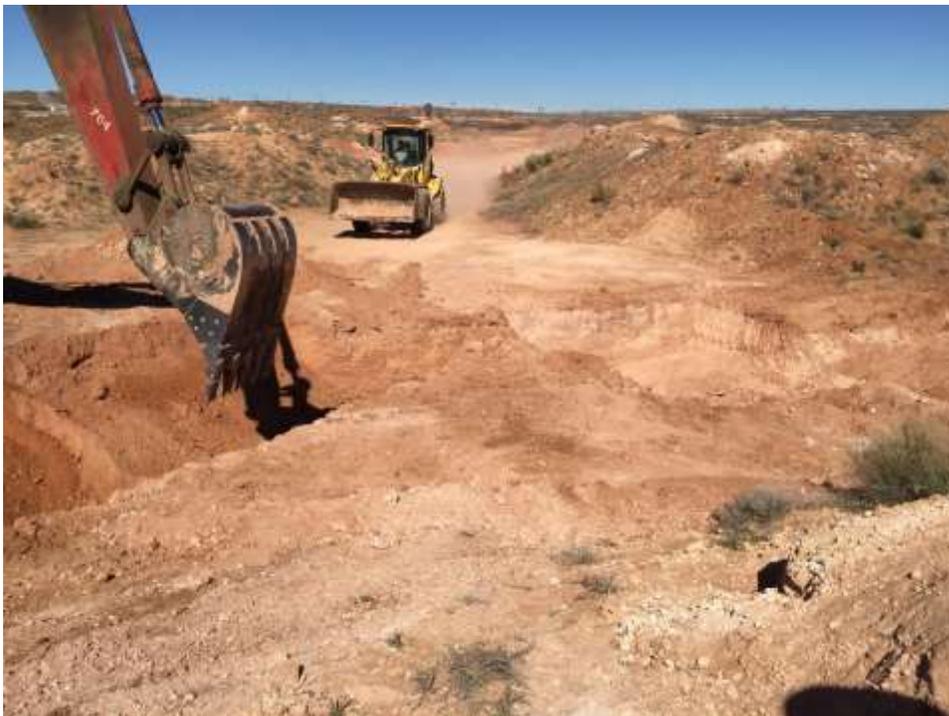
**Photograph: 22**

**Description:**  
Excavating

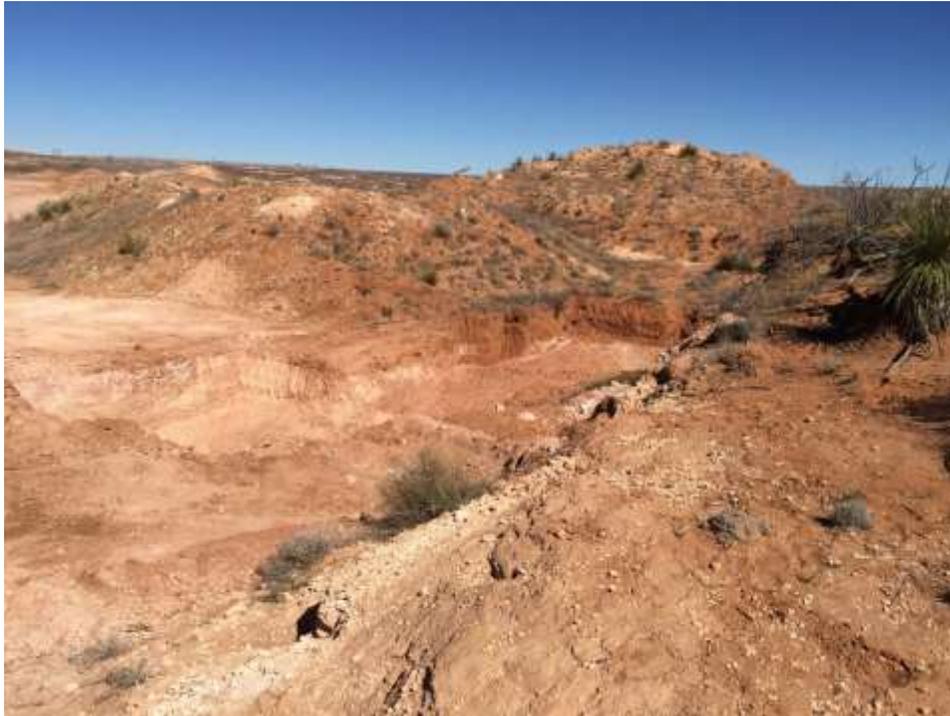
**Photograph: 23**

**Description:**  
Excavating

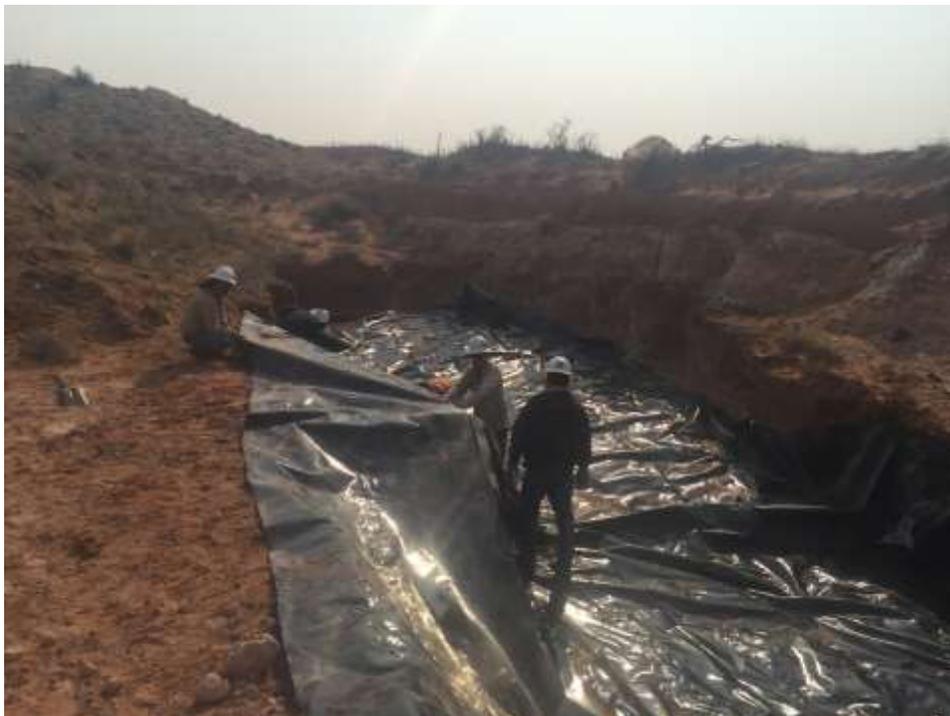
**Photograph: 24**

**Description:**  
Lining

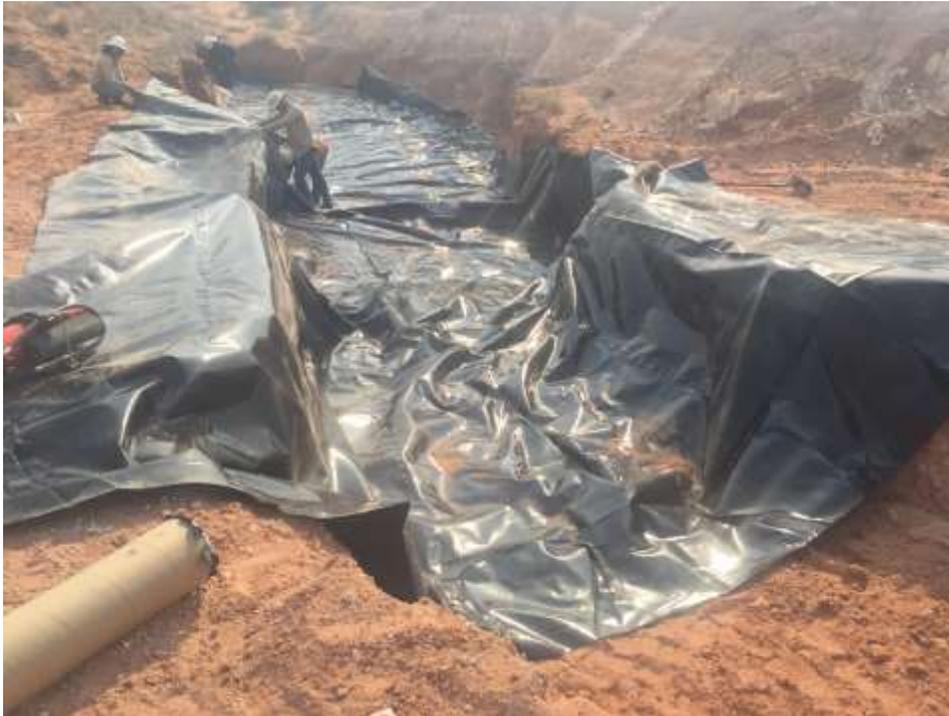
**Photograph: 25**

**Description:**  
Lining

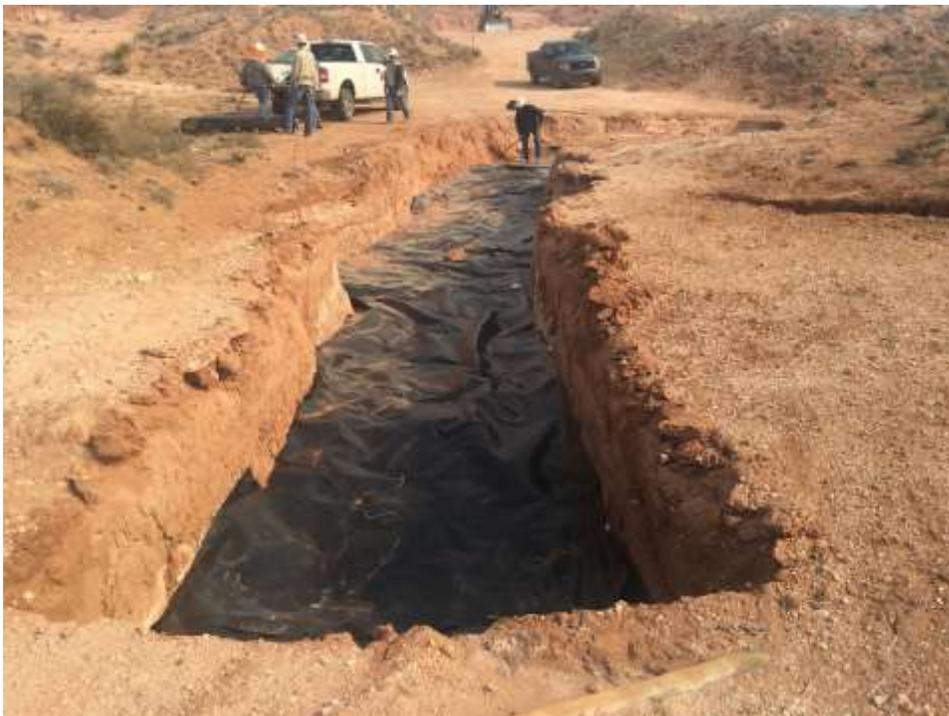
**Photograph: 26**

**Description:**  
Lining

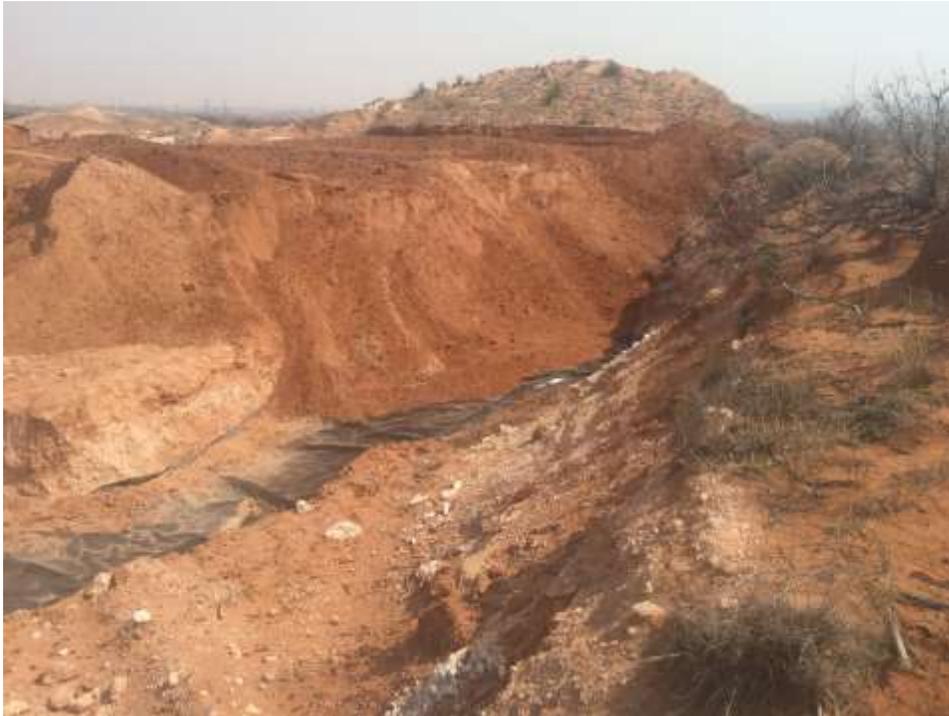
**Photograph: 27**

**Description:**  
Backfilling

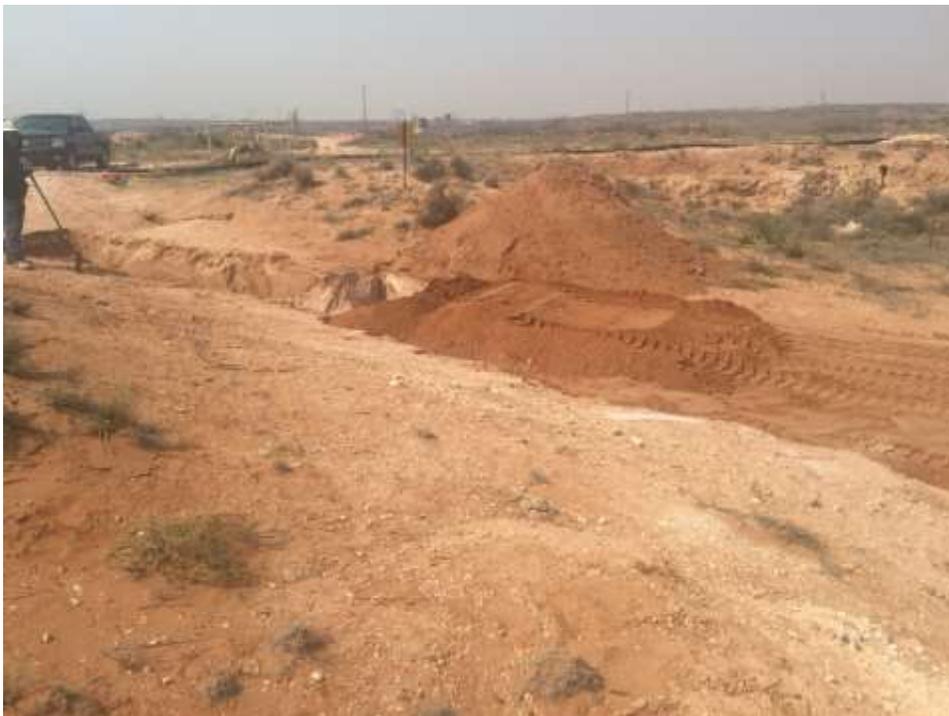
**Photograph: 28**

**Description:**  
Backfilling

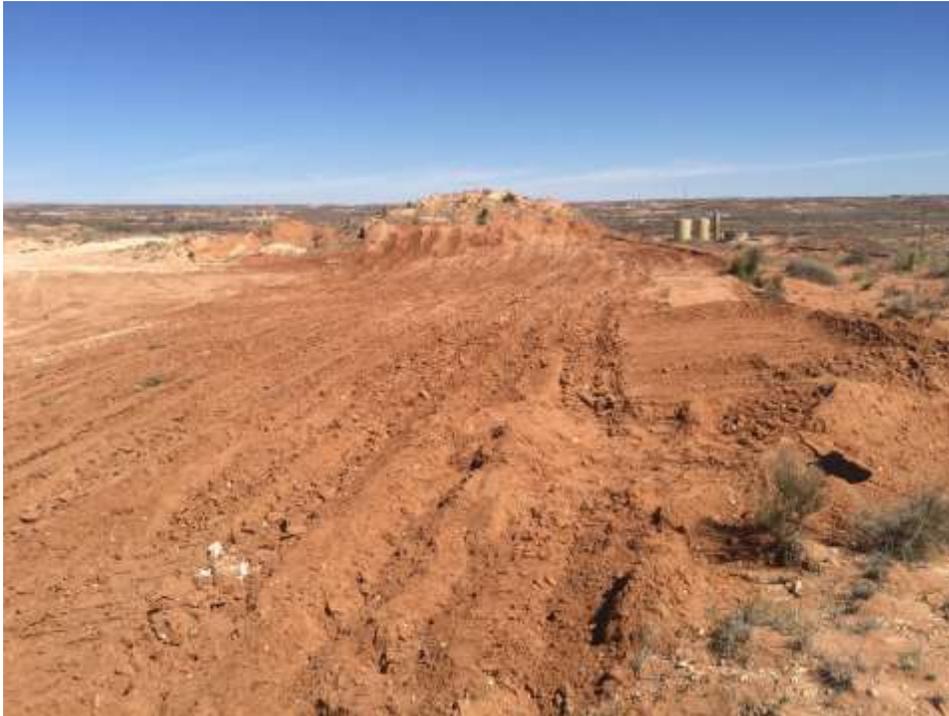
**Photograph: 29**

**Description:**  
Contouring

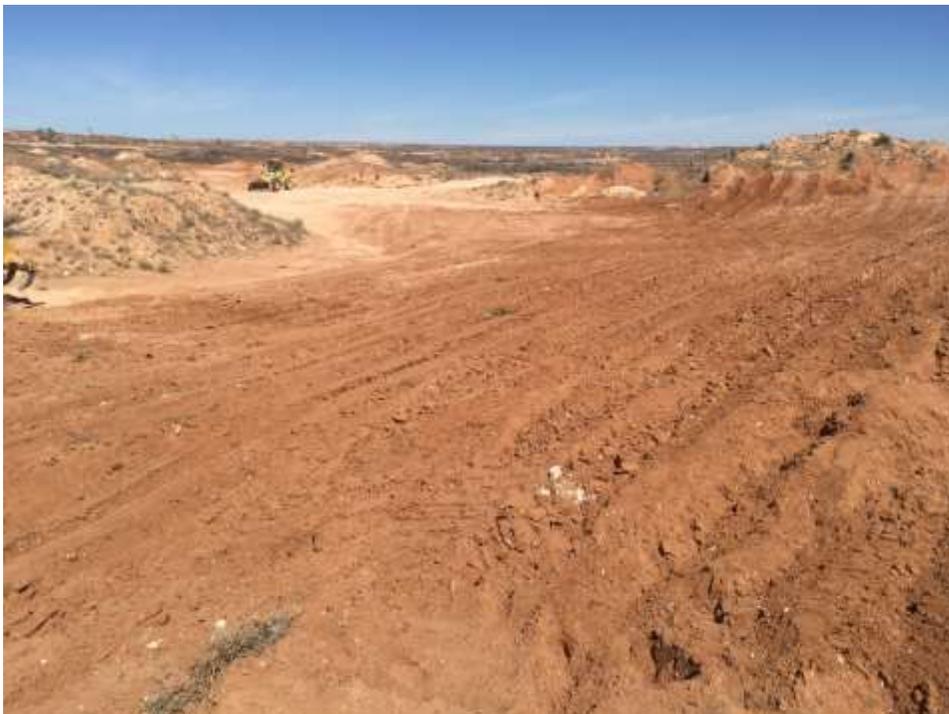
**Photograph: 30**

**Description:**  
Contouring

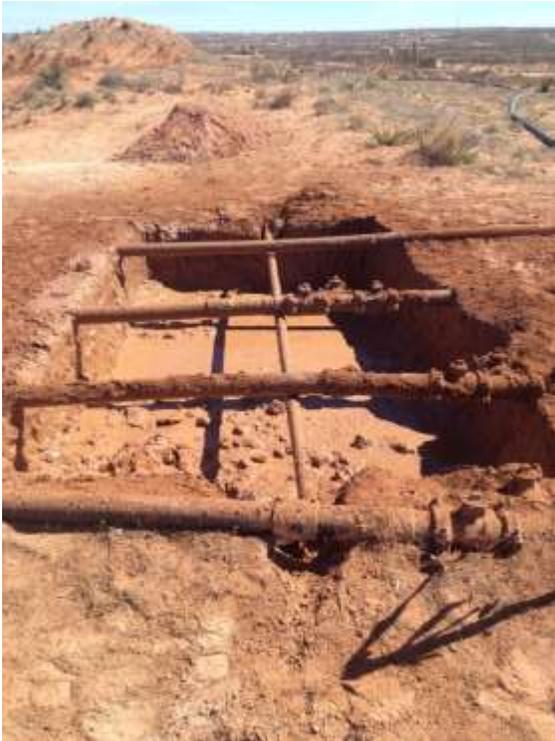
**Photograph: 31**

**Description:**  
ROW excavation with  
Hydrovac

EPI brought an auger (50 ft total depth capabilities) for delineation of the Rights-of-Way (ROW) area on Bureau of Land Management (BLM) surface. The delineation started at two feet below ground surface (bgs), repeated in two foot intervals to six feet bgs and then to four feet intervals starting at last interval in previous vertical until impacts were no longer encountered at 34 feet bgs. All soil samples collected (including the representative sample for hydrocarbon constituents) were sent to Cardinal Laboratories for analyzing. Once results were received, Jennifer made contact with Mike Bratcher with the OCD, Amber with the SLO, and Randy Pair with the BLM. It was approved to line at four feet and backfill with clean soil. A hydrovac was brought in to remove impacted soils to four feet due to multiple poly lines in the exact area of excavation. The lines were supported with pipe and excavation began. Some rock was encountered at three feet, so hydrovac worked around these areas. The excavation continued until sidewalls showed to be clean utilizing the Hanna GroLine Direct Soil EC Tester. All four walls were collected for lab confirmation. After area was excavated,

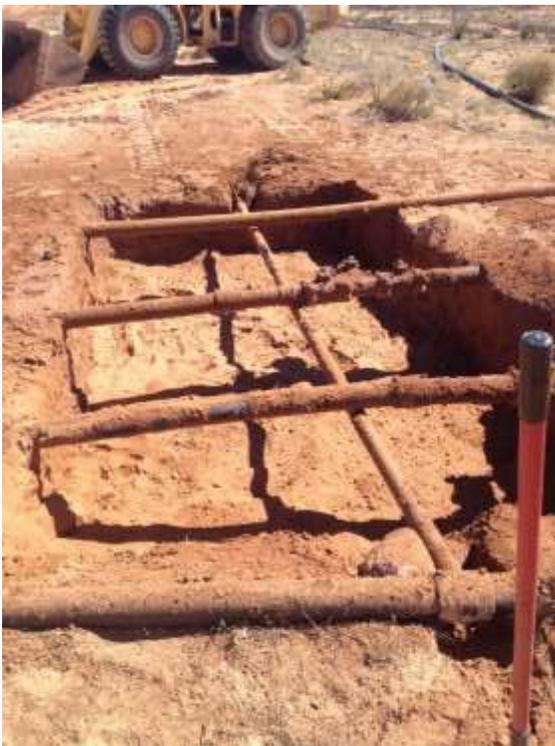
**Photograph: 32**

**Description:**  
Padding with sand

sand was placed in the bottom to protect the integrity of the liner. The liner was installed and area backfilled with clean soil.

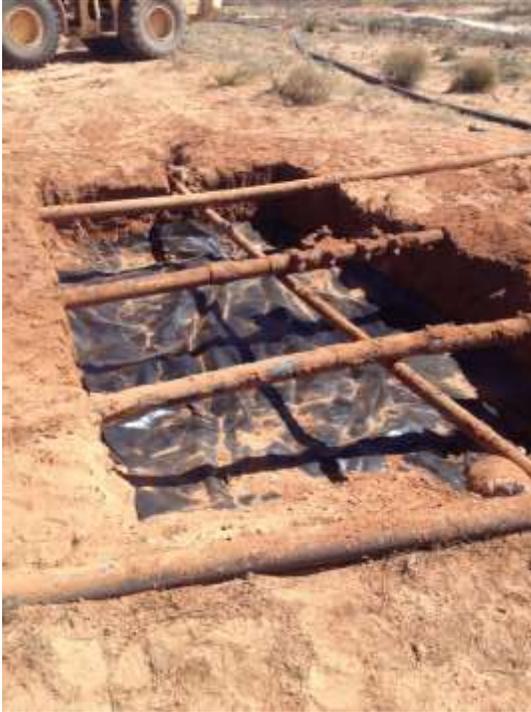
**Photograph: 33**

**Description:**  
Lining

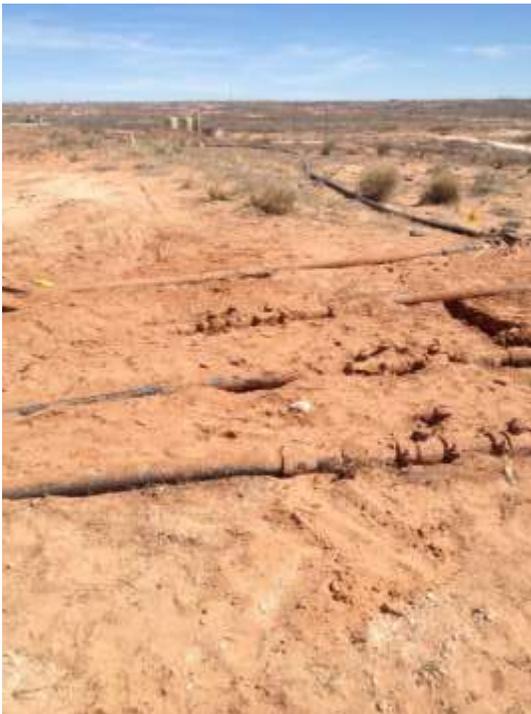
**Photograph: 34**

**Description:**  
Backfilling
