**Devon Energy Production Co LP
Laguna Salado South 1**

Work Plan

**Unit Letter F, Section 22, T23S, R29E
Eddy County, New Mexico**

May 2, 2017

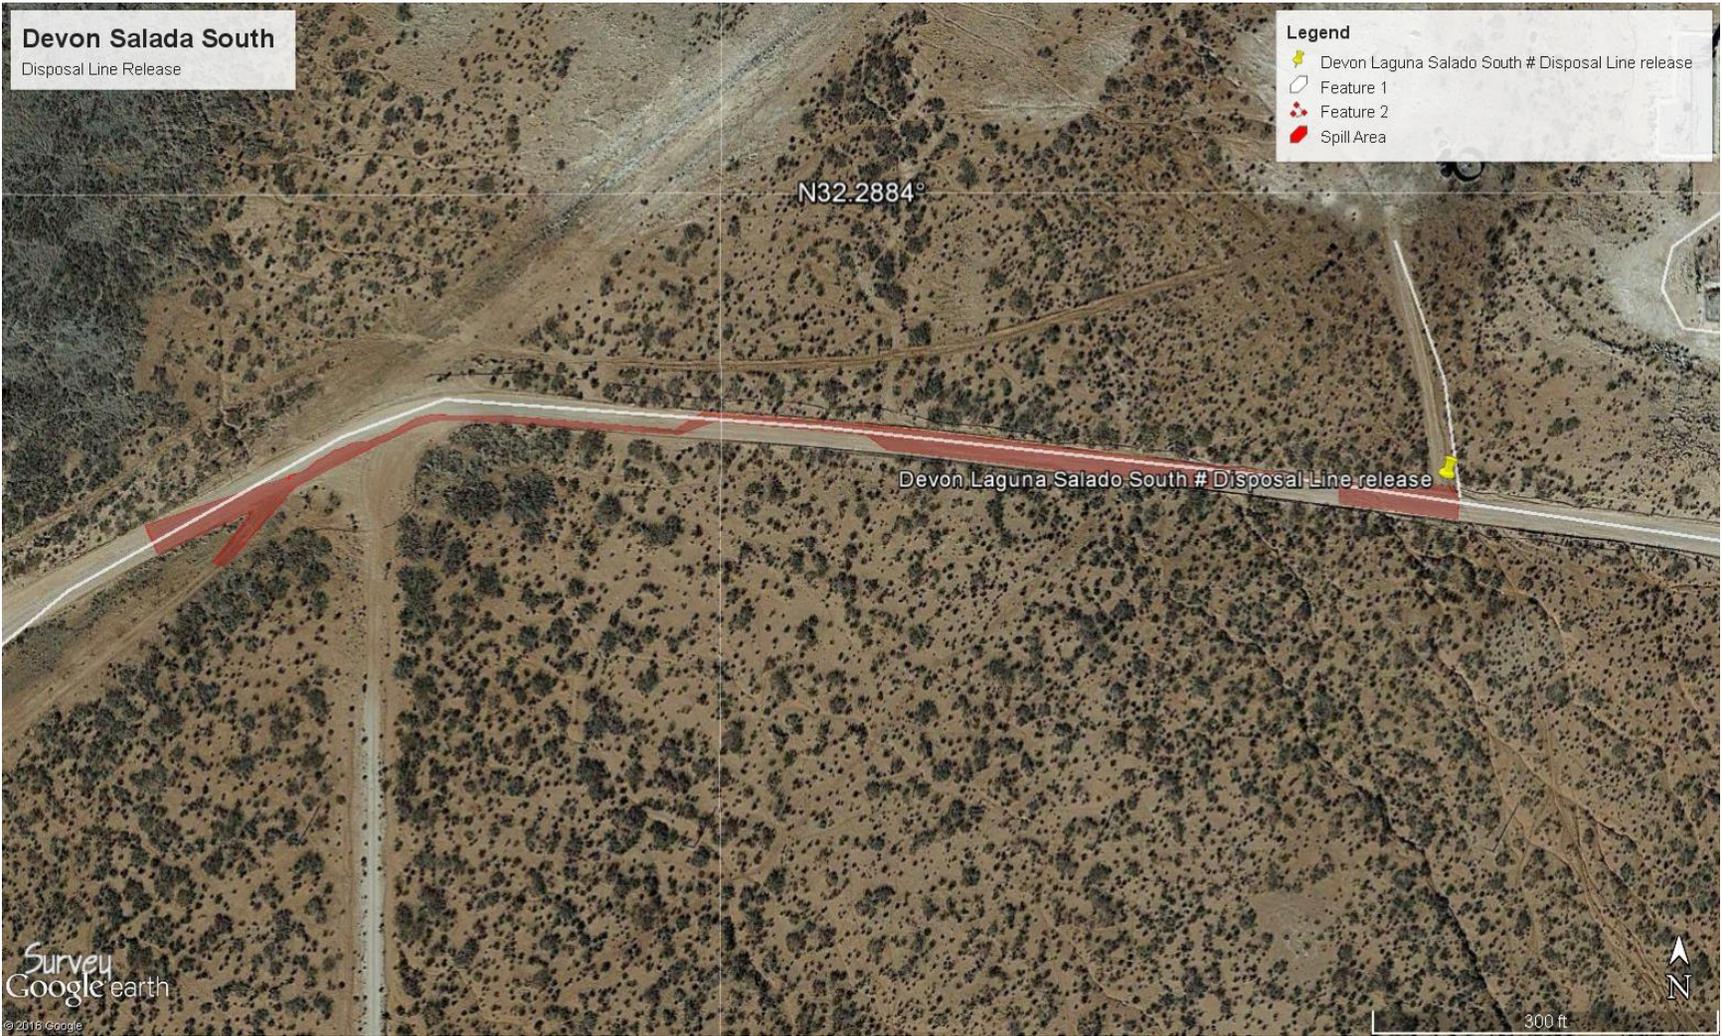
Figure 1
Vicinity Map

Disposal Line Release

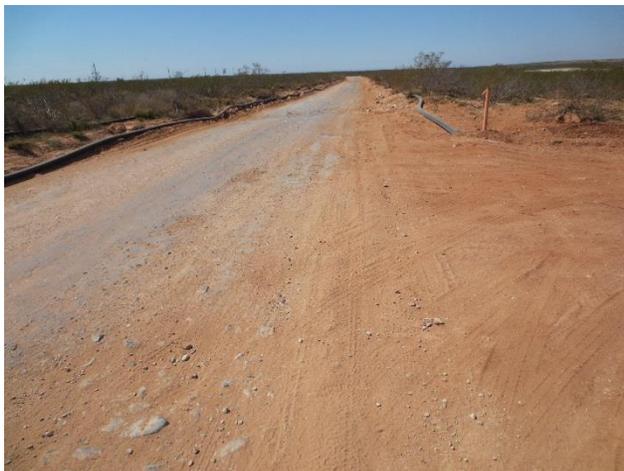
Leak site facing West

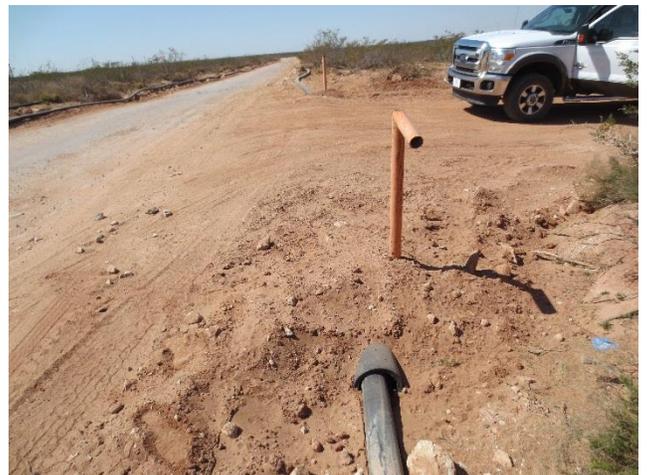
Leak site facing West
