## REMEDIATION WORK PLAN

**Concho Operating, LLC.  
Big Papi Federal Com #002H  
Eddy County, New Mexico  
Unit Letter "C", Section 04, Township 26 South, Range 29 East  
Latitude 32.077566, Longitude -103.986229  
2RP-4141**

September 2017

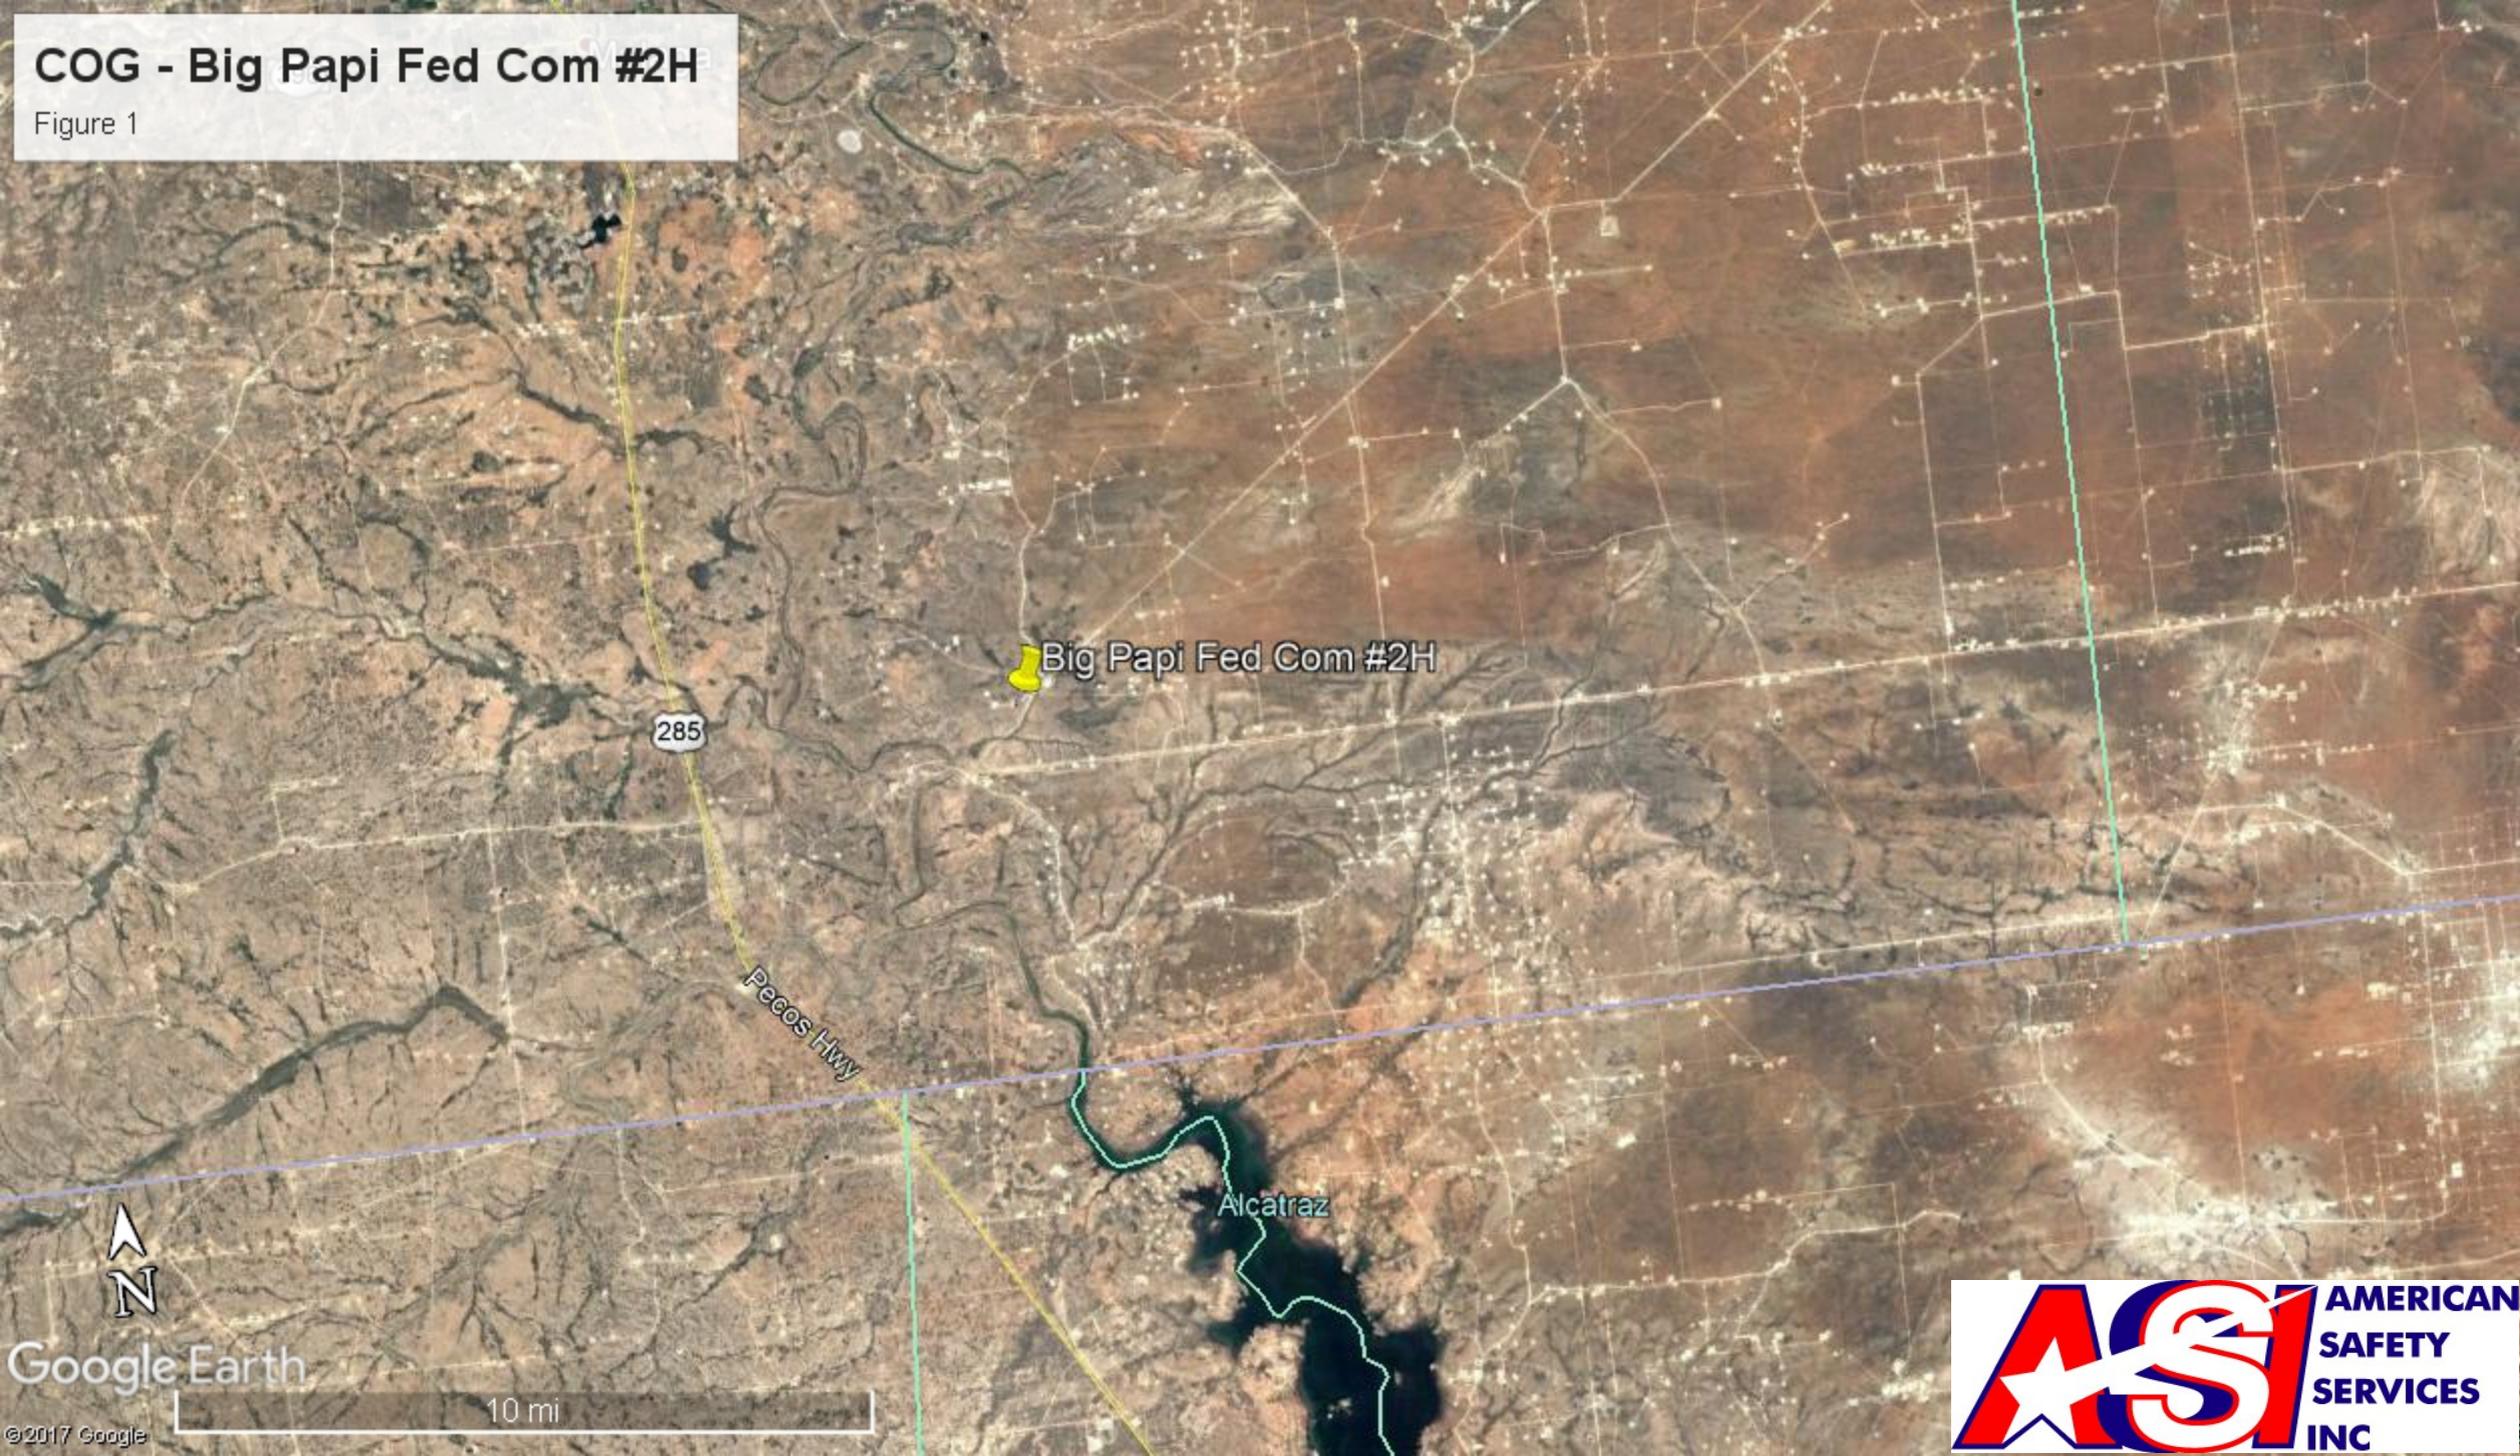
Figure 1

Figures 1 and 2 show the location of COG's Big Papi Federal Com #002H facility in Eddy County, New Mexico and surrounding topography.

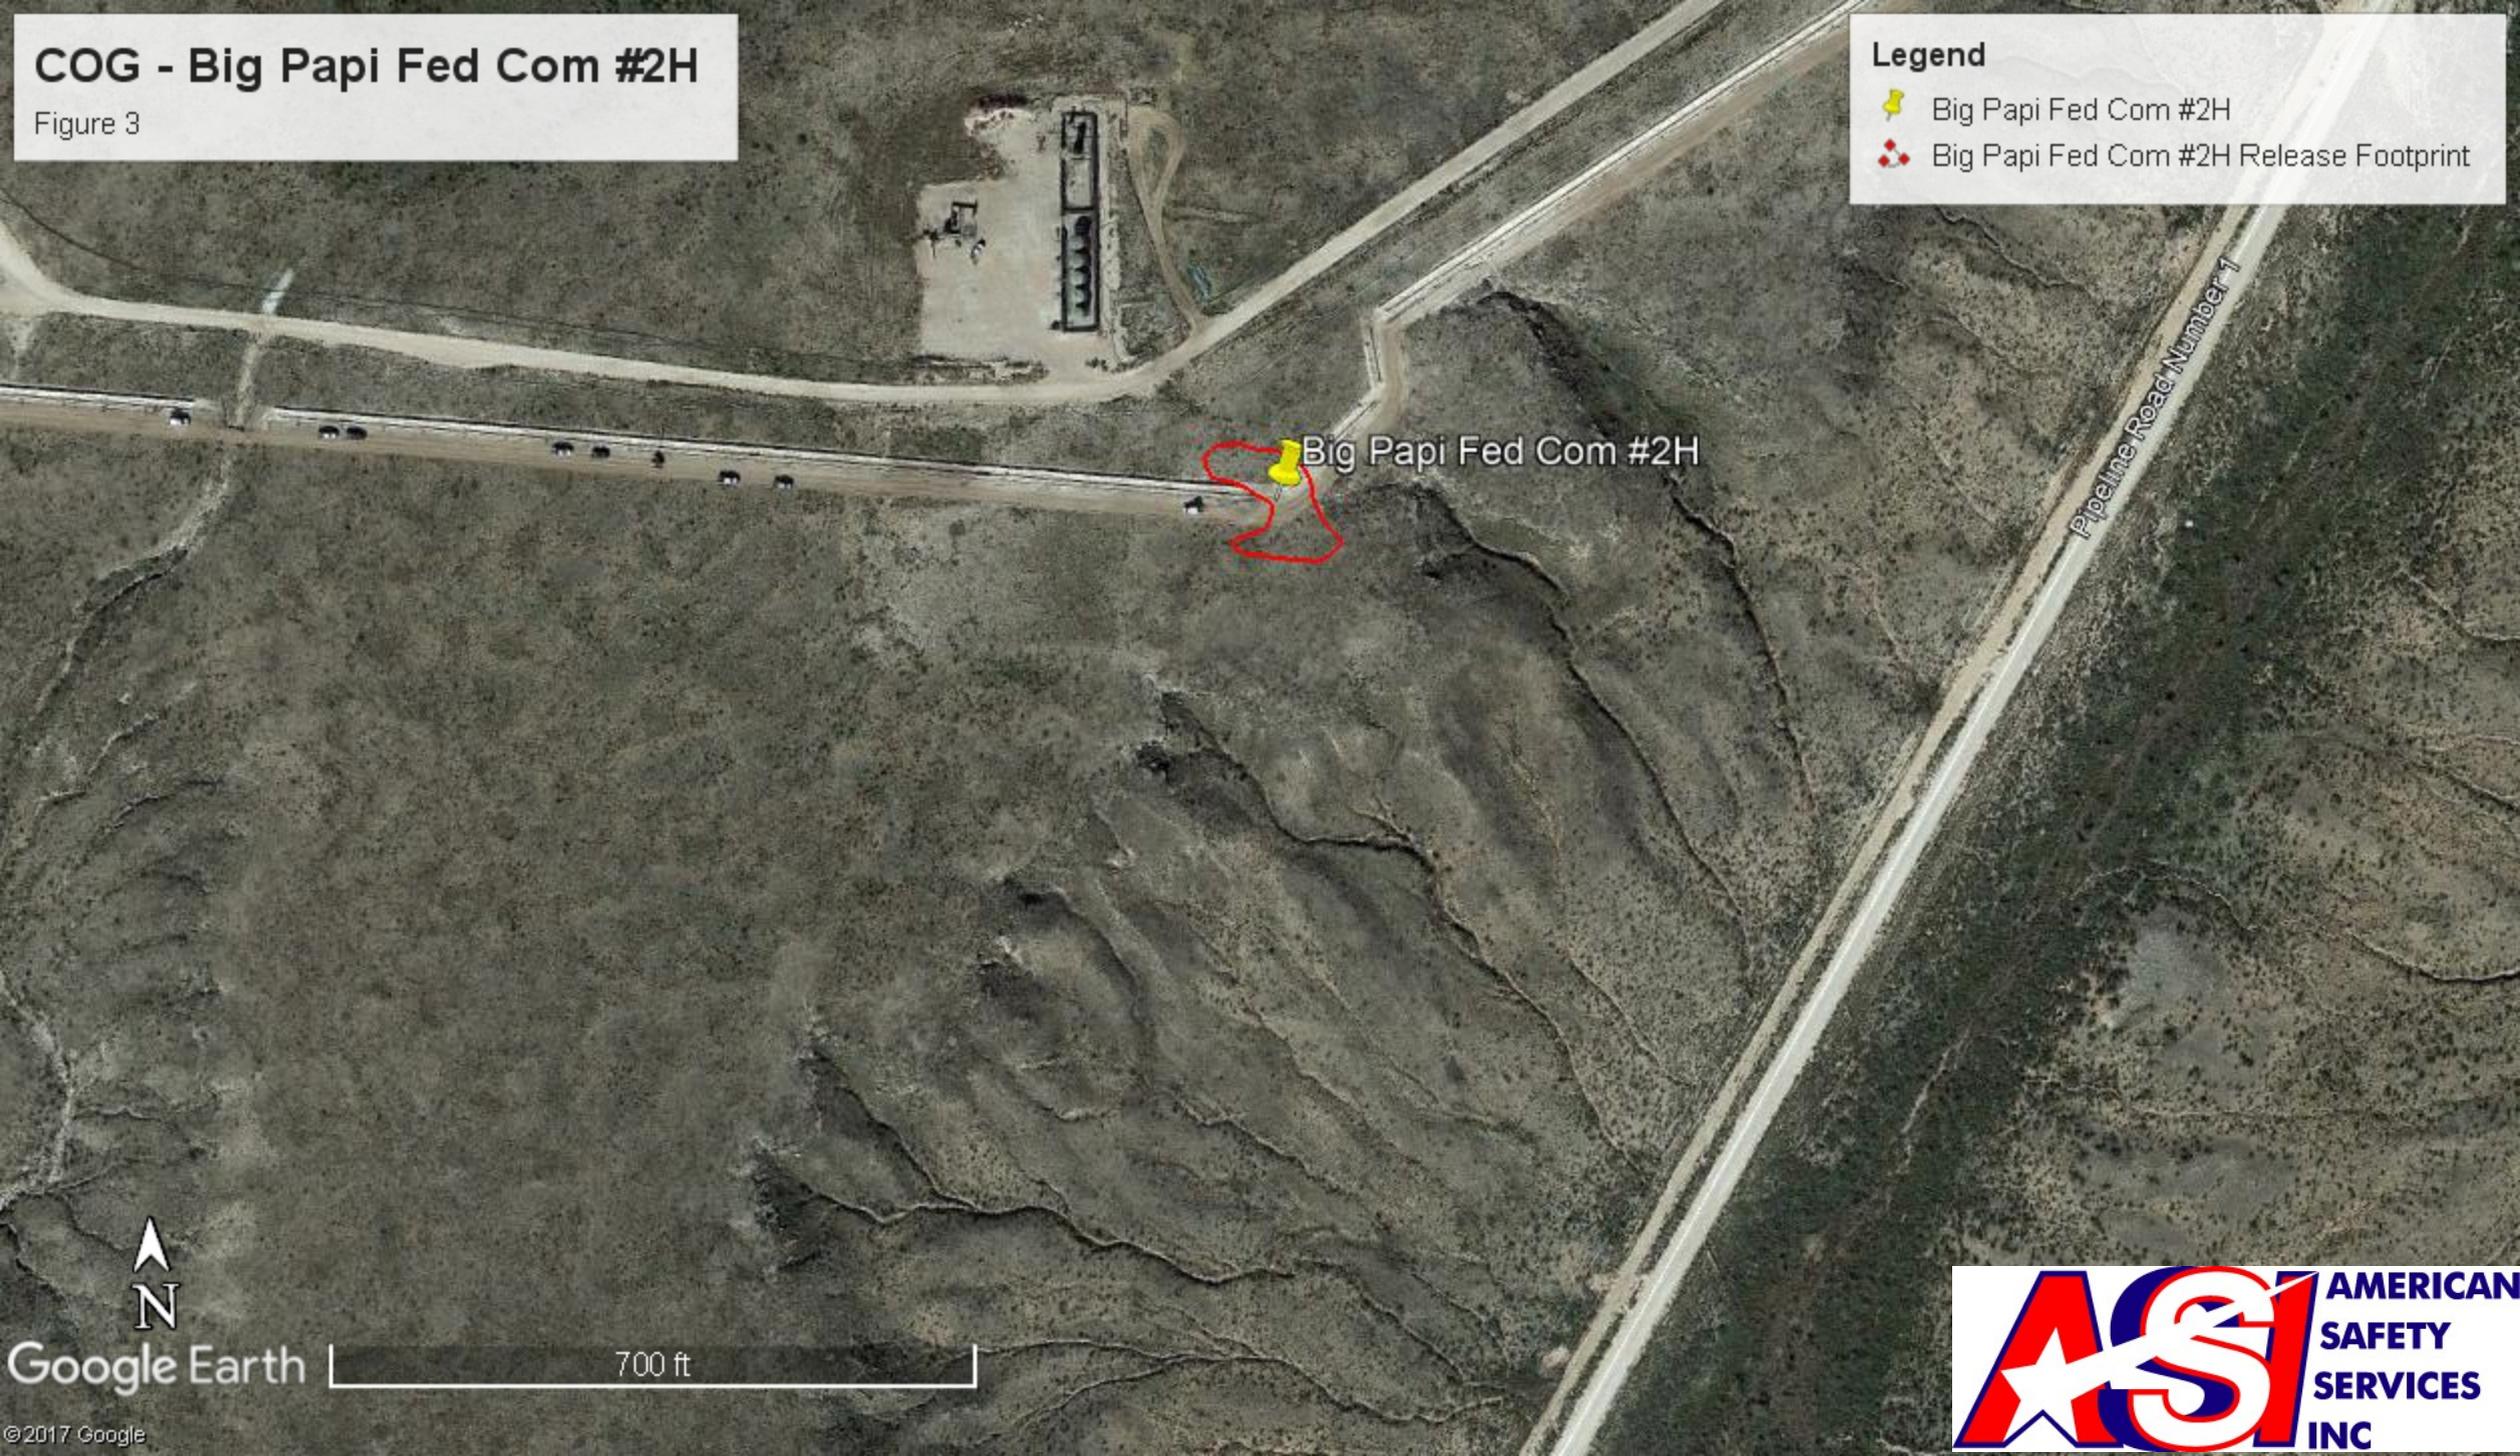
Figure 3

On July 26, 2017, ASSI personnel completed drilling and sampling activities utilizing air rotary drilling techniques at the Big Papi Federal Com #002H facility. This action was in response to a reportable release that occurred on February 28, 2017. Thirty (30) barrels (bbls) of produced water was released directly to the ground. None of the fluids were recovered. The release impacted approximately eight thousand (8,000) square feet of pasture area (Figure 3).

Big Papi Fed Com #2H Release Footprint

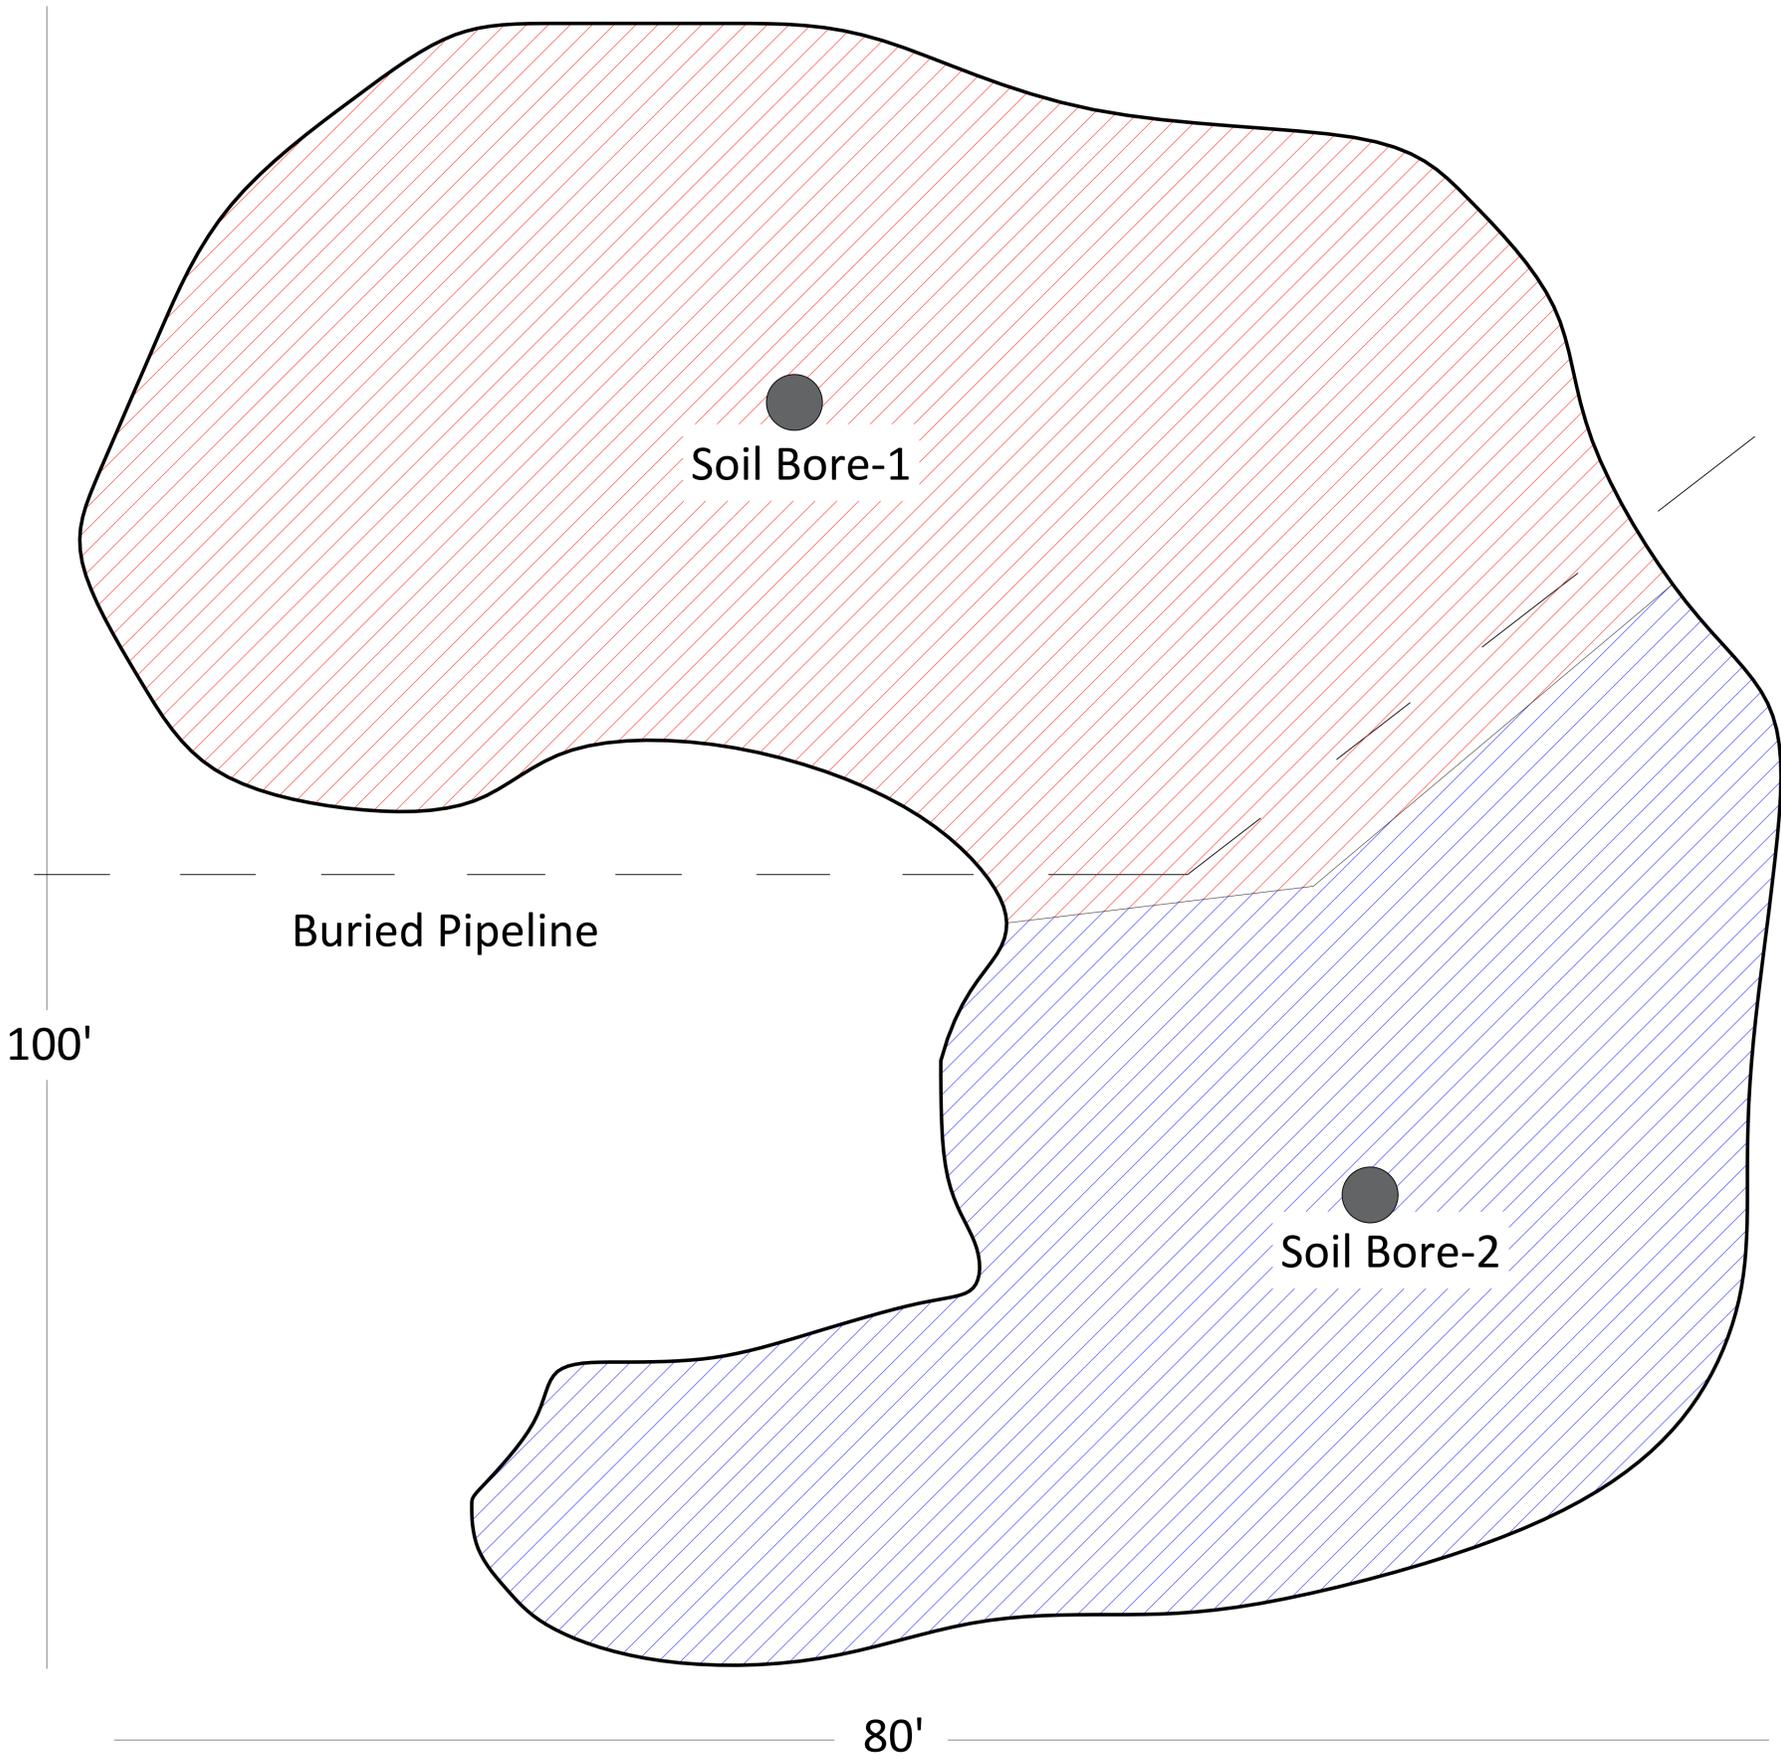
**FIGURE 4**  
**Proposed Excavation**  
**Depths**

Two (2) soil borings (i.e., Soil Bore-1 and Soil Bore-2), were advanced to delineate Chloride at depth. Soil boring locations are shown on Figure 4. Discrete samples were collected from Soil Bore-1 at the following depths: 1', 3', 5', 7', 10', and 20', below ground surface (bgs). At Soil Bore-2 discrete samples were collected at the following depths: 1', 3', 5' 7' and 15' bgs. Soil was field screened for Chloride utilizing electro conductivity during drilling operations.

Figure 4 shows the approximate location of the sampling (i.e., Soil Bore) locations and dimensions of the proposed excavation area in relation to pertinent land features and general Site boundaries, which is included in Appendix A.

— 4' Excavation
-

— 3' Excavation
-

Based on the analytical data presented in Table 1, COG and ASSI propose to complete a removal action of the impacted material. The area adjacent to and around Soil Bore-1 will be excavated to a depth of approximately four (4) feet bgs. The area adjacent to and around Soil Bore-2 will be excavated to a depth of approximately three (3) feet bgs (Figure 4). All material will be removed by mechanical means, be temporarily stockpiled onsite and subsequently removed (hailed away) offsite to a proper disposal facility under appropriate manifest. Prior to beginning backfilling operations, sidewall samples will be collected from each excavation in their prospective cardinal direction for Chloride only and submitted for laboratory analysis. The excavated areas will be backfilled to grade with clean imported material and the surface grade contoured to the surrounding landscape.
