**Report Type: Closure Report      2RP-4083**

<b>Site:</b>	Burch Keely Unit #933H				
<b>Company:</b>	COG Operating LLC				
<b>Section, Township and Range</b>	Unit E	Sec. 13	T 17S	R 29E	
<b>Lease Number:</b>	API No. 30-015-40970				
<b>County:</b>	Eddy County				
<b>GPS:</b>	32.835019° N			104.035119° W	
<b>Surface Owner:</b>	Federal				
<b>Mineral Owner:</b>					
<b>Directions:</b>	From the intersection of Hwy 82 (Lovington Hwy) and Kewanee Rd in rural Eddy County, travel north on Kewanee Rd for approximately 1.0 mi, turn east onto the lease road for approximately 330 feet to the location on the south side of the lease road.

**Re: Closure Report for the COG Operating LLC., Burch Keely Unit #933H, Unit E, Section 13, Township 17 South, Range 29 East, Eddy County, New Mexico. 2RP-4083**

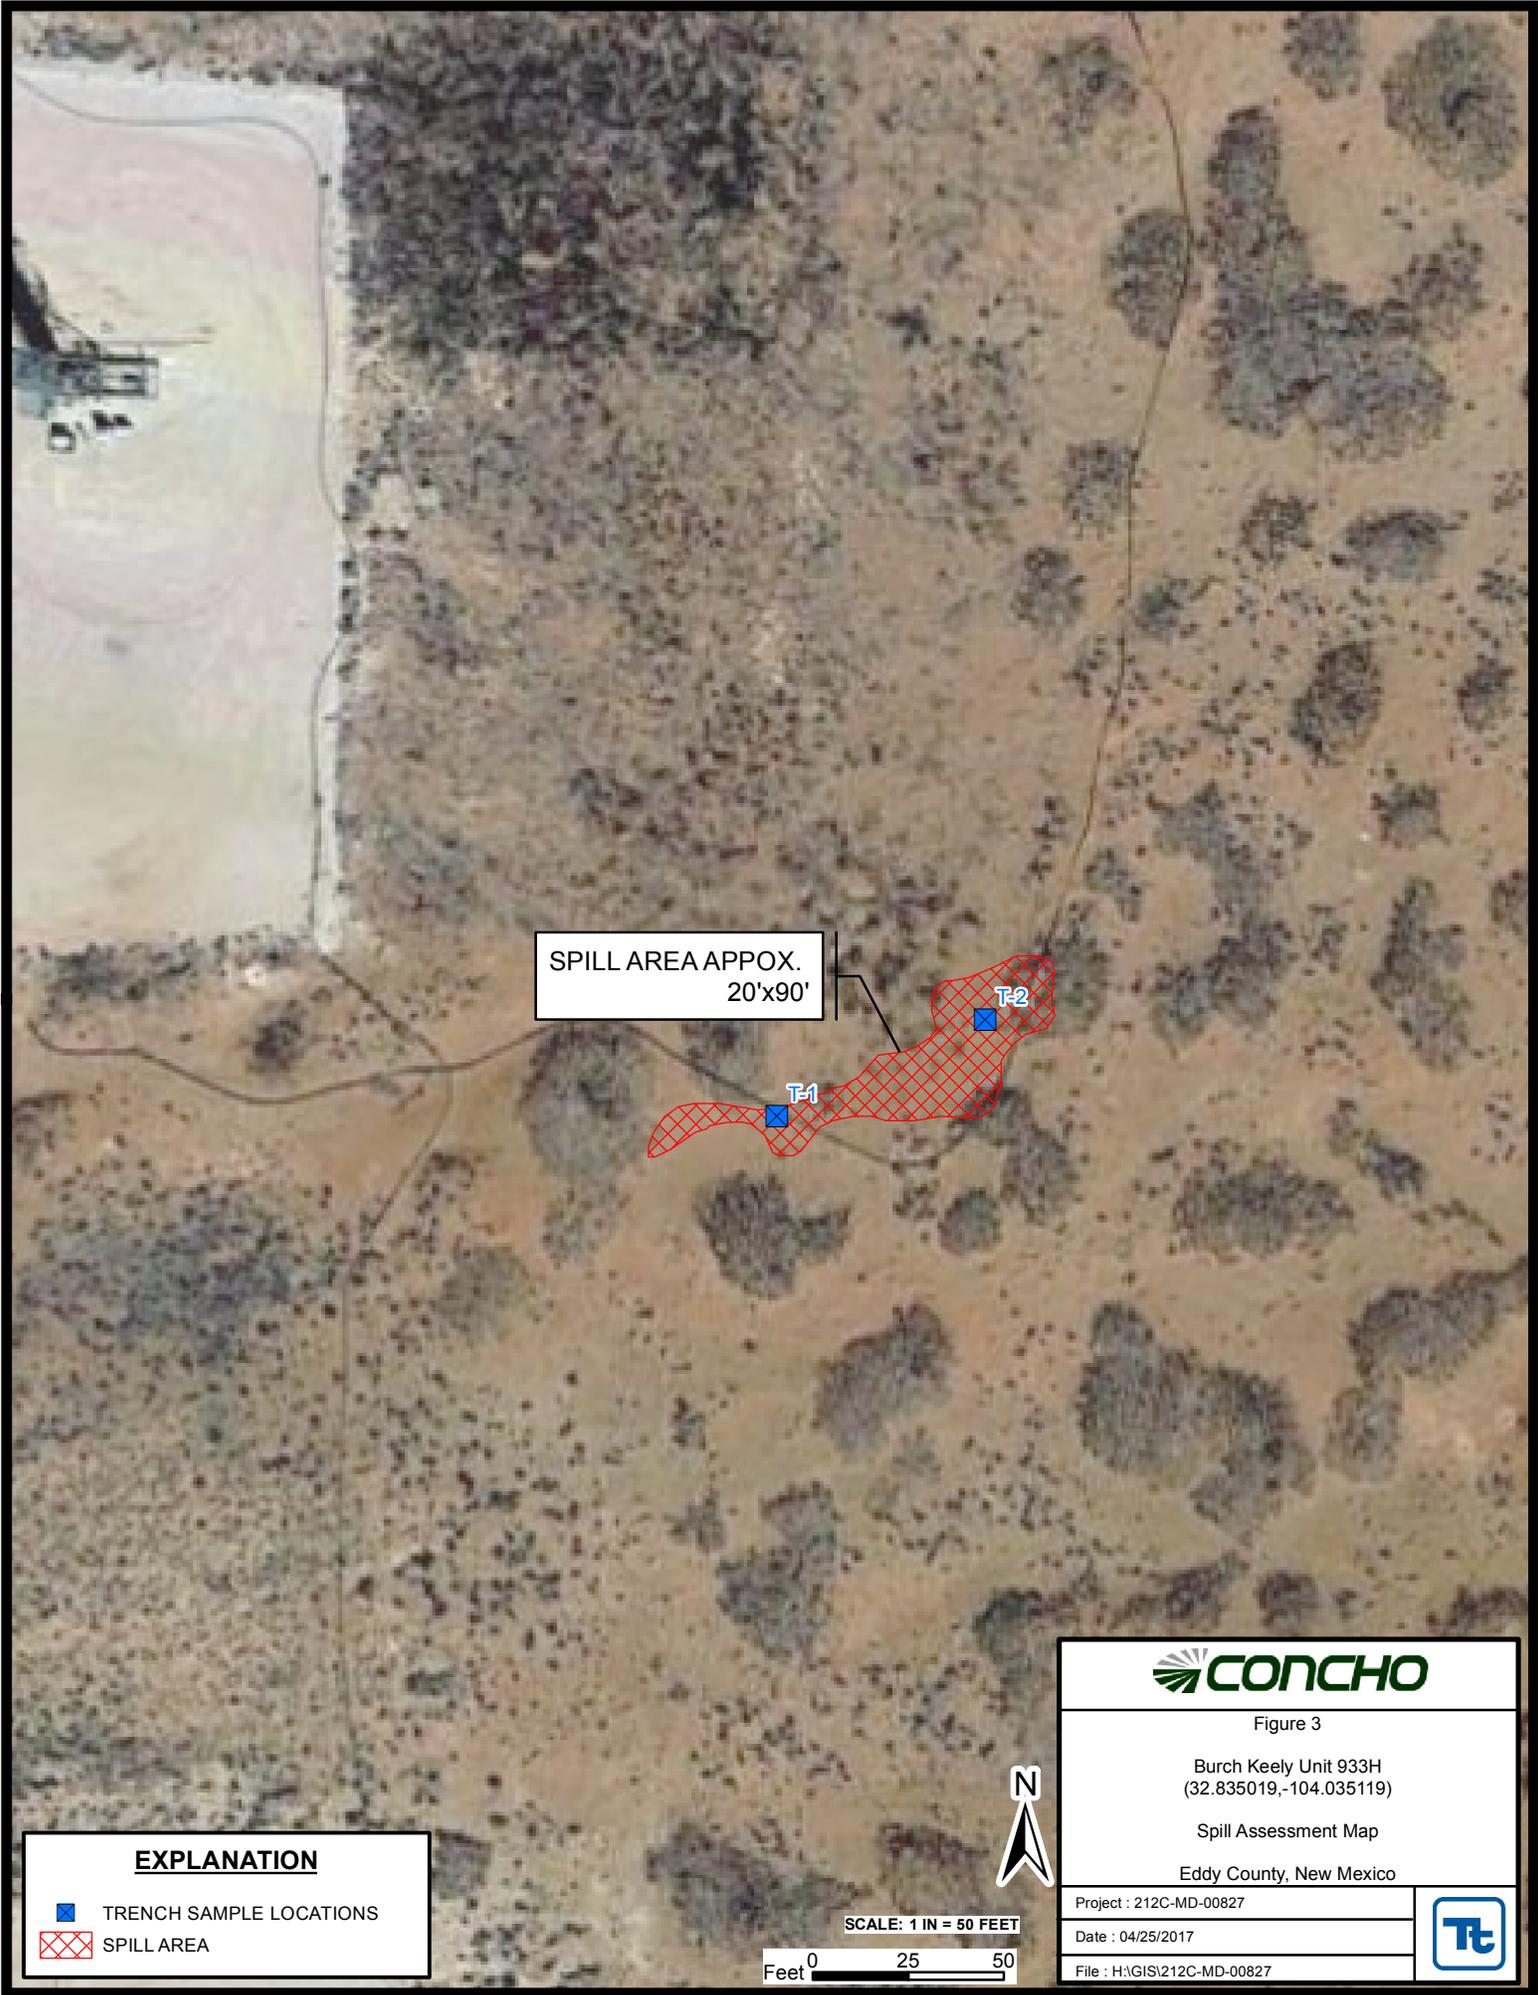
Figure 3	
Burch Keely Unit 933H (32.835019,-104.035119)	
Spill Assessment Map	
Eddy County, New Mexico	
Project : 212C-MD-00827

On February 7, 2017, COG personnel were onsite to evaluate and sample the release area. Using a backhoe, two (2) trenches (T-1 and T-2) were installed to a total depths of 5.0' below surface. Selected samples were analyzed for TPH analysis by EPA method 8015 modified, BTEX by EPA Method 8021B, and chloride by EPA method 300.0. Copies of the laboratory analysis and chain-of-custody documentation are included in Appendix C. The results of the sampling are summarized in Table 1. The trench locations are shown on Figure 3.

Referring to Table 1, the areas of trenches (T-1 and T-2) showed chloride highs of 160 mg/kg and 48.0 mg/kg at 1.0' below surface, respectively, before declining with depth to 16.0 mg/kg (T-1) and <16.0 mg/kg (T-2) at 2.0' below surface. Total TPH and benzene concentrations were below the RRAL's in all collected samples. However, total BTEX concentrations exceeding the RRAL's were detected in the shallow soils with concentrations of 105 mg/kg (T-1) and 122 mg/kg (T-2) at 1.0' below surface. The total BTEX concentrations declined with depth to below the laboratory detection limits at 2.0' below surface at both trench locations.

SPILL AREA APPROX.  
20'x90'

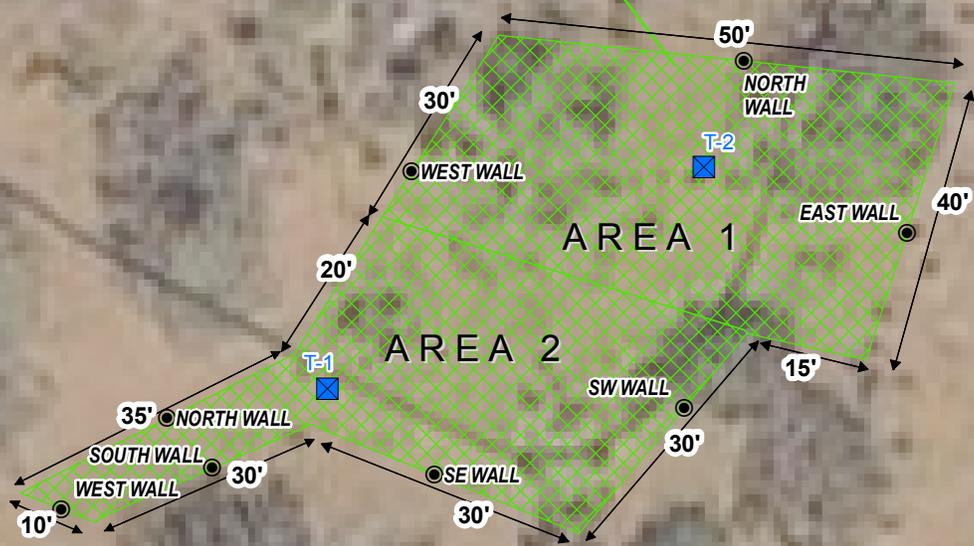
On June 19-20, 2017, Tetra Tech personnel were onsite to supervise the excavation and remediation activities. The excavated areas and depths are shown on Figure 4 and highlighted (green) in Table 1. The areas of trenches (T-1 and T-2) were excavated to 1.0' below surface. A total of five (5) sidewall samples (West Wall, North Wall, South Wall, South East Wall, and South West Wall) were collected in the area of trench (T-1) and three (3) sidewall samples (North Wall, East Wall, and West Wall) were collected in the area of trench (T-2).

Tetra Tech field screened the samples for soil headspace gas survey measurements of the relative concentration of volatile organic constituents in the soils. The concentration of organic vapors were measured using a photo-ionization detector (PID). Based on the field screening, the excavation footprint expanded accordingly to ensure proper removal of the impacted soils. Selected samples were analyzed for BTEX by EPA Method 8021B. Copies of the laboratory analysis and chain-of-custody documentation are included in Appendix C. The sampling results are summarized in Table 1. The sidewall sample locations are shown on Figure 4.

Excavation Areas & Depths Map

Referring to Table 1, all of the sidewall samples collected showed total BTEX concentrations below the RRAL's with concentrations ranging from <0.00200 mg/kg to 0.302 mg/kg. Once the excavation was completed, the areas of trenches (T-1 and T-2) were backfilled with clean material to grade. Approximately 180 cubic yards of excavated material was transported offsite for proper disposal.

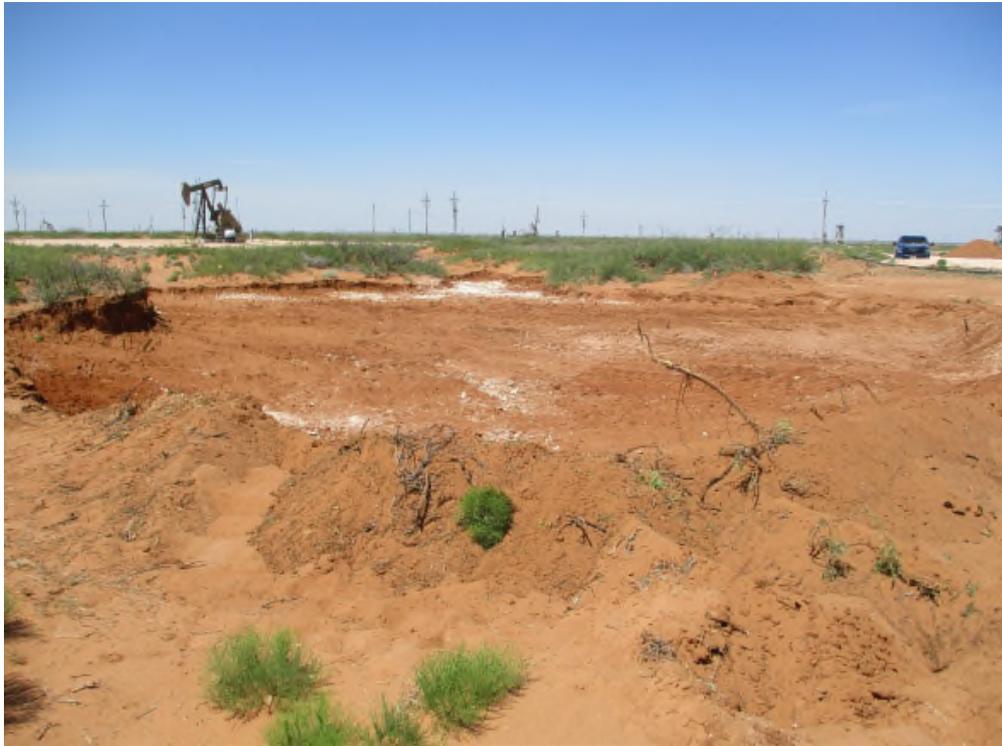
View Southwest – Excavated Area of T-1

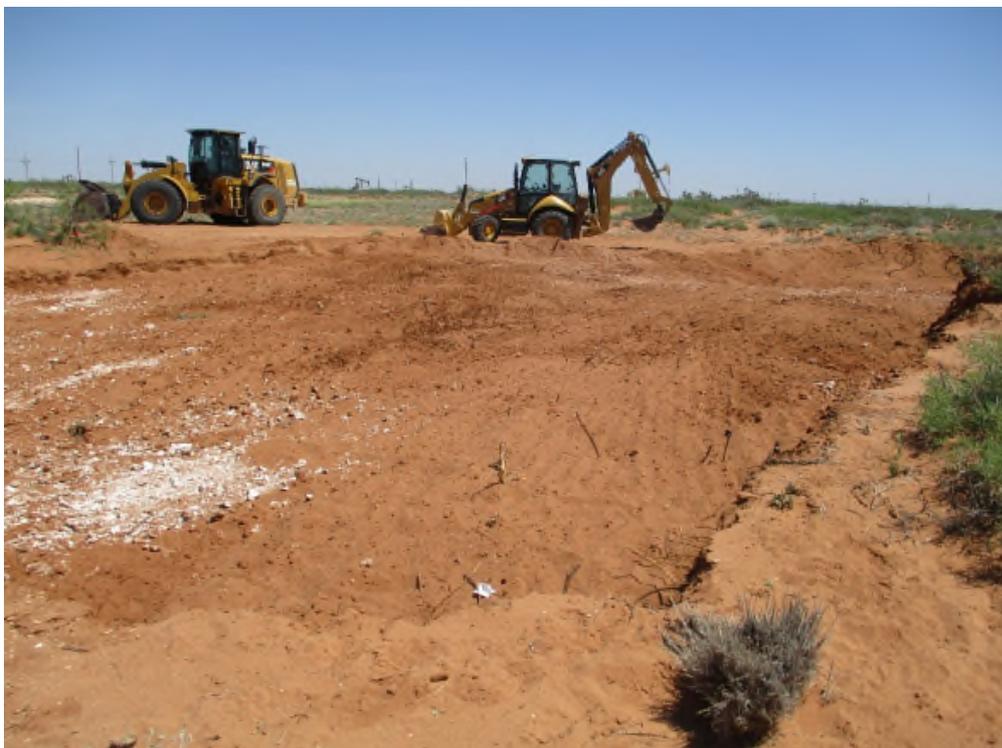
View North – Excavated Area of T-2

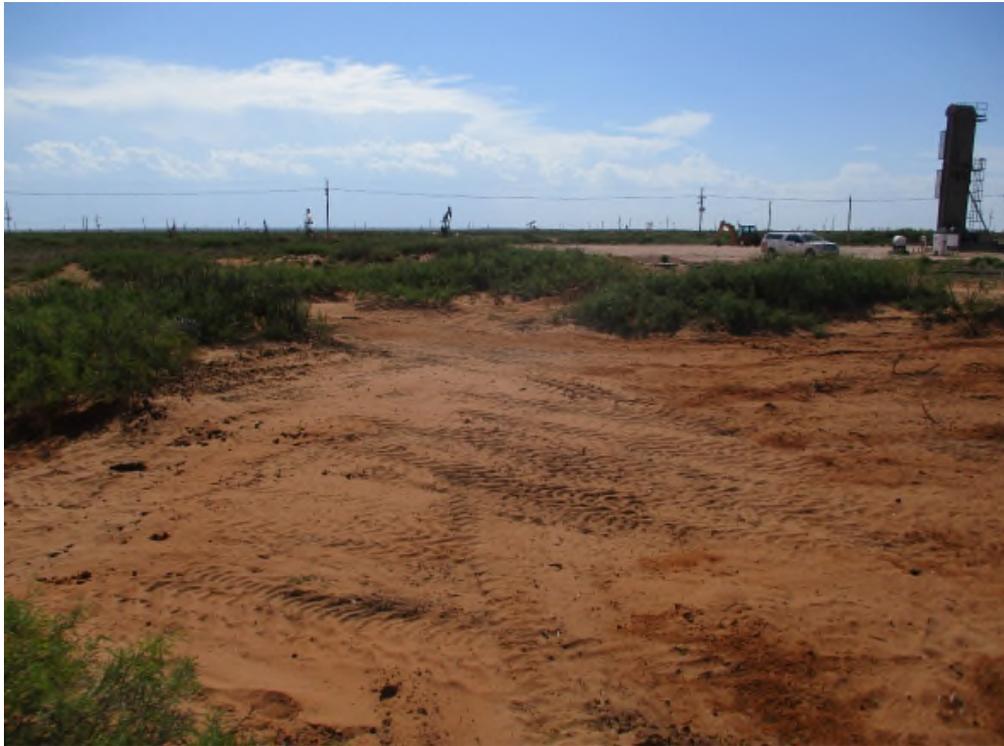
View Southwest – Backfilled Area of T-1

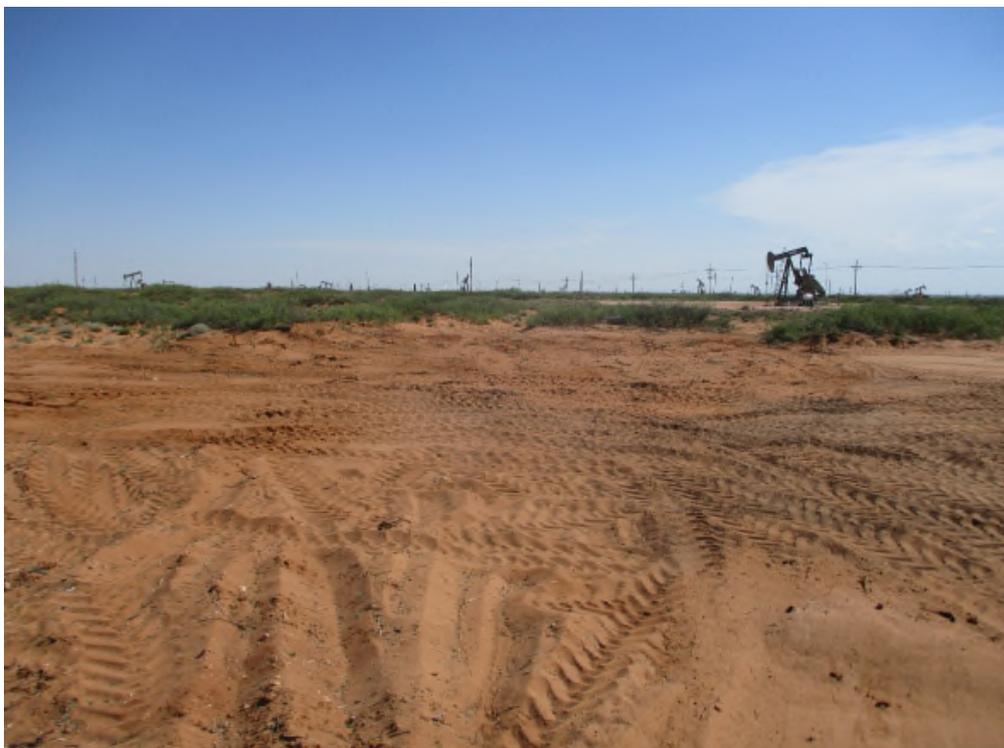
View Northwest – Backfilled Area of T-2
