Southwest Royalties, Inc. respectfully submits the enclosed Release Characterization Report and Remediation Work Plan for release site 2RP-4322.

Subject: Release Characterization Report and Remediation Work Plan

Location: Southwest Royalties, Inc.
POGO 36 State #1 Battery
NMOCD Remediation Case #2RP-4322

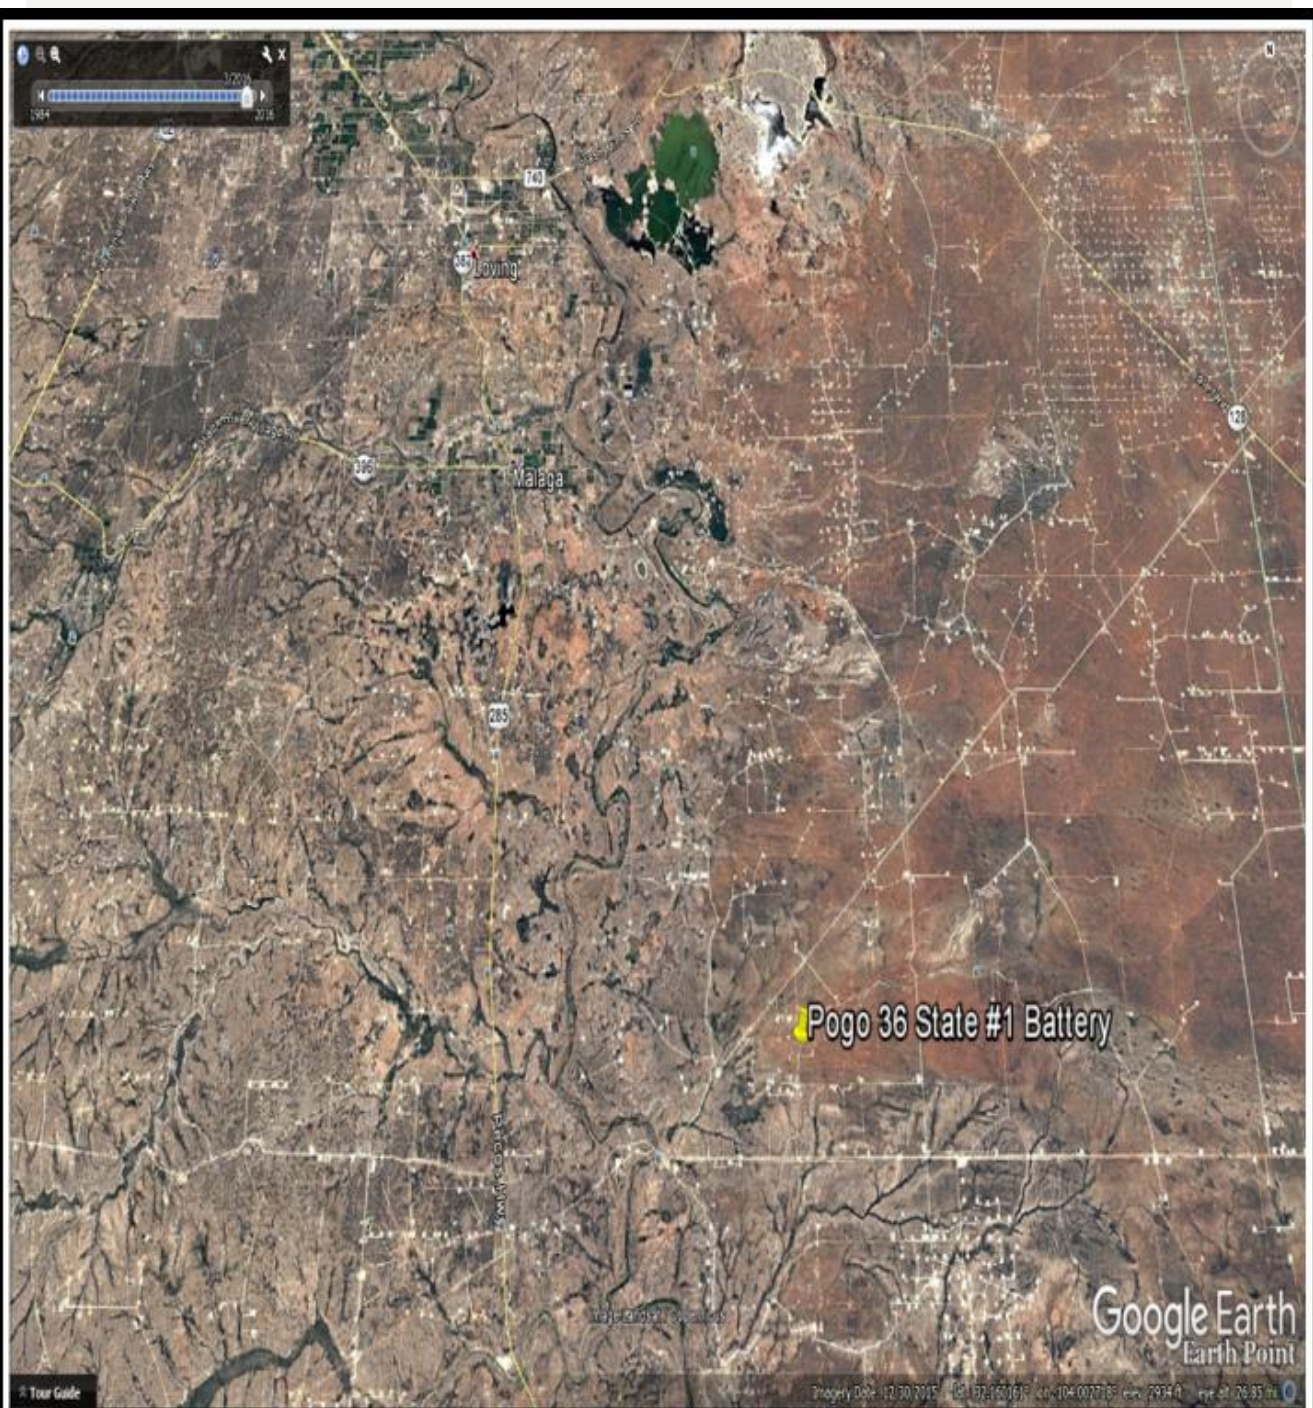
Site Map 1

Southwest Royalties Inc.
Pogo 36 State #1 Battery Spill
Eddy County, NM
GPS 32.085529N,-103.945357W

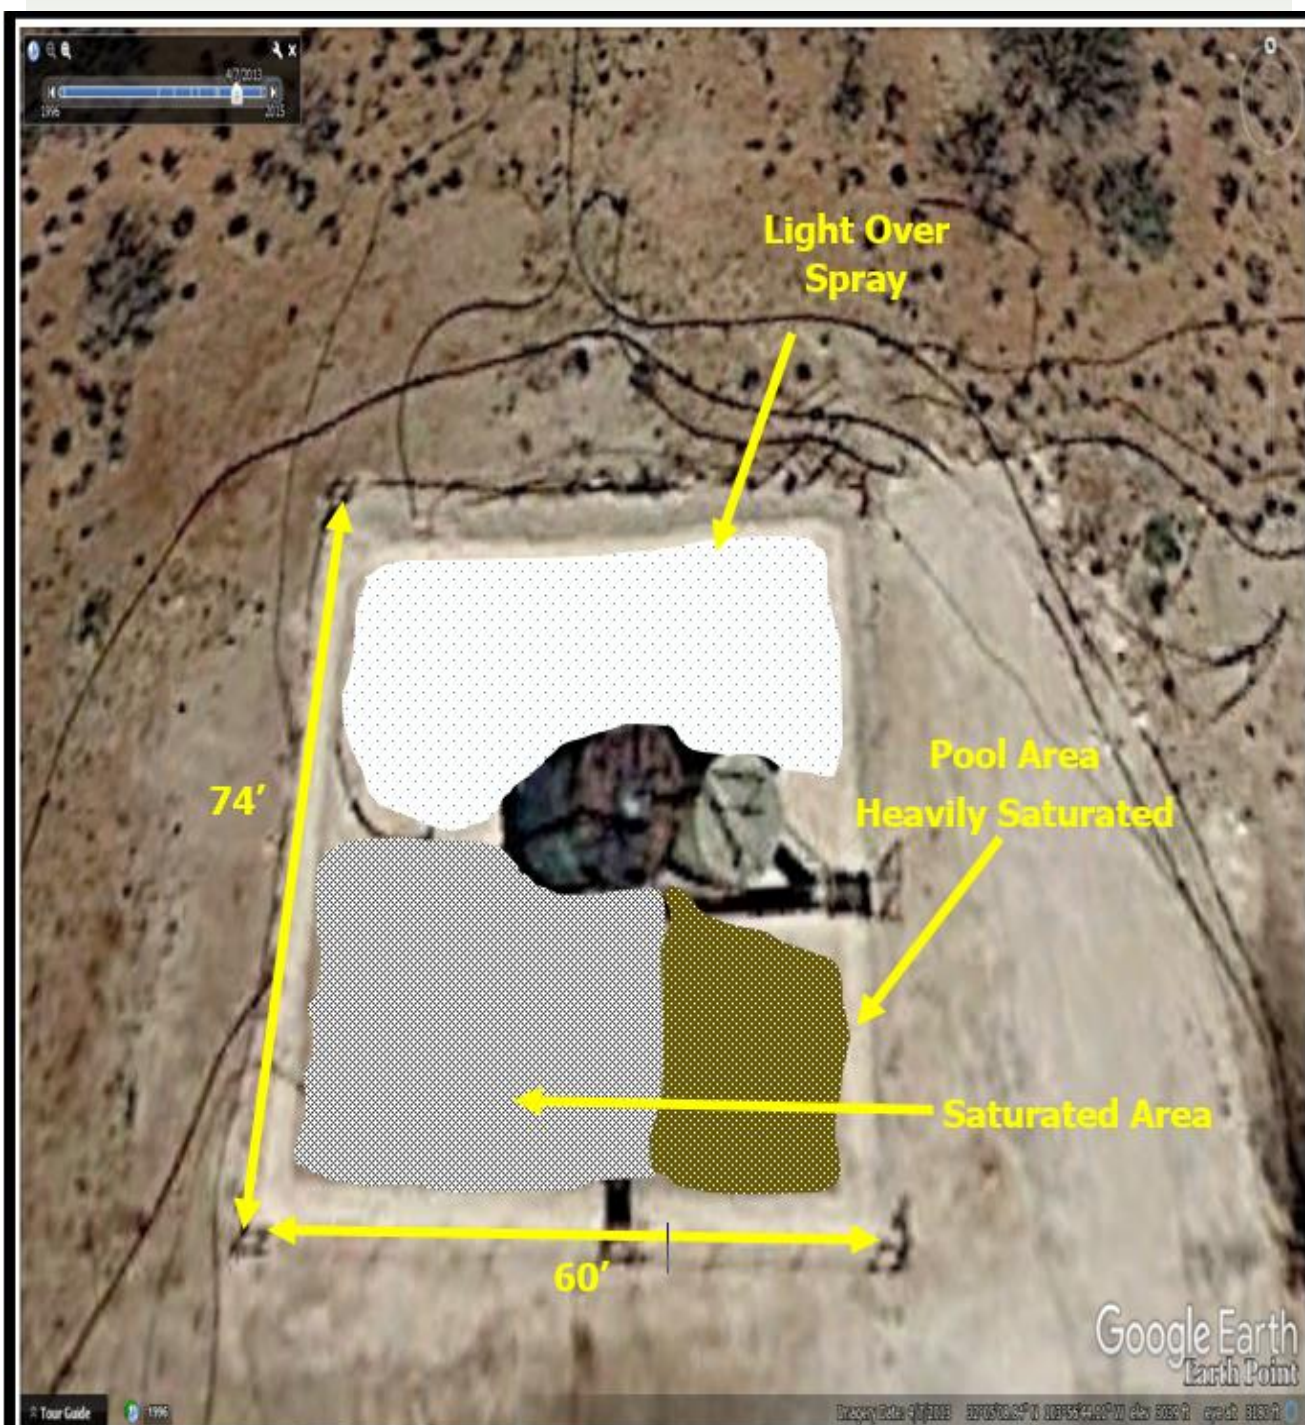
Site Map 2

Southwest Royalties Inc.
Pogo 36 State #1 Battery Spill
Eddy County, NM
GPS 32.085529N,-103.945357W

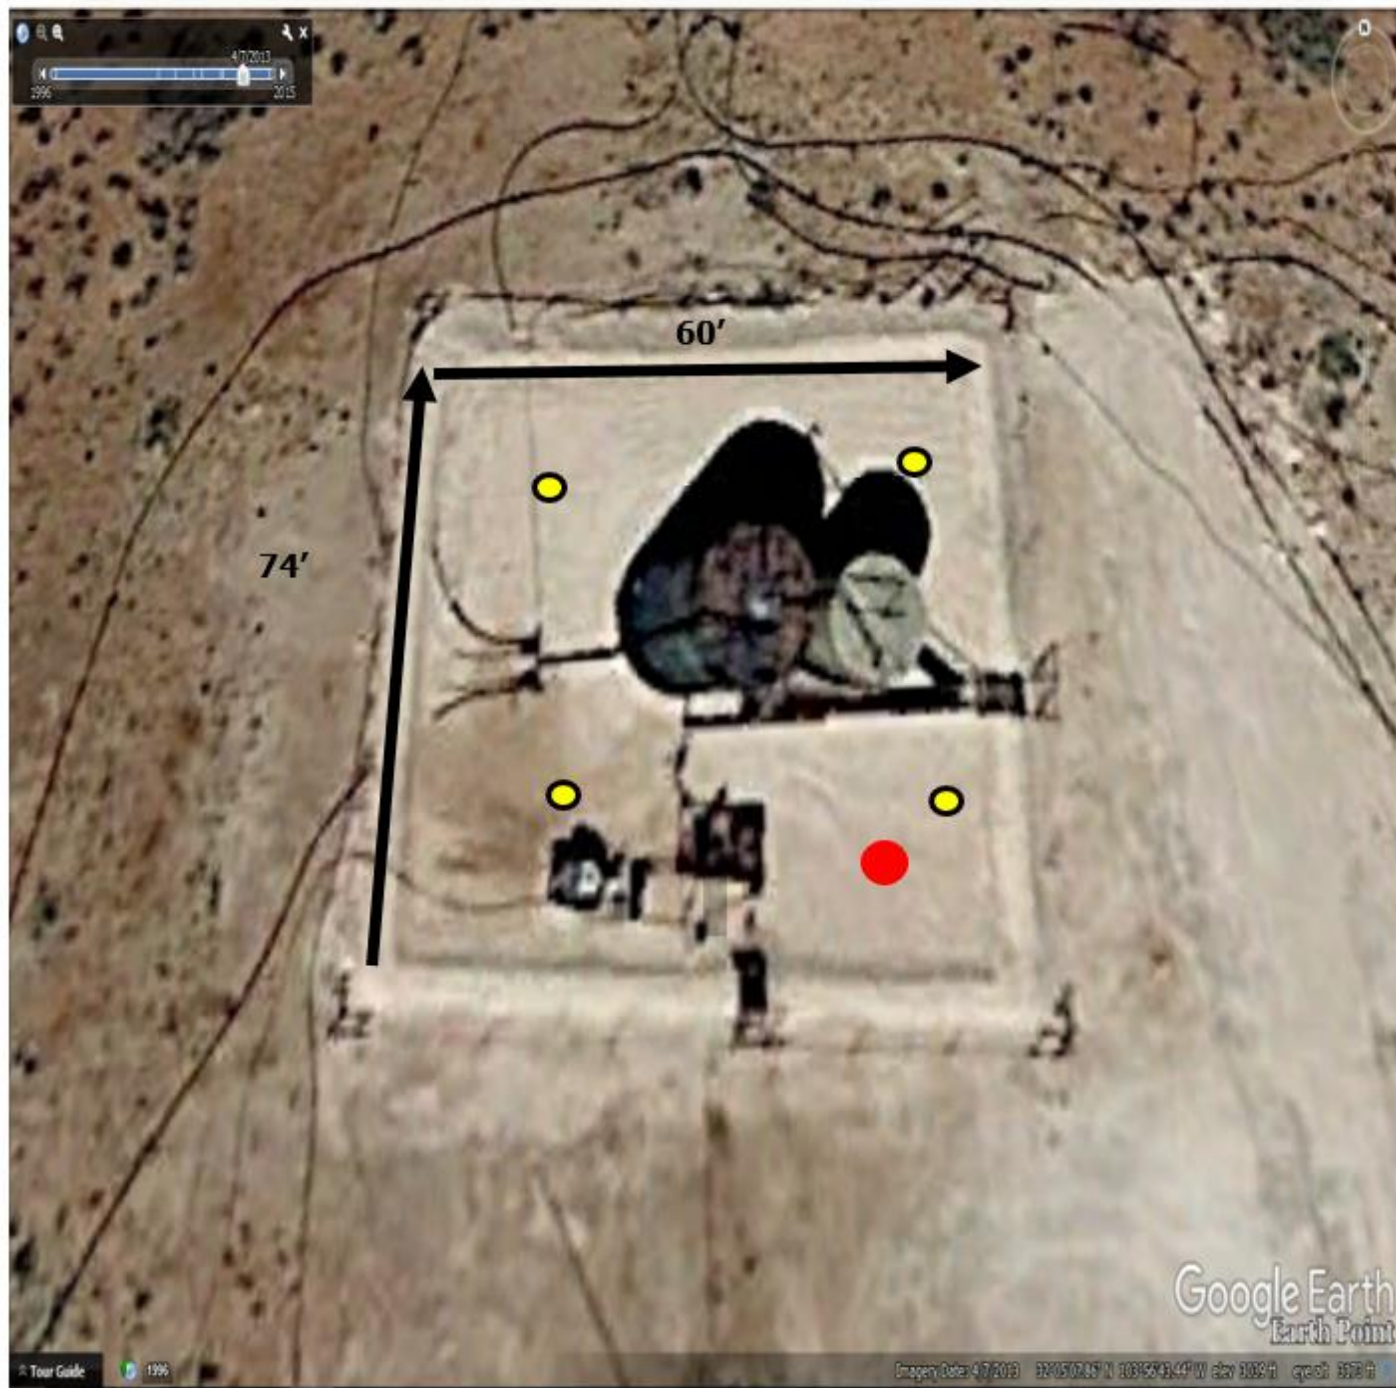
Appendix VI
Field Samples
Bore Hole

6/29/2017 - Republic used a hand auger to perform four field samples. (See Appendix VI). Field Samples POGO 1, POGO 2, POGO 3, POGO 4 were collected at 4' bgs. All soil samples were performed by Republic Backhoe Service LLC personnel wearing clean nitrile gloves. Field Samples were conducted at the following GPS Coordinates:

On 9/20/2017 and 9/22/2017 Big Dog Drill Inc. was contracted to drill a bore hole at the Pogo 36 State #1 Battery. Based on field sample results conducted on 6/29/2017, one bore hole was drilled to satisfy the vertical delineation requirements. The bore hole (1) was drilled in the pooling area inside of the battery bermed area at the following GPS Coordinates 32.085485N, -103.945329W (See Appendix VI). Samples were taken at 5', 10', 15', 20', 25', 30', 38' 40', 45', and 50' bgs. The soil samples were placed in laboratory provided sample containers and transported to Cardinal Labs in Hobbs, NM for analysis. The chlorides samples were analyzed per Method SM4500C1-B.

See Appendix VI for Site sample points.
