REMEDIATION WORK PLAN

**Concho Operating, LLC.
Burch Keely Water Flood Satellite C
Eddy County, New Mexico
Unit Letter "H", Section 13, Township 17 South, Range 29 East
Latitude 32.8364334, Longitude -104.0220566
2RP-4052**

September 2017

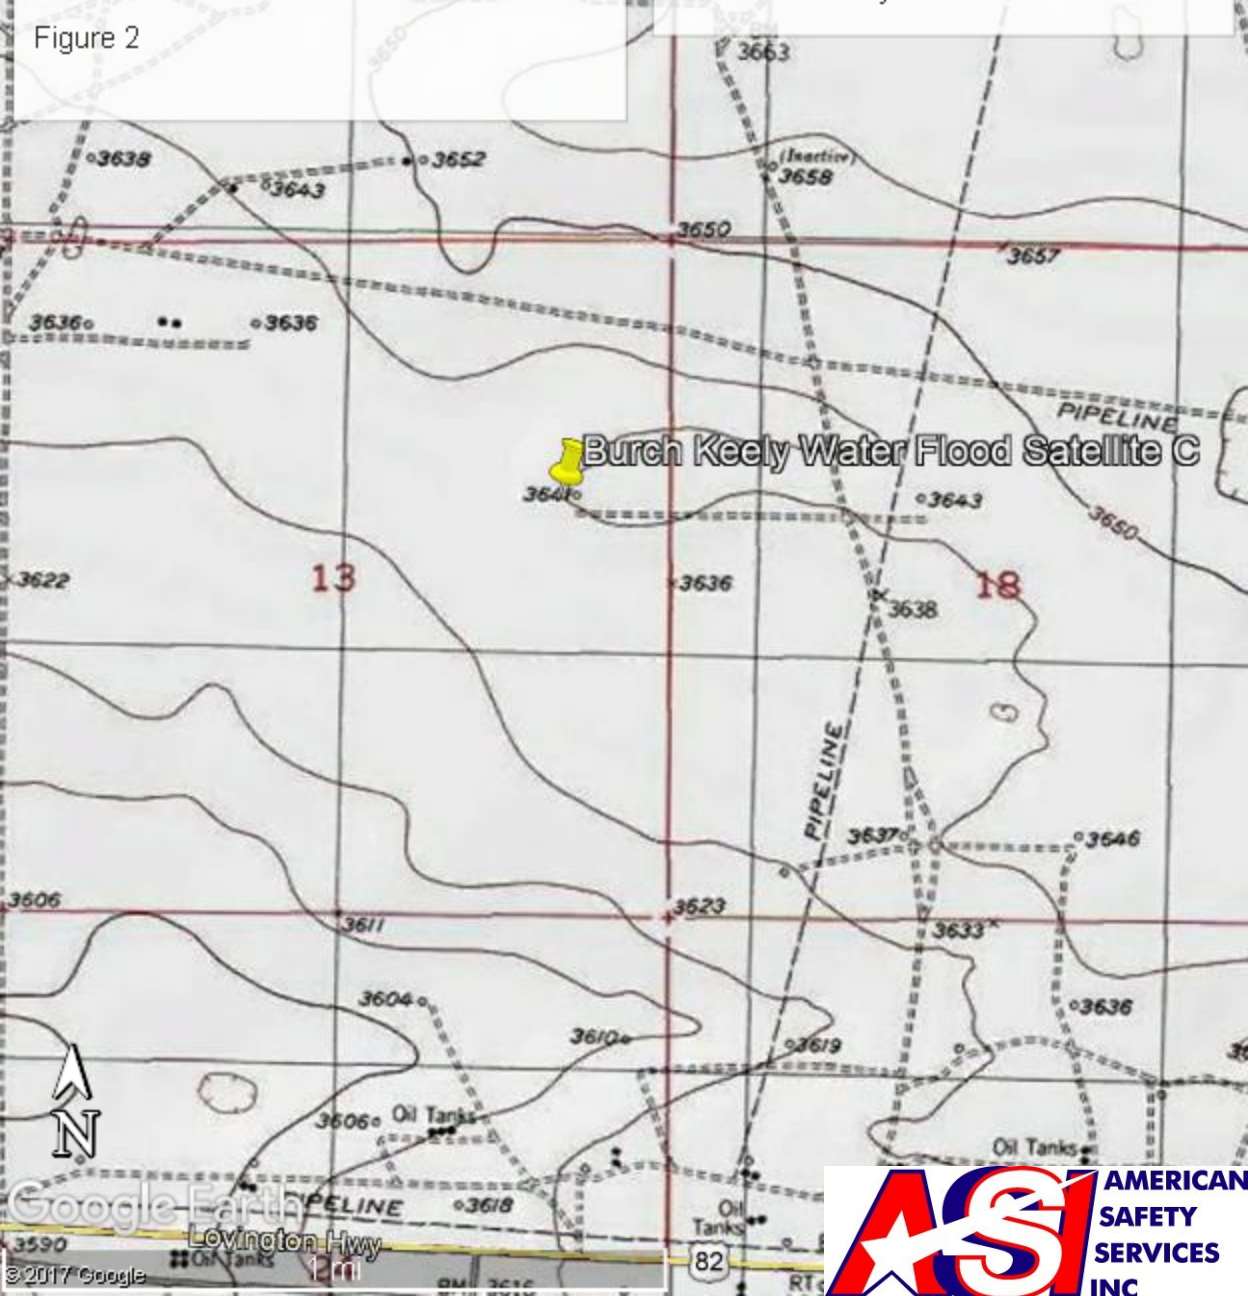
Figure 3

On January 9, 2017, COG and GCI Construction personnel collected samples by means of trenching using mechanical means (i.e., backhoe tractor) in an effort to vertically delineate existing Total Petroleum Hydrocarbon (TPH) and Chloride in soil. Sampling activities were in response to a reportable release directly to the ground that occurred on December 22, 2016. Fifteen (15) barrels (bbls) of crude oil and twenty-five (25) bbls of produced water was released caused by a leak on a buried flowline. Ten (10) bbls of crude oil and twenty (20) bbls of produced water were recovered. The release impacted approximately seven thousand (7000) square feet of pasture area (Figure 3).

BKU Sat. C Release Footprint
-
