REMEDIATION WORK PLAN

**Concho Operating, LLC.
Big Papi Federal Com #002H
Eddy County, New Mexico
Unit Letter "C", Section 04, Township 26 South, Range 29 East
Latitude 32.077566, Longitude -103.986229
2RP-4141**

September 2017

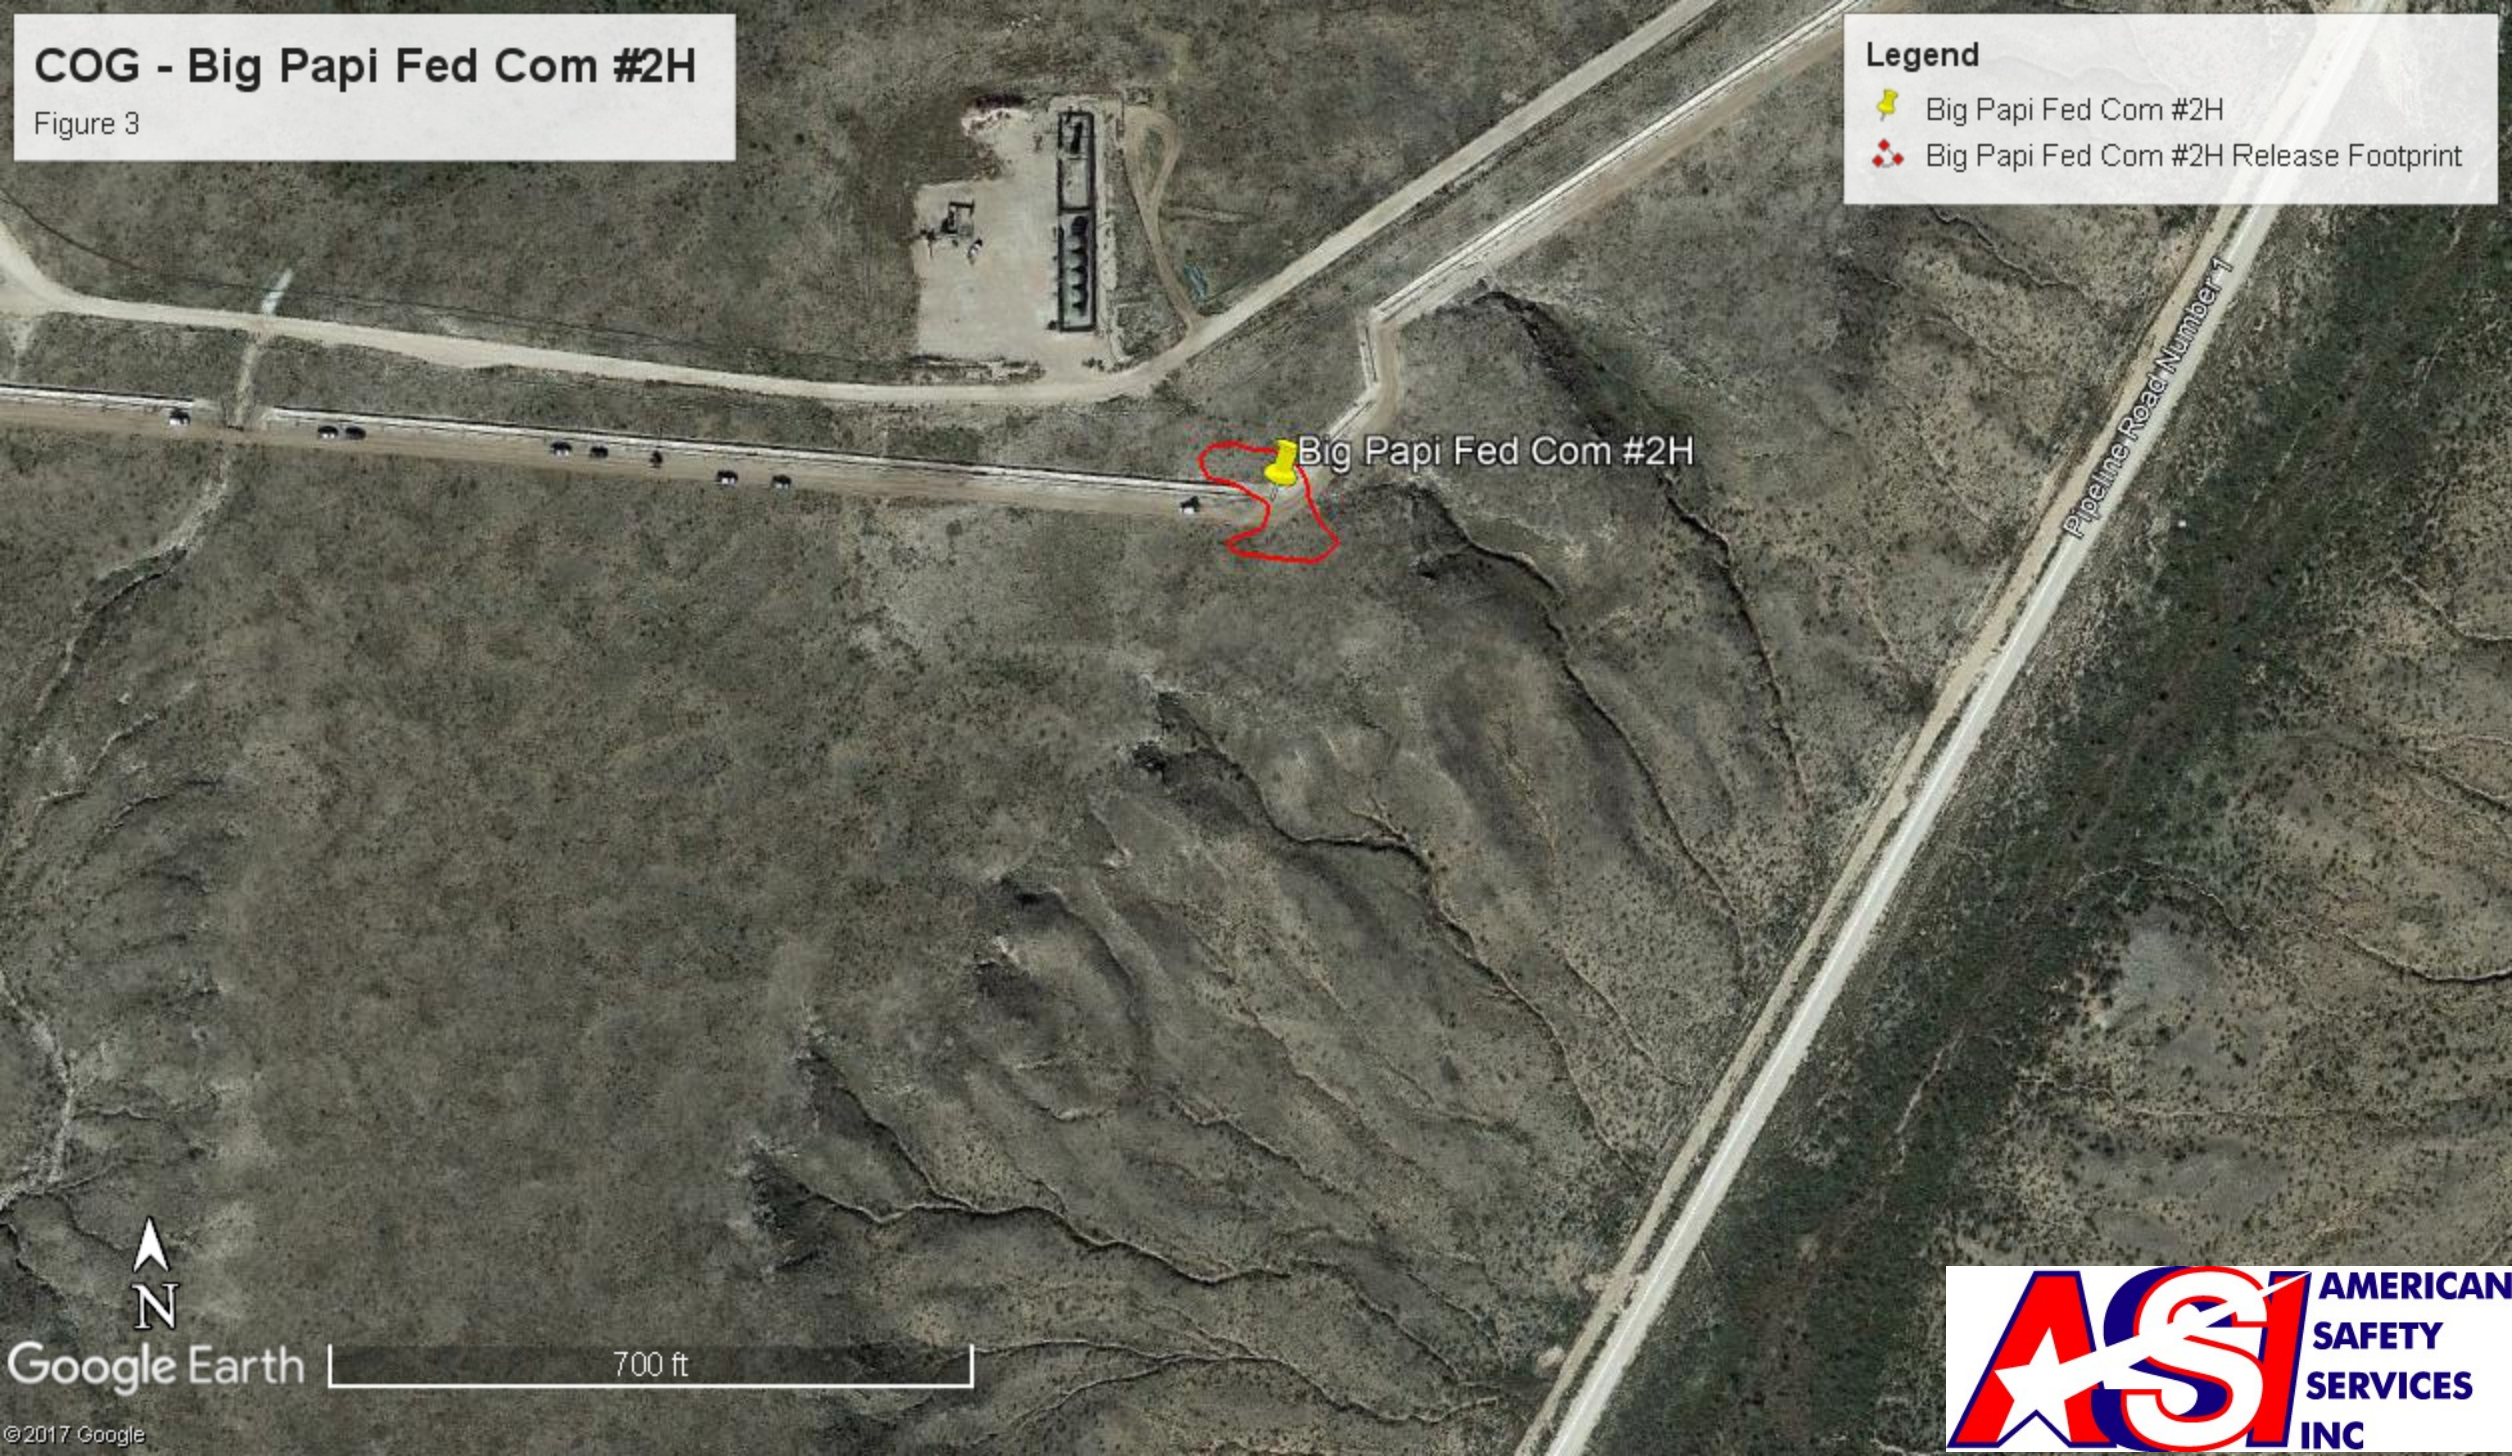
Figure 3

Big Papi Fed Com #2H Release Footprint

On July 26, 2017, ASSI personnel completed drilling and sampling activities utilizing air rotary drilling techniques at the Big Papi Federal Com #002H facility. This action was in response to a reportable release that occurred on February 28, 2017. Thirty (30) barrels (bbls) of produced water was released directly to the ground. None of the fluids were recovered. The release impacted approximately eight thousand (8,000) square feet of pasture area (Figure 3).

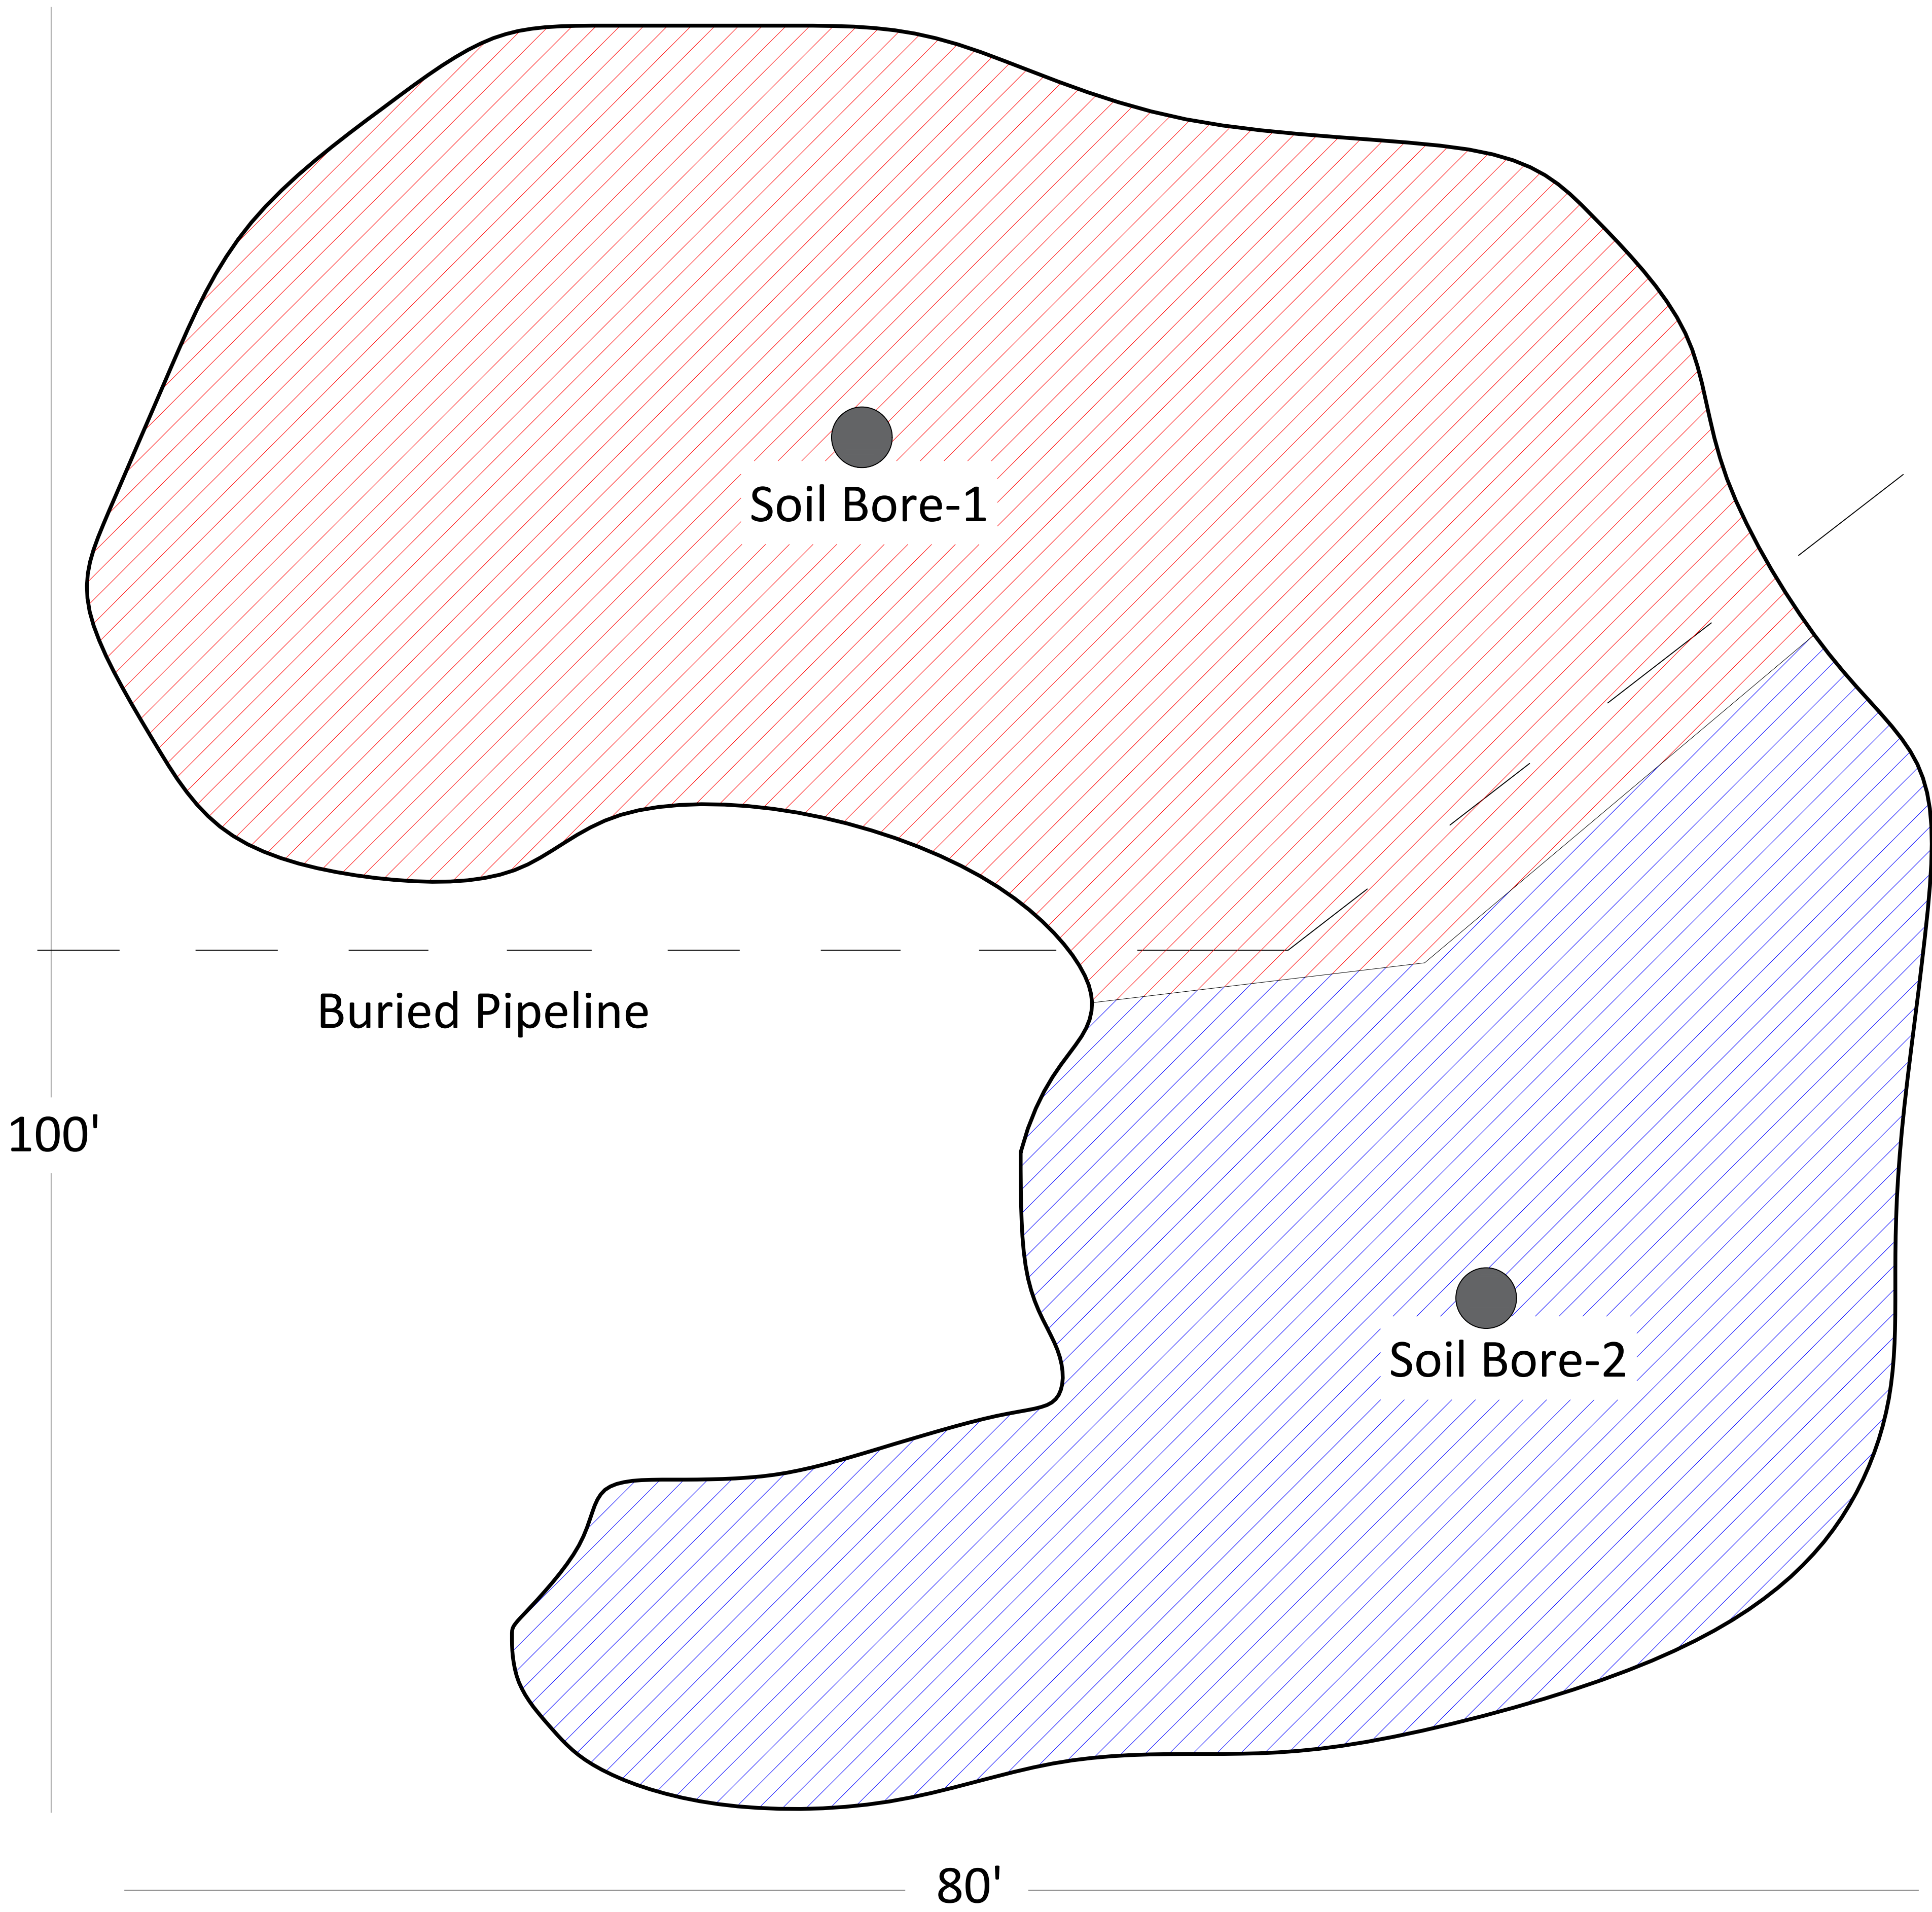
FIGURE 4
Proposed Excavation
Depths

— 4' Excavation
-

— 3' Excavation
-

— Sample Point

Two (2) soil borings (i.e., Soil Bore-1 and Soil Bore-2), were advanced to delineate Chloride at depth. Soil boring locations are shown on Figure 4. Discrete samples were collected from Soil Bore-1 at the following depths: 1', 3', 5', 7', 10', and 20', below ground surface (bgs). At Soil Bore-2 discrete samples were collected at the following depths: 1', 3', 5' 7' and 15' bgs. Soil was field screened for Chloride utilizing electro conductivity during drilling operations.

Figure 4 shows the approximate location of the sampling (i.e., Soil Bore) locations and dimensions of the proposed excavation area in relation to pertinent land features and general Site boundaries, which is included in Appendix A.

Based on the analytical data presented in Table 1, COG and ASSI propose to complete a removal action of the impacted material. The area adjacent to and around Soil Bore-1 will be excavated to a depth of approximately four (4) feet bgs. The area adjacent to and around Soil Bore-2 will be excavated to a depth of approximately three (3) feet bgs (Figure 4). All material will be removed by mechanical means, be temporarily stockpiled onsite and subsequently removed (hauled away) offsite to a proper disposal facility under appropriate manifest. Prior to beginning backfilling operations, sidewall samples will be collected from each excavation in their prospective cardinal direction for Chloride only and submitted for laboratory analysis. The excavated areas will be backfilled to grade with clean imported material and the surface grade contoured to the surrounding landscape.
